# Risk Methods Insights Gained From Fire Incidents

Sandia National Laboratories

U.S. Nuclear Regulatory Commission  
Office of Nuclear Regulatory Research  
Washington, DC 20555-0001

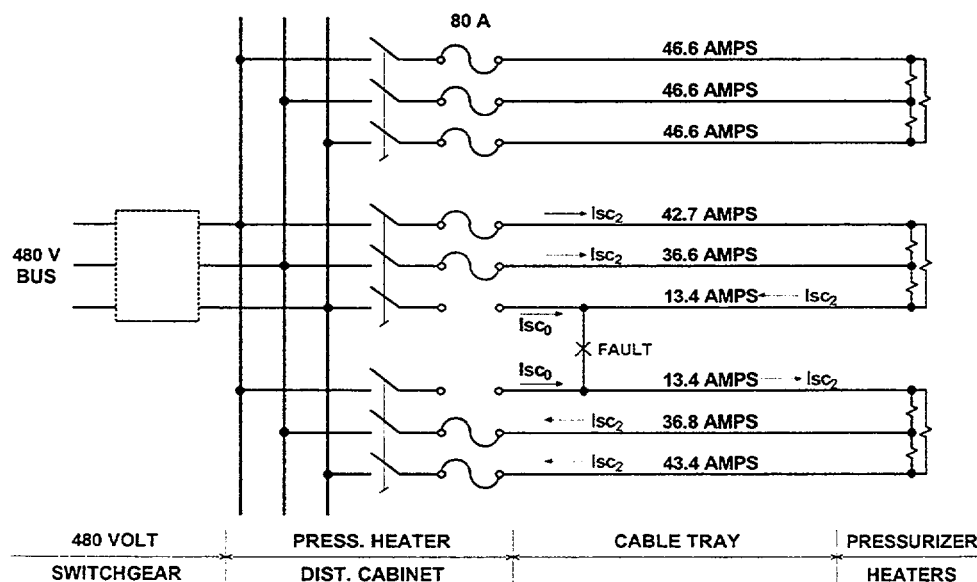
Figure A1-1: Schematic of Pressurizer Heater Circuits.

The initial fault is thought to have been a cable-to-cable, phase-to-phase hot short involving two separate power feeds from the same three-phase power bus. The fusing configuration allowed back-feeding of fault current through the un-faulted phases of each power feed which led to an even more severe over-current condition for the conductors. Figure A1-1 provides a schematic of the power circuit for the pressurized heaters. In that figure,  $I_{SC0}$  depicts the initial short circuit after cable failure and  $I_{SC2}$  is the subsequent short circuit current back-fed through the heaters. Note that the portion of  $I_{SC2}$  passing through the intact fuses is below the continuous rating of each fuse.

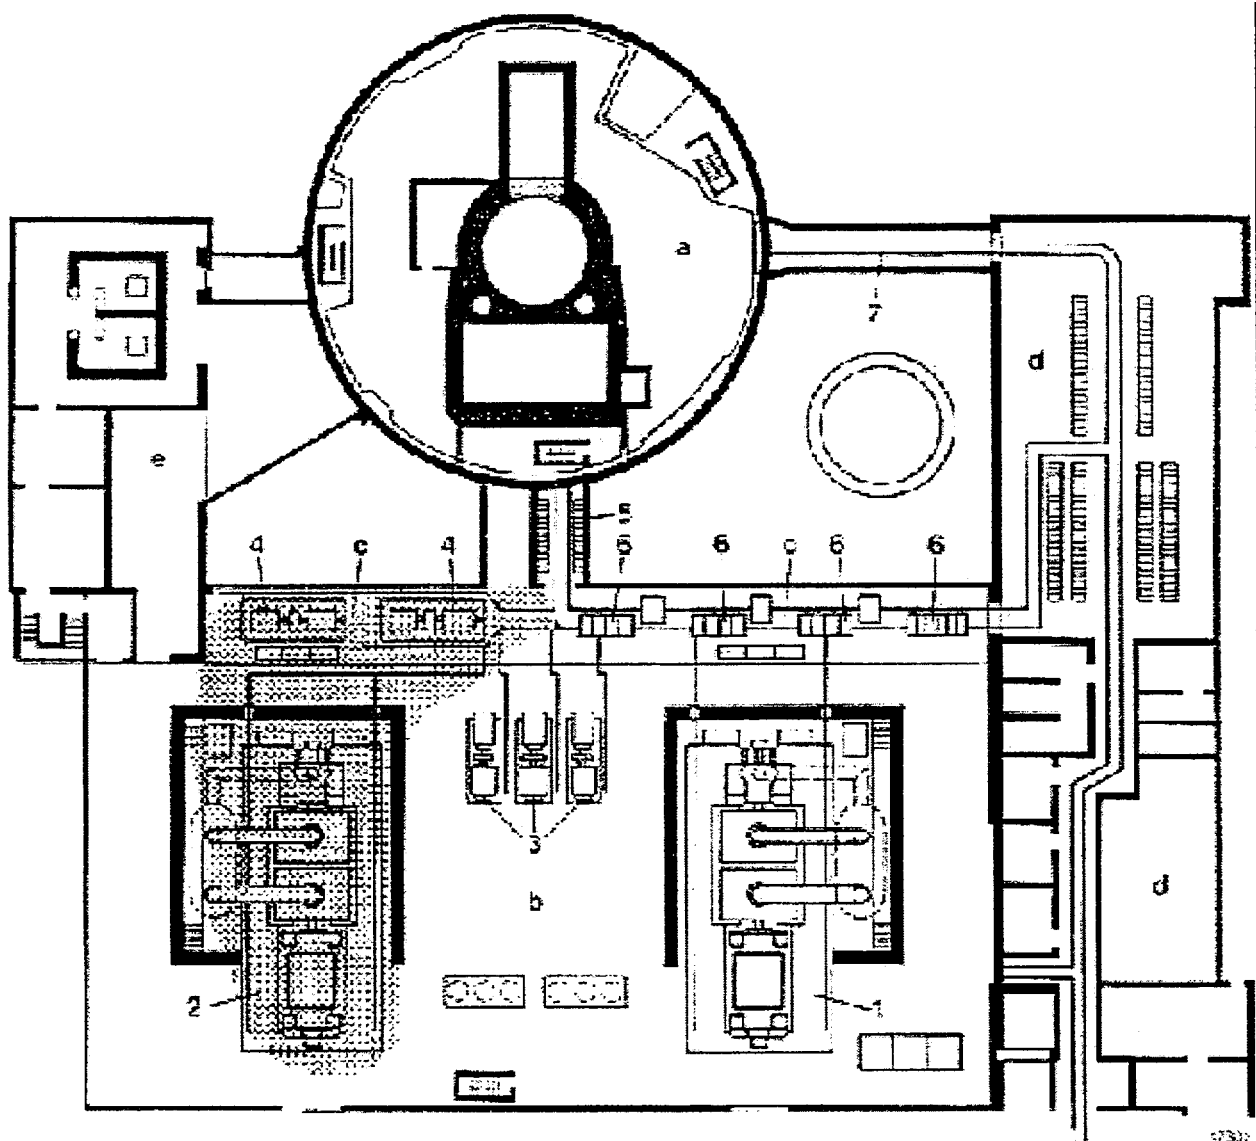
Figure A2-1 Location of Fire at Mühleberg (from Reference [2-1])

Figure A2-1 is a simplified layout drawing of the plant that shows the area where fire occurred. Note that the single lines extending between various items depict cable routes. Item 2 in that figure is the turbine-generator B, item 4 is the two motor generator sets, items 5 and 6 are the non-safety switchgear and item 7 is the cable "bridge" (as noted in Reference [A2-1]) between the reactor and turbine buildings.

Extensive damage was inflicted on the turbine building itself. It is estimated that 75% of the roof

covering, 60% of the windows and 50% of the paintwork were severely damaged. Some of the purlins of the building were deformed, concrete surfaces near the turbine B, a number of gratings and wall insulation slabs were damaged. Aside from cables and electrical equipment, little direct damage was sustained by major mechanical equipment. Some peripheral items, insulation and piping were found to be damaged. However, the cables and electrical equipment sustained extensive damage. Turbine instrumentation, control panels, lighting equipment and 3000 kg of PVC cables were found to be severely damaged.
