May 14, 2002

Subject: Duke Power Company, Oconee Nuclear Station, Unit 1
Docket No. 50-269
Reactor Vessel Head and Penetration Nozzle Condition Report

**Oconee Unit 1
End-of-Cycle 20 Refueling Outage
Reactor Vessel Head Penetration Nozzle Indication Report**

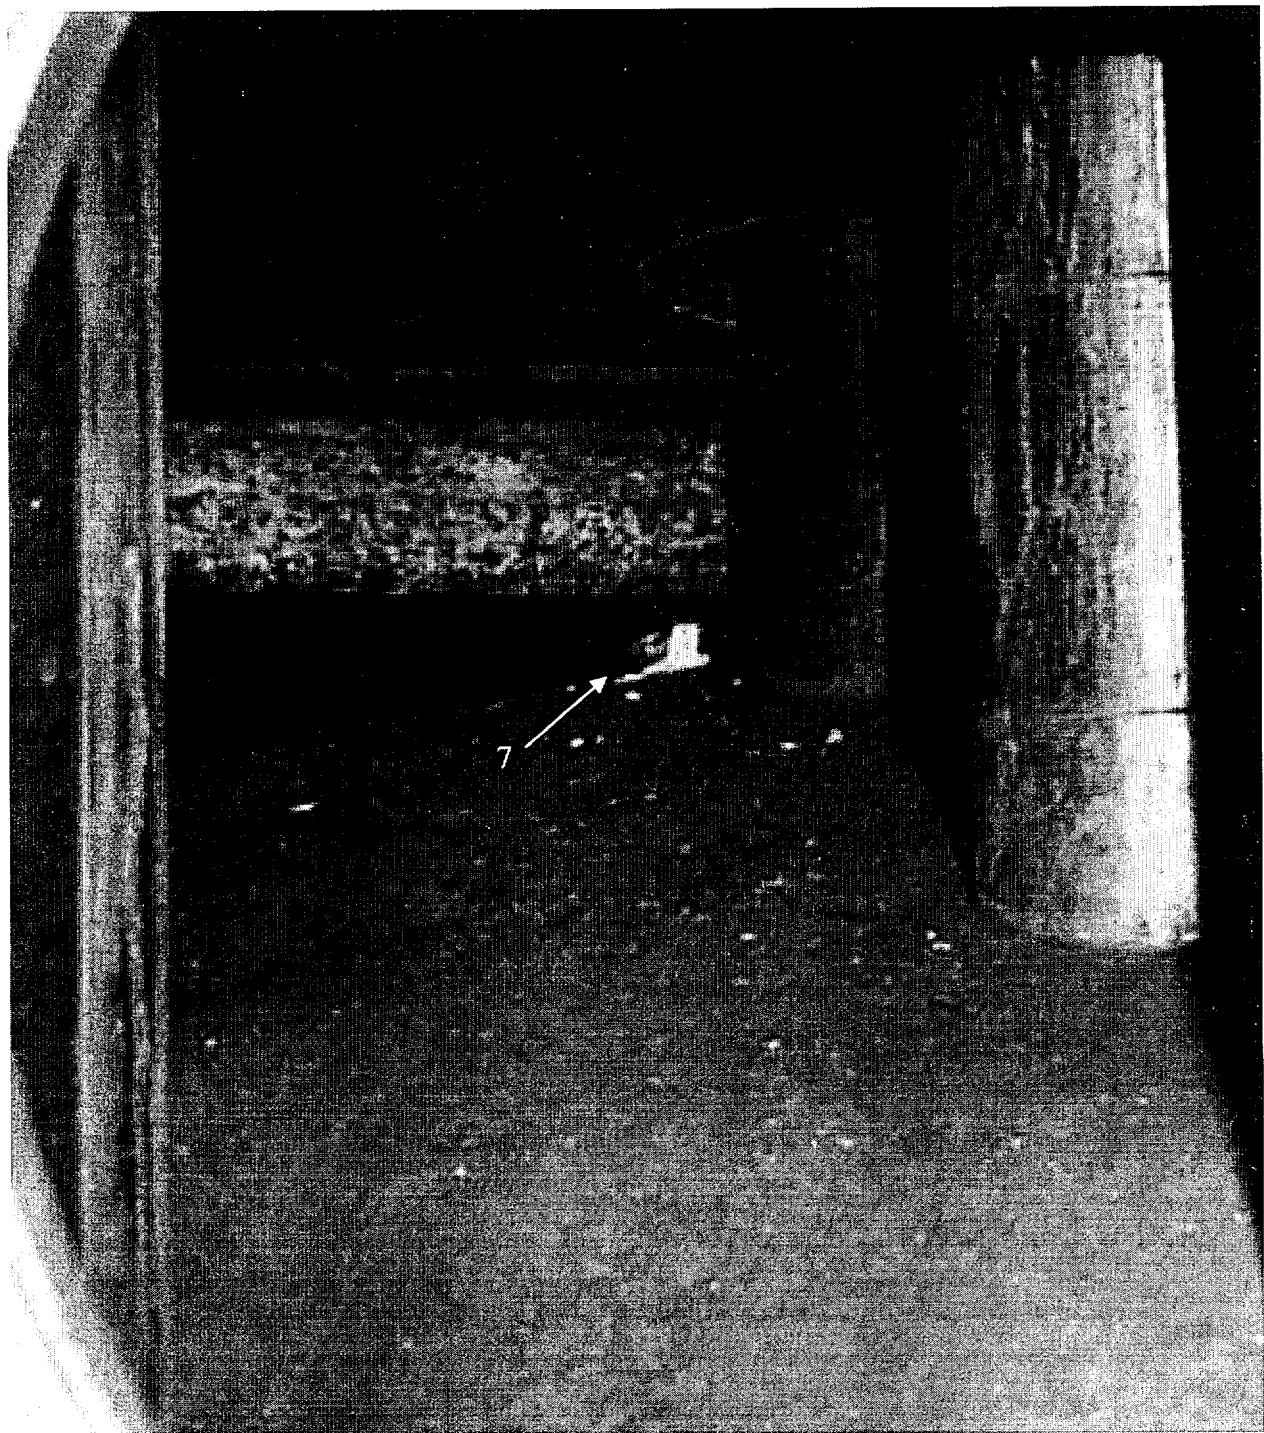
Figure 1 Oconee Unit 1 CRDM Nozzle 7, Top of RV head inspection for Boric acid crystals, 03/31/02

Nozzle 7 was masked by a fresh looking deposit (white) with a band going up the side of the nozzle. The band extending up the nozzle, shown in Figure 1, opened the possibility that the boric acid crystals may have originated from a CRDM flange leak. Further video inspections, after the head was placed on the stand, disclosed that the band stopped before tying into any leakage indications from above (which would be more indicative of a CRDM flange leak). Ultrasonic inspection looking for indications in Nozzle 7, showed 5 axial indications (none of which constituted a leak path within the nozzle) extending from below the J-groove weld up into the nozzle area adjacent to the weld. The longest of the indications extended up about 2/3 of the length through the adjacent weld thickness. The liquid penetrant examination of the bore of Nozzle 7 after removal of the nozzle revealed two axial indications high in the original weld. This could indicate a leak path through the weld. The video inspection for CRDM flange leaks found no leaking flanges, and a review of a video of the top of the head made during the previous outage did not show evidence of the new deposit around nozzle 7. All the evidence above make a circumstantial case that Nozzle 7 was leaking through the weld and that the leak initiated during the past operating cycle.

Two CRDM Nozzles (numbers 7 and 8) were repaired during this outage using the automated Framatome-ANP "ID Ambient Temper Bead Repair" technique as described in the Relief Requests 02-02 and 02-03. Corrective action taken and future outage plans remain consistent with Duke's NRC Bulletin 2001-01 and 2002-01 submittals.

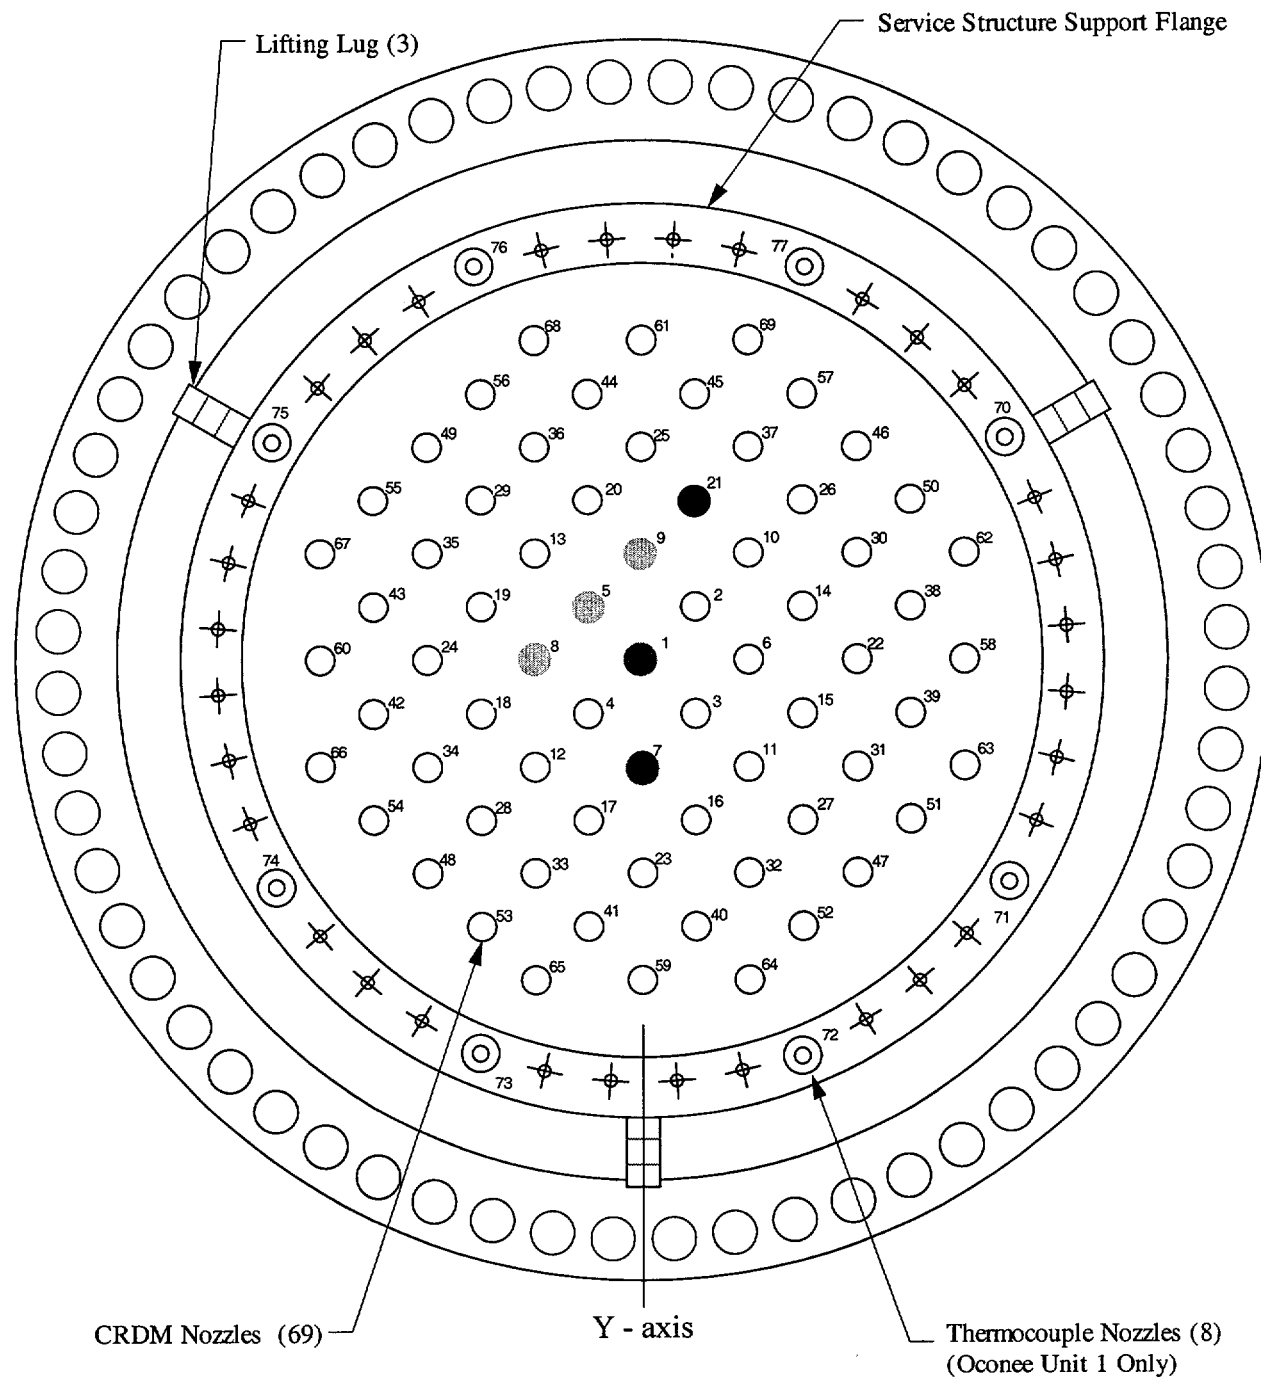
Figure 2 Bare metal visual inspections of RV head, Oconee Unit 1 CRDM nozzles identified as suspect, during EOC-20 refueling outage, March 31, 2002

On March 24, 2002, during the End-of-cycle (EOC) 20 refueling outage, a visual inspection of the top surface of the Oconee Unit 1 reactor vessel closure head while the head was still on the vessel showed two nozzles where boron deposits were evident and their source inconclusive. These nozzles were classified as "masked". This inspection was performed in accordance with Duke's response to NRC Bulletin 2001-01¹ as a "Qualified Visual" inspection. Examination of the eight repaired thermocouple locations did not identify any leakage. Nozzle 1 had a thin film of boric acid crystals surrounding it which appeared to come from an old flange leak. A quantity of boric acid crystal deposits was seen on nozzle 7, however the source of the leakage was not immediately apparent. Three additional CRDM Nozzles (Number 5, 8, and 9) were identified as not being able to see completely 360° around the nozzle and were also examined.

After the head was cleaned and placed on the reactor vessel head stand, a visual inspection was performed looking for wastage. The inspection using fiber scopes where needed was able to see 360° around each nozzle and no wastage was identified. Figure 2 shows the location of the above described CRDM nozzles on RV head for this outage (EOC-20) and the location of Nozzle 21, which was found to be leaking in November 2000.

- Nozzles 1 and 7 identified as masked during EOC-20
- Nozzles 5, 8 and 9 identified as not being able to see 360° around nozzle
- Nozzle 21 identified as leaking by top of head visual inspection during EOC-19 and repaired
