VIRGINIA ELECTRIC AND POWER COMPANY
NORTH ANNA POWER STATION UNITS 1 AND 2
NRC BULLETIN 2002-02 – REACTOR PRESSURE VESSEL HEAD AND VESSEL
HEAD PENETRATION NOZZLE INSPECTION PROGRAMS
30-DAY RESPONSE FOR NORTH ANNA UNIT 2 INSPECTION RESULTS AND
RESPONSE TO NRC REQUEST FOR ADDITIONAL INFORMATION

**30 Day Response of Inspection Scope and Results
NRC Bulletin 2002-02 - Item 2.A**

North Anna Power Station Unit 2

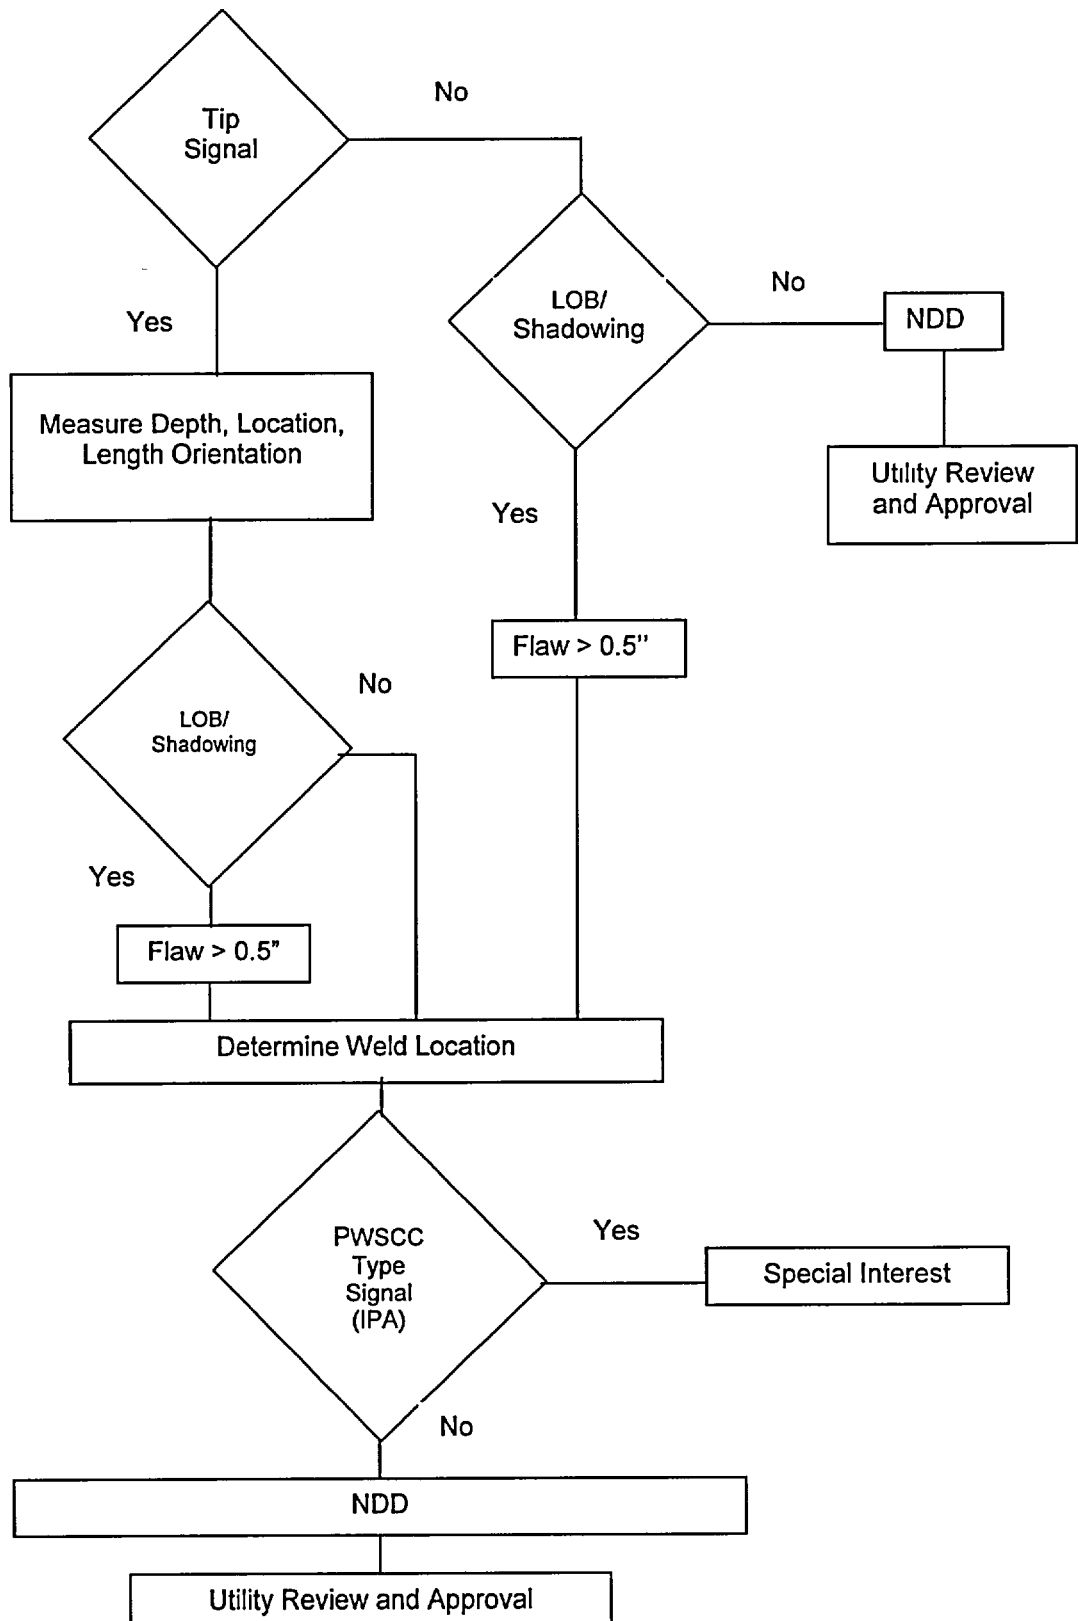
FIGURE 2 - PENETRATION TUBE OD FLAW EVALUATION

fabrication process, including welding, grinding and repair, can produce a variety of false positive ultrasonic indications, these results are not considered conclusive. Many of these signals can be evaluated as non-relevant in the data analysis process. However, a confirmatory OD surface examination is performed to determine if the indication initiates on a wetted surface. For these confirmatory inspections, an eddy current technique is performed on the J-groove and/or the nozzle OD below the weld. In instances where meaningful eddy current results are not possible due to geometric constraints, for example, at the thermocouple column locations (#51, #53, #55, and #57), supplementary penetrant tests are performed. The data analysis logic for evaluation of OD indications is presented in the flow chart in Figure (2).

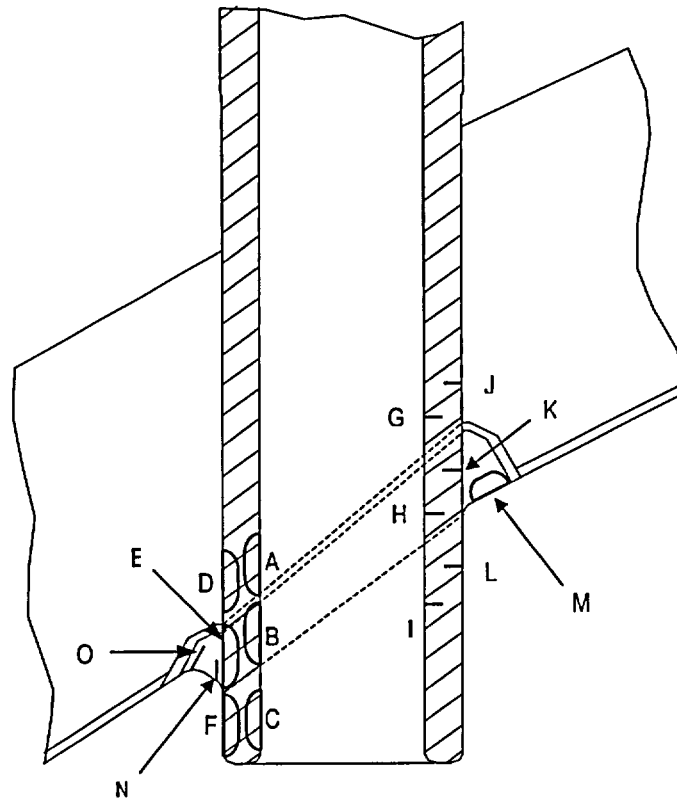
Sketch - Flaw Type/Location Designations

Flaw Designation	Flaw Description	Contained in Mockups
A	ID Axial Above the Weld	Yes
B	ID Axial Over the Weld	Yes
C	ID Axial Below the Weld	Yes
D	OD Axial Above the Weld	Yes
E	OD Axial Over the Weld	Yes
F	OD Axial Below the Weld	Yes
G	ID Circumferential Above the Weld	N/A (Note 1)
H	ID Circumferential Over the Weld	N/A (Note 1)
I	ID Circumferential Below the Weld	Yes
J	OD Circumferential Above the Weld	Yes
K	OD Circumferential Over the Weld	Yes
L	OD Circumferential Below the Weld	Yes
M	Axial/Radial @ Wetted Surface of the J-Groove Weld	Yes
N	Circumferential/Radial @ Wetted Surface @ Head/J-Groove Weld	Yes
O	Circumferential/Radial @ Wetted Surface @ Tube/J-Groove Weld	Yes
Notes:	(1) Presence of back-wall does not influence detection and analysis of ID surface initiated flaws to the degree that it affects OD surface initiated flaws

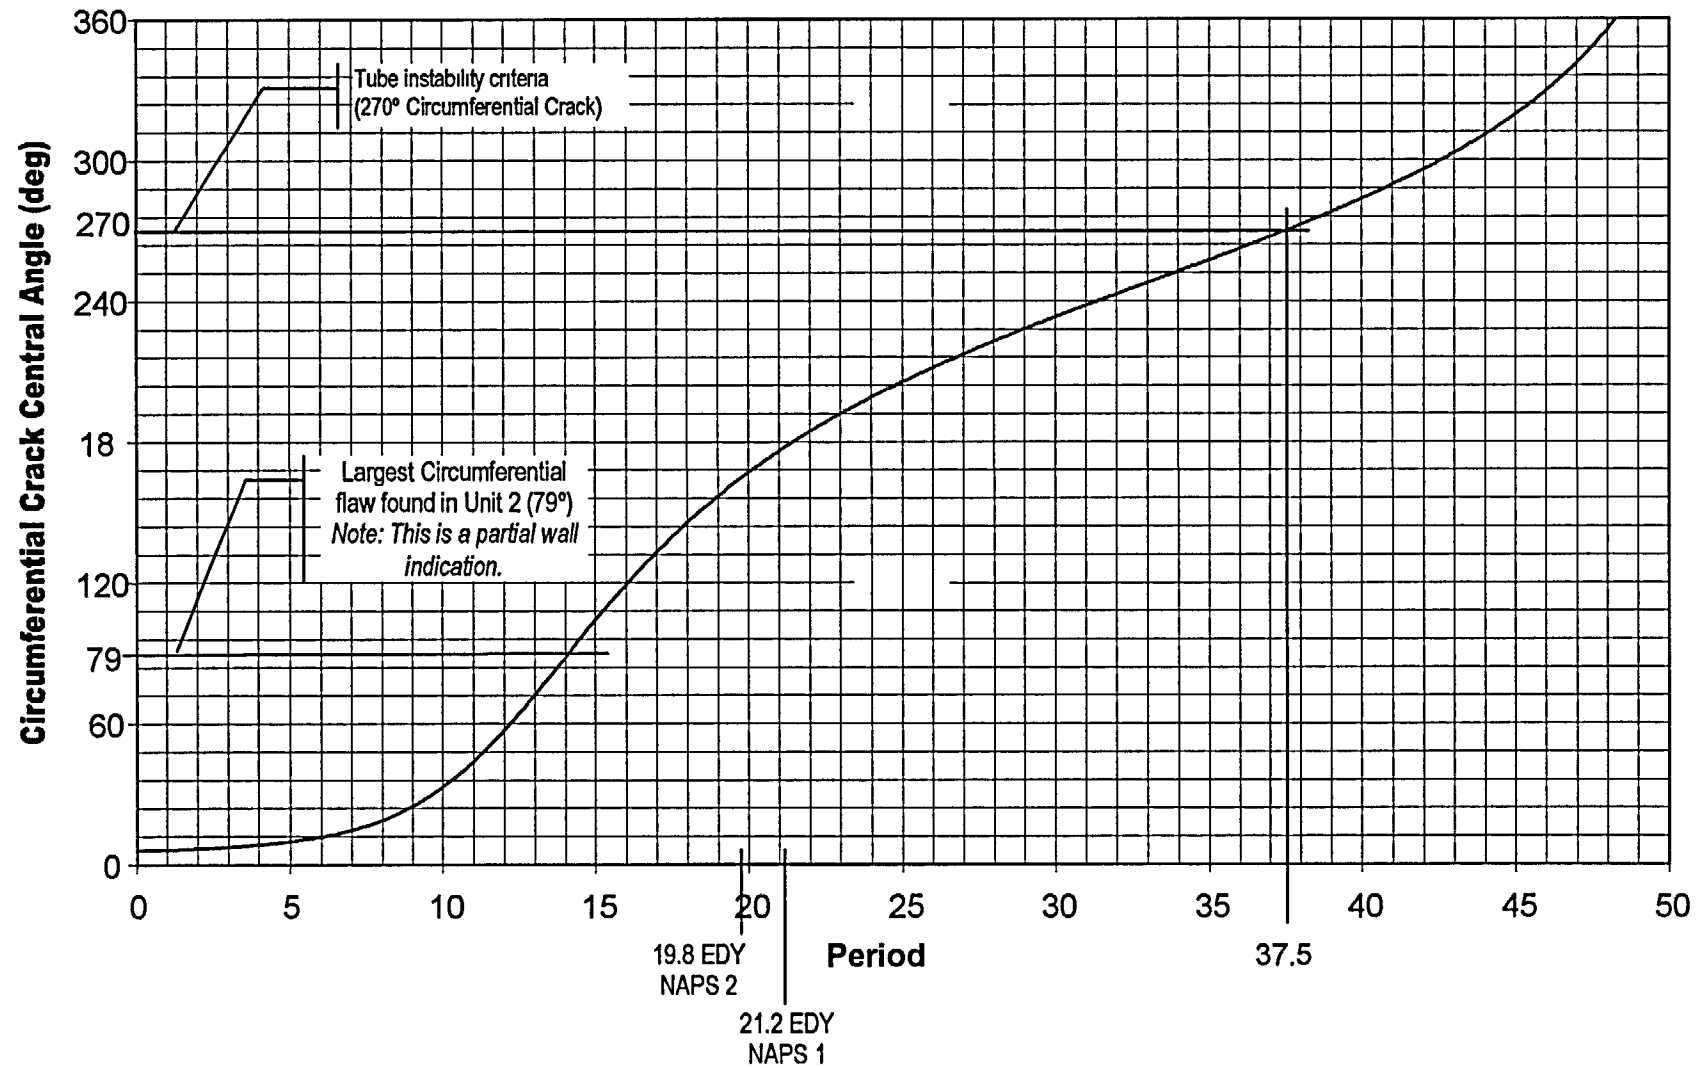
Stress Corrosion Crack Growth Prediction for Circumferential Through-wall Crack Near the Top of the Attachment Weld

Also, a through-wall circumferential crack growth curve (Attachment 1) was developed using the same bases as those contained in Reference 1 except that the latest (i.e., more conservative) crack growth model recommended by the EPRI Material Reliability Program (Reference 4) and stress intensities as developed by the NRC (Reference 5) were used. The curve shows that a circumferential, through-wall crack, if initiated at the beginning life of the plant, would not grow to 270 degrees (3/4 of the circumference), the criteria for determining instability of the tube, until the unit has operated for 37.5 years. Since North Anna Unit 1 will only have 21.2 Effective Degradation Years usage by the 2003 refueling outage when the next inspection would be performed, no circumferential through-wall crack is expected that would approach this criterion. The maximum circumferential flaw size found in North Anna Unit 2 was contained within a central angle of 79 degrees and was part through-wall. However, it is estimated that this flaw would grow to through-wall in 1.8 years, and would require another 24.2 years to reach the 270 degree stability limit. Therefore, the tube would remain stable for approximately an additional 26 operating years.
