November 21, 2002

L-2002-233
10 CFR 50.4
10 CFR 50.54 (f)

RE: St. Lucie Units 1 and 2
Docket Nos. 50-335 and 50-389
Reactor Pressure Vessel Head (RPVH) Inspection
NRC Bulletin 2002-02 Supplemental Response

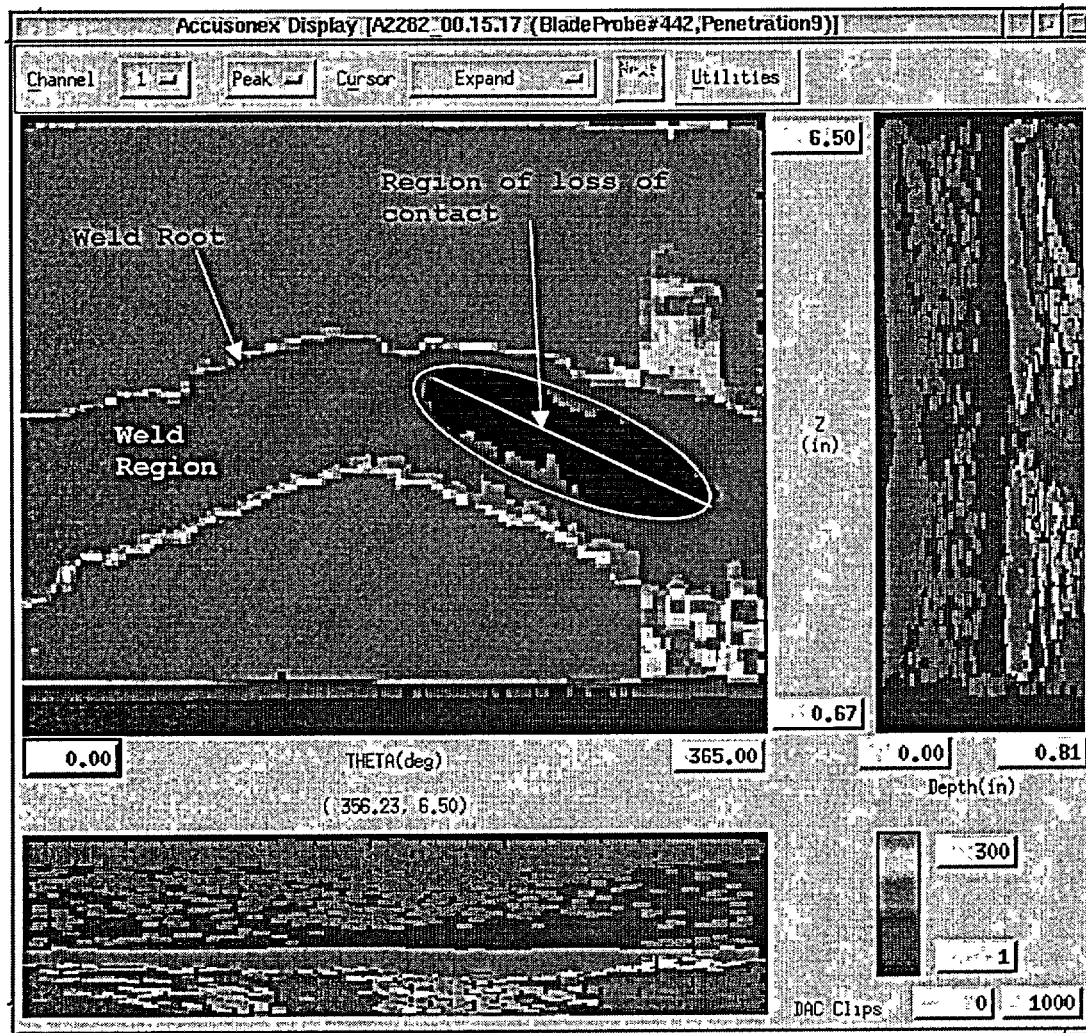
A review of the areas of loss of inspection coverage to evaluate its significance was performed. The inspection coverage was separated into four distinct regions for evaluation. Those regions include the area above the weld root, the area at/adjacent to the root, the nozzle area adjacent to the weld, and the area below the weld. A matrix of the UT inspection weld coverage is shown in Table 2.

Figure 1: Typical UT Scan Showing Lack of Coverage Area in the Nozzle Material Adjacent to the Weld.

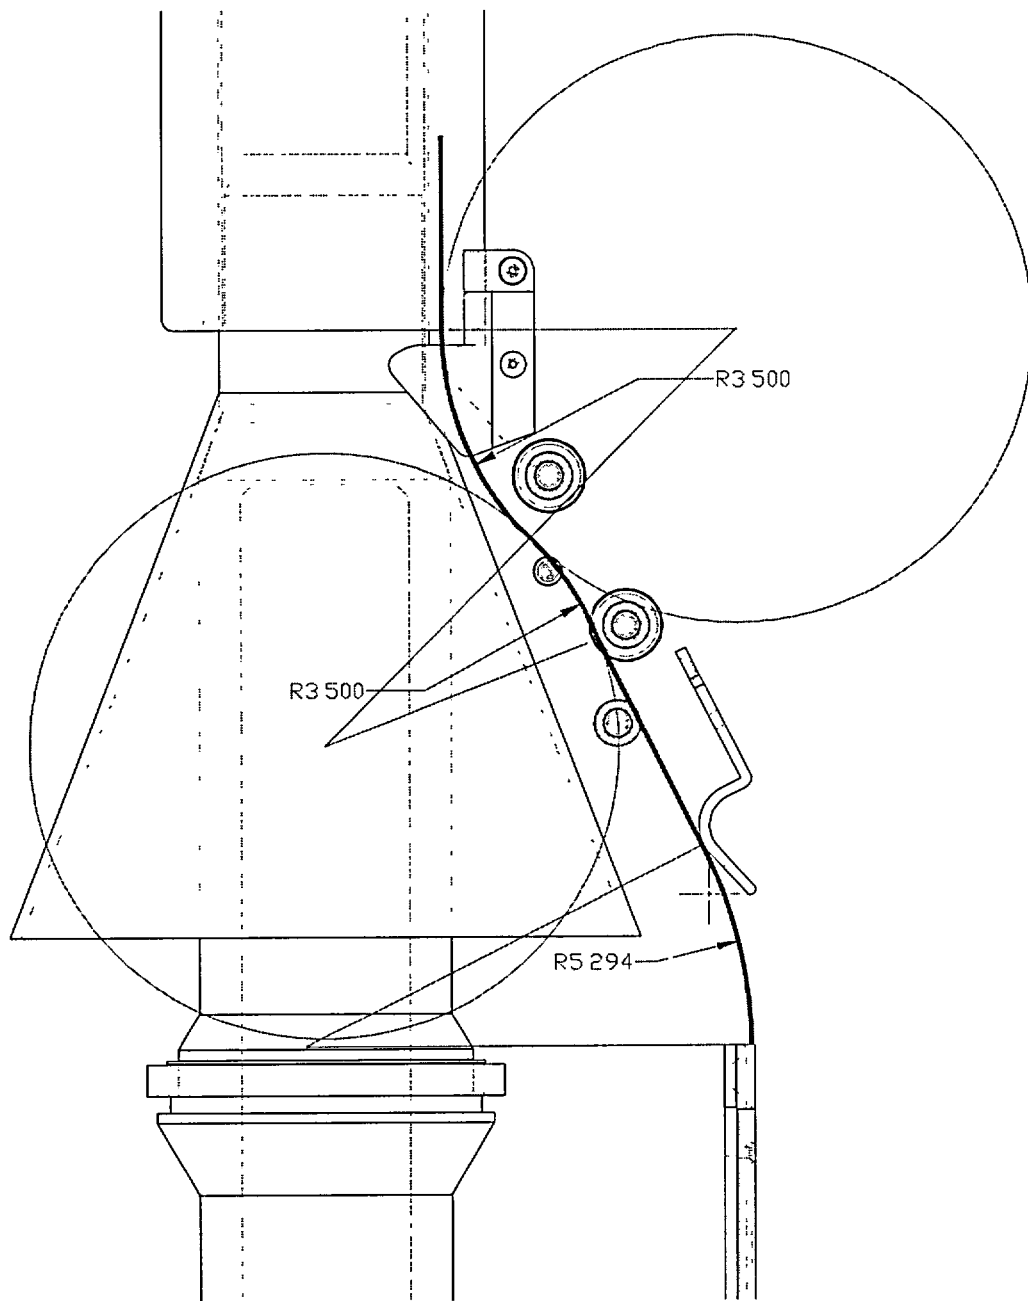
The guide sleeves cannot be moved to adjust the gap between the sleeve and the nozzle penetration. Initially, additional scans were performed in an attempt to provide more coverage of the examination area. Also, slower probe speeds, additional couplant, and different probe designs were tried. The rescans were unsuccessful in providing additional coverage of the examination area. It is the inspection vendor's position that the data supplied is the best that could be provided using blade probes.

Figure 2: UT Blade Probe Path to Inspect the St. Lucie Unit 1 CEDM
(Dimensions are in inches)

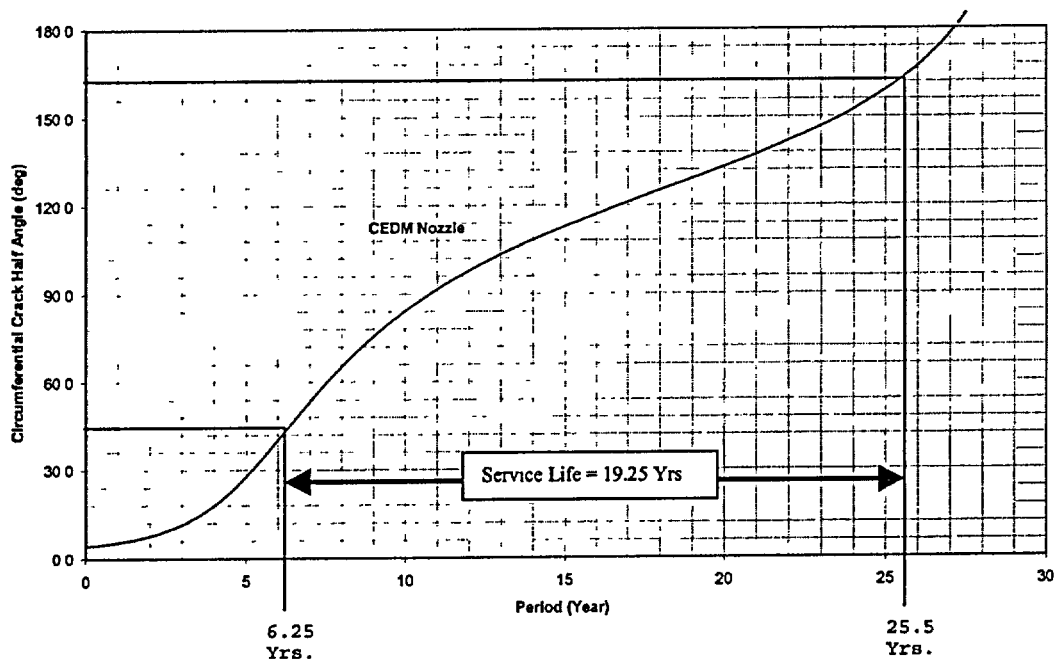
uncertainty. Based on the UT inspection results of no indications in the nozzle area examined at the weld root and above, and this evaluation, there are no concerns with the structural integrity of the RVHPs for over 19 years of operation. This conclusion postulates a circumferential crack in the missed coverage areas in the RVHP material at the weld root or above. The RVHPs will be reinspected with UT within 4 effective degradation years (EDY) not to exceed 10 EFPY and visually inspected at every refueling outage, based on the current MRP-75 recommended reinspection interval.

Figure 3: Crack Growth Predictions for an 85° Circumferential Through-Wall Flaw Near the Top of the Attachment Weld for CEDM Nozzles (This figure is based on Figure 6-21 from WCAP-15945-P with the MRP-55 factor of 2.0 included)
