UNITED STATES NUCLEAR REGULATORY COMMISSION OFFICE OF NUCLEAR REACTOR REGULATION WASHINGTON, D.C. 20555

March 31, 1995

NRC INFORMATION NOTICE 95-18, SUPPLEMENT 1: POTENTIAL PRESSURE-LOCKING OF

GATE VALVES

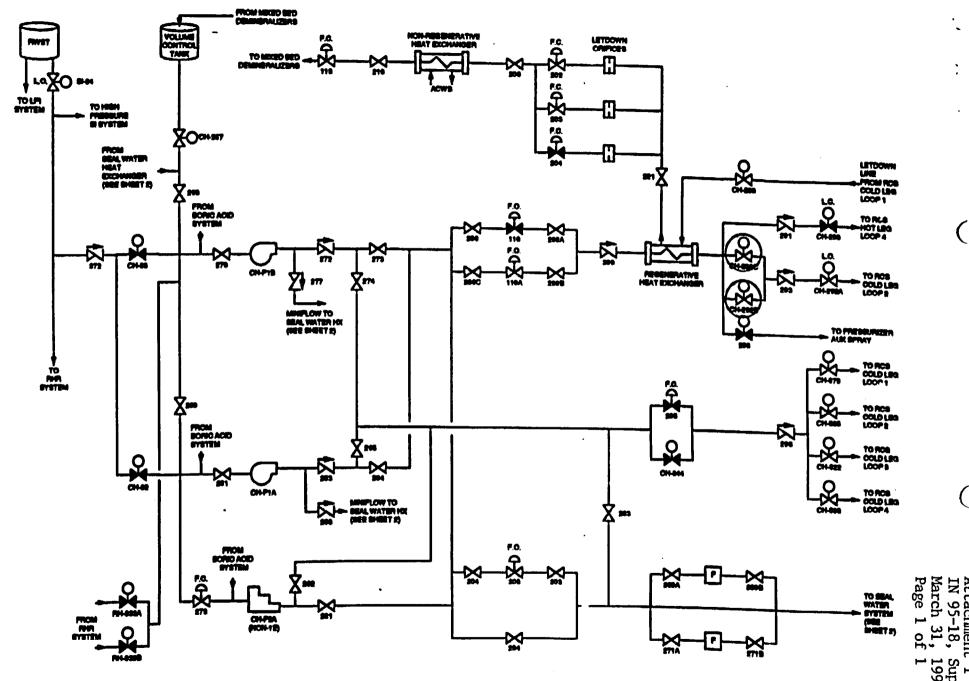
Haddam Neck Charging System (CVCS)

- 1. Two charging system injection valves (CH-MOV-292B and 292C). These normally open valves may be required to close to prevent residual heat removal (RHR) pump runout. Once closed, the valves would be susceptible to pressure-locking due to heatup of the fluid in the bonnet caused by high containment temperature. This could prevent the valve from reopening for subsequent accident mitigation. (See Attachment 1)

The Haddam Neck plant has been shut down for refueling since January 28, 1995. The licensee plans to modify the susceptible valves before restarting the plant. Proposed modifications consist of drilling a hole in the valve disc or venting the bonnet area to relieve internal pressure.

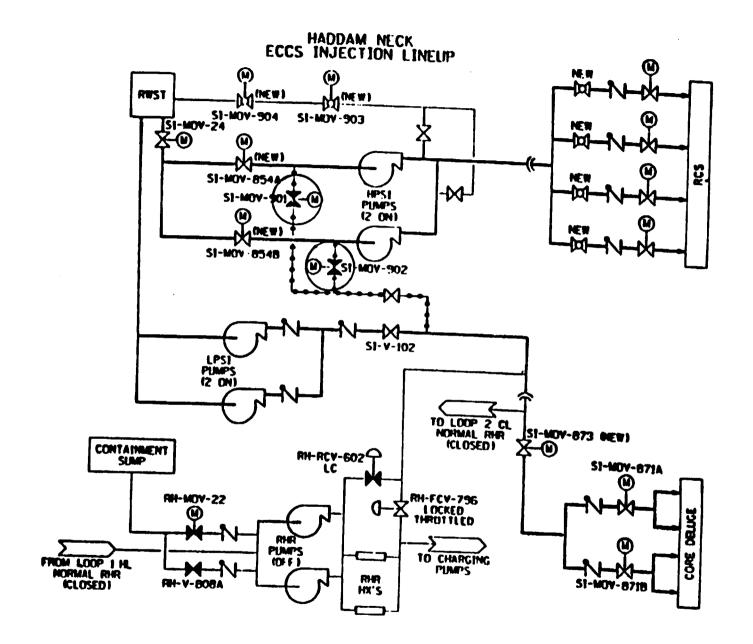
Attachment 2 IN 95-18, Supp. March 31, 1995

- 2. Two cross connect valves from RHR to high-pressure safety injection (SI-MOV-901 and 902). These normally shut valves could become pressurized from the discharge of the low-pressure safety injection pumps and fail to open when required for high-pressure recirculation. (See Attachment 2)
