UNITED STATES  
NUCLEAR REGULATORY COMMISSION  
OFFICE OF NUCLEAR REACTOR REGULATION  
WASHINGTON, D.C. 20555

July 2, 1992

NRC INFORMATION NOTICE 92-50: CRACKING OF VALVES IN THE CONDENSATE RETURN  
LINES OF A BWR EMERGENCY CONDENSER SYSTEM

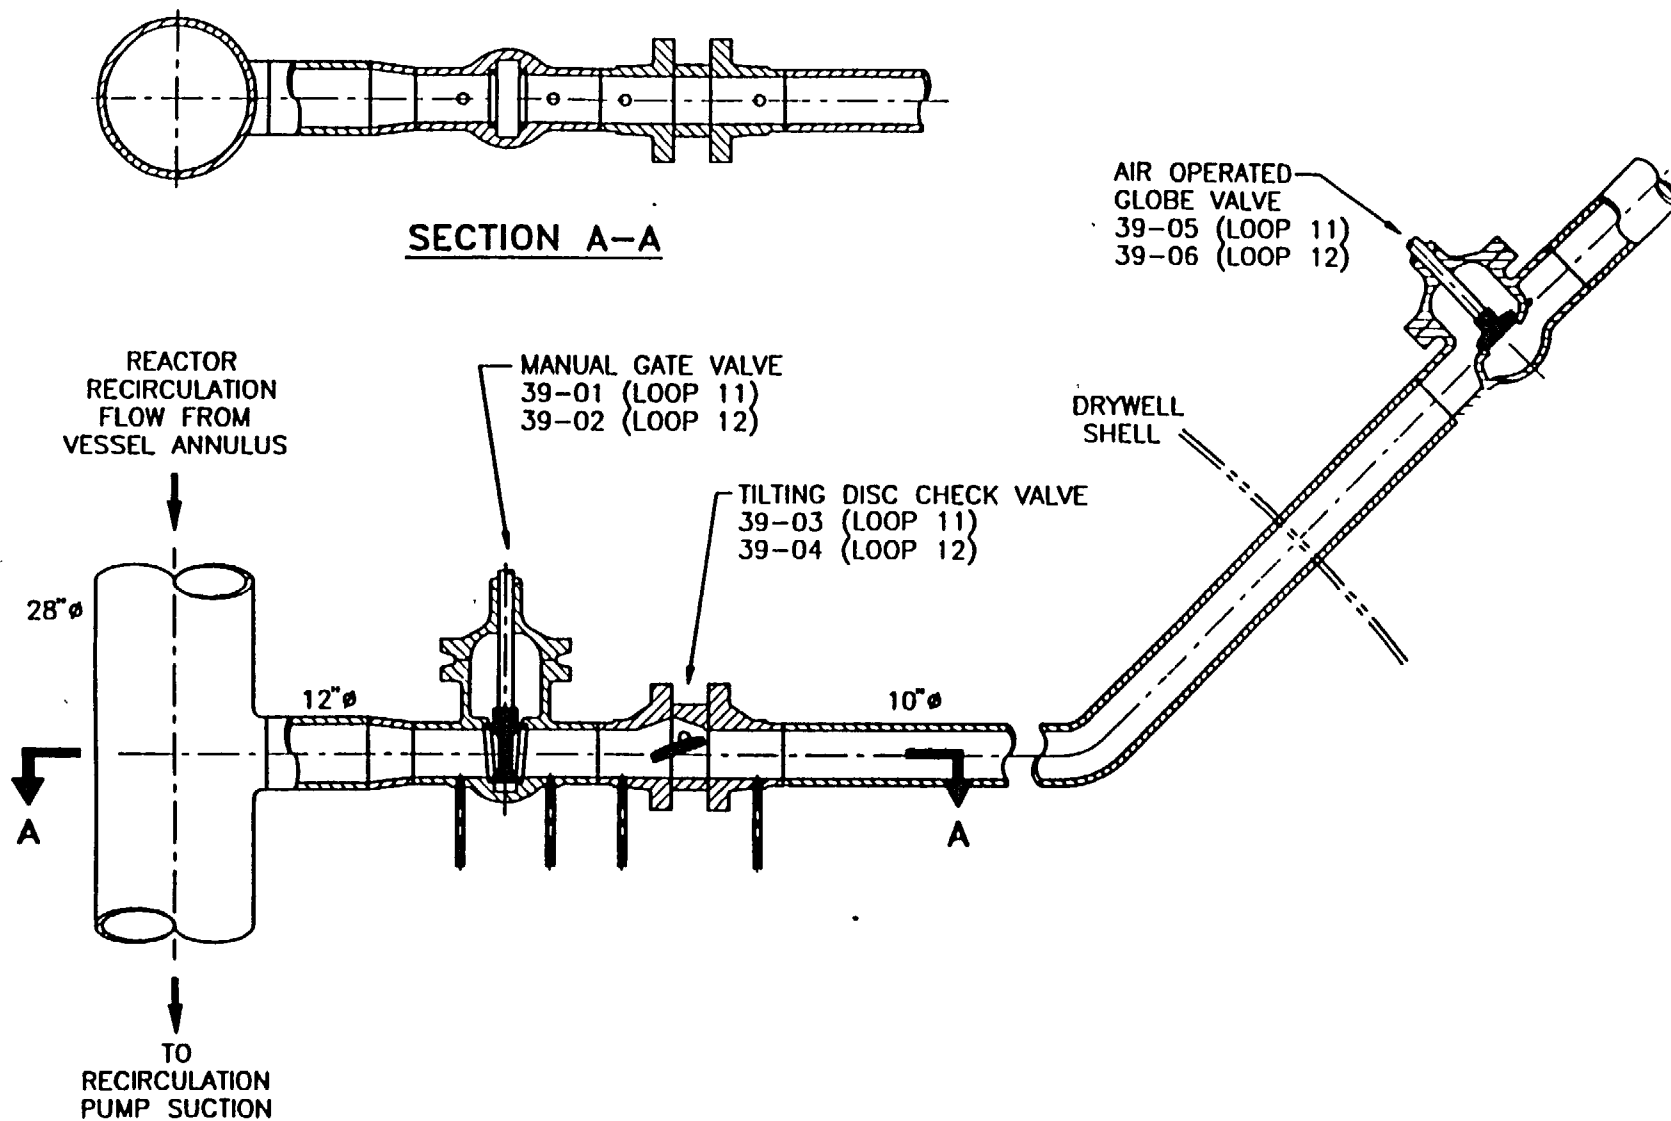
**FIGURE 1**  
**NMP-1 EMERGENCY CONDENSER SYSTEM**  
**CONDENSATE RETURN LINE**  
**CONFIGURATION INSIDE DRYWELL**

The emergency condenser system has two independent loops (loops 11 and 12). Figure 1 shows the configuration of the condensate return line in loops 11 and 12. In the condensate return line, a manual gate valve is connected downstream of a tilting disc check valve. At each of those two valves, two 1-inch drain lines are connected to the bottom part of the valve body with one drain line at the upstream side and the other one at the downstream side of the valve. The valve bodies are made of CF8M cast stainless steel.

While investigating the leakage at the manual gate valve 39-02, the licensee removed the internal components of the adjacent check valve to perform a visual test (VT), a radiographic test (RT), and an ultrasonic test (UT). The licensee visually observed cracks on the inside surfaces at both valves in loop 12. At gate valve 39-02, the licensee found cracks near each of the two drain holes. At check valve 39-04, the licensee found cracks near a downstream drain hole and found evidence of cracking in the threads of the

upstream drain. These cracks were further examined radiographically and ultrasonically. The licensee found four cracks including a throughwall crack near the drain hole upstream of gate valve 39-02. The licensee reported the throughwall crack to be about 3.5 inches long and oriented radially outward from the hole. The other three cracks were all reported to be within 0.15 to 0.35 inch of passing through the wall (1.25 inch wall thickness). The licensee found two cracks in the drain hole area downstream of the gate valve (39-02), which is the unisolable side of the valve body. The licensee reported the deepest crack to be about 1 inch long and within 0.15 inch of passing through the wall. The licensee found four cracks near the drain hole downstream of check valve 39-04 with the deepest reported to be within 0.1 inch of passing through the wall. The licensee visually observed one small indication on the seat ring in manual gate valve 39-02. The licensee also examined valves 39-01 and 39-03 in the condensate return line for loop 11 of the emergency condenser system and found two cracks near the drain hole upstream of manual gate valve 39-01. The largest crack was reported to be about 1.25 inch long and 1 inch deep. The licensee reported the cracking of the valve body in loop 11 to be less severe than that in loop 12. The licensee observed cracking indications on the inside surface of a butt weld that joins the gate valve to the check valve but did not confirm these indications by the radiographic examination. The licensee ultrasonically examined selected piping welds inboard of the condensate return isolation valves and found no indications.

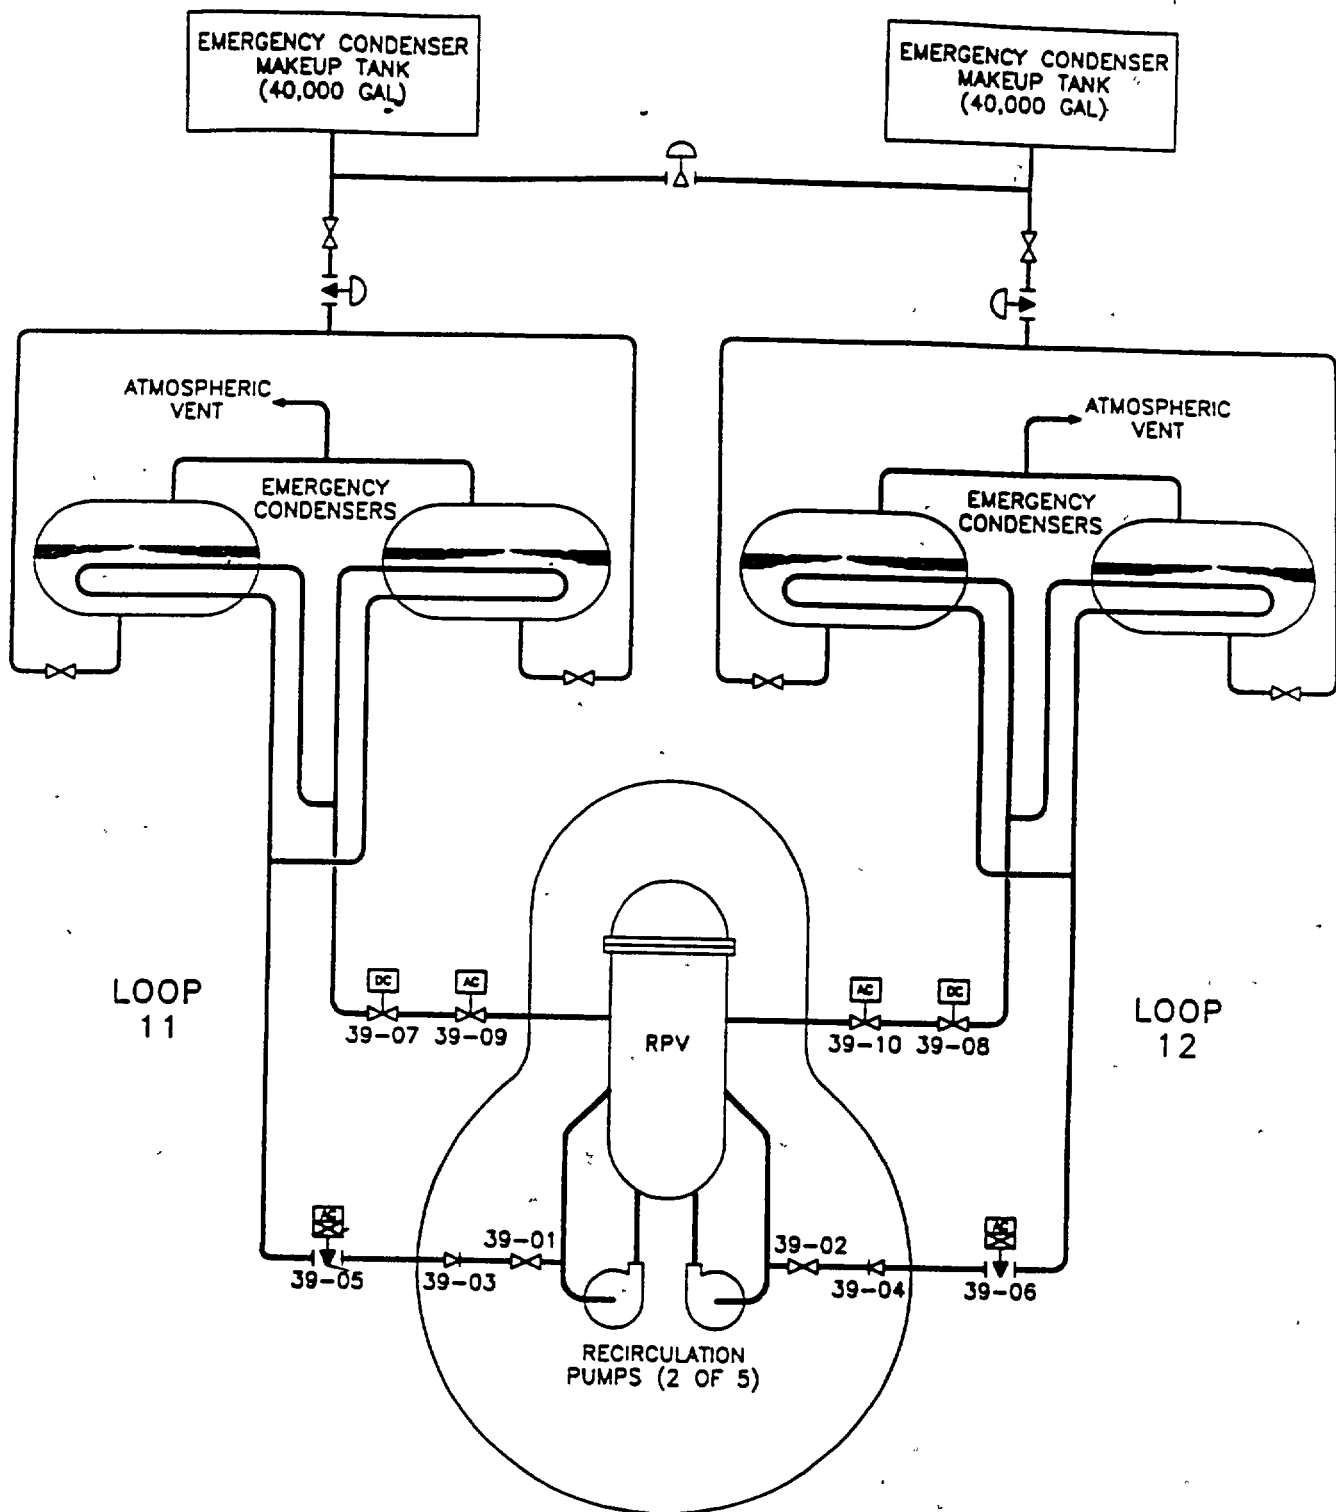
**FIGURE 2 NINE MILE POINT UNIT ONE  
EMERGENCY CONDENSER SYSTEM  
SIMPLIFIED DIAGRAM**

The emergency condensate system at Nine Mile Point, Unit 1, which is connected directly to the reactor coolant system, operates by natural circulation and acts as a backup for the main condenser to remove the reactor decay heat following a reactor isolation. The emergency condenser system at Nine Mile Point, Unit 1, as shown in Figure 2, has two loops (loop 11 and loop 12) with two condensers in each loop. During normal plant operation, the condensate return isolation valves (39-05 and 39-06) are closed, and the steam isolation valves (39-07, 08, 09, and 10) are open in each loop. As shown in Figure 1, two valves, a manual gate valve and a tilting disc check valve, are located in horizontal sections of the condensate return line. The horizontal sections are connected to the suction side of the recirculation piping system. The manual gate valves are maintenance valves and are open during normal operation.
