Docket Number 50-346

Serial Number 2973

Subject: Davis-Besse Nuclear Power Station Incore Monitoring Instrumentation Nozzle  
Inspections

**SUMMARY OF INCORE MONITORING INSTRUMENTATION (IMI) NOZZLE  
INSPECTIONS AND RELATED ACTIVITIES DURING THE DAVIS-BESSE  
NUCLEAR POWER STATION THIRTEENTH REFUELING OUTAGE**

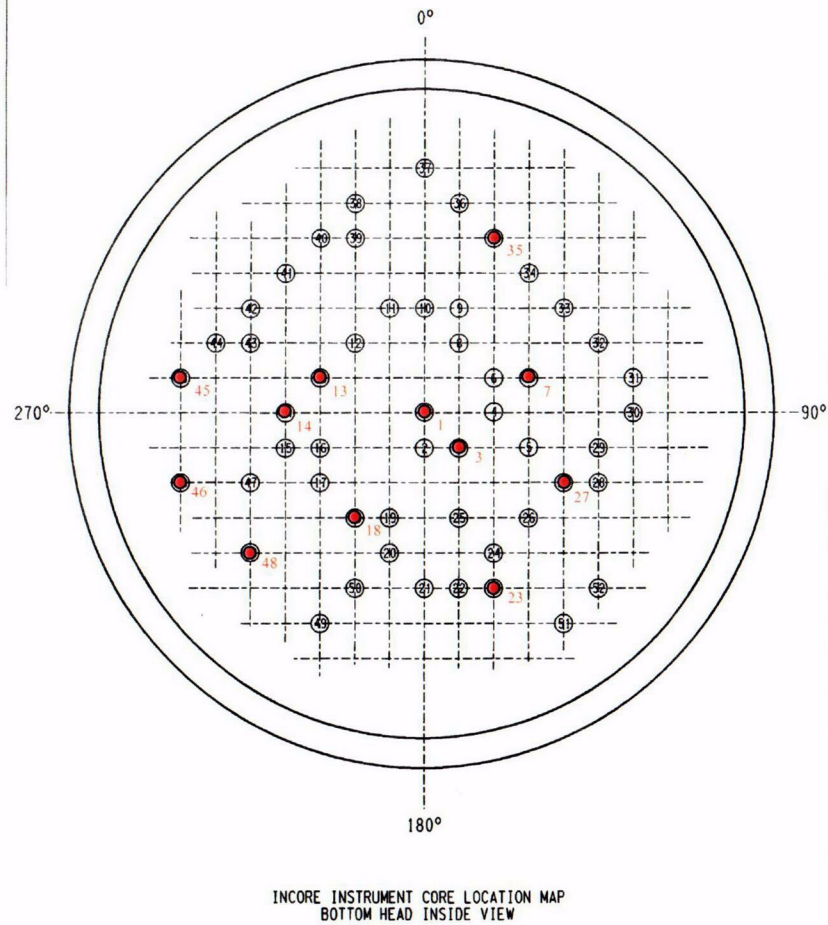
# Sampling of Deposits

Since the deposits were flat and tightly adhering to the vessel and nozzle surfaces, wire brushes and cleaning pads were used to collect deposit samples from two trails of residue on the lower sides of the Reactor Vessel and from twelve IMI nozzles on the bottom of the Reactor Vessel (see attached figure). The samples were collected in accordance with recommendations in Framatome ANP's (reactor vendor) document, "Recommended IMI Nozzle Inspection Plan".

- Decreasing lithium and boron concentrations in the samples from Nozzle #27 to #3 to #1 (i.e., from the more peripheral nozzle locations to the center location) would suggest a flow path, however, the southeast quadrant (90° to 180° location on the attached figure) flow sample concentrations were less than the concentrations at Nozzle #27. Nozzle #27 had the highest lithium and boron concentrations of any of the samples: lithium 12,548 parts per million, boron 39,469 parts per million.

- The total activity peaked in the southeast quadrant boric acid trail sample, then decreased in a downhill direction to Nozzle #27, Nozzle #3, and then Nozzle #1. This is consistent with the southeast quadrant boric acid trail providing material to those nozzles.

- Nozzle sample locations (●)

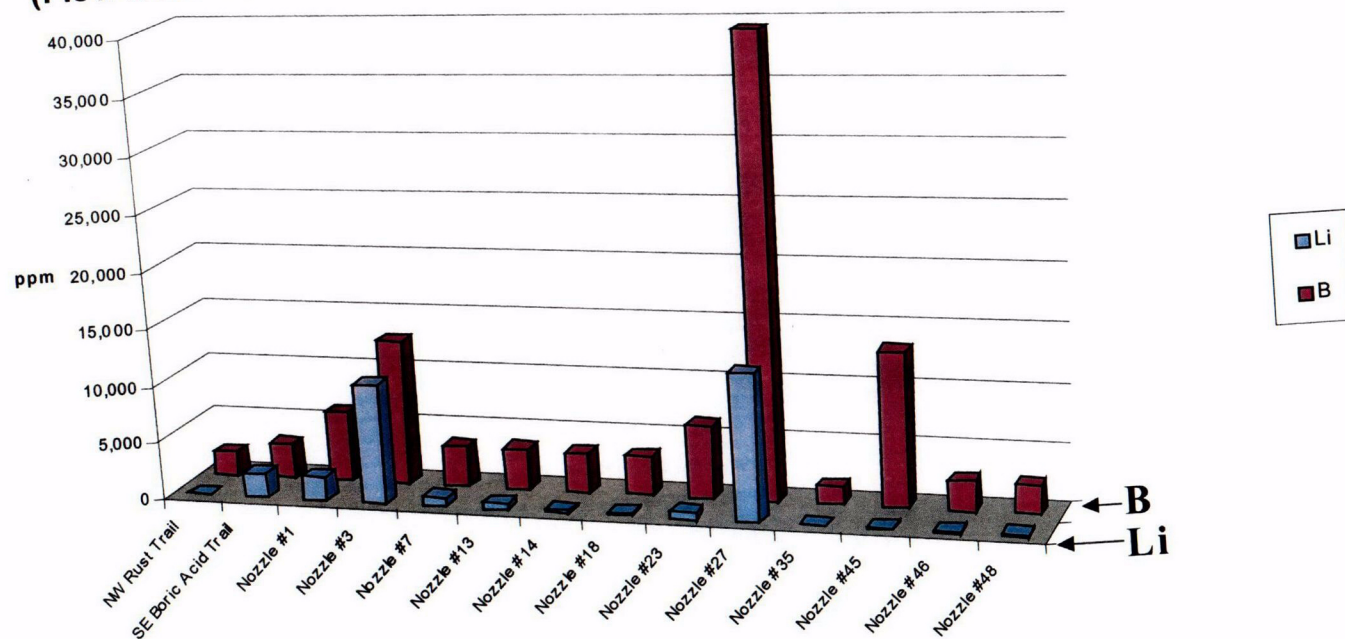
# Deposit Characterization Summary

- The IMI Nozzle #3 lithium, and Nozzle #27 lithium and boron concentrations were significantly higher than the flow trail samples as well as the remaining nozzle samples (see attached graph). The peak normalized boron (39,469 parts per million) and lithium (12,548 parts per million) concentration were found at Nozzle #27. They were more similar to the lithium and boron concentrations in the deposit samples collected earlier in 2002 during the removal of Reactor Vessel upper head Control Rod Drive Mechanism Nozzle #2.

Comparison of Normalized Boron and Lithium Concentrations  
(Flow trails at bottom of reactor head and incore nozzle deposits)
