Edwin I. Hatch Nuclear Plant  
Measurement Uncertainty Recapture Power Uprate (MURPU)  
Post MURPU Steam Dryer Performance Monitoring and Inspections

## Post MURPU Steam Dryer Performance Monitoring Inspections

### BWR steam dryer integrity

**SIL No. 644  
Supplement 1  
September 8, 2003**

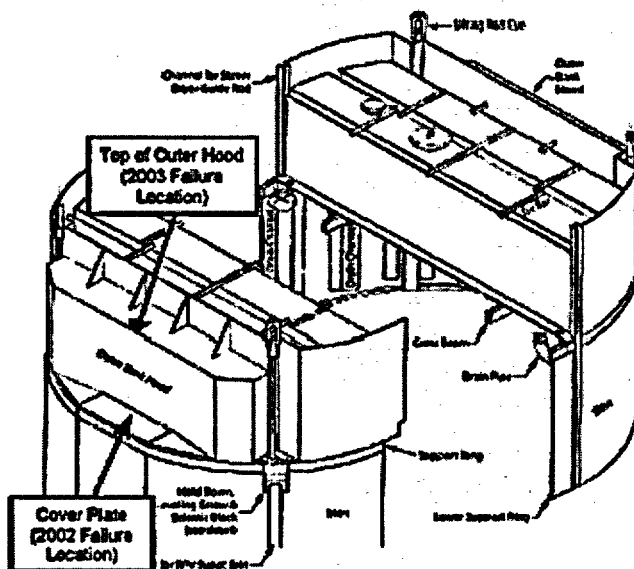
The purpose of this Supplement 1 to SIL No. 644 is to describe a second steam dryer failure that occurred at the same BWR/3 approximately one year following the initial steam dryer failure. The location of the failure (refer to Figure 1) and the root cause are different than the earlier failure. As a result, additional monitoring and inspections are recommended for all BWR plants that are operating, or plan to operate, at power levels greater than the OLTP. SIL 644 applied to BWR/3-style steam dryer design plants. This Supplement 1 to SIL No. 644 presents revised recommendations for plants with BWR/3-style steam dryers and provides recommendations applicable to plants with BWR/4 and later steam dryer designs.

Figure 1 — Steam Dryer Failure Locations, 2002 and 2003

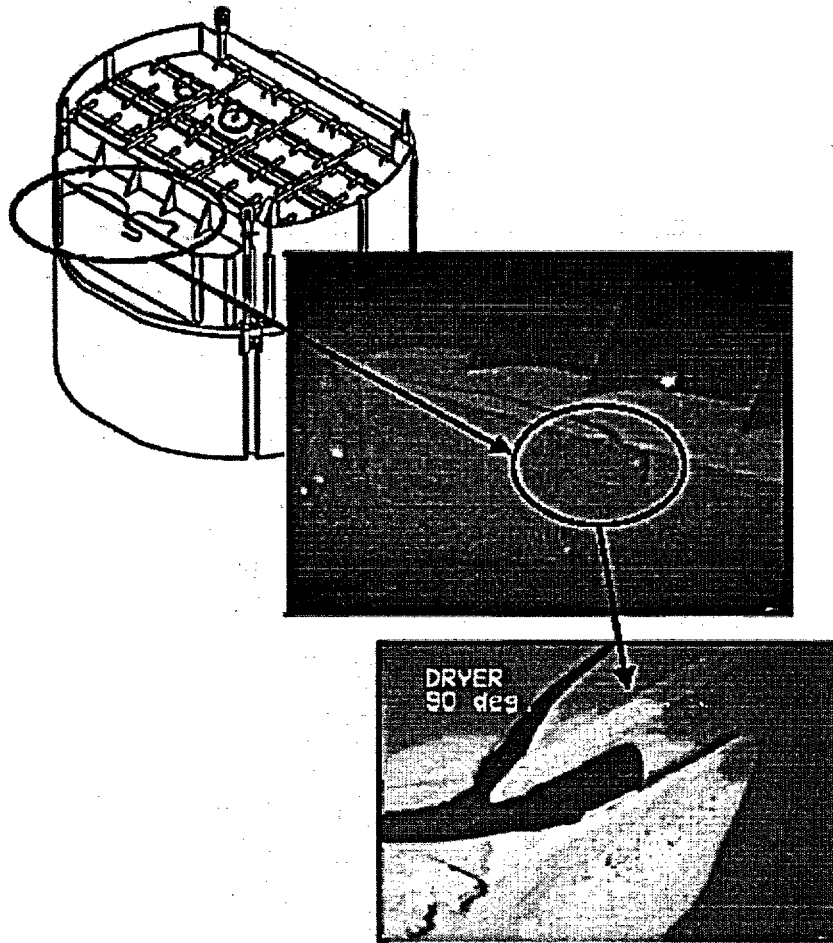
Detailed visual inspection of the accessible external and internal areas of the steam dryer revealed significant steam dryer damage. The damage was most severe on the 90-degree side of the steam dryer, the side that was closest to the PORV that had opened. On the 90-degree side, a through-wall crack approximately 90 inches long and up to three inches wide was observed in the top of the outer hood cover plate and the top of the vertical hood plate (refer to Figure 2). Three internal braces in the outer hood were detached and one internal brace in the outer hood was severed. The detached braces were found on top of the steam separator. All detached parts were accounted for and retrieved. On the opposite side of the steam dryer (270-degree side), incipient cracking was observed on the inside of the outer hood cover

plate and one vertical brace in the outer hood was cracked. No damage was found in the cover plates that had been replaced following the first steam dryer failure in 2002.

Extensive metallurgical and analytical evaluations (e.g., detailed finite element analyses, flow induced vibration analyses, computational fluids dynamics analyses, 1/16" scale model testing and acoustic circuit analyses) concluded that the root cause of the steam dryer failure was high cycle fatigue resulting from low frequency pressure loading. There are two potential contributing factors to the failure:

Figure 2 — Steam Dryer Damage 90 Degree Side

1. replaced damaged ½ inch outer hood plates with 1 inch plates
2. removed the internal brackets that attached the internal braces to the outer hood
3. added gussets at the outer vertical hood plate and cover plate junction
4. added stiffeners to the vertical welds and horizontal welds on the outer hood

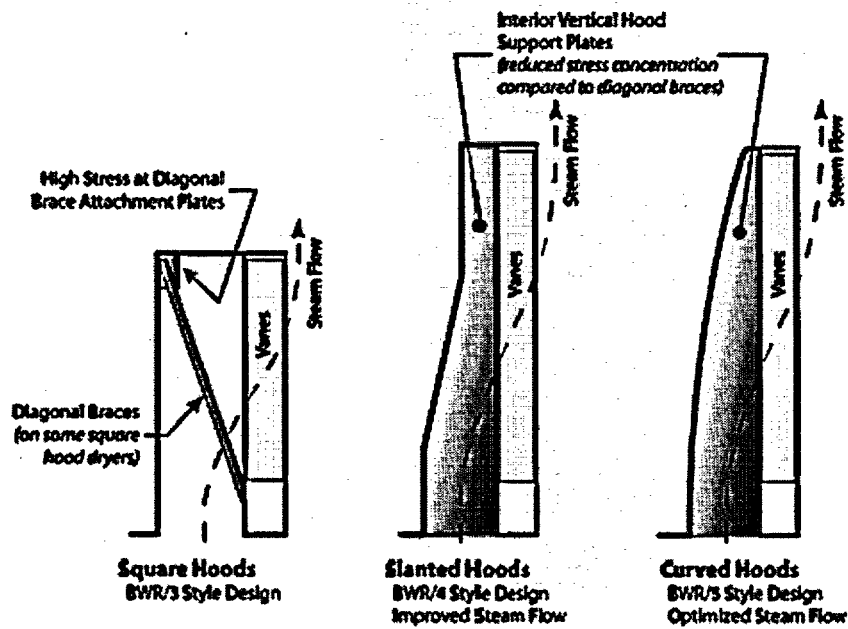
There are two key attributes that determine the susceptibility of a particular plant to steam dryer degradation. The dominant attribute is the steam dryer configuration. There are three general types of steam dryer configurations (refer to Figure 3):

1. BWR/3-style steam dryers with a square hood and internal braces. This design results in maximum stresses where the internal braces attach to the outer hood. The crack initiation at the BWR/3 occurred at this high stress location. Higher stresses result in a greater susceptibility of the components to crack initiation. Some BWR/3-style steam dryers do not incorporate the internal braces. This design eliminates the stress concentration associated with the brace attachment.

2. BWR/4-style steam dryers that have slanted hoods. This design replaced the internal braces with internal plates that substantially reduced the maximum calculated stresses.
3. BWR/3 and later steam dryer designs that incorporated curved hoods to optimize the steam flow. This design retained the internal plates, further reducing the maximum calculated stresses.

Figure 3 — Steam Dryer Hood Configurations

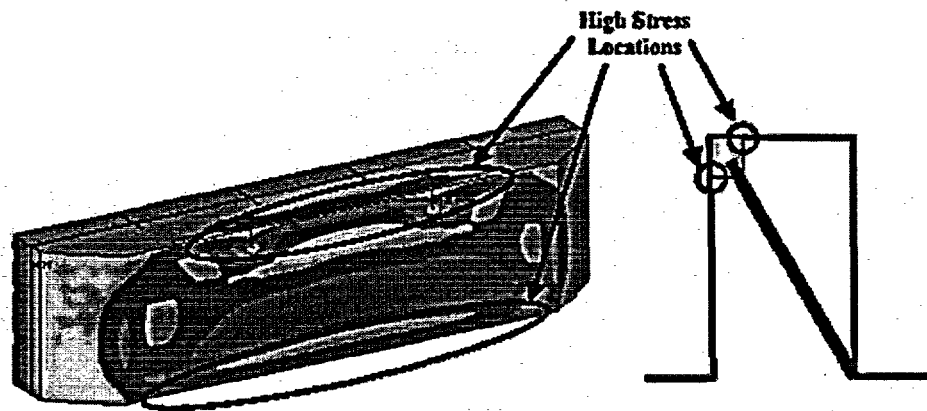
Figure 4 — High Stress Locations  
Square Hood with Braces

- e. Perform a visual inspection ("best effort" VT-1) of the steam dryer at the next scheduled refueling outage. This inspection should include the most susceptible locations as determined by a dryer stress analysis (refer to Figure 4). This inspection should include both an external and internal inspection of the accessible areas. Remove trapped bubbles to ensure complete coverage of internal areas.

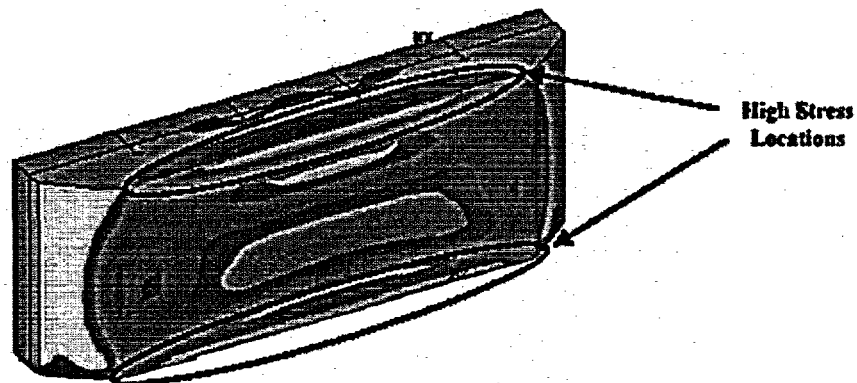
Figure 5 — High Stress Locations  
Square Hood without Braces

| <p>c. Perform a visual inspection ("best effort" VT-1) at the outage prior to initial operation above the OLTP or at the next scheduled refueling outage if already operating above the OLTP. This inspection should include the most susceptible locations as determined by a dryer stress analysis (refer to Figure 5). This inspection can be limited to an external inspection of the most susceptible locations.</p> <p>d. Repeat the visual inspection in 2.c at every other refueling outage.</p> <p>3. BWR/4 and later steam dryer designs:</p> <p>a. Implement recommendations 1.a, 1.b and 1.e.</p> <p>b. Implement recommendation 2.b. However, the moisture content monitoring frequency can be relaxed to once per month.</p> | <p>c. Perform a visual inspection ("best effort" VT-1) prior to initial operation above the OLTP or within the next two scheduled refueling outages if already operating above the OLTP. This inspection should include the most susceptible locations as determined by a dryer stress analysis (refer to Figures 6 and 7), including the vertical rib areas on each of the outer hoods and the end plates on the two outermost banks. This inspection can be limited to an external inspection of the most susceptible locations.</p> <p>d. Repeat the visual inspections in 3.c at every other refueling outage.</p> <p><b>Note:</b> These inspection recommendations do not supersede existing utility program requirements or other inspections recommended as a result of industry operating experience.</p> |

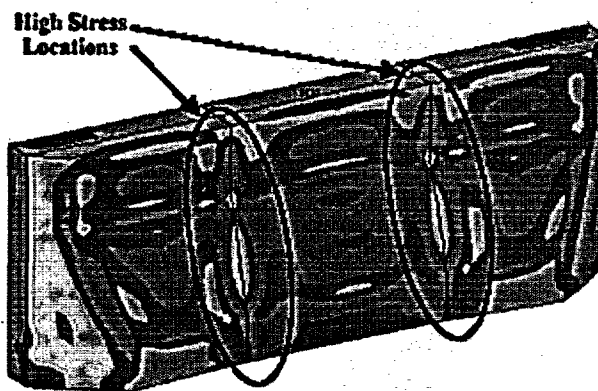
Figure 6 — High Stress Locations  
Slanted Hood

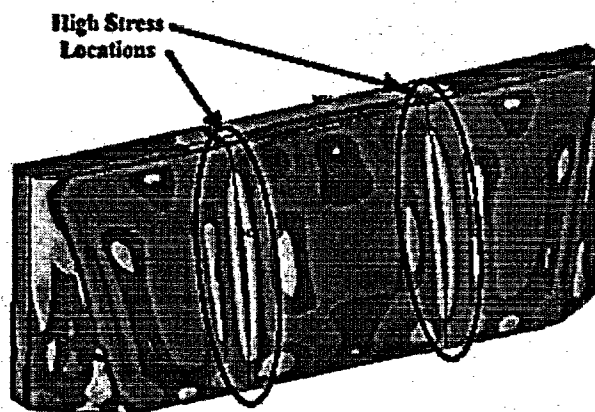
Figure 7 — High Stress Locations  
Curved Hood
