Re: Turkey Point Unit 4
Docket No. 50-251
Order (EA-03-009) Relaxation Request
Examination Coverage of Reactor Pressure Vessel Head
Penetration Nozzles

**TURKEY POINT UNIT 4 RELAXATION REQUEST
FROM US NRC Order EA-03-009**

**“Hardship or Unusual Difficulty without Compensating Increase in
Level of Quality or Safety”**

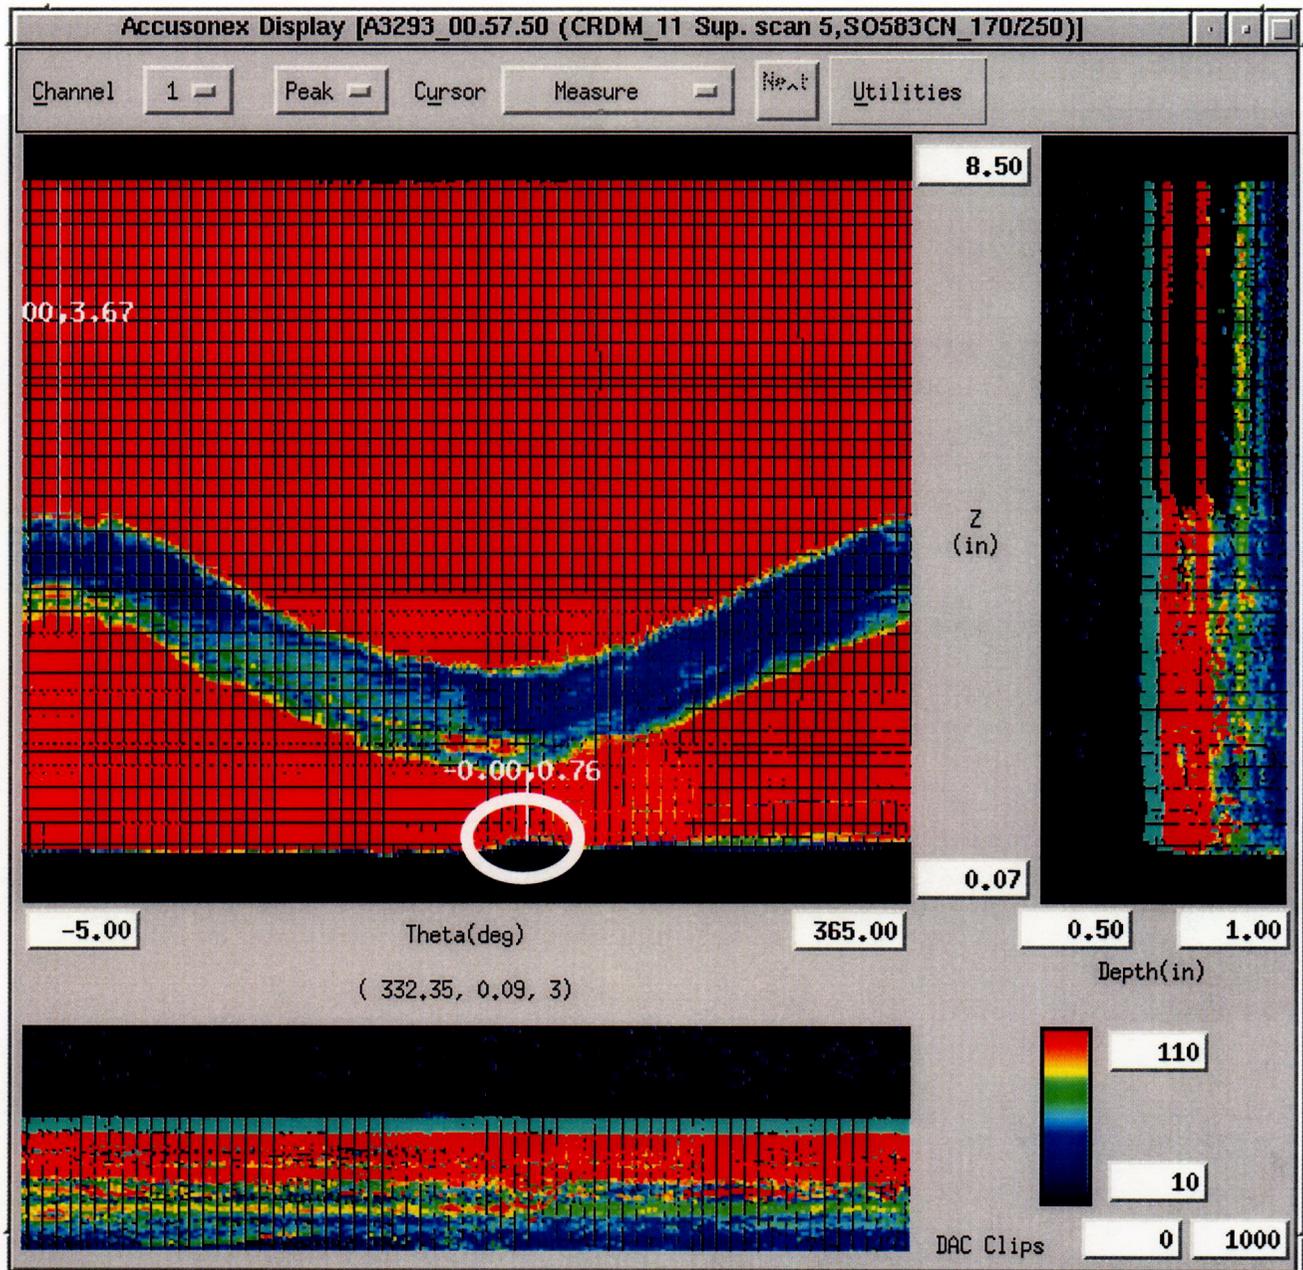
RPV head penetration # 11 contains an area of coverage less than that required by the NRC Order. The Order requires examination from 2 inches above the J-groove weld to the "bottom of the nozzle." The coverage below the weld, in the non-pressure boundary portion of the RPV head penetration nozzle, did not extend to the "bottom of the nozzle" for the full circumference. The actual area of missed coverage is a 32° arc, starting 0.76 inches below the bottom of the weld. A presentation of the UT coverage area, with the area of missed coverage identified, is shown in Figure 1.

Figure 1: RPV Nozzle # 11 UT Inspection "C" Scan with area of missed coverage identified the white oval at the low point of the weld.

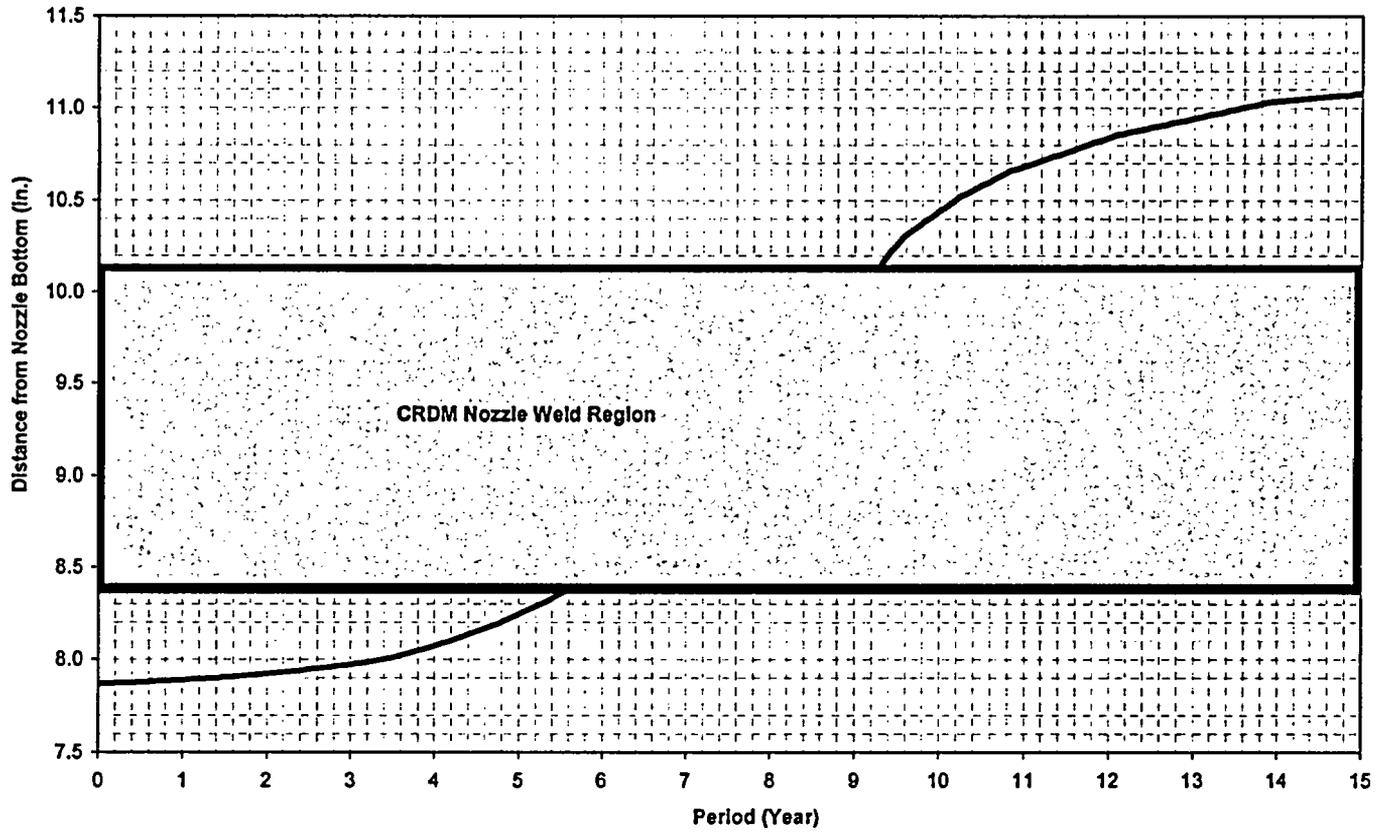
To determine the significance of an axial flaw that is contained in the non-pressure boundary nozzle material in the un-inspected region greater than 0.62 inches below the weld, a flaw tolerance approach is used. A flaw evaluation was performed postulating an axial flaw in the area of missed coverage below the weld using WCAP-16027-P.³ A through wall flaw is postulated in the nozzle material from the bottom of the penetration to 0.62 inches from the bottom of the weld. This is a conservative assumption since the inspected region extends 0.39 inches farther below the weld on the ID surface of the nozzle. The flaw evaluation in WCAP-16027-P is based on Turkey Point Unit 3 and 4 specific stresses in the nozzle penetrations. Since the stresses in the region greater than 0.62 inches below the weld are too low to propagate an axial flaw, the WCAP-16027-P flaw evaluations start at ½ inch below the weld, and evaluate the time to propagate the flaw in the nozzle to the bottom of the weld (start of the pressure boundary portion of the nozzle material or toe of the J-groove weld). Assuming a through wall flaw below the weld, with the flaw end located at ½ inch below the weld (which is in the area of complete UT examination coverage), an axial flaw would take greater than 5 years of operation (Figures 6-12 through 6-20 in WCAP-16027-P) in any nozzle location to grow to the point of contact with the weld. This time period is significantly greater than the current inspection frequency of every refueling cycle (18 months for Turkey Point Unit 4) identified in NRC Order EA-03-009. As an added conservatism, this evaluation does not attempt to evaluate the time for the axial flaw to grow from the bottom of the weld through the pressure boundary. Figure 2 provides a graphical presentation of the

above flaw evaluation discussion for the outer most penetration location (most limiting case).

Figure 2: Through-Wall Axial Flaws Located in the 42.6 Degree Row of Penetrations, Uphill Side - Crack Growth Predictions (From Figure 6-19, WCAP-16027-P)
