**Subject: Beaver Valley Power Station, Unit No. 2  
BV-2 Docket No. 50-412, License No. NFP-73  
Reactor Head Inspection 60-Day Report for 2R12**

**Evaluation Report for**

**Beaver Valley Power Station Unit 2**

**Reactor Vessel Head Penetration**

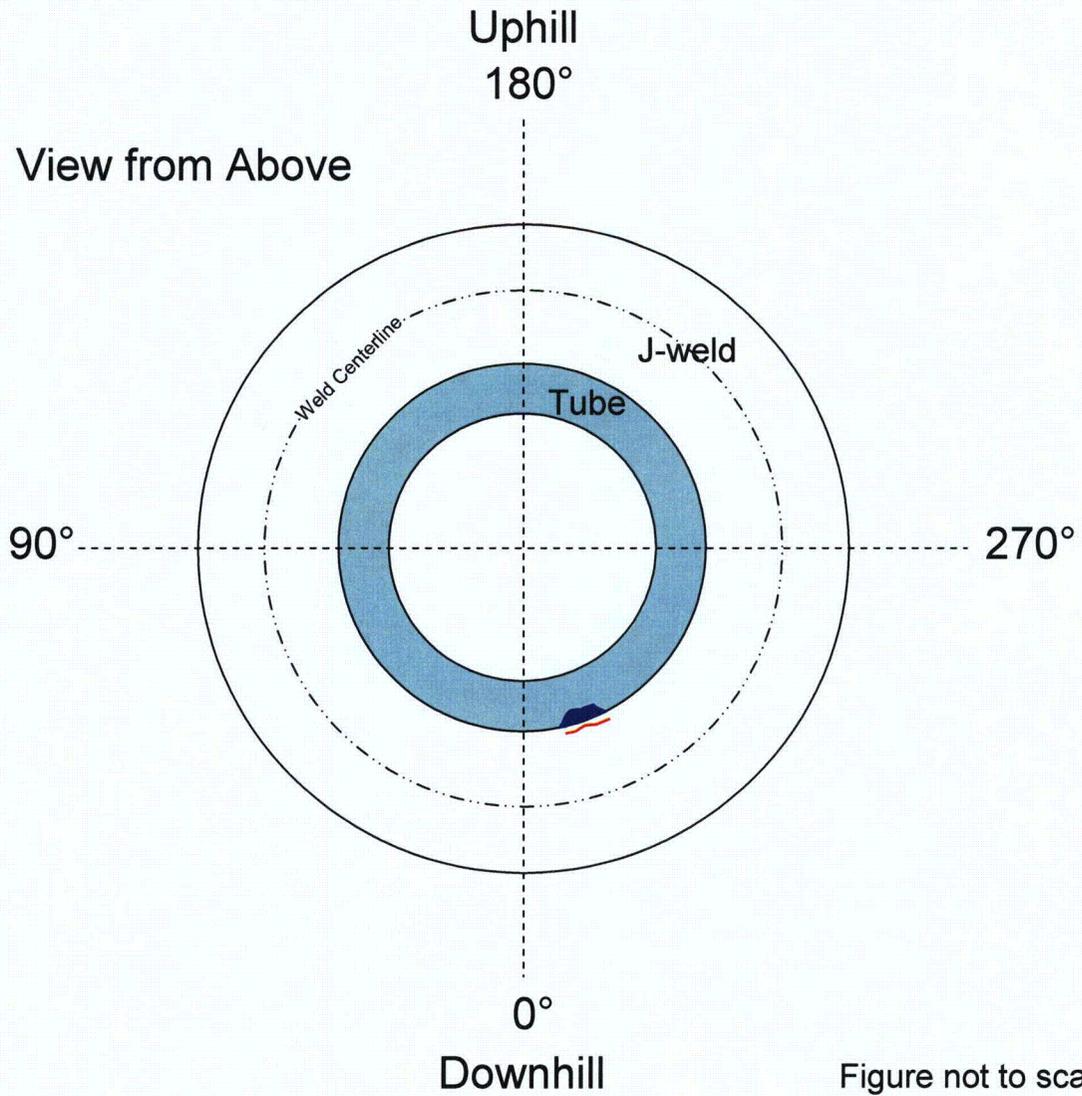
**Figure 1: Penetration 16**

Trinity Probe ultrasonic examination of CRDM Penetration 16 identified a reflector approximately 0.192 inches from the outside surface of tube at a radial position of 348°. The reflector measured approximately 0.5" in the circumferential orientation.

The reflectors observed in Penetrations 16, 56, and 61 prompted a focused, independent review of the 2R10 (Fall 2003) ultrasonic examination data in the areas of interest. During the course of this review, the indications identified in Penetrations 16 and 61 were discovered to be present in the Fall 2003 results, but neither was reported as Primary Water Stress Corrosion Cracking (PWSCC). When compared to the 2006 results, the indication in Penetration 16 showed no appreciable growth (i.e. any growth observed was within the tolerance of the measurement

The J-groove weld dye penetrant examination results on Penetrations 16, 56, and 61, while acceptable per the Construction Code, prompted FENOC to further interrogate these locations via minor excavation. A burring tool was used to perform minor metal removal on the J-groove weld indications on all three "special interest" locations, in conjunction with iterative dye penetrant exams. Following removal of between 30 and 60 mils of material, the subsequent dye penetrant exams revealed linear indications at all three locations.

Pen #	LPT (As-found)	LPT (after 1 <sup>st</sup> grind)	LPT (after 2 <sup>nd</sup> grind)
16	- Small rounded indication near J-weld/Tube OD interface @ ~348°	- ~1/4-3/8" linear indication, circ., near J-weld/Tube OD interface @ ~348°	
45	OD, J-weld @ 95° - PT White - SAT		
56	- Tube OD, NDD - J-weld, 1/16" Rounded @ ~10-15°	- Tube OD, NDD - J-weld, 1/16" Rounded @ ~10-15°	- Tube OD, NDD - J-weld, ~1/2" Linear, circ. @ ~10-15°
61	- Tube OD, NDD - J-weld, Two aligned, rounded indications, 3/32" x 3/16" @ ~315°	- Tube OD, NDD - J-weld, Single rounded indication with linear branching @ ~315° - New 1/16" rounded indication	- Tube OD, NDD - J-weld, Intersecting linear indications, ~0.75" circ x ~0.5" axial @ ~315°

Following the examinations, weld overlay repairs were performed on Penetrations 16, 56, and 61 in accordance with Beaver Valley Relief Request BV3-RV-04 (Reference Letter L-03-065), which was approved by the NRC (SER dated May 13, 2003) and remains in effect for the current BV-2 In-Service Inspection interval. The repairs were performed using the embedded flaw repair technique, consisting of a three-pass Alloy 52 weld overlay of the J-groove weld and a two-pass overlay of the penetration tube OD for each of the three penetrations. Post-repair dye penetrant examinations of all repaired regions identified no indications (PT white).

Upon completion of the repairs, ultrasonic and eddy current examinations were performed from the tube ID to verify that the repair process did not introduce any new flaws or adversely change the size or characteristics of the previously reported flaws. Analysis of the post-repair TOFD ultrasonic examination results revealed no new indications. Furthermore, the TOFD sizing results indicate the through-wall dimensions and lengths of the reflectors did not change as a result of the repair process. The conclusion can be made that the applied repair process had no detrimental effect on the tubes, did not result in any crack growth and did not result in the initiation of any additional cracking in the tubes.

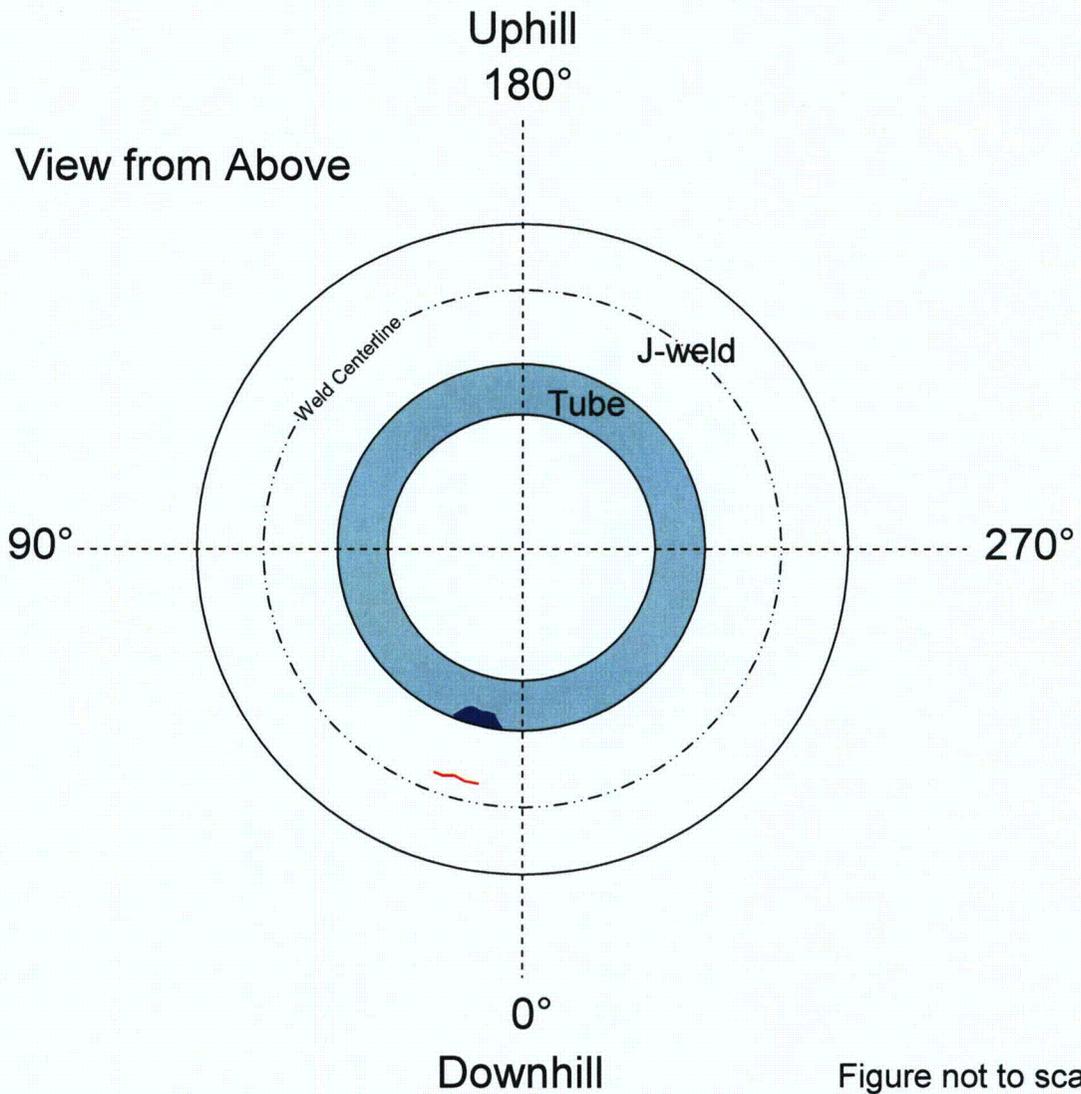
**Figure 2: Penetration 56**

Trinity Probe ultrasonic examination of CRDM Penetration 56 identified a reflector approximately 0.162 inches from the outside surface of tube at a radial position of 12°. The reflector measured approximately 0.5" in the circumferential direction and 0.25" in the axial direction.

technique). The indication in Penetration 61 was approximately 0.080" deeper than shown in the 2003 data. The indication in Penetration 56 was a new reflector, not apparent in the 2003 data.

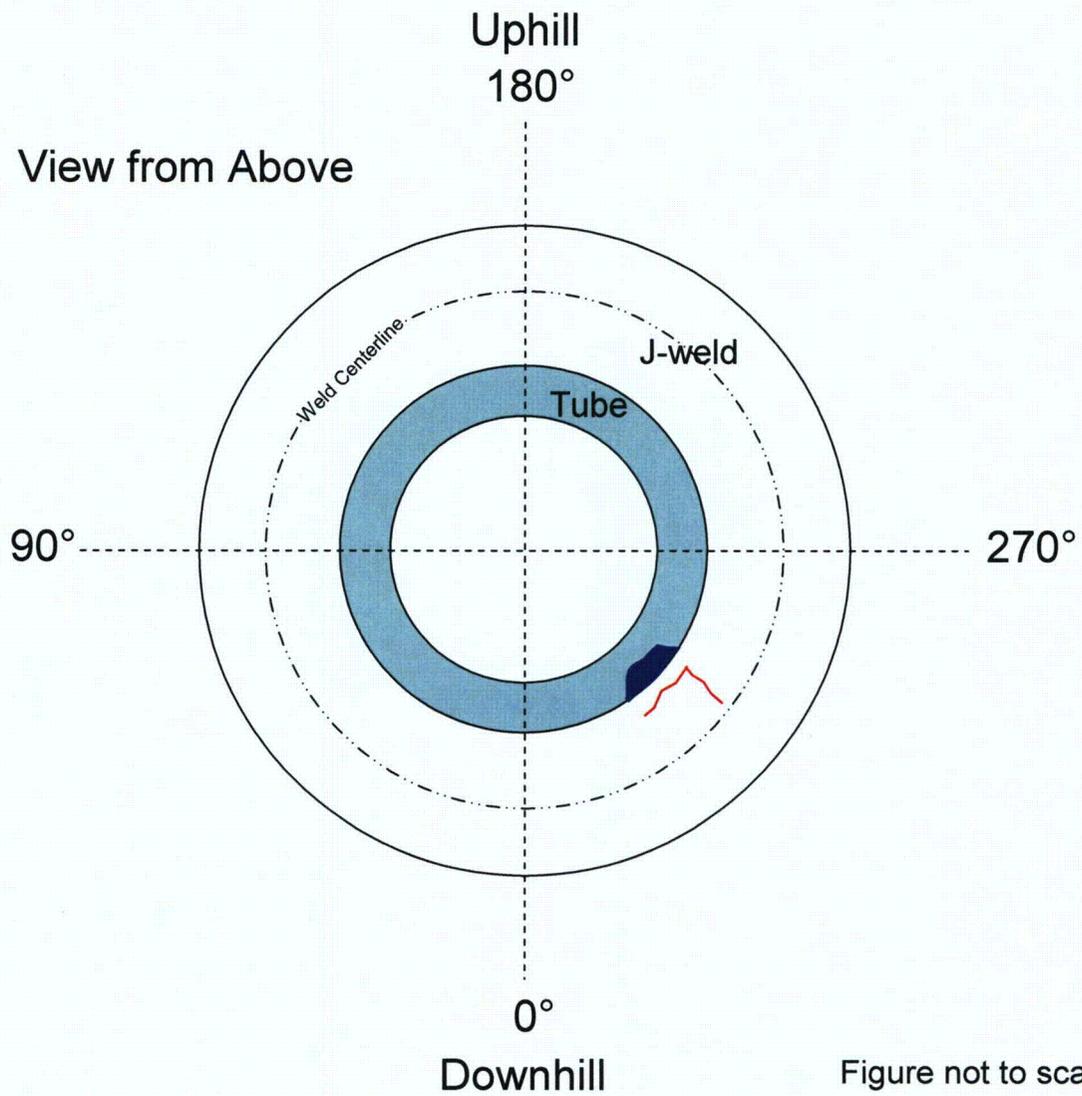
**Figure 3: Penetration 61**

Trinity Probe ultrasonic examination of CRDM Penetration 56 identified a reflector approximately 0.349 inches from the outside surface of tube at a radial position of 315°. The reflector measured approximately 0.7" in the circumferential direction and 0.3" in the axial direction.
