Subject: St. Lucie Unit 1 Retired PZR Safety "A" Nozzle DM Weld Destructive
Examination Report

MRP Materials Reliability Program _____ MRP 2008-053
(via email)

SUMMARY

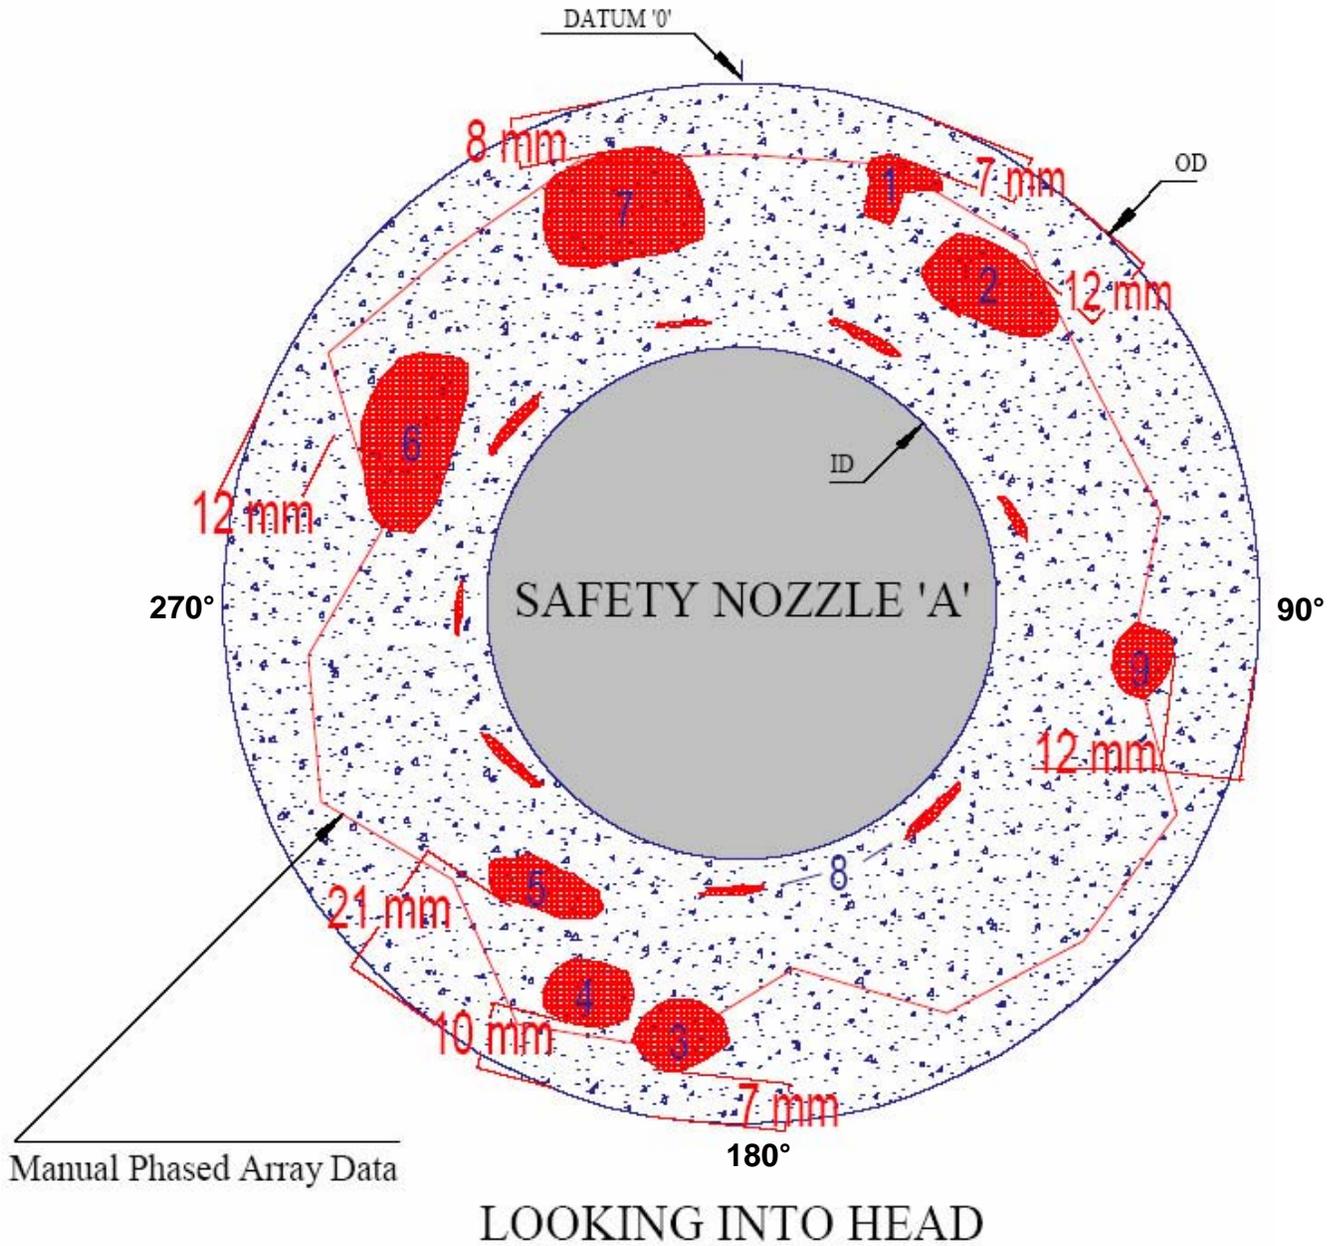
Extensive non-destructive testing was performed on the DM weld prior to shipping to B&W. Figure 4 provides a plan view summary of the manual and automated ultrasonic test (UT) data for the DM weld. The automated UT technique reported nine indications, which were designated UT1 through UT9. A summary of the results for all the NDE performed on the DM weld is shown in Figure 5. This summary includes the nine UT indications, plus the indications found during radiography, penetrant, and eddy current testing.

Figure 4: UT (manual and automatic) data for nozzle "A". (NOTE: According to UT inspection personnel, the indications shown above in red are strictly pictorial and not intended to convey actual size or shape.)

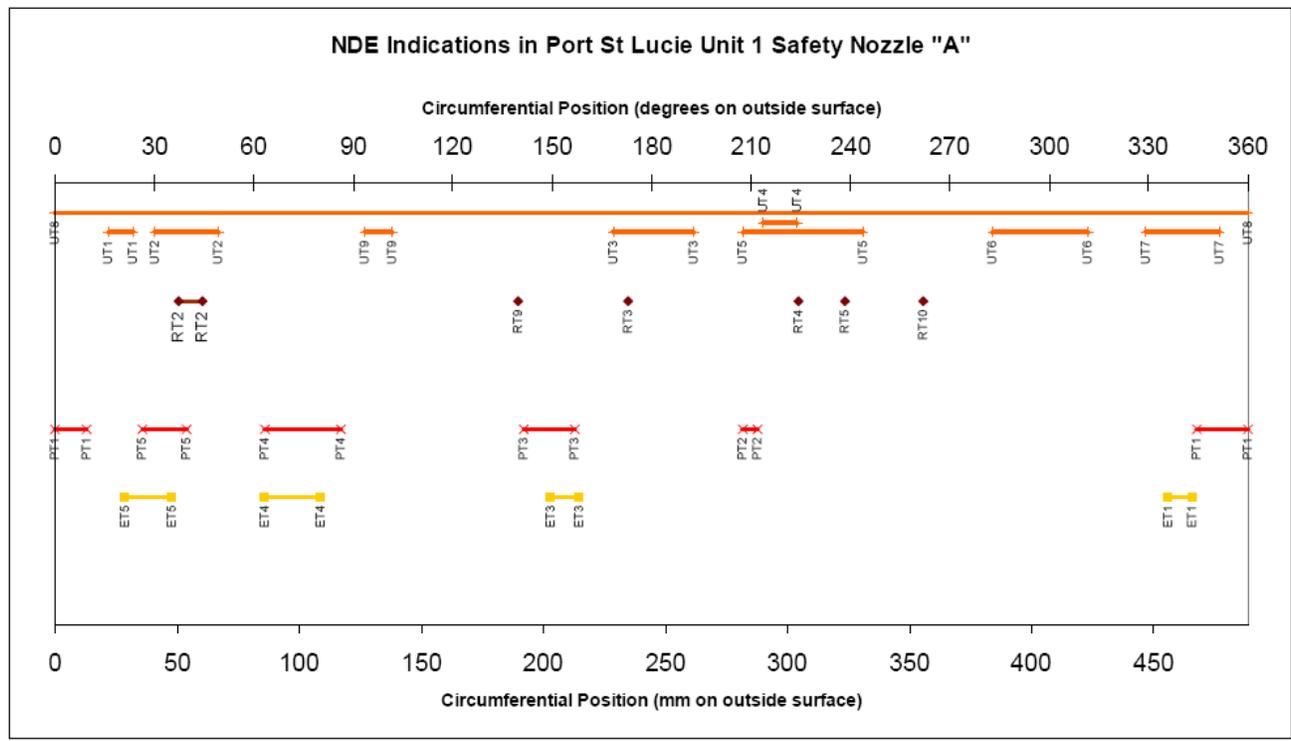
Figure 5: Summary of NDE data for nozzle.

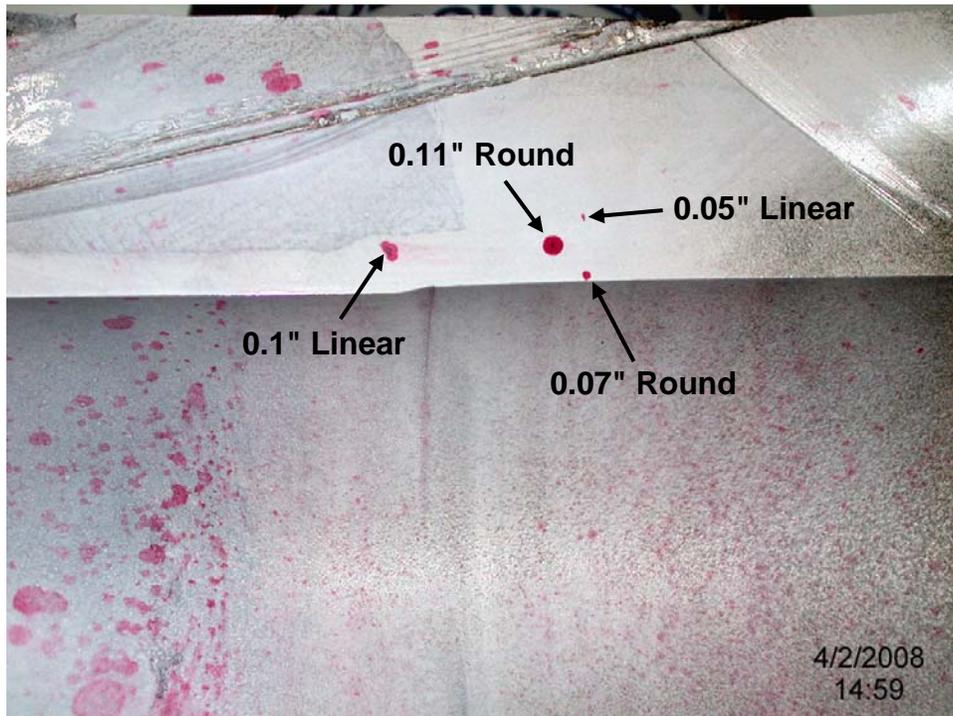
A visible dye penetrant examination was also performed on piece 2 to ensure no ID surface connected defects were present. No indications were found on the ID surface during the laboratory test (Figure 11 upper).

Figure 11: Visible dye PT photographs of piece 2. Four small indications were detected on the 150° cut face; no ID-connected indications were found. No further work was performed on piece 2.

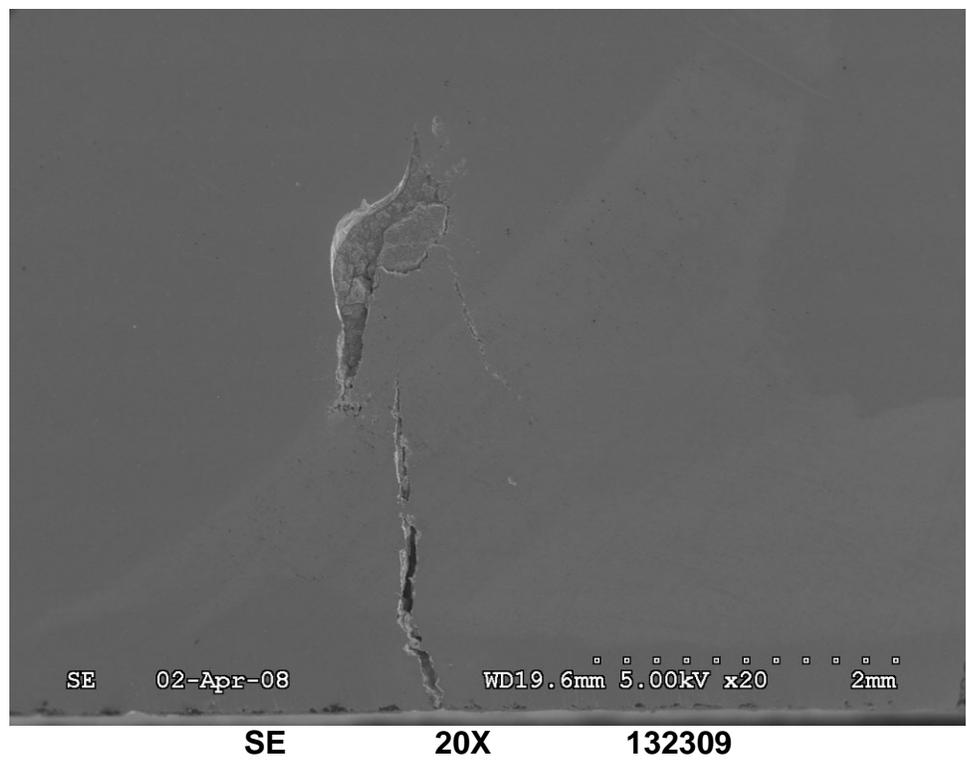
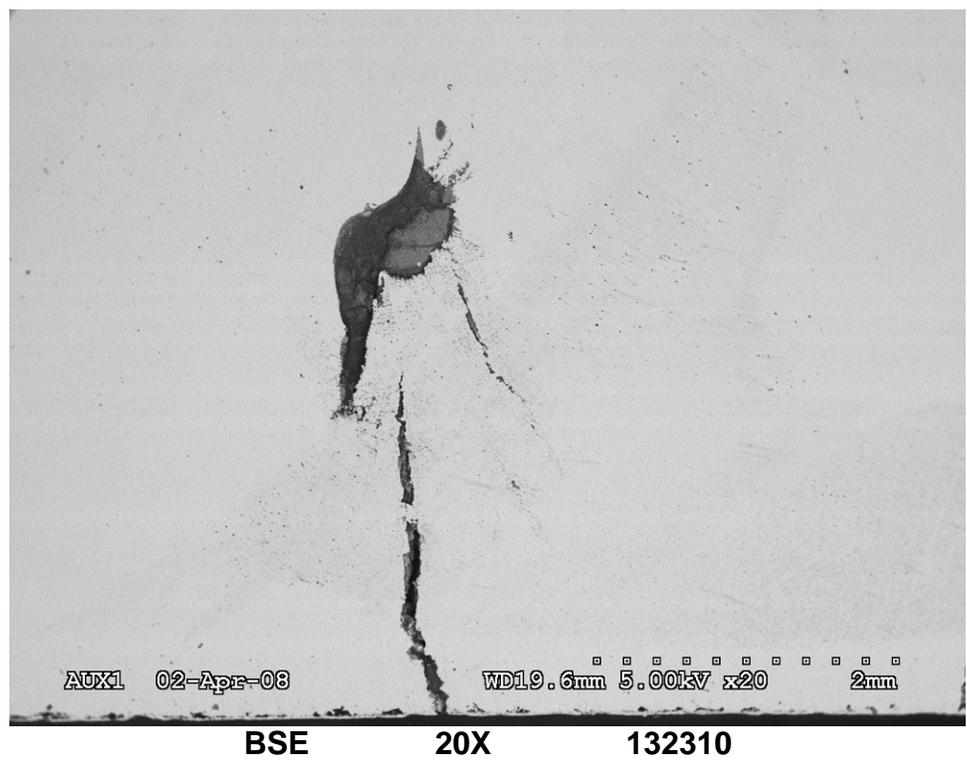
Low magnification SE and BSE micrographs showing the ID surface connected crack are provided in Figure 17. The ID surface of the nozzle is located along the bottom edge of each micrograph. The crack extended 0.16" into the Alloy 182 weld metal, including the weld void located ahead of the crack tip. There was no branching associated with the cracking. Higher magnification SE and BSE images of the weld void are shown in Figure 18 and Figure 19. EDS analysis of the substance within the weld void indicated the presence of elements normally associated with weld flux (oxygen, fluorine, magnesium, aluminum, calcium, and titanium). Alloy 182 constituents were also detected in this area (chromium, manganese, iron, nickel, and niobium).

Figure 17: Low magnification SE and BSE micrographs showing the crack present in the cross section prepared through the 350° orientation.

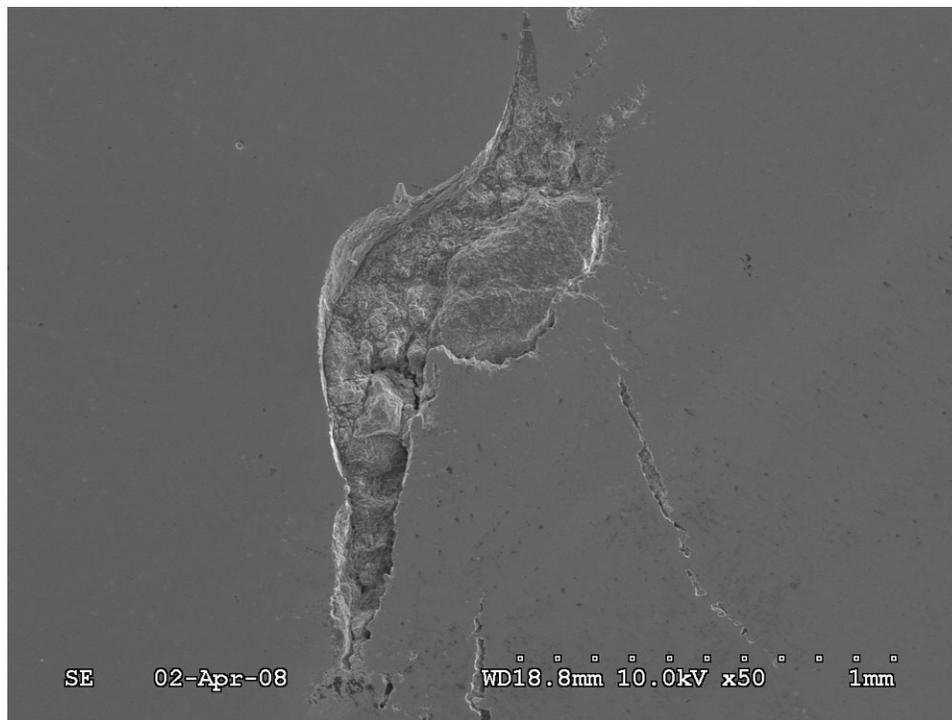
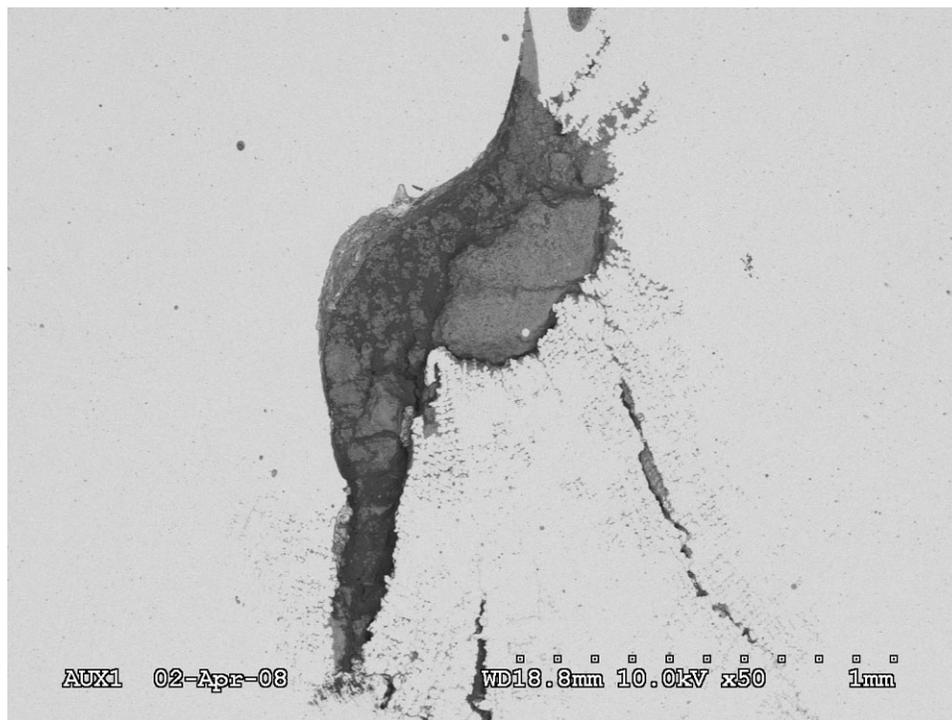
Figure 18: Slightly higher magnification SE and BSE micrographs taken near the crack tip.

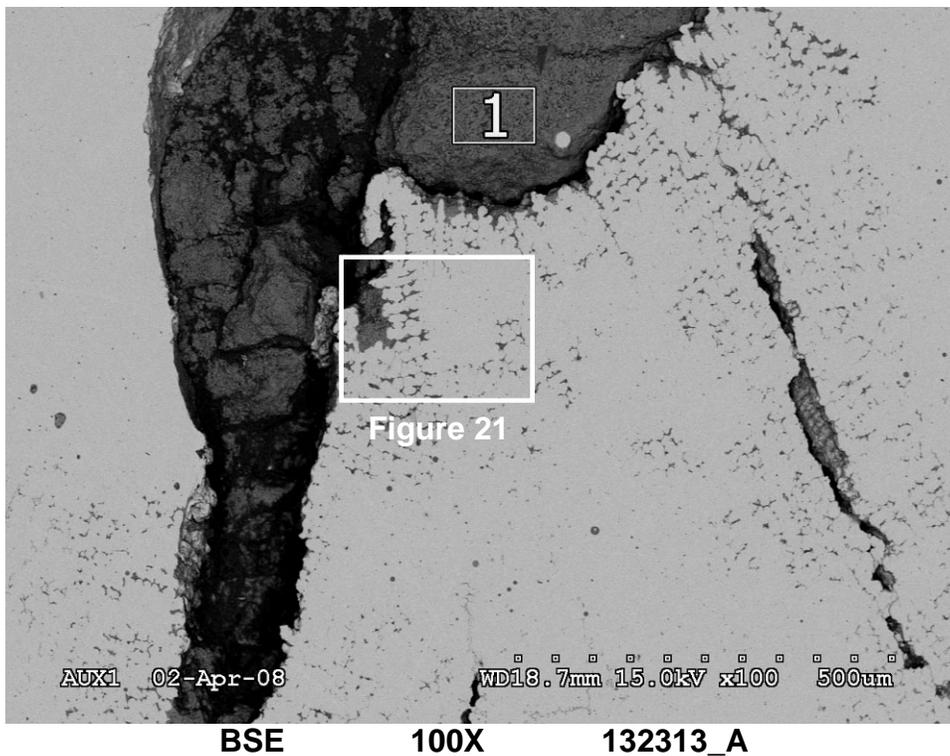
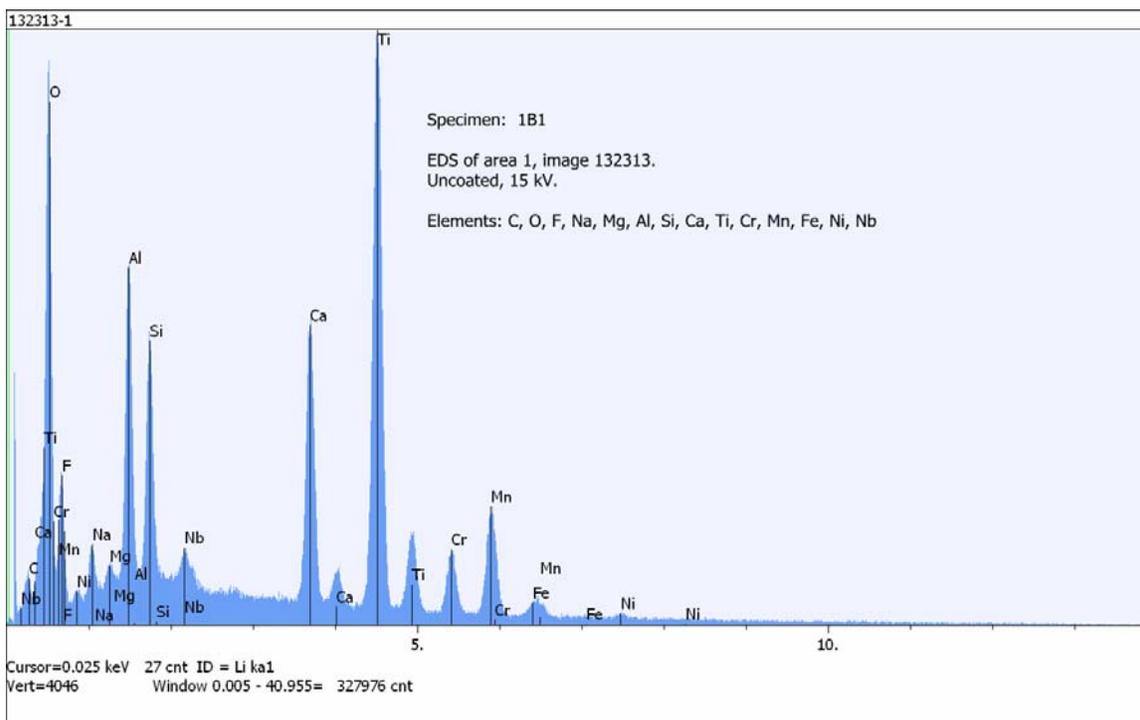
132313-1

Figure 19: EDS results for area 1 shown in upper micrograph. This area, which was located within a weld void, contained carbon, oxygen, fluorine, sodium, magnesium, aluminum, silicon, calcium, titanium, chromium, manganese, iron, nickel, and niobium.

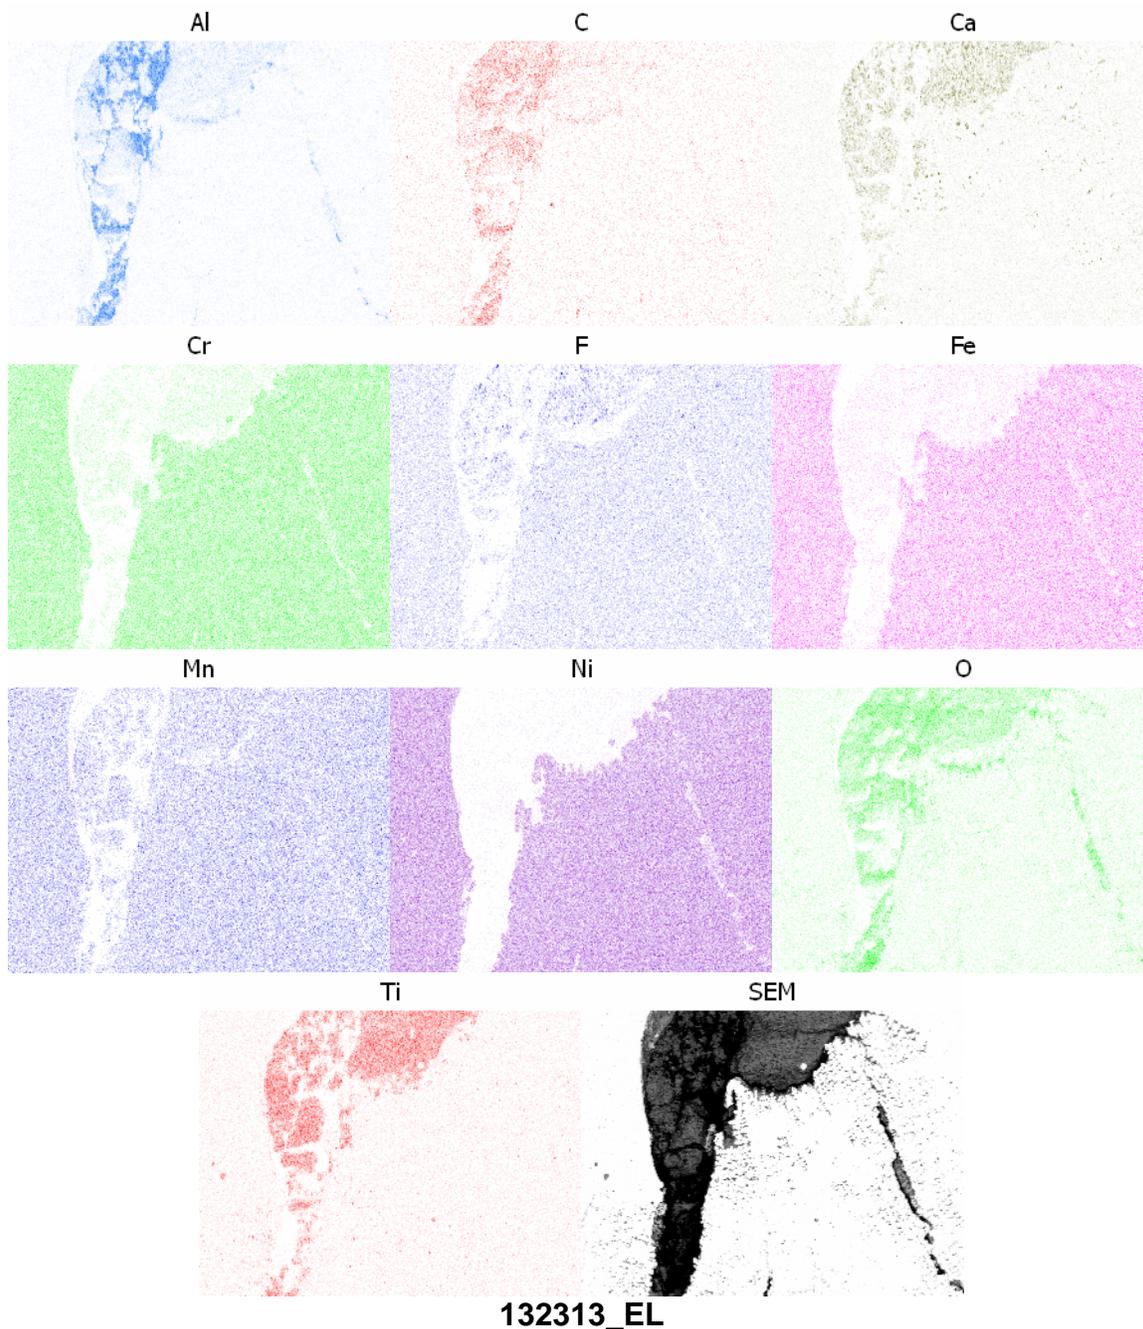
Figure 20: EDS dot map results for the area shown in Figure 18. The weld void contained primarily aluminum, carbon, calcium, fluorine, manganese, oxygen, and titanium. It appeared that the aluminum was an artifact from the polishing process. The weld metal contained the expected elements, chromium, nickel, iron, and manganese. (NOTE: There is an overlap between the fluorine and iron energy levels. The fluorine is not uniformly distributed on the sample, but rather it is located where there is an absence of iron, i.e. within the weld void.)

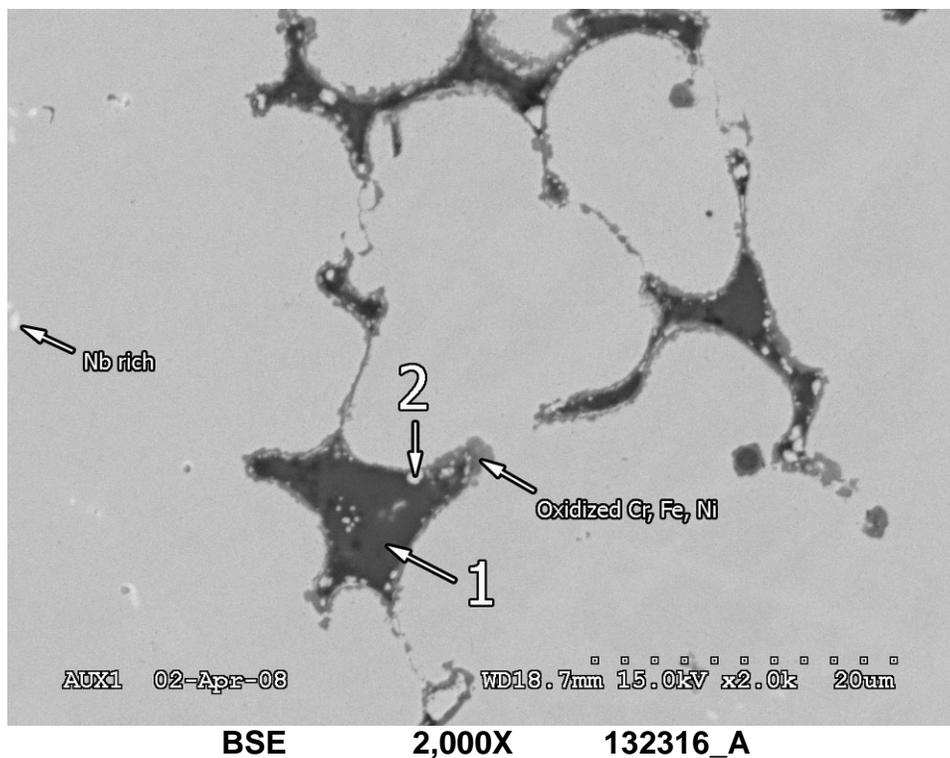
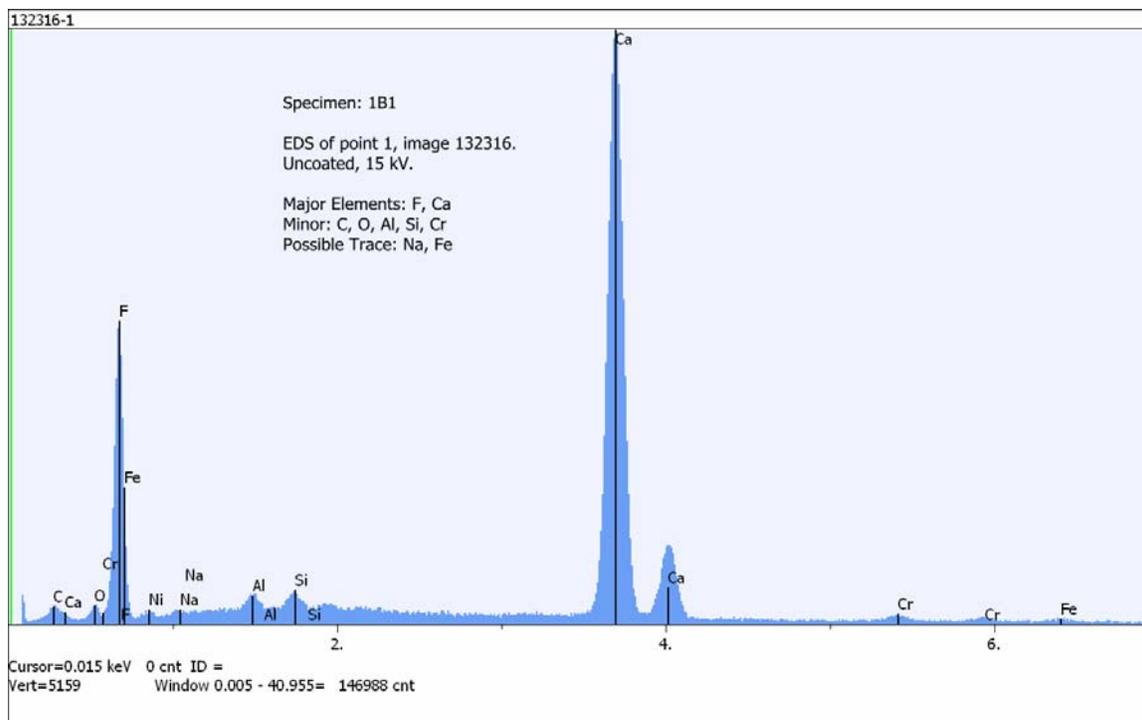
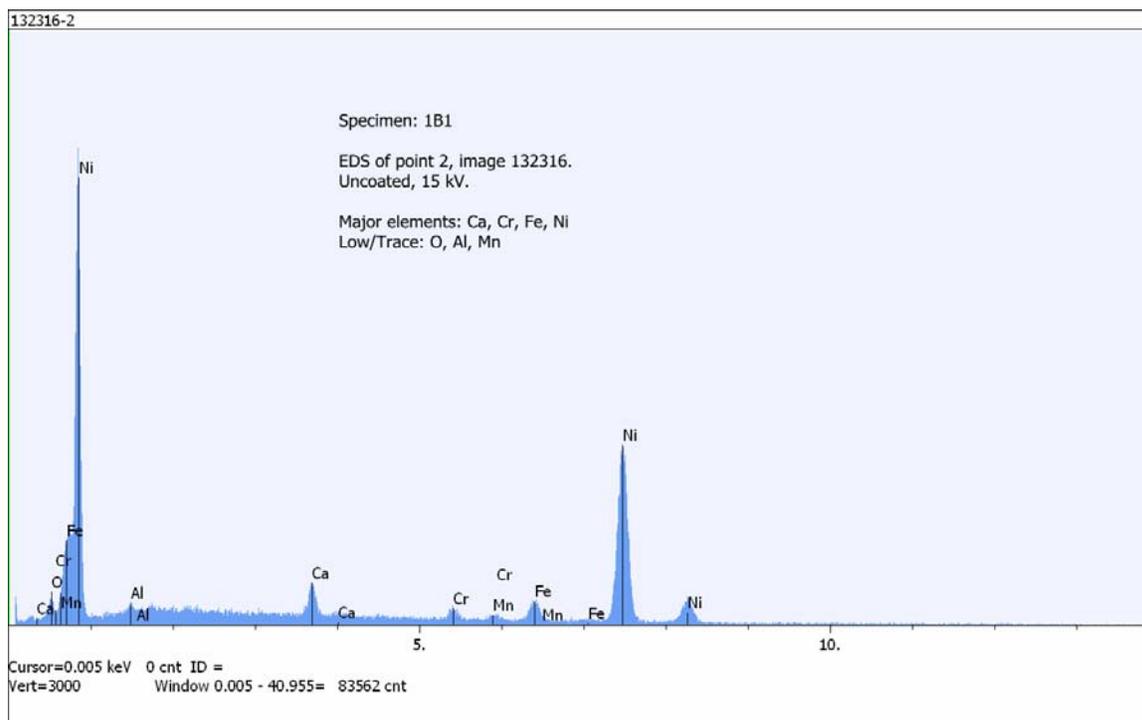
Figure 22: Higher magnification micrograph showing areas selected for EDS analysis. Oxidized weld metal (chromium, iron, and nickel) was present along the perimeter of the dendritic structure.

Figure 22 (cont.): EDS results for previous micrograph. Point 1 contained primarily calcium and fluorine, while point 2 contained primarily nickel.

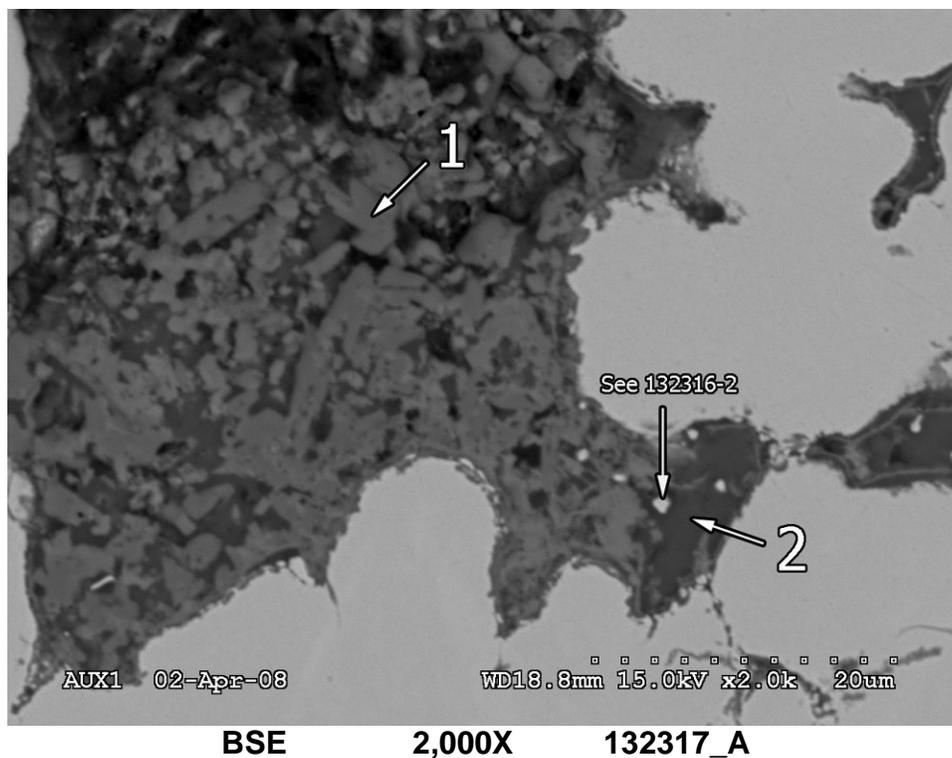
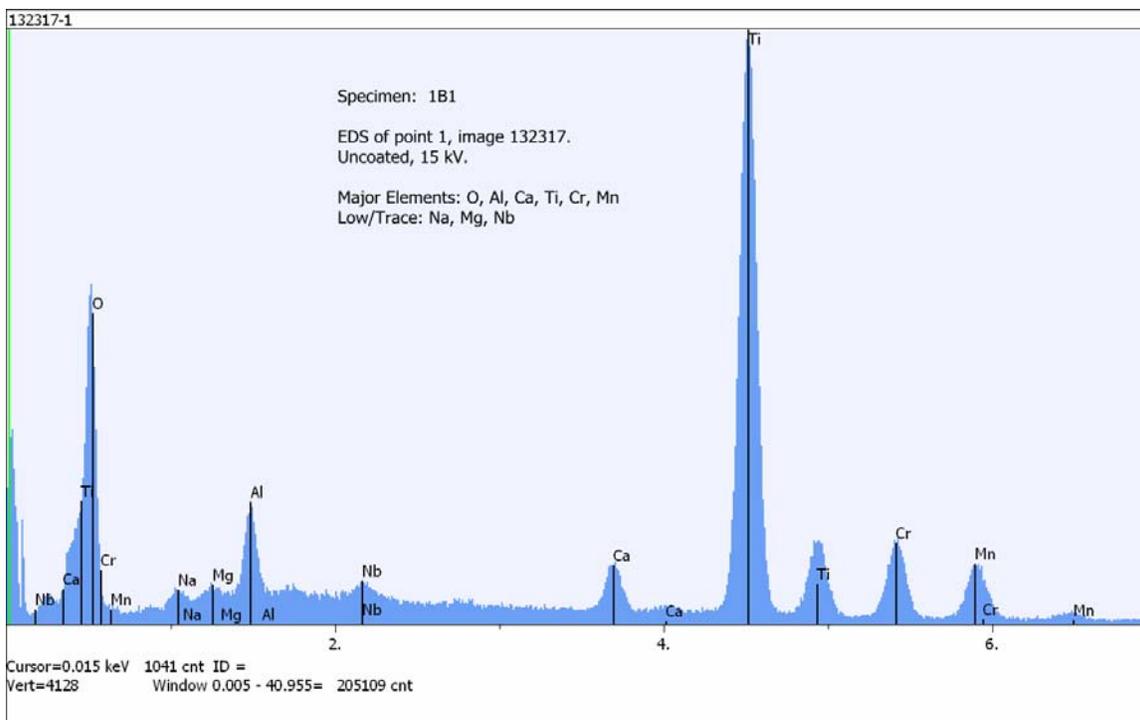
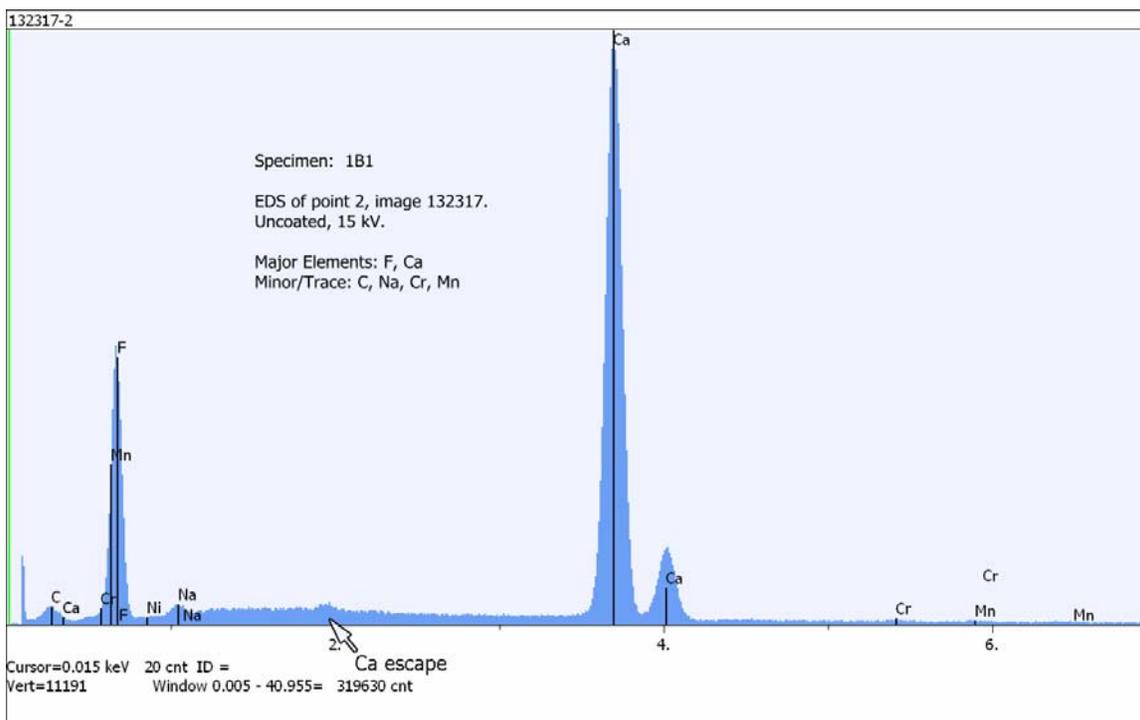
fluorine. These elements are typically associated with weld flux. Areas around the perimeter of the void contained oxygen, chromium, iron, and nickel as well as nickel-rich regions. Figure 23 highlights a second region located closer to the main weld void. This area contained two distinct chemical compositions, as suggested by the BSE gray level contrasts. Point 1 was primarily titanium and oxygen, while point 2 contained calcium and fluorine. Each of these elements is found in weld flux, as calcium fluoride and titanium oxide.

Figure 23: Higher magnification micrograph showing areas within the weld void selected for EDS analysis. The bright regions within the void contained primarily nickel, i.e. similar to 132316-2 (lower spectrum in previous figure).

Figure 23 (cont.): EDS results for previous micrograph. Point 1 contained primarily titanium and oxygen, while point 2 contained primarily calcium and fluorine.

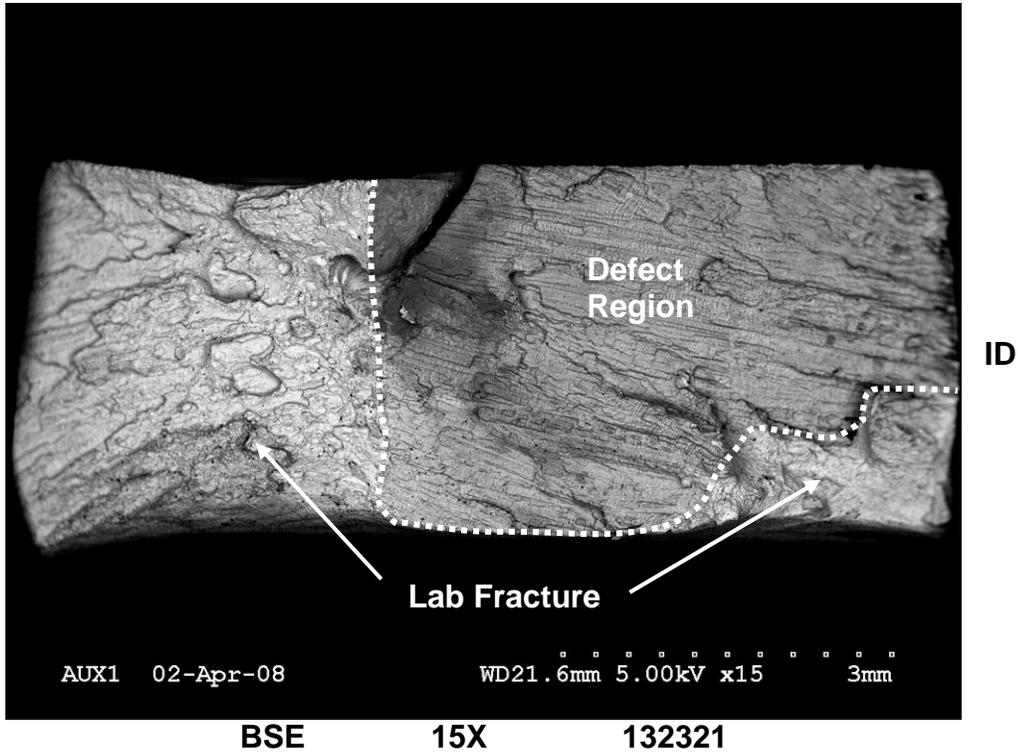
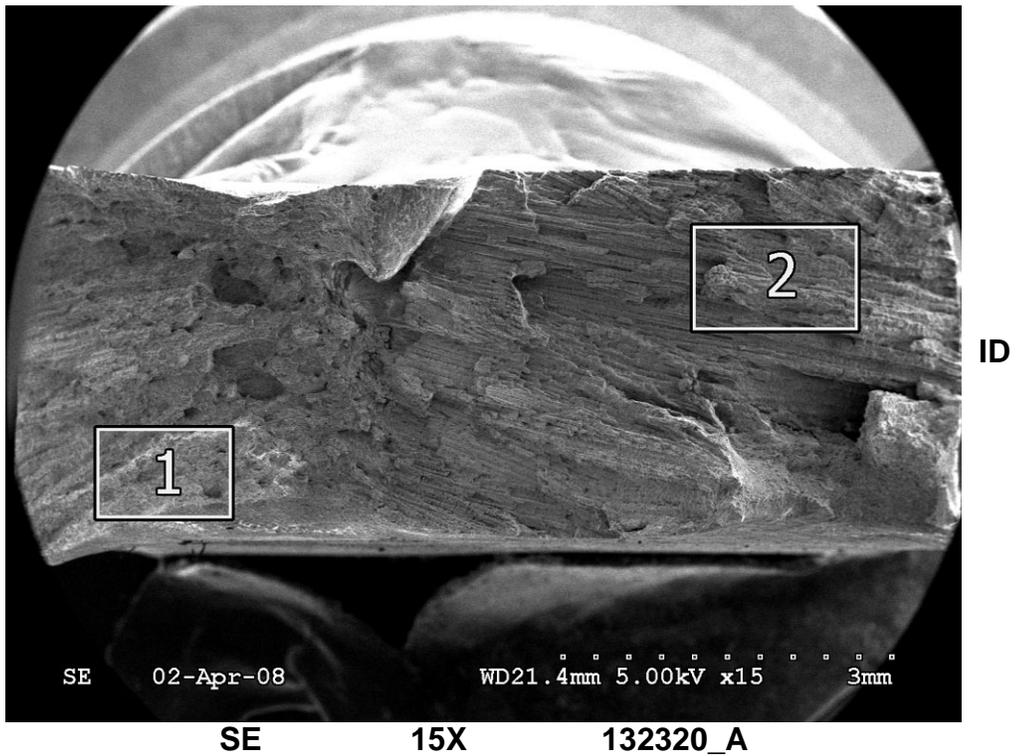
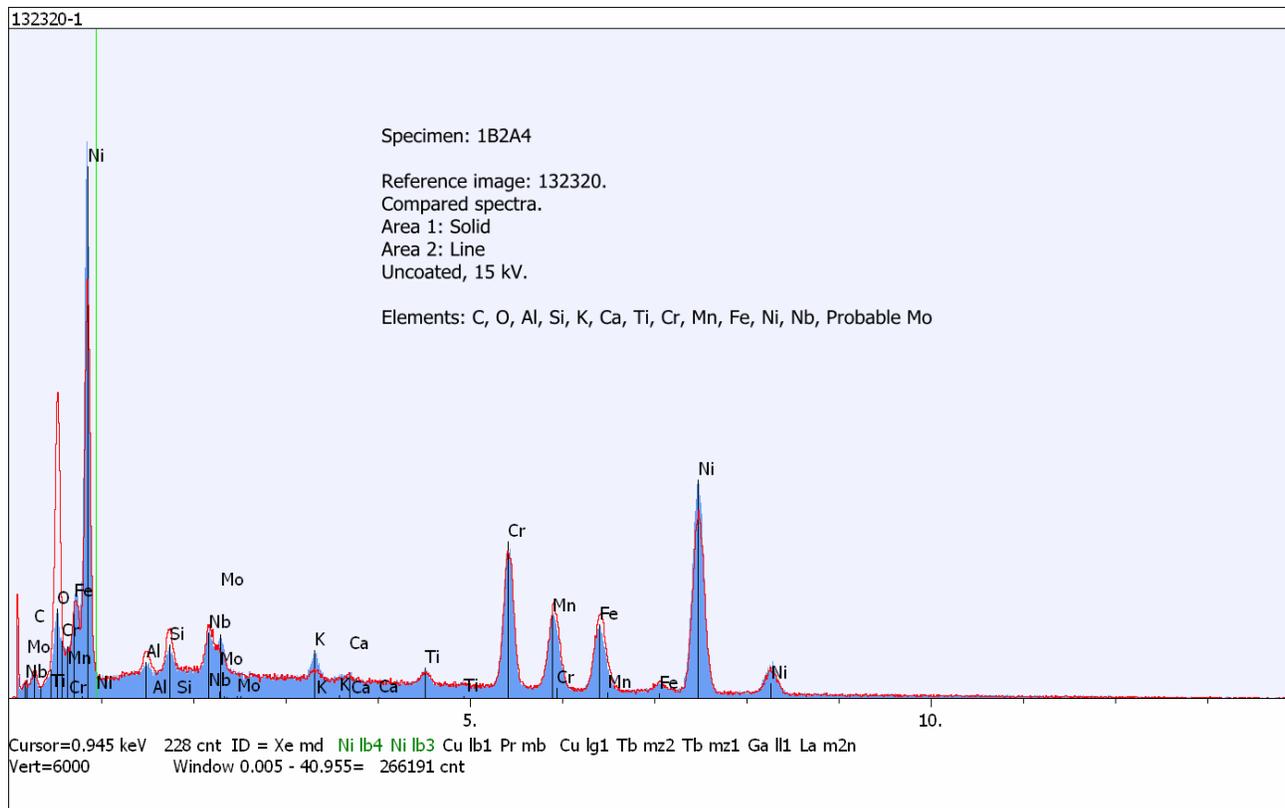
The open crack specimen prepared from the 340°-350° region of the weld is shown at low magnification in Figure 24. The pre-existing defect region is darker compared to the laboratory fracture region in the BSE image. This is normally due to higher oxygen levels on the pre-existing fracture surface. Two areas of this fracture surface were selected for comparative EDS analysis. Area 1 was located within the laboratory fracture, while area 2 was within the pre-existing defect region. The comparative EDS spectra indicated increased oxygen and potassium as well as decreased nickel in the pre-existing defect relative to the laboratory fracture. The potassium may have originated from the red dye.

Figure 24: Low magnification micrographs showing open crack specimen prepared from the 350° orientation. Lower micrograph shows two areas selected for EDS analysis. The ID surface is located to the right in both micrographs.

Figure 24 (cont.): Comparative spectrum results for area 1 and area 2 shown in previous figure. Area 1 was located within the lab fracture and is shown in solid blue, while area 2 was within the existing defect and is shown as a red line. The primary differences between the two spectra were increased oxygen and decreased nickel in the pre-existing defect relative to the lab fracture.

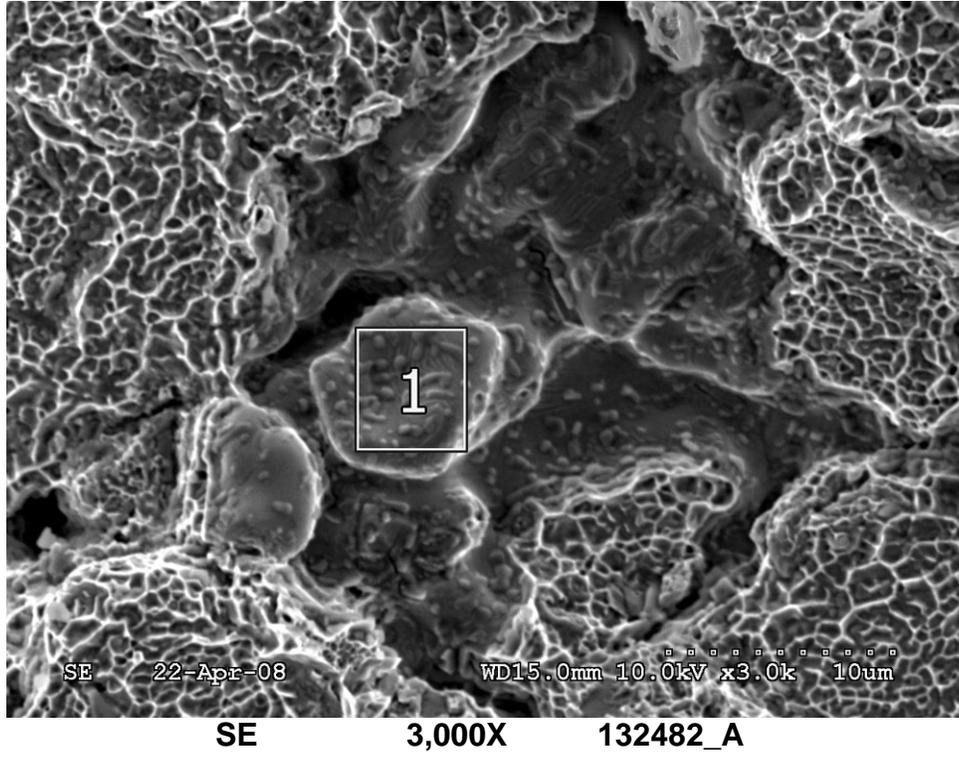
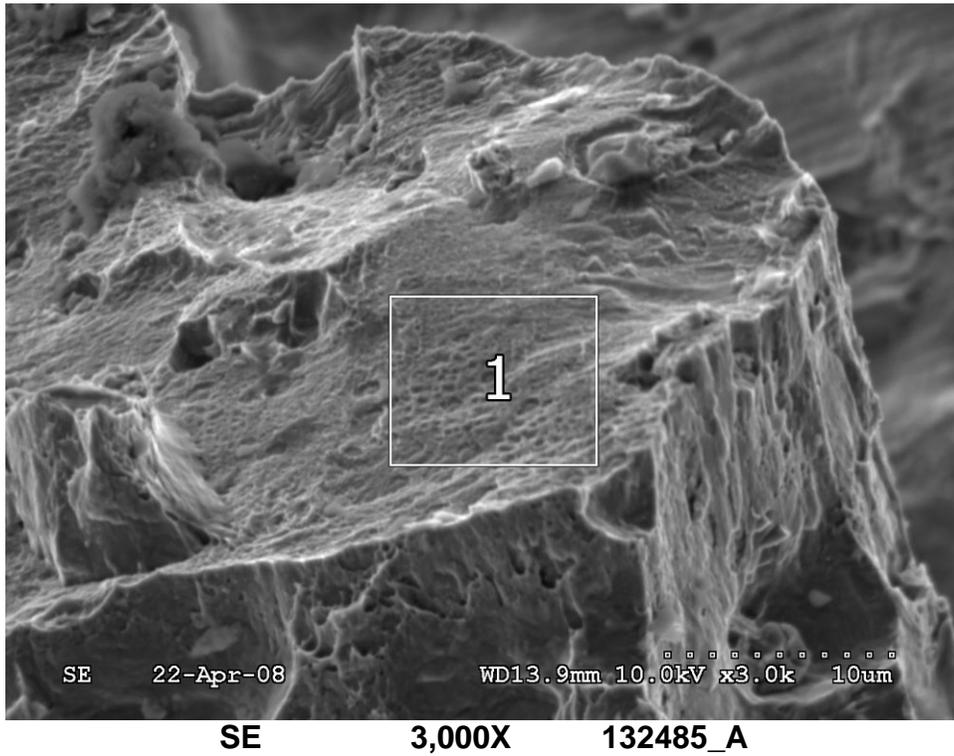
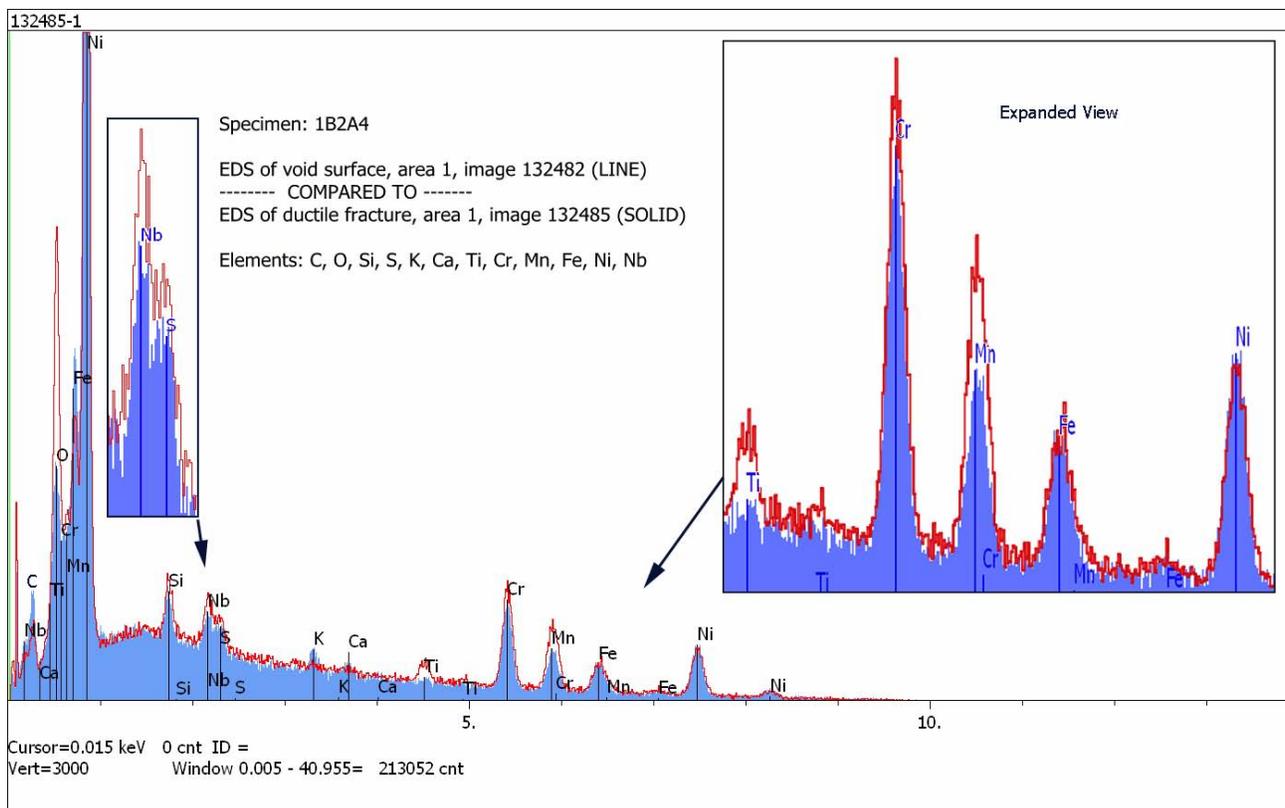
Since the fracture surface chemical compositions are expected to be different for primary water stress corrosion cracking and hot cracking (Ref. 1), it was decided to select regions of the pre-existing crack and laboratory crack at higher magnification to minimize the impact of extraneous constituents on the fracture surface. (Note that the open crack sample was lightly UT cleaned in acetone and that some penetrant and/or developer residue was likely present in the fracture crevices.) The two areas selected for EDS are shown in Figure 25. The EDS spectrum data indicated higher levels of oxygen, niobium, titanium, and manganese in the pre-existing crack relative to the laboratory fracture. Enrichment in niobium and manganese on a crack surface relative to a clean fracture surface has been attributed to hot cracking. The enrichment of these elements suggests the existence of a liquid film wetting the surfaces of the hot-formed crack (Ref. 1).

Figure 25: Typical areas of the defect region (upper micrograph) and laboratory fracture (lower micrograph) at higher magnification showing the areas selected for EDS analysis.

Figure 25 (cont.): Comparative EDS spectrum data for areas shown on previous page. The line spectrum represents the defect region, while the solid spectrum represents the laboratory fracture. The defect region contained higher levels of oxygen, niobium, titanium, and manganese compared to the laboratory fracture.
