Subject: St. Lucie Unit 1 Retired PZR Safety "A" Nozzle DM Weld Destructive
Examination Report

MRP Materials Reliability Program _____ MRP 2008-053
(via email)

SUMMARY

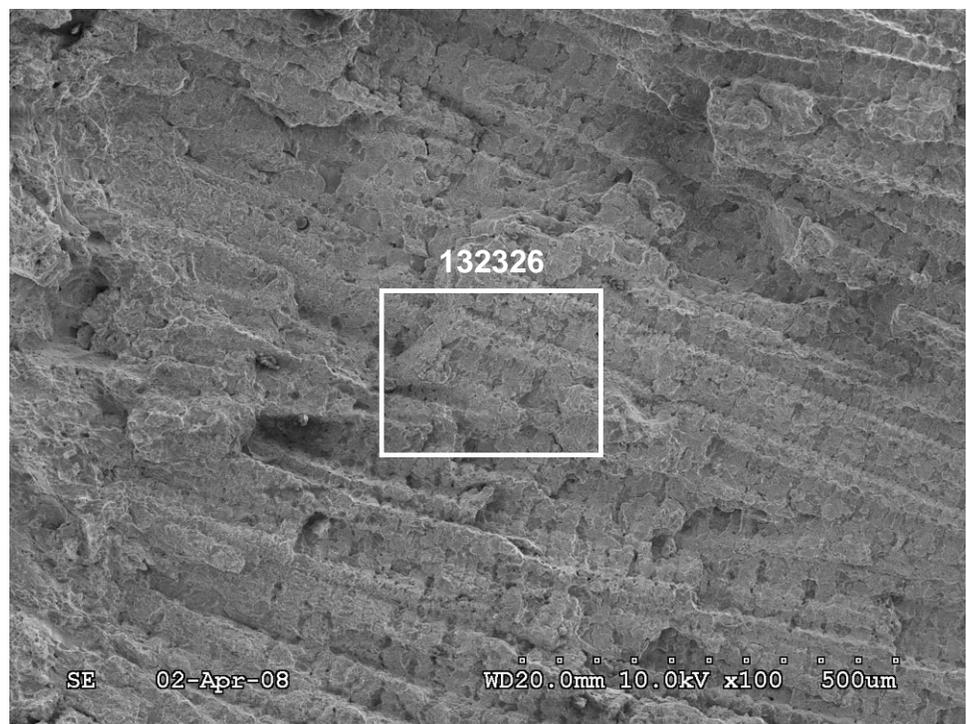
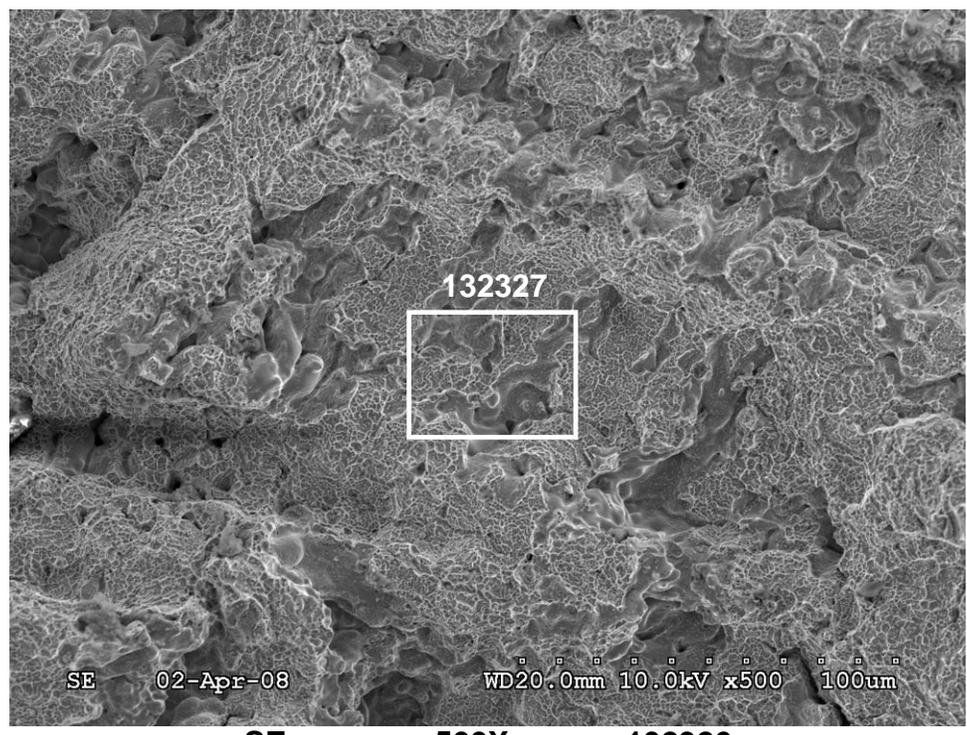
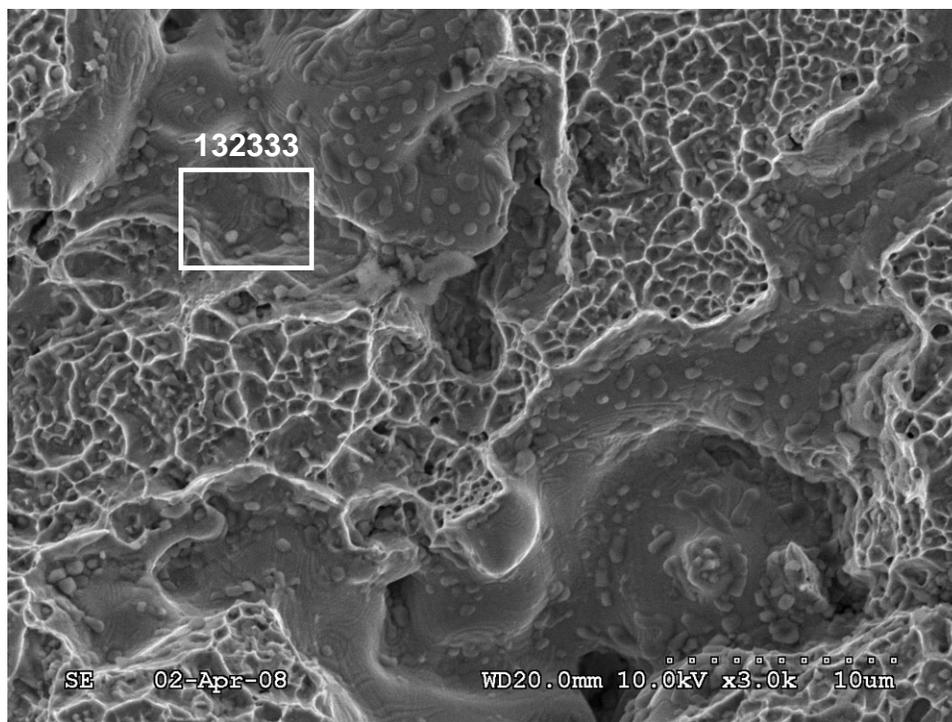
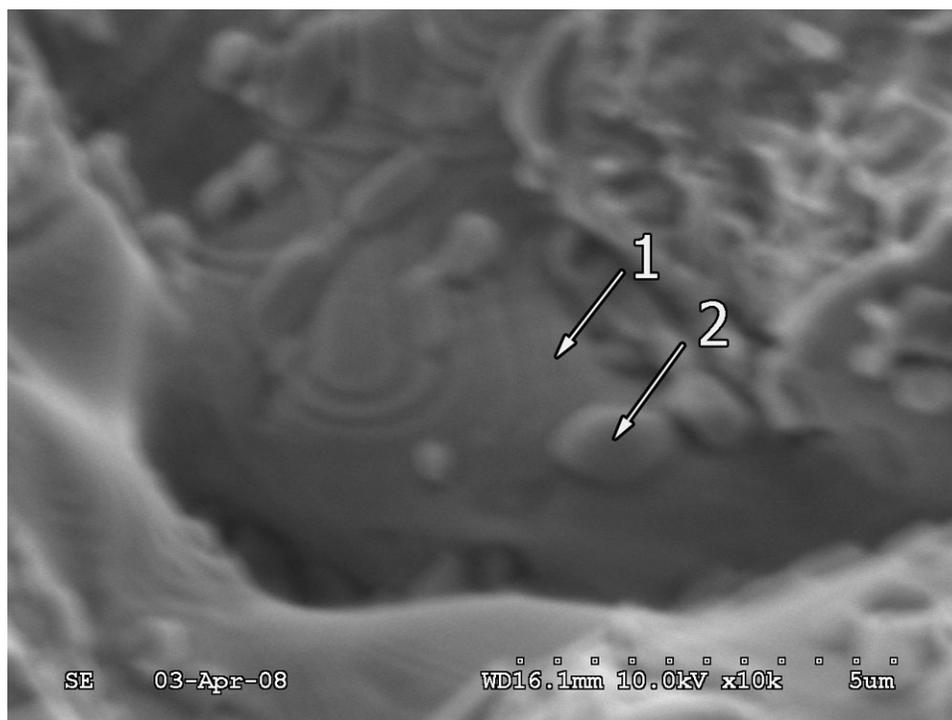
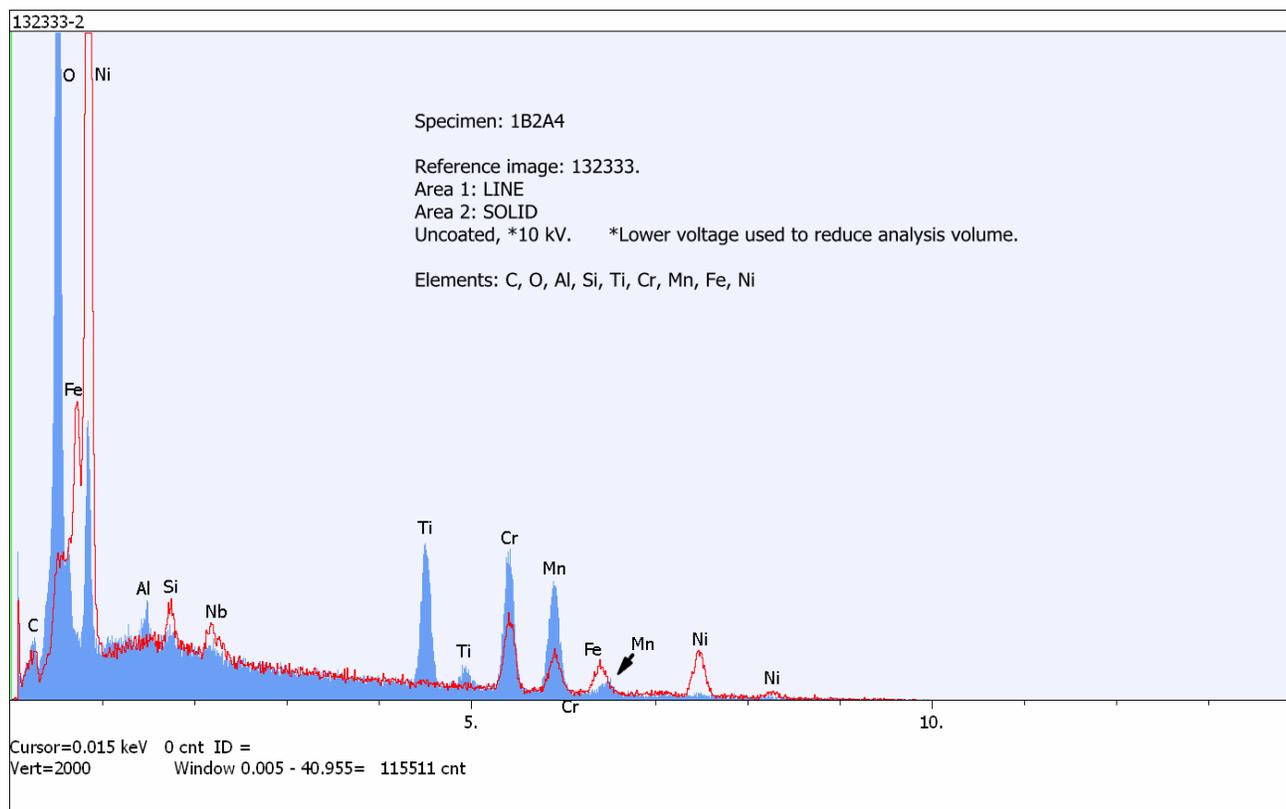
Progressively higher magnification SE micrographs showing the typical morphology of the pre-existing fracture surface are provided in Figure 26. These micrographs illustrate the mixed-mode nature of the fracture surface, which consisted of non-fused regions (smooth texture) and ductile microvoid coalescence. Small (2-3 micron diameter) raised nodules were detected at high magnifications on the non-fused portions of the fracture surface (micrographs 132327 and 132333 in Figure 26). Comparative EDS spectra were collected from typical smooth and raised regions. The spectrum data are presented in Figure 26 (EDS 132333-1-2). Area 1 (smooth region) contained higher levels of nickel, silicon, niobium, and iron as well as lower oxygen, titanium, chromium, manganese, and aluminum concentrations relative to area 2 (raised area). These results indicate mixing between the flux and weld metal occurred during solidification.

Figure 26: Progressively higher magnification micrographs showing typical fracture surface morphology in weld defect region.

Figure 26 (cont.): Progressively higher magnification micrographs showing typical mixed fracture morphology in weld defect region. The fracture surface contained both ductile microvoid coalescence and non-fused regions. Area 1 and area 2 were analyzed by EDS.

Figure 26 (cont.): Comparative EDS spectrum results for area 1 and 2 in previous micrograph. Area 1 (smooth texture) contained higher levels of nickel, silicon, niobium, and iron as well as lower oxygen, titanium, chromium, manganese, and aluminum concentrations relative to area 2 (raised nodule). It appeared that there was some interaction between the flux and weld metal during solidification.

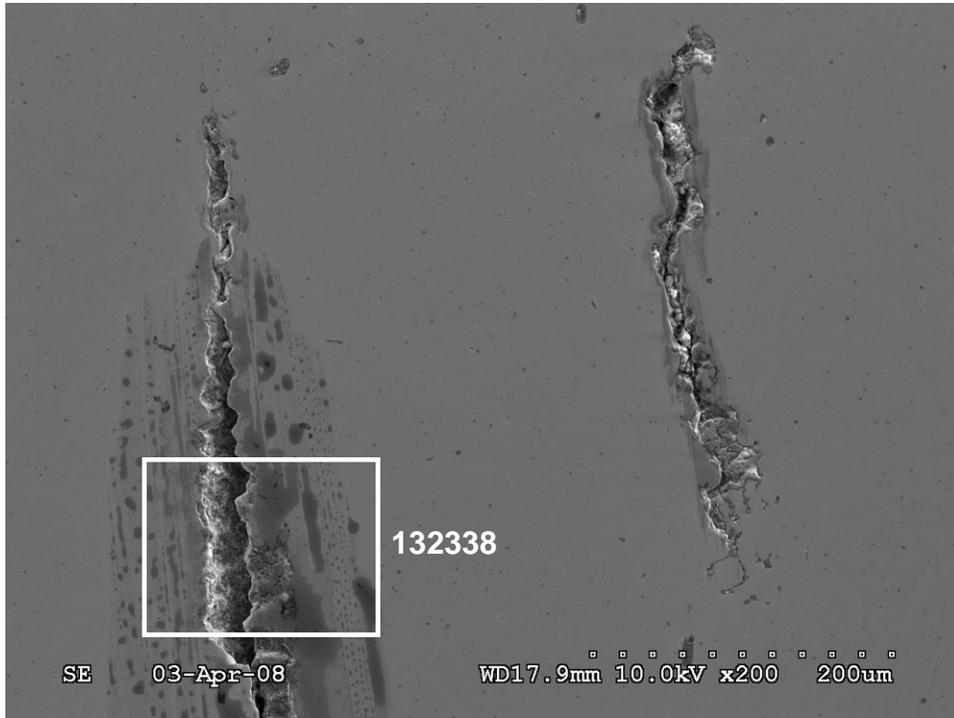
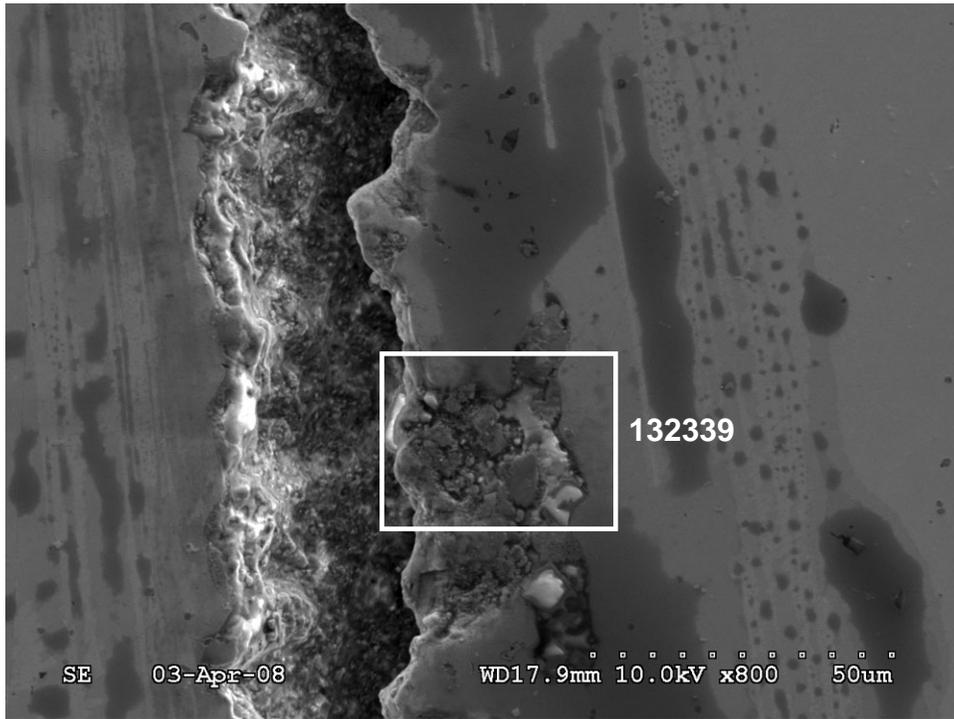
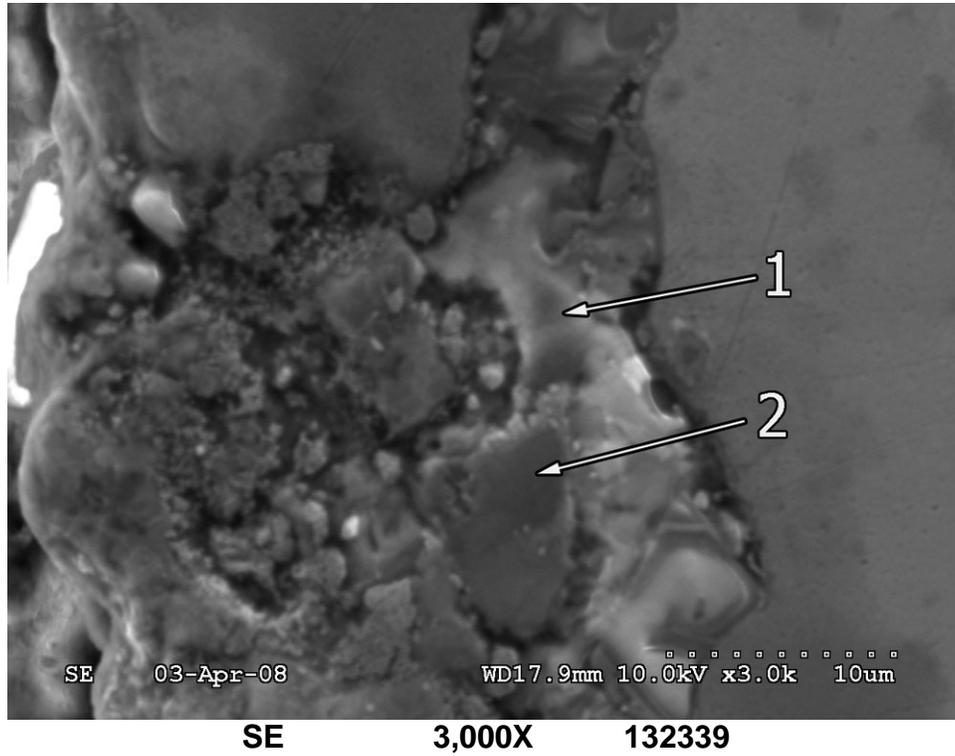
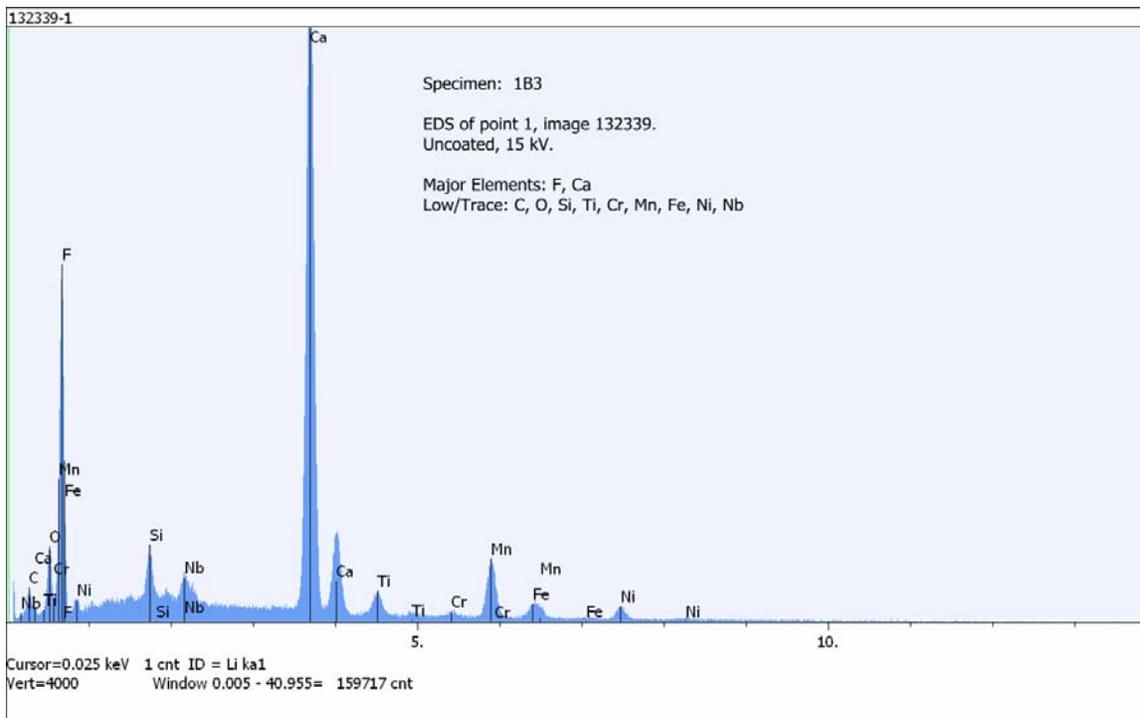
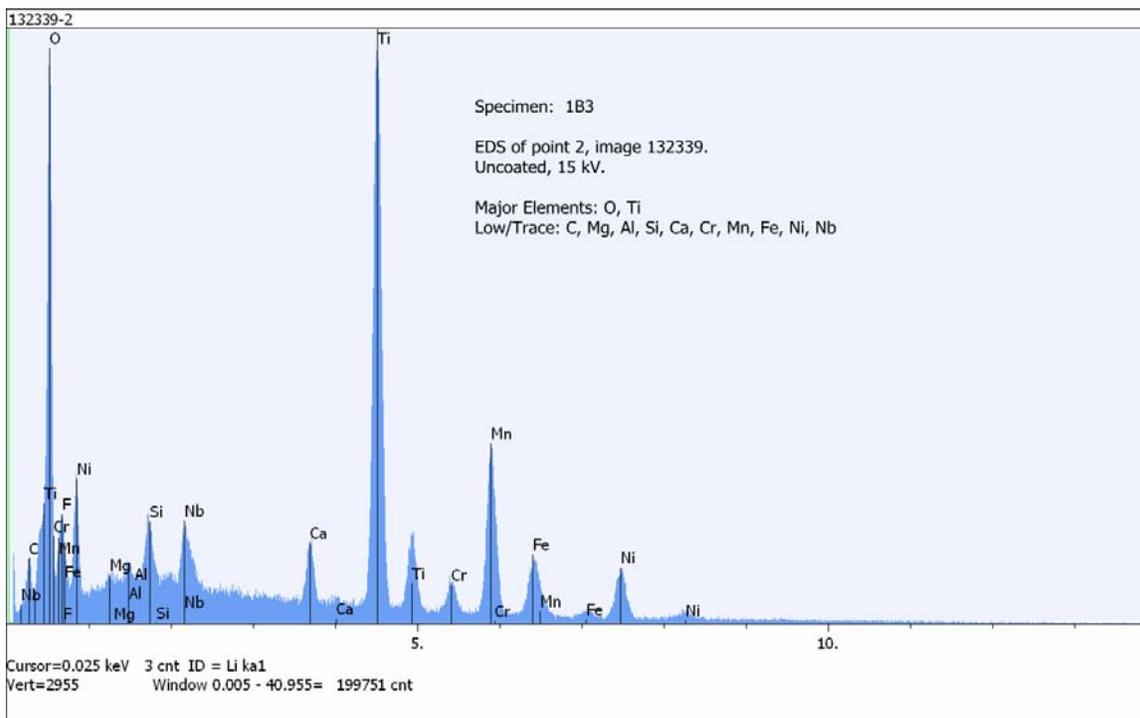
Low magnification SE and BSE micrographs of the crack present in this specimen are provided in Figure 27. The cracking is straight and unbranched. It extends approximately 0.1" into the weld from the ID surface. Progressively higher magnification micrographs taken near the crack tip are provided in Figure 28. EDS analysis was performed on two regions within the crack. The first area contained primarily calcium and fluorine, while the second area contained primarily titanium and oxygen (Figure 28). These results were consistent with those obtained from the crack located at 350° (refer back to Figure 23). SE and BSE micrographs documenting the dendritic nature of the crack near the crack tip are presented in Figure 29.

Figure 28: Higher magnification micrographs of crack present at 35°. Staining adjacent to the crack was caused by bleed out from the defect.

Figure 28 (cont.): EDS results for two areas shown in previous figure. The first area contained primarily calcium and fluorine, while the second area contained primarily titanium and oxygen. These results were consistent with the results obtained from the crack located at 350°.

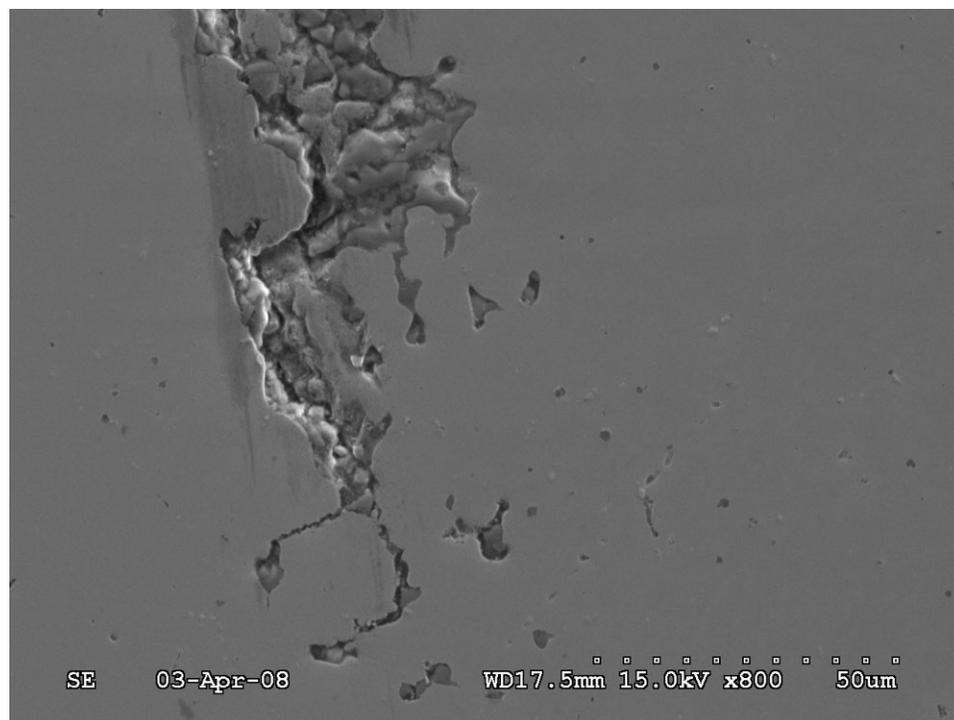
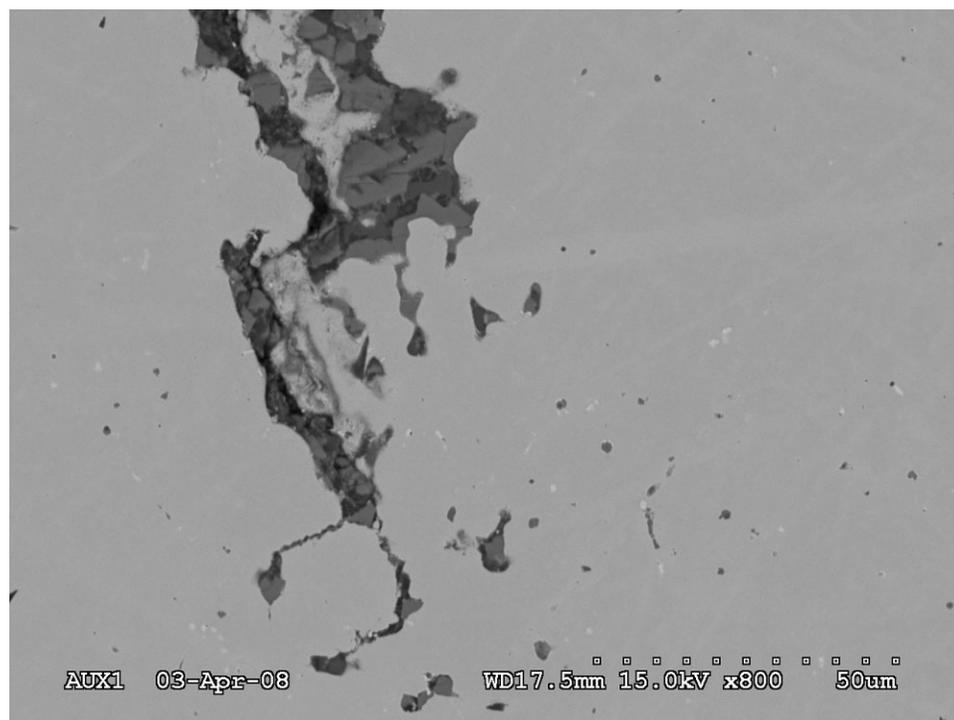
Figure 29: Higher magnification micrographs details of crack showing dendritic structure. This morphology was similar to that seen previously at 350°.

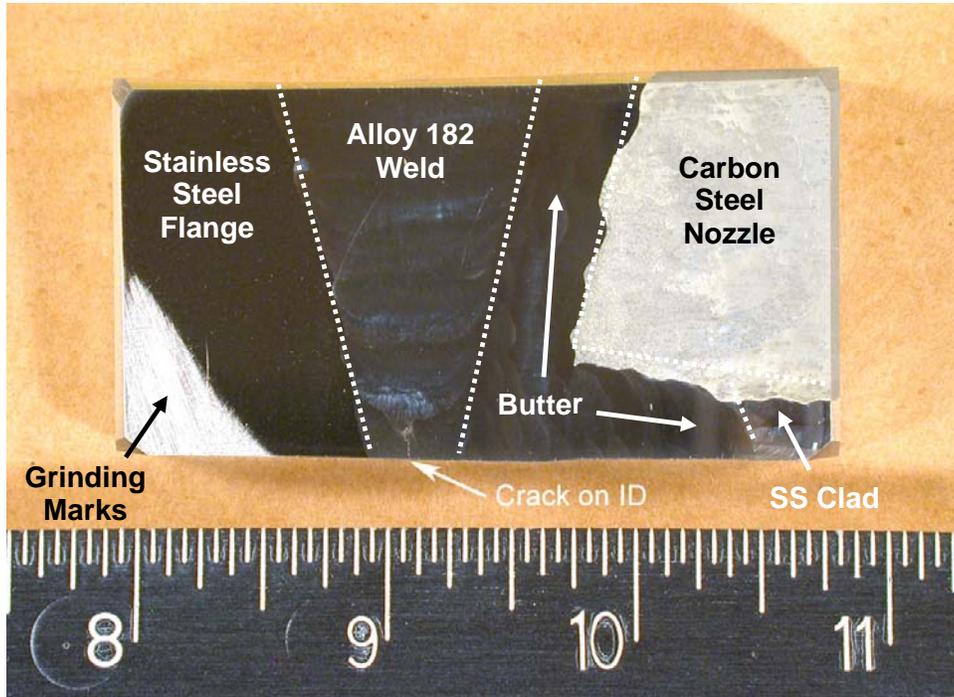
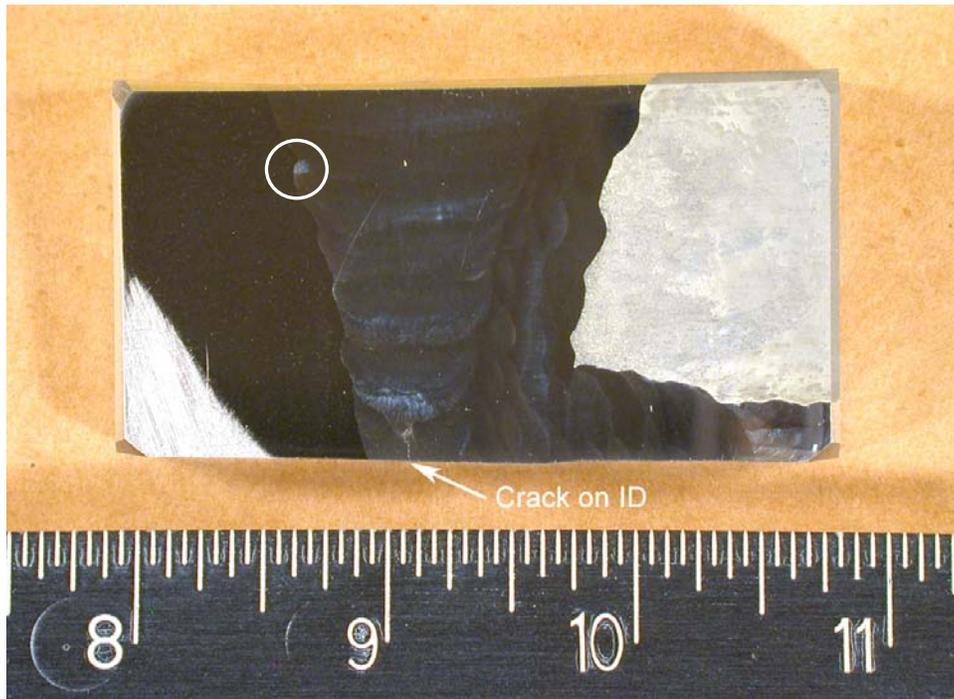
350° (10% oxalic etch)

Figure 30 is a low magnification view of the polished and etched cross section prepared through the 350° orientation. The upper photograph in this figure shows the locations of the stainless steel flange, the Alloy 182 weld, the Alloy 182 butter layer, the carbon steel nozzle, and the stainless steel cladding on the nozzle ID surface. A crack measuring 0.16" deep from the ID surface and a weld void measuring 0.06" in diameter were present at this location. A higher magnification view of the crack is shown in Figure 31 (this is the same crack examined previously by SEM, see Figure 17 for comparison). It was apparent that the void was caused by weld flux entrapped between two weld beads. The weld bead deposited over the flux (top of micrograph) likely contributed to the cracking. The cracking was interdendritic, straight, and unbranched; it was consistent with hot cracking, not a crack that initiated and propagated in-service. A higher magnification micrograph taken of the crack tip and a micrograph of the weld void are shown in Figure 32.

Figure 30: 1B1 macro photograph after etching. A crack extending 0.16" deep from the ID surface and a weld void measuring ~0.06" in diameter (inside circle) were present. The weld void was located at the edge of the Alloy 182 weld, adjacent to the stainless steel flange. (NOTE: The same photo appears twice above; the upper photo was annotated with the various constituents for clarity.)

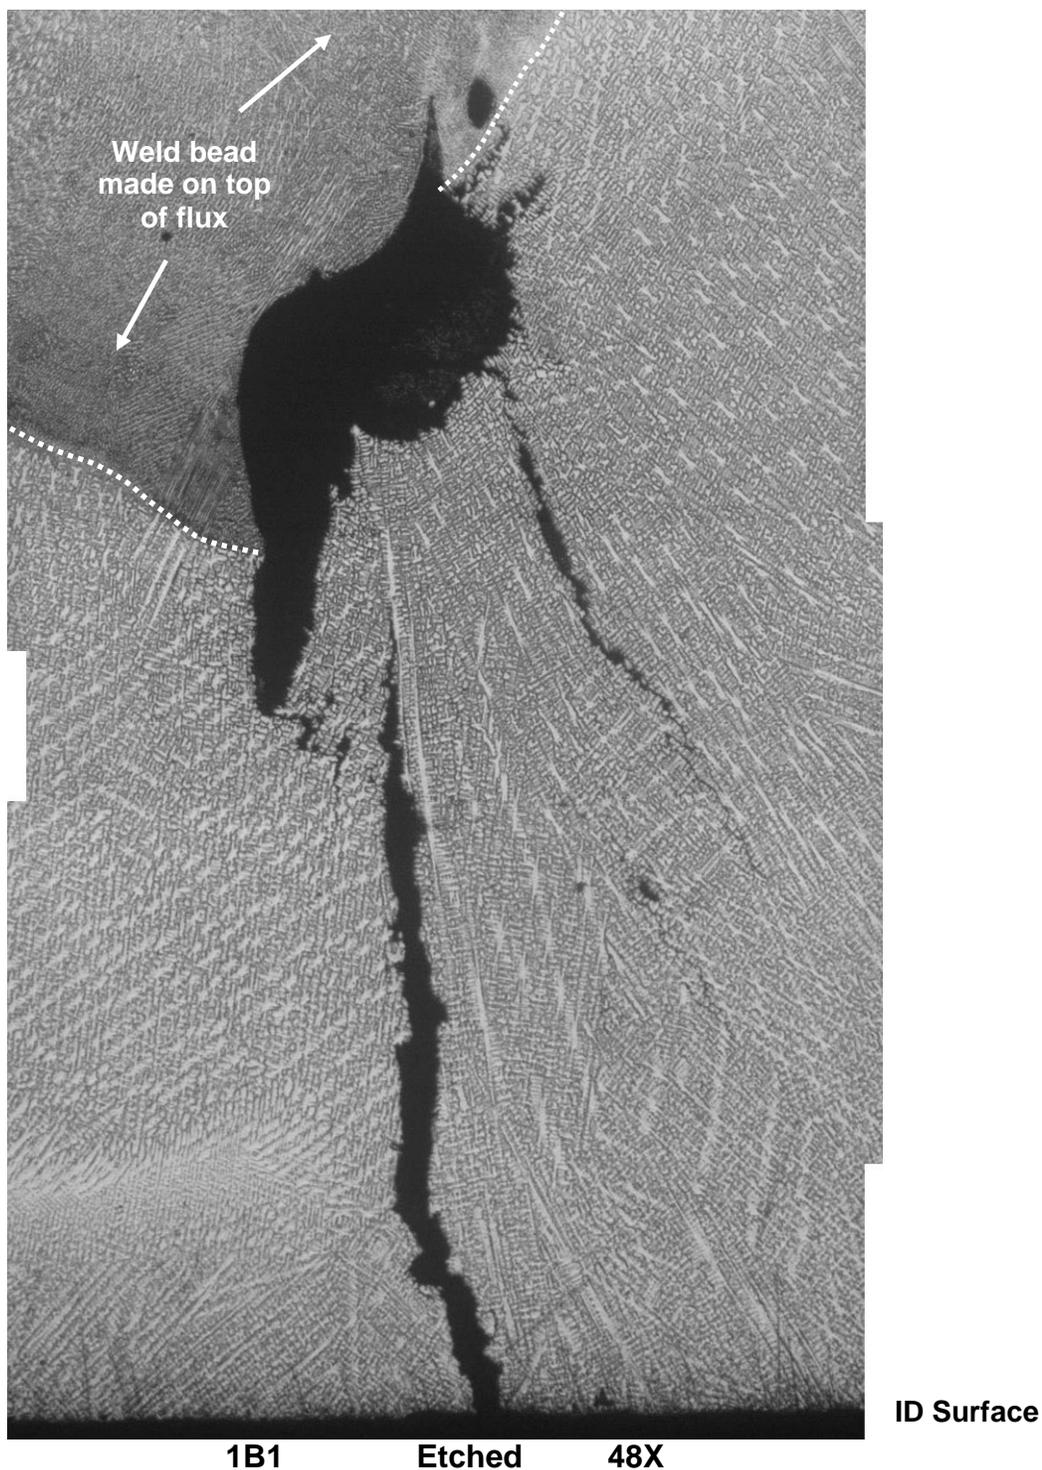
Figure 31: Micrograph montage showing the crack extending from ID surface to a weld void at the 350° orientation. Cracking was interdentritic, straight, and unbranched. The weld bead deposited over the flux likely contributed to the cracking.

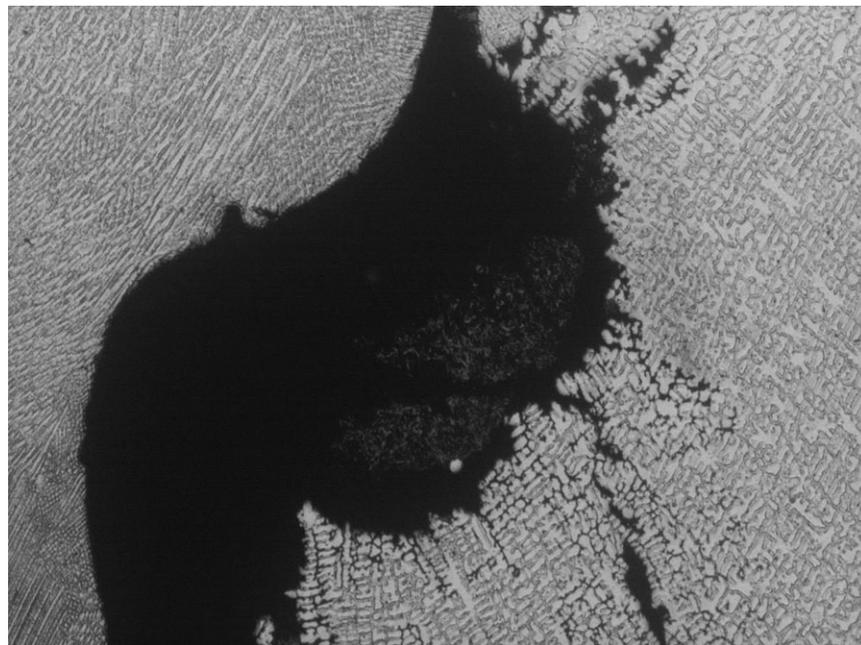
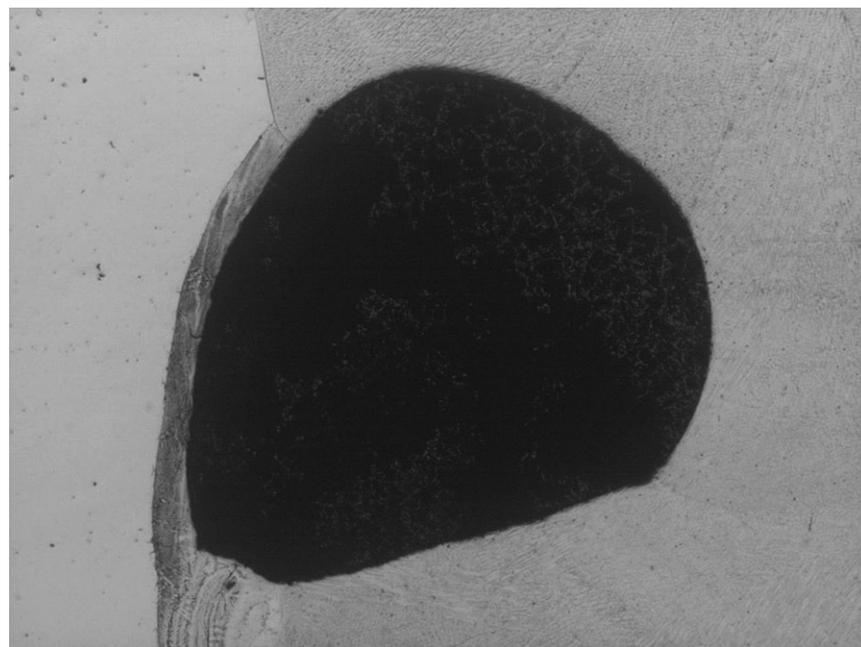
Figure 32: Micrographs showing the crack tip (top) at higher magnification and the weld void (bottom). Non-fused areas are evident adjacent to the void in the upper micrograph. The weld void in the lower micrograph measured 0.06" in diameter; there was no cracking associated with this void.

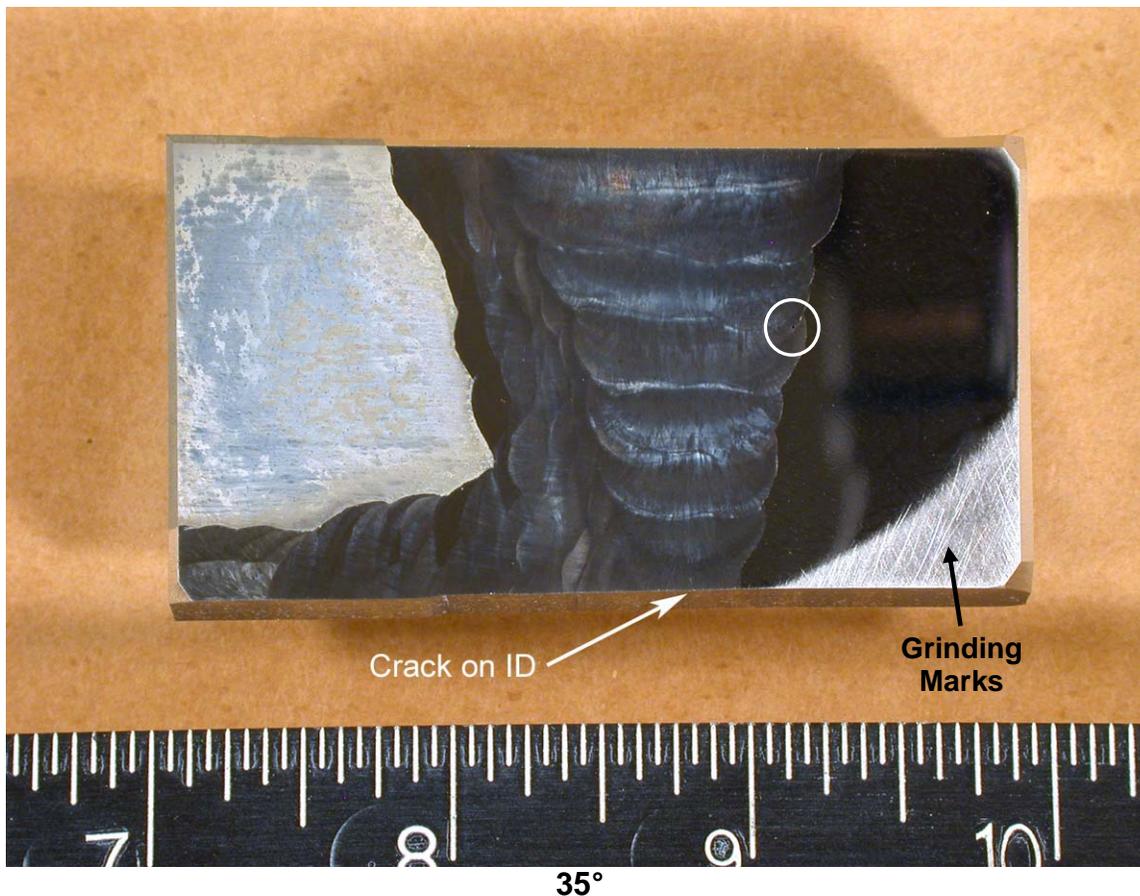
The cross section prepared through the 35° orientation is shown in Figure 33. A crack measuring 0.1" deep extended from the ID surface into the weld metal. One small void measuring 0.03" in diameter was present in the Alloy 182 weld metal adjacent to the stainless steel flange. The crack at this location was interdendritic, straight, and unbranched (Figure 34). The weld void is shown at higher magnification in Figure 35. There was no cracking associated with this weld void.

Figure 33: 1B3 macro photograph after electrolytically etching with 10% oxalic acid. A crack extending 0.1" deep from the ID surface and a weld void measuring less than 0.03" in diameter were present. This void was located adjacent to the stainless steel flange.

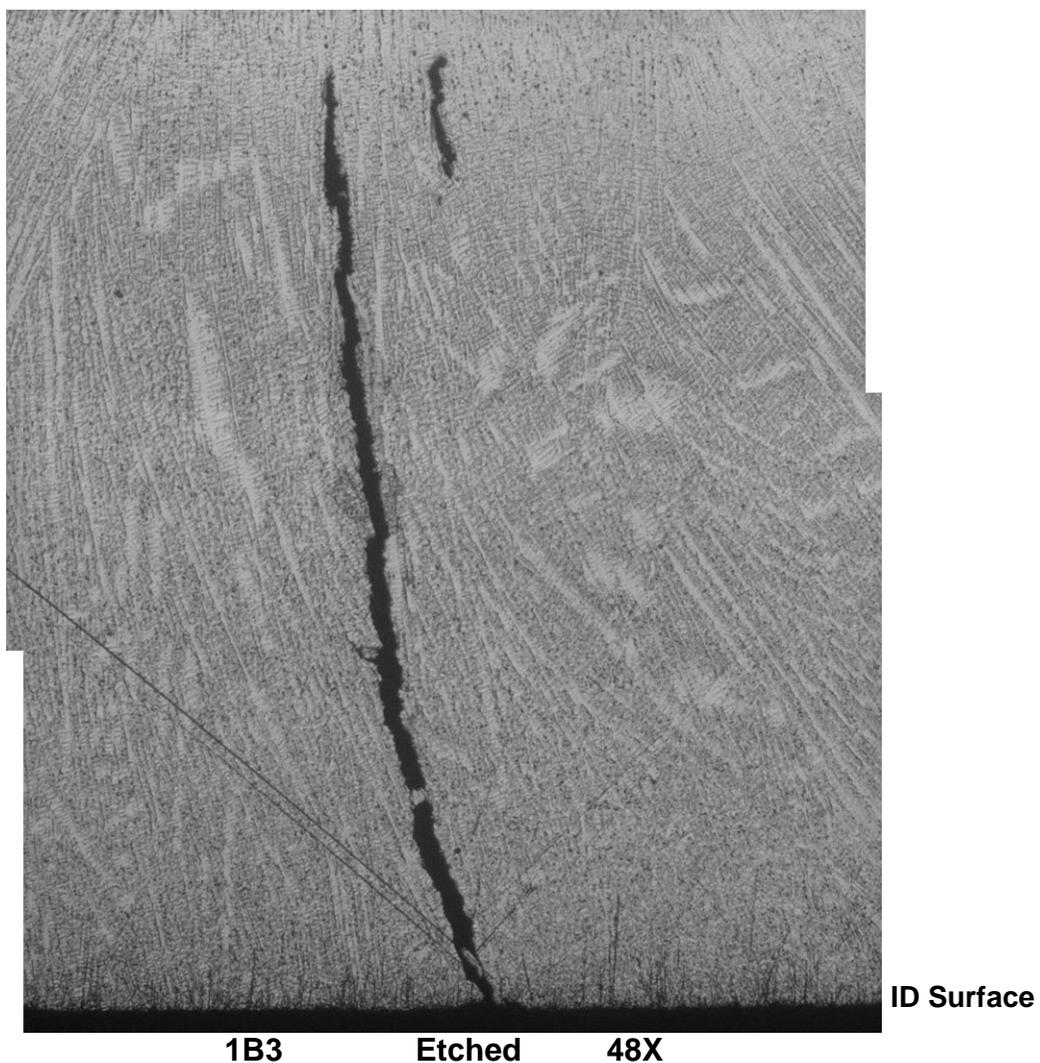
Figure 34: Micrograph montage showing the crack extending from ID surface to a weld void at the 35° orientation. The cracking was interdendritic, straight, and unbranched.

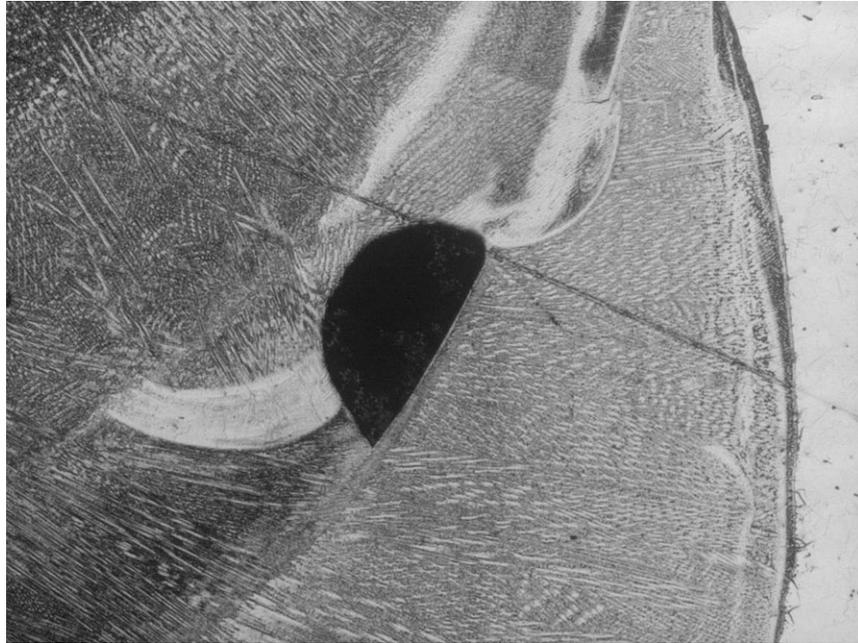
1B3 100X

Figure 35: Weld void measuring less than 0.03" in diameter at the 35° orientation. There was no cracking associated with this void.

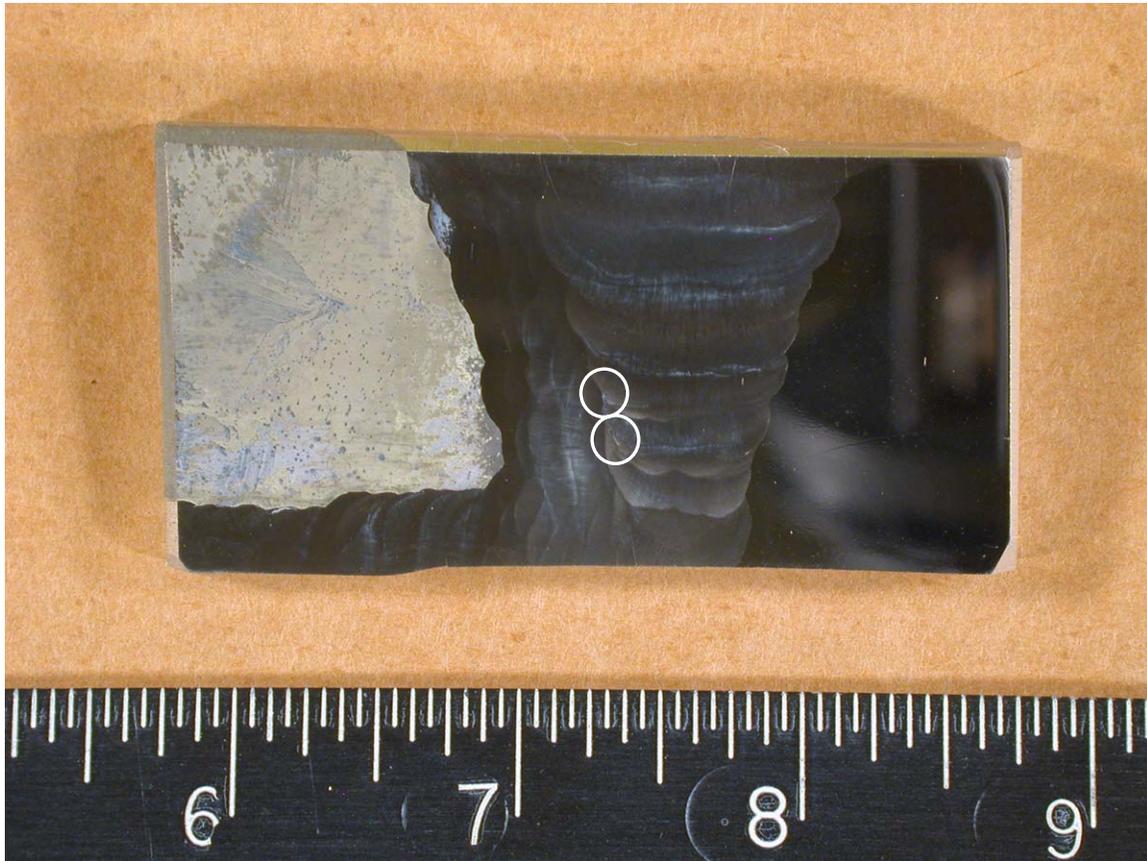
The third cross section, prepared through the 140° orientation, is shown in Figure 36. No cracking was present in this cross section. Two small weld voids measuring less than 0.03" in diameter were detected in the Alloy 182 weld metal adjacent to the butter layer. The larger of these voids is shown in Figure 37. The void measured 0.050" by 0.015" and had a small crack measuring 0.003" long adjacent to the void. This crack was most likely a hot crack created during manufacture, since it was internal to the weld and not exposed to the environment. The second void measured 0.030" by 0.005" and is shown in Figure 38. There was no cracking associated with this void.

Figure 36: 1B5 macro photograph after electrolytically etching with 10% oxalic acid. No cracking was present at this orientation. Two small voids, each measuring less than 0.03", were detected within the weld adjacent to the butter region.

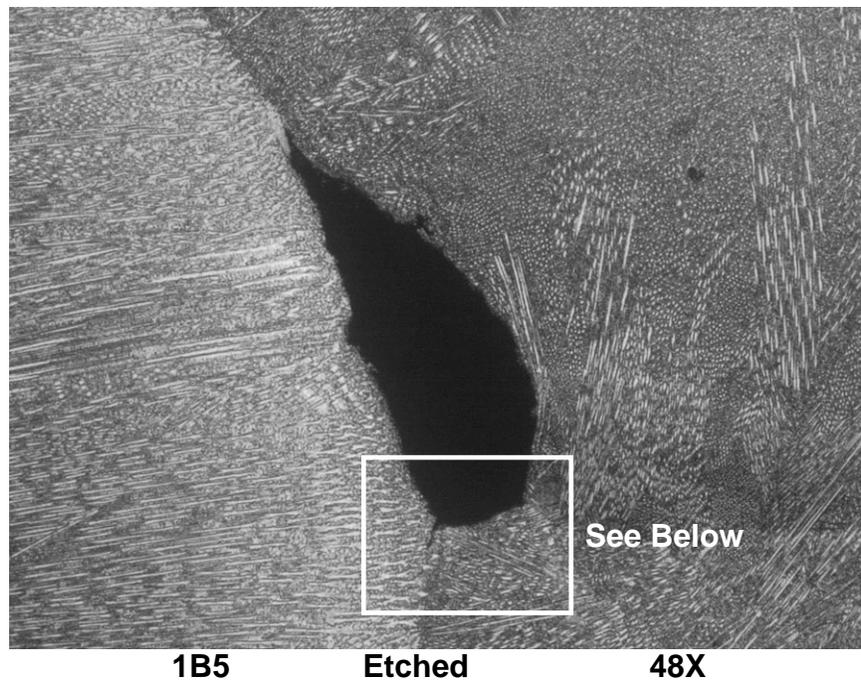
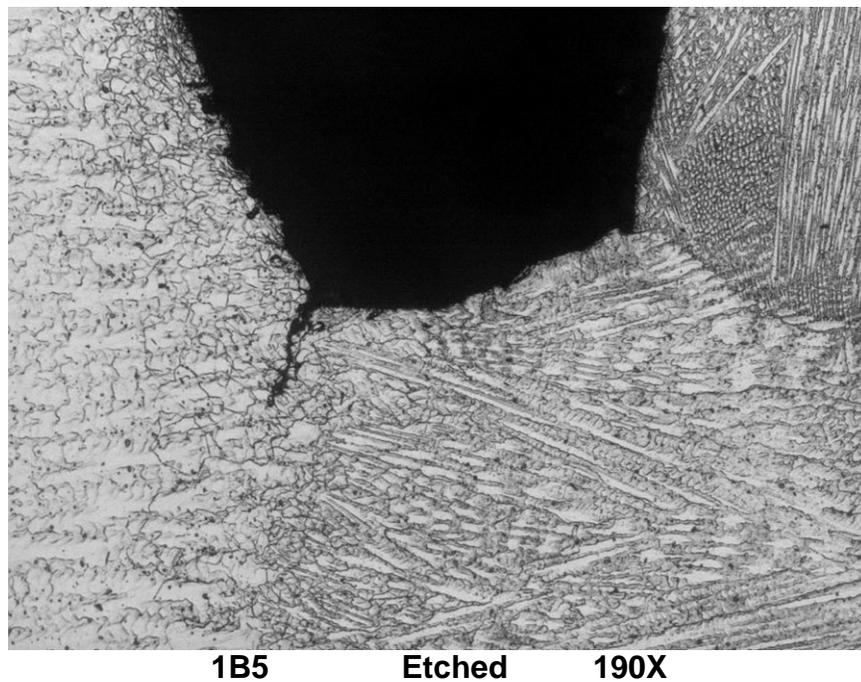
Figure 37: Micrographs showing a weld void measuring 0.050" by 0.015" present at the 140° orientation. A small crack measuring 0.003" long was noted adjacent to the void. This crack was likely a small hot crack.

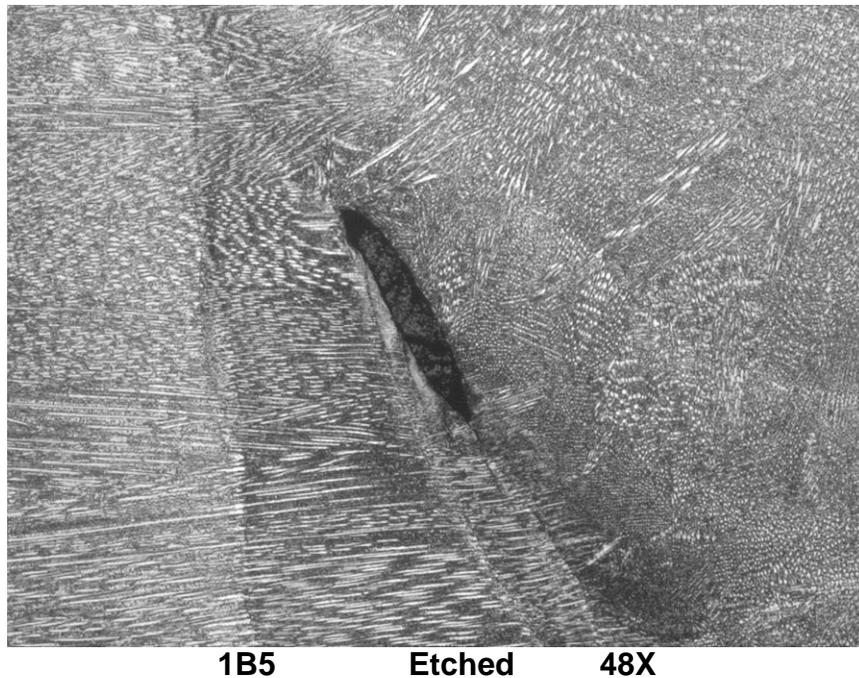
Figure 38: Second weld void present at the 140° orientation. This void measured 0.030" by 0.005". There was no cracking in this area.
