UNITED STATES  
NUCLEAR REGULATORY COMMISSION  
OFFICE OF NUCLEAR REACTOR REGULATION  
WASHINGTON, D.C. 20555

December 22, 1992

NRC BULLETIN NO. 90-01, SUPPLEMENT 1: LOSS OF FILL-OIL IN TRANSMITTERS  
MANUFACTURED BY ROSEMOUNT

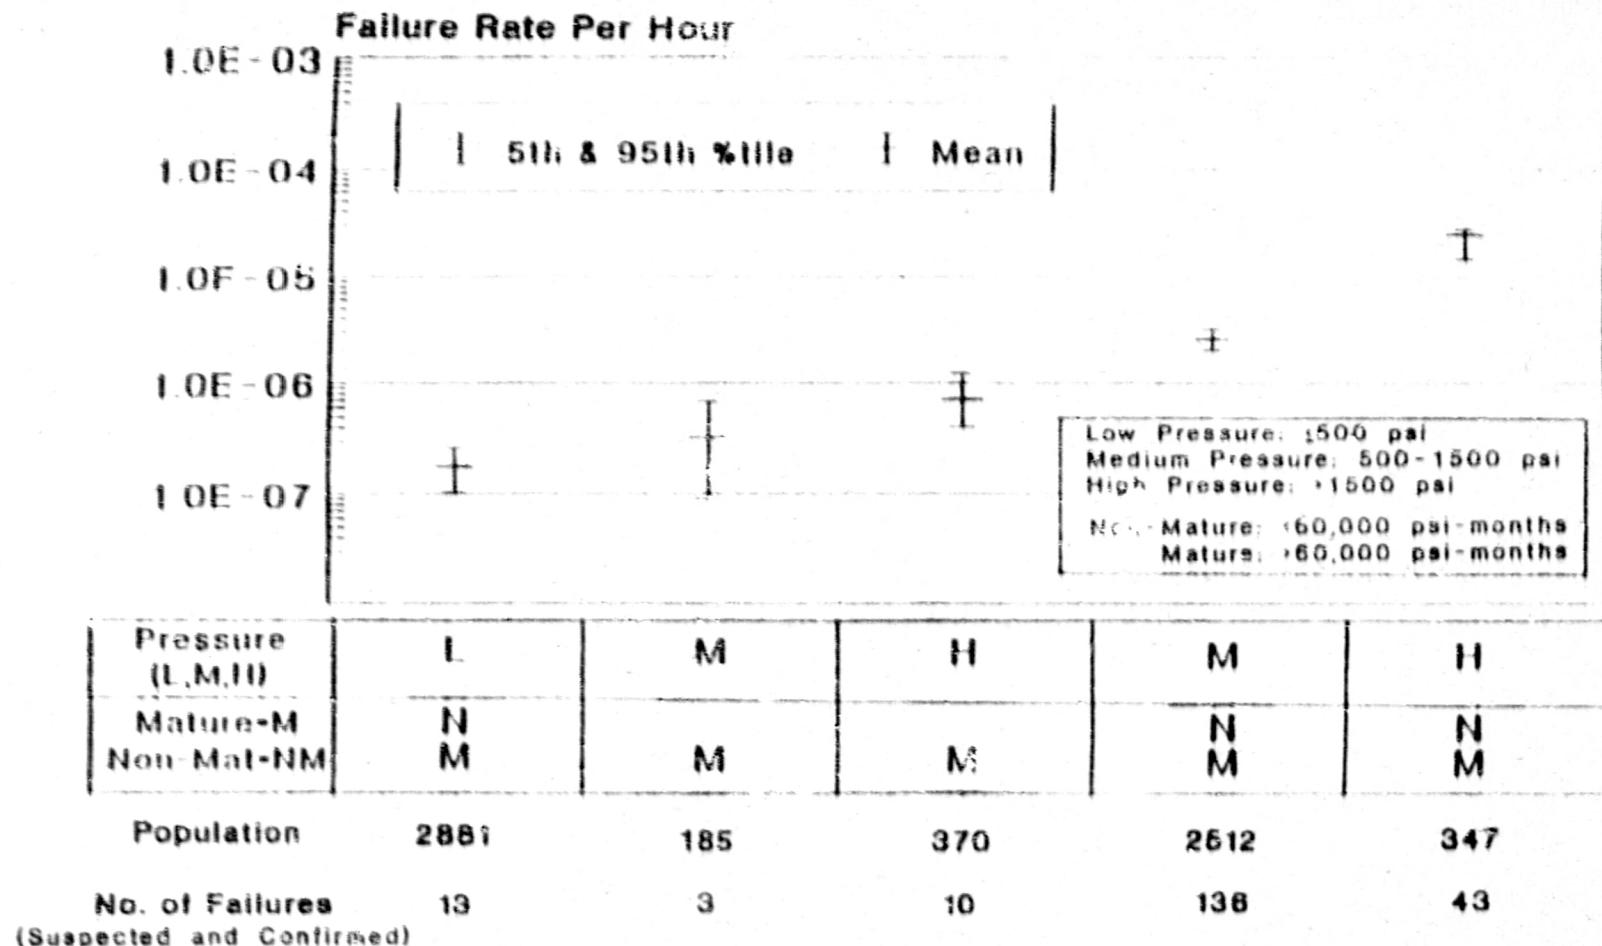
**Figure 1. Rosemount Transmitter Failure Rates  
(90% chi-squared confidence interval)**

In evaluating this issue, the staff confirmed a relationship, as had been previously found by Rosemount and NUMARC, between operating pressure, time-in-service, and the suspect and nonsuspect lot classifications in identifying where the transmitters would most likely fail. A high operating pressure was the most dominant factor leading to a loss of fill-oil.

Second among these factors was time-in-service, with those transmitters having been in service for less than 60,000 psi months exhibiting higher failure rates than transmitters that had been in service for more than 60,000 psi months. Attachment 1 represents the staff estimates of Rosemount transmitter failure rates based on pressure application and the time in service derived from the NUMARC survey data.
