# **Farley Breakers: Lessons Learned**

EPRI JUTG Meeting  
August 26-28, 2008

Victor Hall, NRR/DE/EQVB

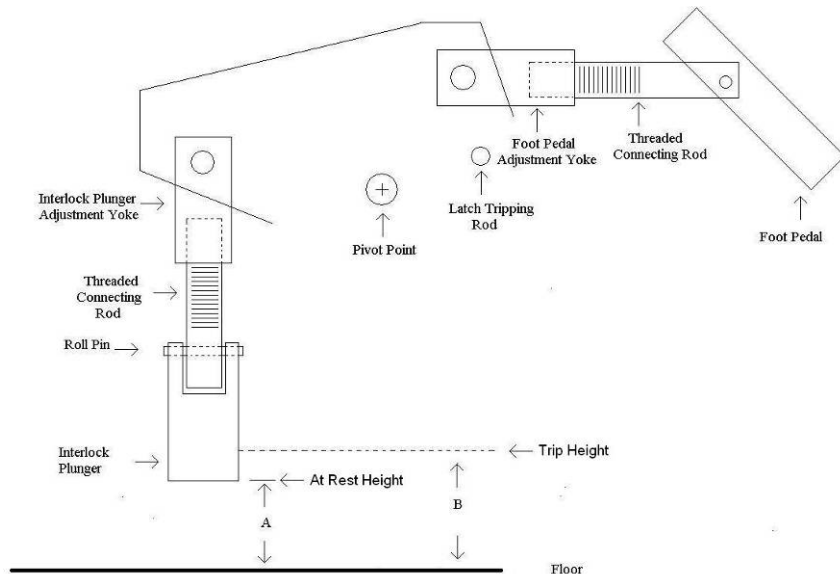
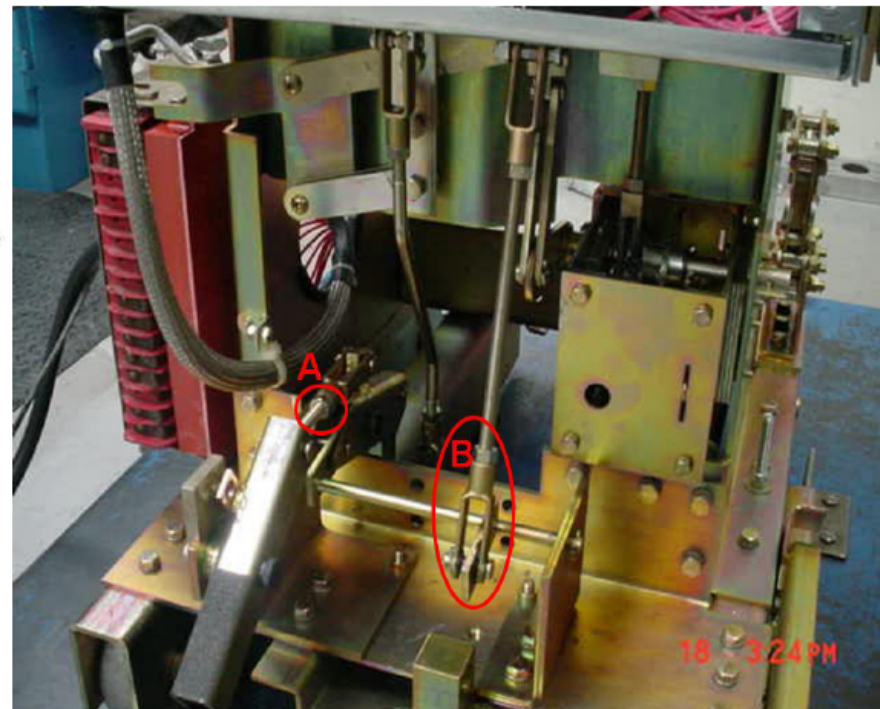
- Improper manipulation of foot pedal rendered breaker inoperable

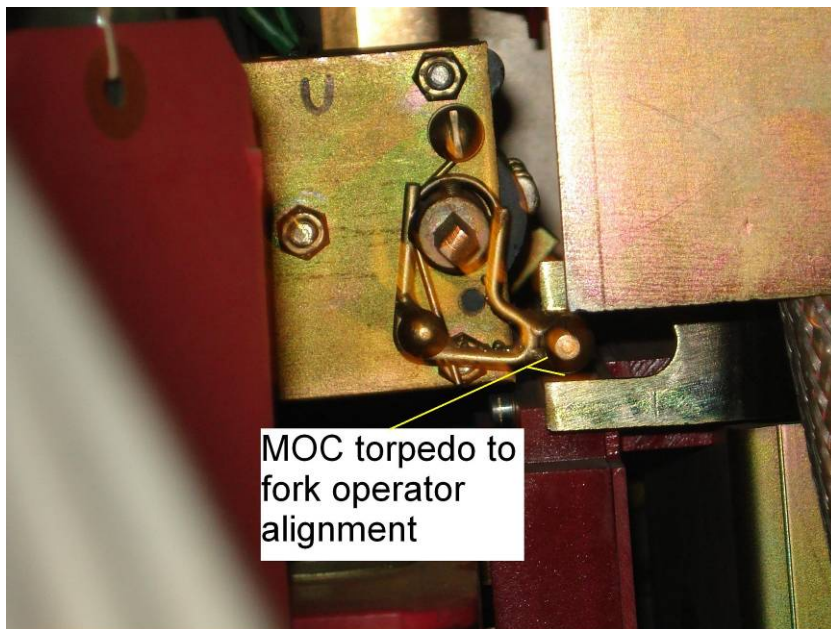
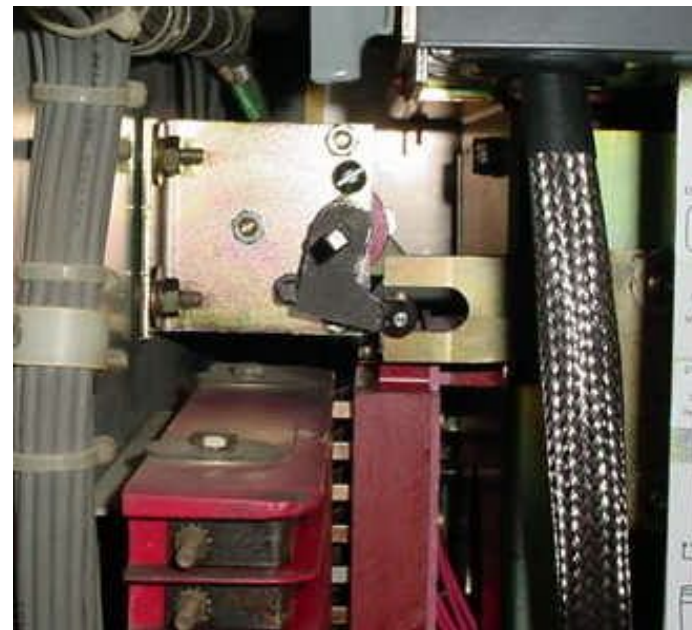
- February 2007: Switch contacts did not operate properly, leading to incorrect indications (SW)
  - Caused by incorrect Mechanism Operated Cell (MOC) switch alignment
- April 2007: Switch contacts did not operate properly, leading to incorrect indications (EDG)
  - Caused by incorrect MOC switch alignment
- September 2007: Breaker failed to close (CCW)
  - Manipulation of foot pedal placed breaker in trip-free condition
- October 2007: Breaker failed to close (RHR)
  - Mis-aligned latch check switch arm precluded a micro switch from making up.
- October 2007: Breaker failed to close during testing (Station Service Transformer)
  - Anti-pump relay found out of socket

- Mechanism Operated Cell (MOC)  
Switch Alignment

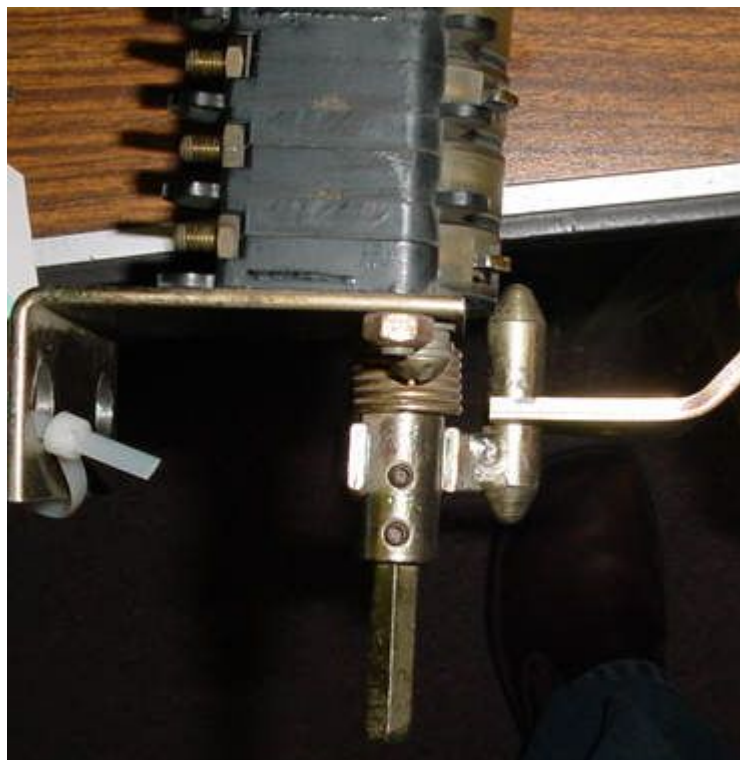
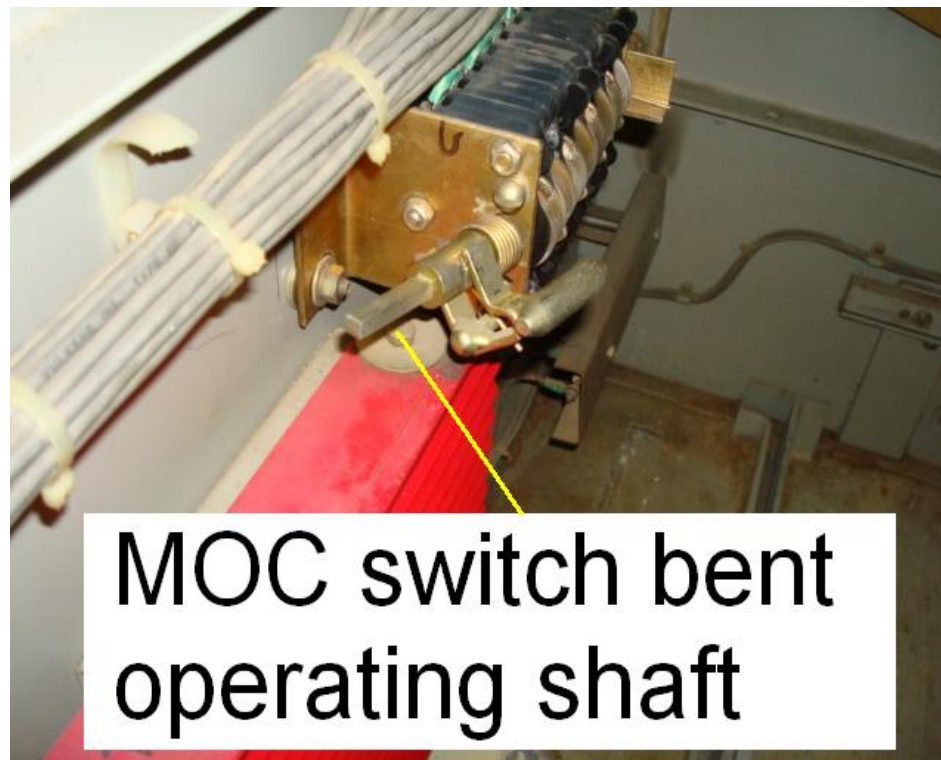
- MOC switch damage during racking

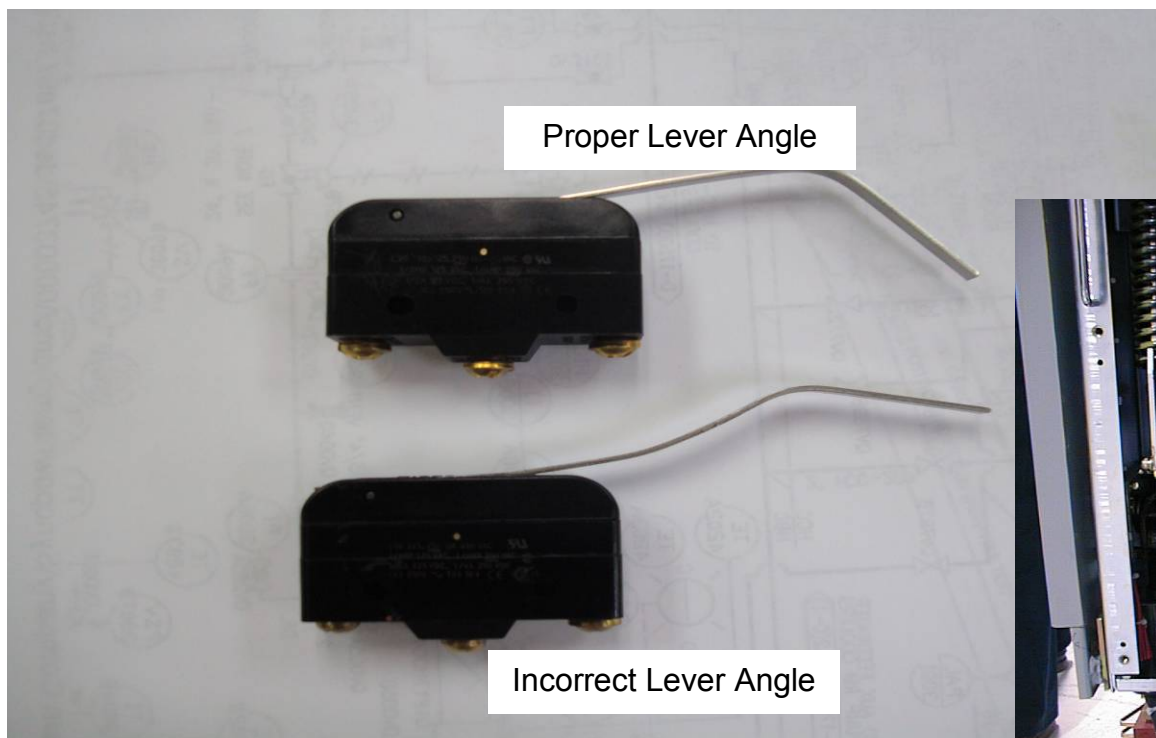
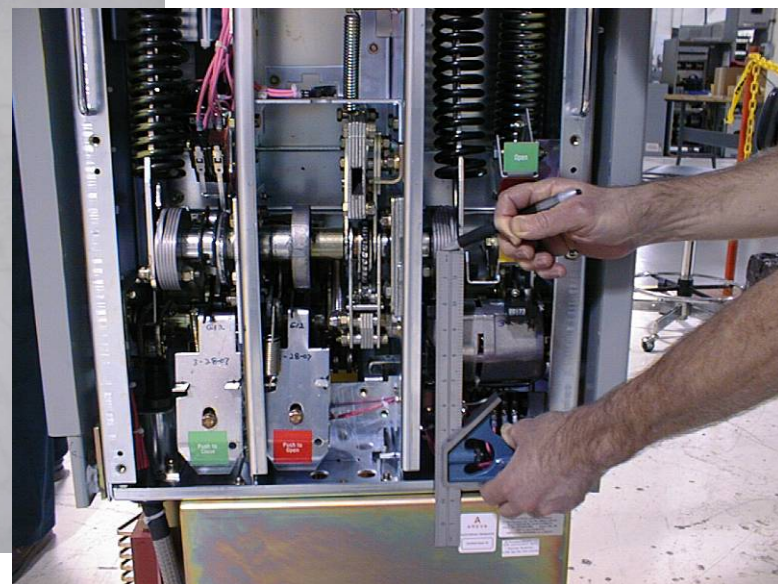
- Latch Check Switch improperly bent

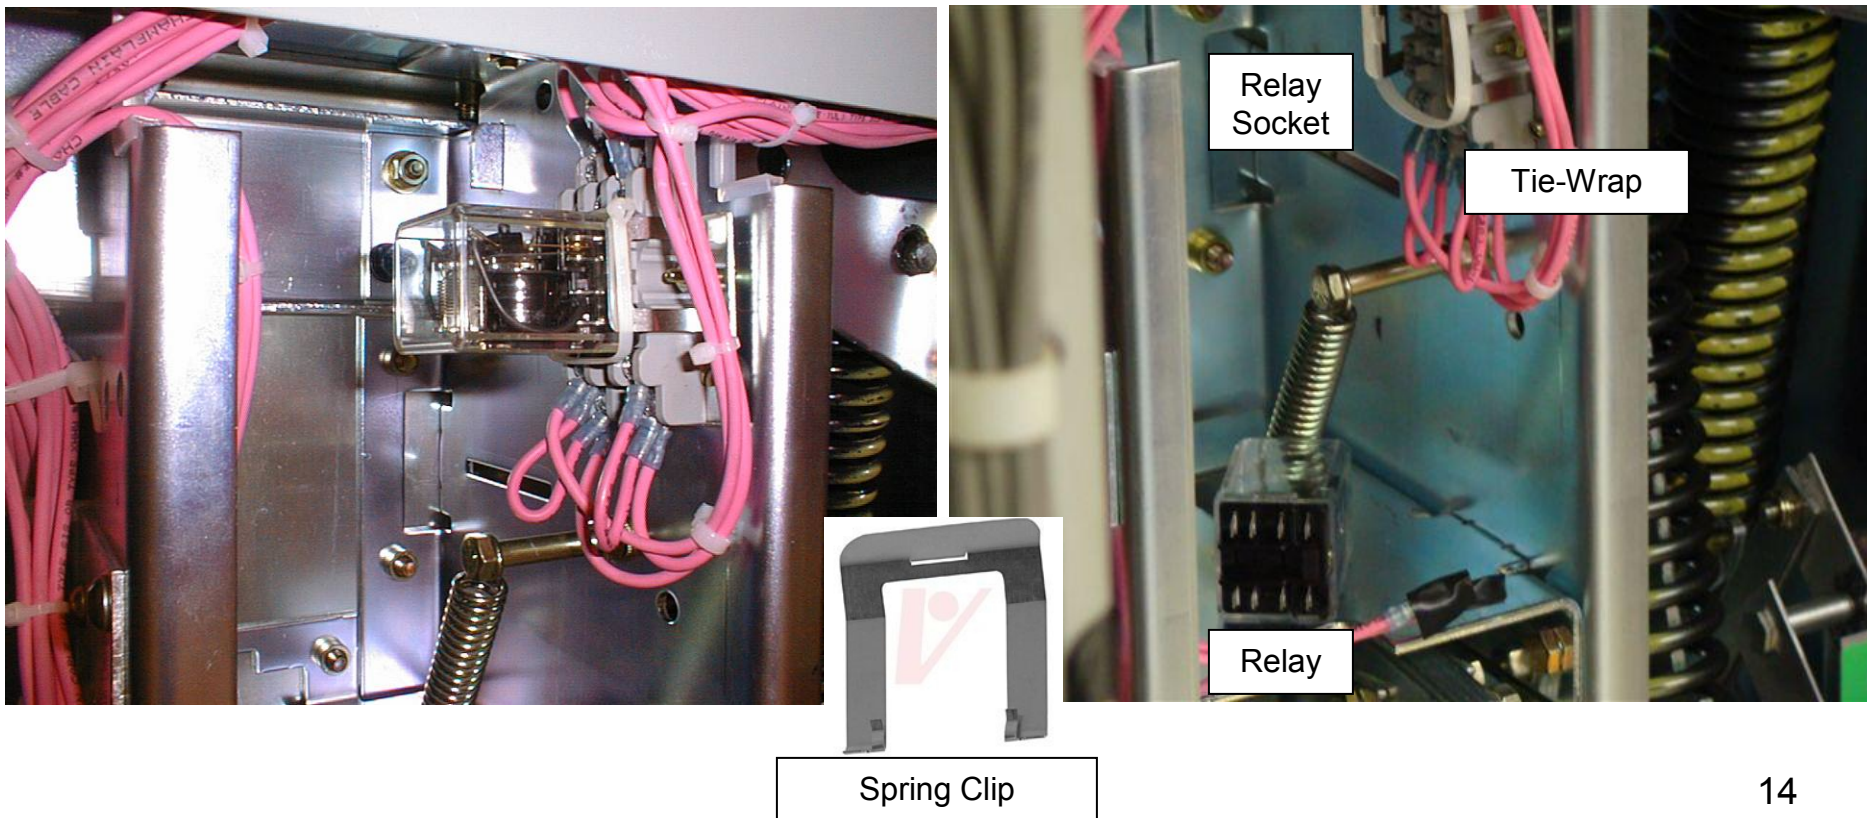
- Anti-pump relay found out of socket

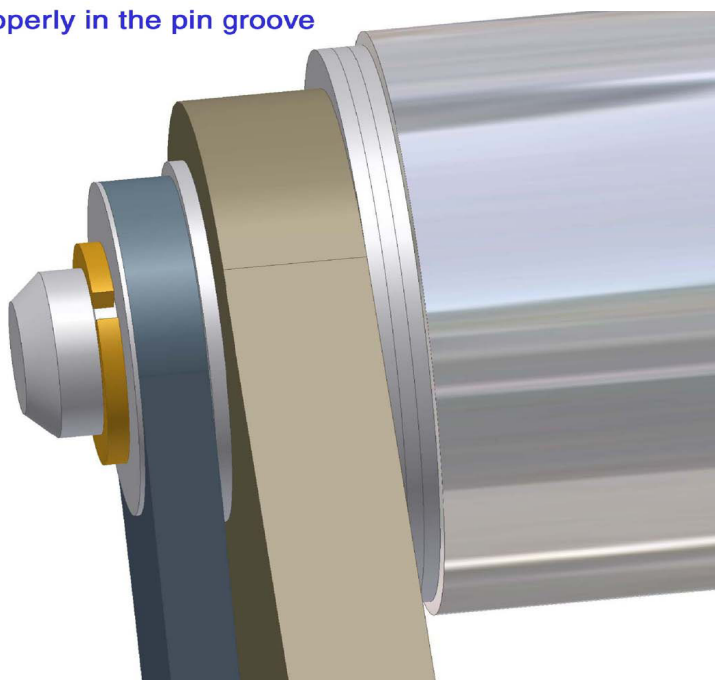
- “C” Ring on Main Link Roller: Led to Part 21 Notification

“C” Ring properly in the pin groove

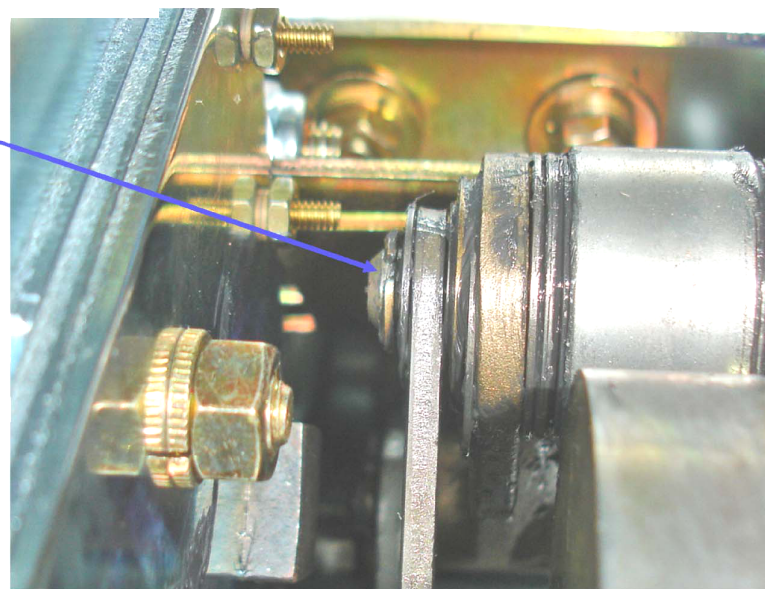
“C” Ring out of groove
