6 Destructive Testing and Results

6.5 Metallographic Examination of Cracking in Nozzle 31 Section 2

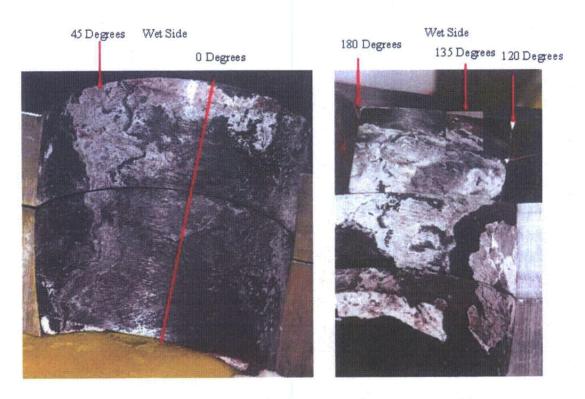
The annulus showed clear indications of water flow through the interference fit and the associated boric acid deposits left in the annulus. Two main indications of flow through the annulus were found—a small flow indication at 45 degrees and a very large indication with heavy boric acid deposits ranging from 120 to 190 degrees. A boric acid deposit found from 90 to 120 degrees also is shown in Figure 6.8. Two small flow indications were found close to 200 and 225 degrees. The two main flow indications and the indications near 200 and 225 degrees are shown in Figure 6.9.

Figure 6.8 Two Main Flow Regions at 45 Degrees and 120 to 190 Degrees

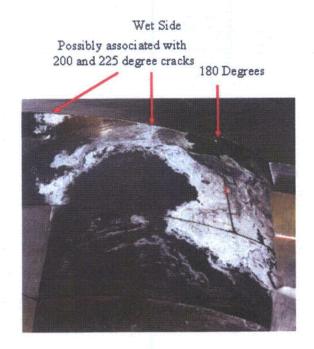
Figure 6.9 Two Smaller Flow Regions at 45 Degrees and 120 to 190 Degrees

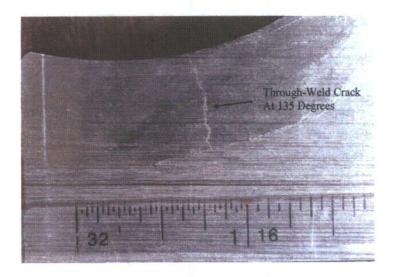
Careful ET examination and high-resolution photography did not find any evidence of through-weld cracking in Sections 1 and 3. A through-weld crack was immediately apparent, however, in the buttering of Section 2 at 135 degrees. This crack was clearly visible with the naked eye and was confirmed with ET and photography. This crack is shown in Figure 6.12. Because this crack was in a region shown to have crack-like indications and none of the other sections showed any indications of through-weld cracking, all attention was focused on Section 2 near this crack.

Figure 6.12 Confirmed Through-Weld Crack Found Above the Triple Point in Section 2 at 135 Degrees

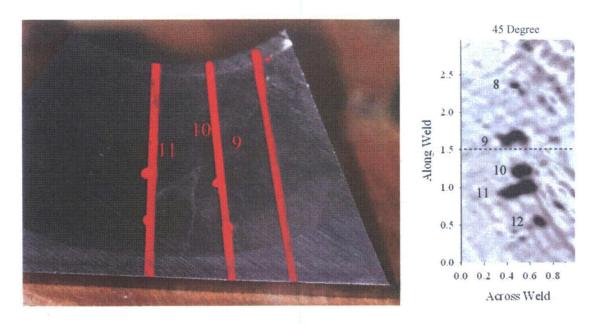
After the cutting, it was clear, based on the position and spacing of the cracks, which cracks were associated with which ET indications. Figure 6.14 shows the three cracks on the cut face 8 mm below the wetted surface. One interesting aspect of the cracks and the ET indications is how much longer the cracks are 8 mm into the weld than they were at the wetted surface. ET indication 9 is 8 mm long on the surface, and the visible crack length is 21-mm long at the cut surface. ET indication 10 is 6 mm long at the surface and is 25 mm long at the cut surface. Indication 11, which is 10 mm long at the wetted surface, is 15 m long at the cut surface. The crack spacing is preserved; cracks 10 and 11 are 5 mm apart on both surfaces, and cracks 9 and 10 are 11 mm apart on the wetted surface and 10 mm apart on the cut surface. By contrast, ET indication 8 is 16 mm apart from ET indication 9. It is worth noting that ET indications 8 and 12 do not represent cracks that penetrated 8 mm into the weld.

Figure 6.14 Eddy Current Testing Indications at 145, 155, and 160 Degrees Confirmed Using Destructive Examination

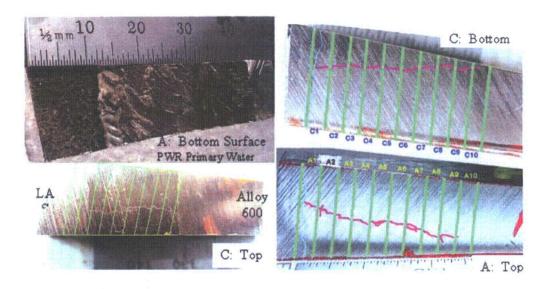
Figure 6.17 Top and Bottom Surfaces for Pieces A and C with Highlighted Cracks and Proposed Serial Sectioning. The bottom surface for piece A was exposed to primary water during PWR service.

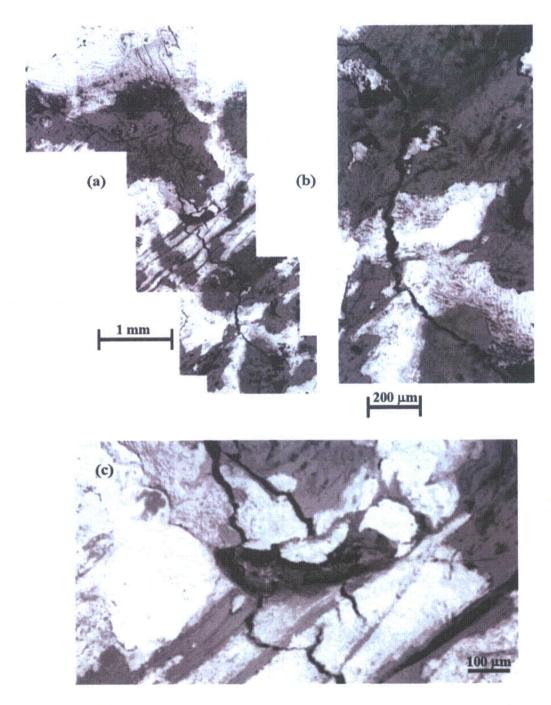
Before the three major pieces A, C, and E were sectioned, additional surface examinations were performed using scanning electron microscopy (SEM) to better document crack characteristics. The A surface exposed to PWR primary water was rough, and relatively thick oxide corrosion products remained in many locations. The SEM images revealed an obvious crack in the Alloy 182 weld metal, perhaps widest in the region near the transition from the butter passes to the J-groove weld metal. A full crack montage is shown in Figure 6.20(a), with a slightly higher-magnification image illustrating the crack morphology in Figure 6.20(b). It is not possible to accurately determine crack openings from these images, but widest locations were on the order of 30 µm (0.0012 in.).

Figure 6.20 Observed Crack on the PWR Water Surface of Piece A at Two Magnifications. The rough as-welded surface and relatively thick corrosion-product oxide in places (white contrast) made SEM imaging of fine secondary cracks difficult. However, the main crack is seen to extend ~6 mm (0.25 in.) on this surface. A moderate-size defect (pit) near the center of the main crack is shown in (a) and magnified in (c).

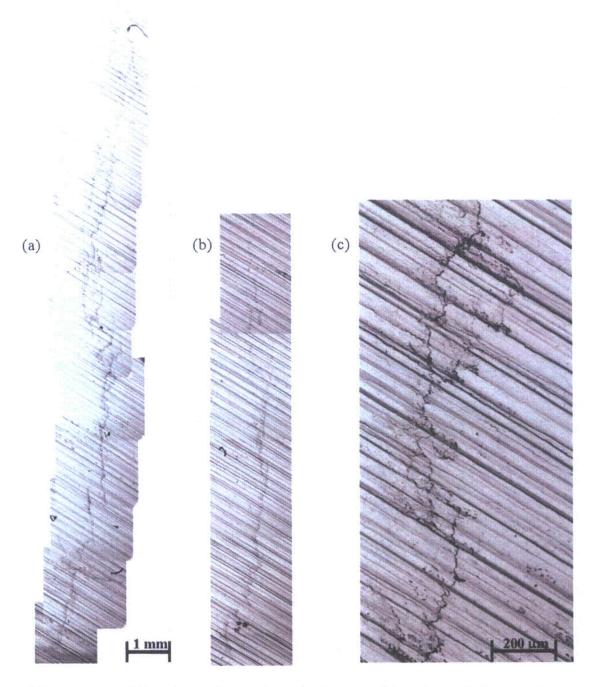
The top (inside) saw-cut surface from piece A enabled a much better observation of the full extent of the cracks. The SEM montages for the two primary cracks observed on this surface are shown in Figure 6.21(a) and (b). The main crack extends to the low-alloy steel interface and well into the Alloy 182 J-groove weld, while the secondary crack is near the edge of piece A and appears to have propagated into the adjacent piece B sample that was not examined. The higher-magnification SEM image in

Figure 6.21(c) documents the tortuous and branched crack path probably along interdendritic and grain boundaries. This will be examined in much more detail on the individual metallographic cross sections.

Figure 6.21 Cracks on Piece A Top (inner) Saw-Cut Surface: (a) main crack, (b) secondary crack, and (c) higher magnification of typical crack morphology from (a)

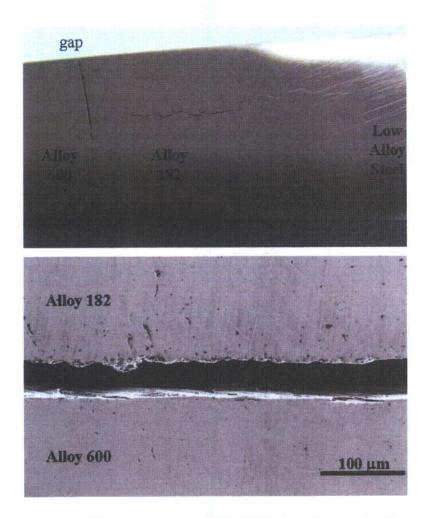
The surfaces of pieces C and E also were characterized with SEM before sectioning. The interference-fit gap was identified on the C top surface (facing E) both optically and by SEM, as illustrated in Figure 6.22. In addition to the bottom surface of piece E, the crack exit surface into the gap was examined. The Alloy 182 machined surface that made up the interference-fit gap with the Alloy 600 tube

Figure 6.22 Interference-Fit Gap Between the Alloy 182 Butter Passes and the Alloy 600 Tube on Top Surface of Piece C (facing bottom surface of piece E)

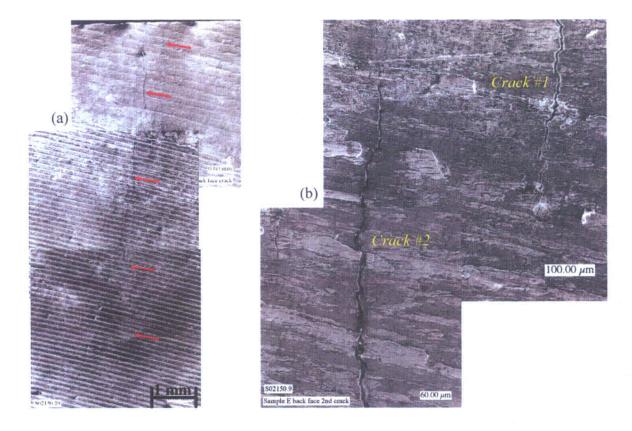
was found to have two relatively long cracks, as presented in Figure 6.23. When the two cracks were combined, a total crack length approaching \sim 7 mm (0.27 in.) was found on this exit surface, with the crack opening reaching \sim 10 μ m (0.0004 in.) in places. The cracks were filled with an unknown material, probably boric acid powder and corrosion-product oxide.

Figure 6.23 Machined Surface and Exit Location for Through-Wall Cracks from Piece E Alloy 182 Weld Metal into Interference-Fit Gap Between Alloy 182 Butter and Alloy 600 Tube. Low-magnification SEM image (a) shows full length and two major cracks, while higher magnification (b) illustrates crack morphologies.

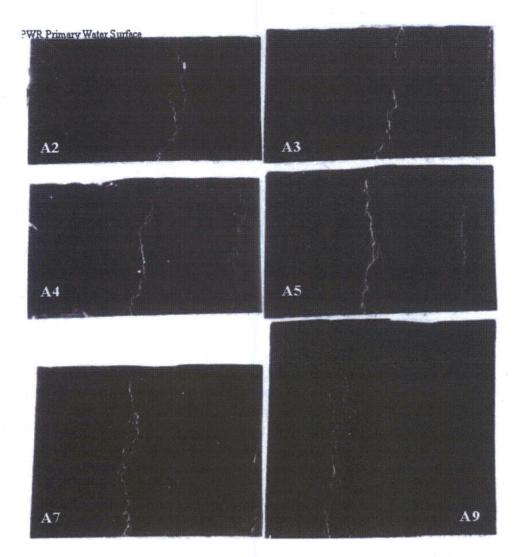
Figure 6.24 Macro Cracks in Several Cross-Section Samples from Piece A Shown Through Photography. Note that PWR primary water surface is now on the top side of these images.

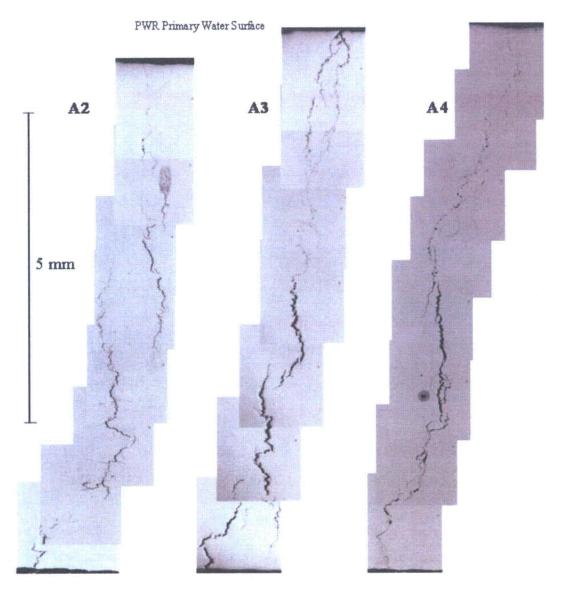
The macro images show extensive cracking through the Alloy 182 weld metal regions with possible initiation sites in cross section A3. A much more detailed evaluation of crack characteristics has been documented by recording systematic images mapping the full range of the cracks in each cross-section sample. Examples of these crack maps are shown for the A cross sections in Figures 6.25, 6.26, and 6.27. The secondary crack present in many of these cross sections also was mapped but will not be presented here. It is sufficient to note that this crack revealed a similar branched morphology.

Figure 6.25 Optical Micrographs for A2, A3, and A4 Cross-Section Samples Showing the Main Crack Essentially Running Through Entire Thickness of Each Sample

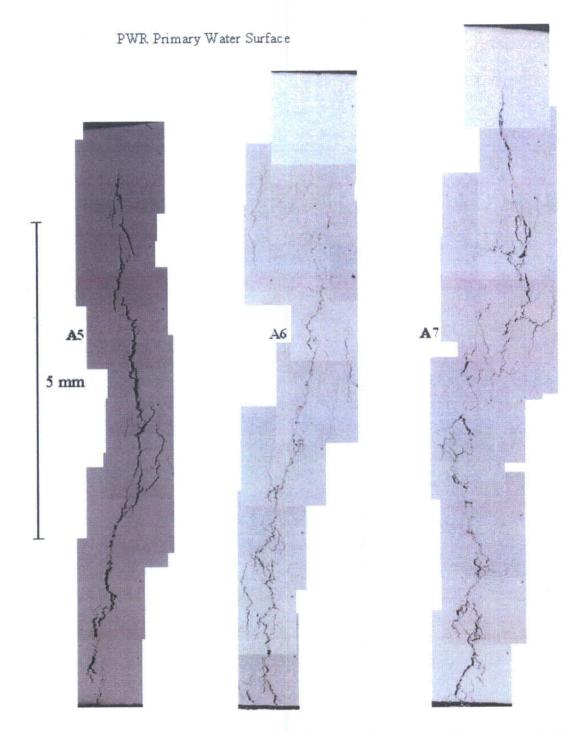
Figure 6.26 Optical Micrographs for A5, A6, and A7 Cross-Section Samples Showing the Main Crack Appearing Below the PWR Primary Water Surface and Through Remaining Thickness of Each Sample

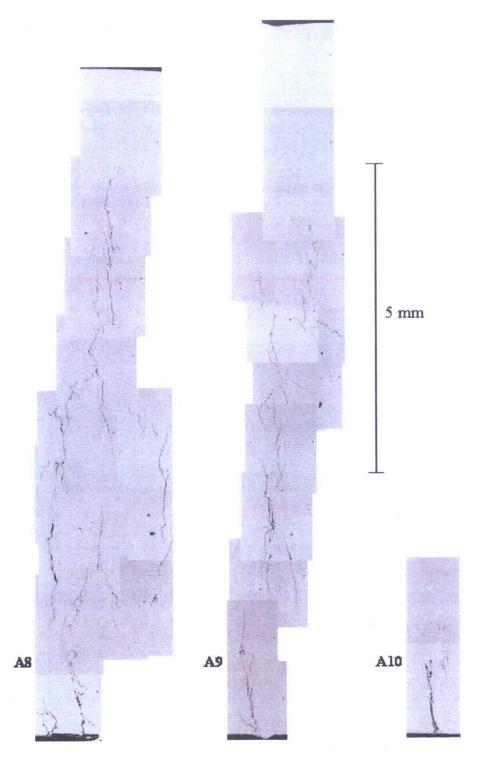
Figure 6.27 Optical Micrographs for A8, A9, and A10 Cross-Section Samples Showing the Main Crack Appearing Farther Below the PWR Primary Water Surface as a Function of Distance from the Crack Initiation Sites in A3

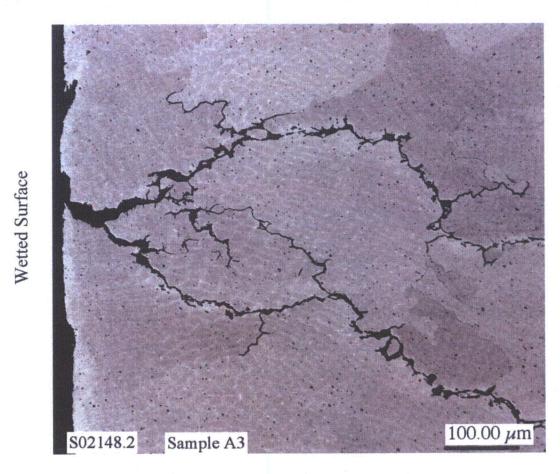
The apparent crack initiation site is near the A3 slice location, as illustrated in the optical micrograph for this cross section in Figure 6.27 and in a higher-magnification SEM image in Figure 6.28. The SEM micrograph suggests a region of damage at the surface near the crack opening. The width of the crack at the surface in the region is $\sim 30~\mu m$ (0.0012 in.), consistent with the SEM examination of the cracks on the piece A primary-water surface presented in Figure 6.20. Crack morphology can be seen as heavily branched immediately below the surface and following convoluted interdendritic or grain boundaries for the most part. The SEM backscatter-electron (BSE) image provides both orientation (grain-to-grain) and compositional contrast. Both can be seen in Figure 6.28, with large grains several hundred micrometers in diameter and finer contrast within grains due to segregation (e.g., manganese and niobium) during final solidification. The heavily branched crack path continues throughout the Alloy 182 weld metal, as illustrated by the tight cracks shown in Figure 6.29. This area is from the mid-depth of the A3 cross section. Similar to the near-surface morphology, the main crack again has split into two separate cracks within this plane and has propagated along parallel interdendritic or grain boundaries. These images from the A3 cross section are representative of the general cracking morphology found within the Alloy 182 weld metal microstructures in nearly all metallographic sections examined.

Figure 6.28 Location Where Crack Intersects the PWR Primary-Water Surface in Sample A3 and May Be Near the Initiation Site. Microstructural contrast within individual grains is due to solidification segregation in the Alloy 182 weld metal.

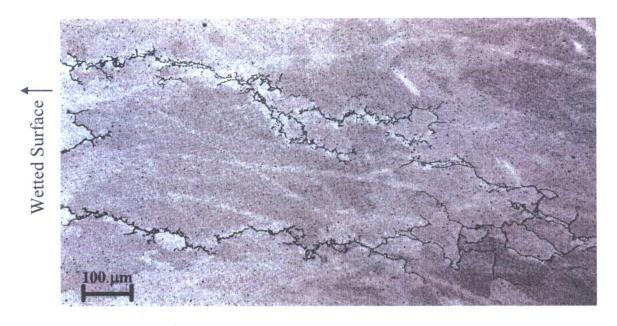
Figure 6.29 Highly Branched Cracks Near Mid-Thickness in Cross-Section Sample A3

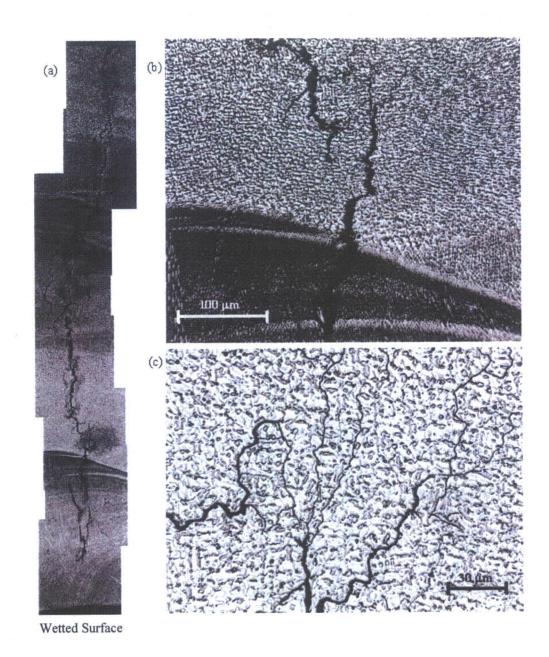
After optical and SEM images were recorded on as-polished samples, several samples were given a two-step nital/orthophosphoric etch to highlight weld-metal microstructures. Typical examples are shown in Figure 6.30 for sample A5. The full crack montage in Figure 6.30(a) illustrates that the crack propagates through several different passes of the J-groove weld within the thickness of piece A. In most cases, crack openings appeared to be wider as cracks approached weld pass boundaries (Figure 6.30(b))). This may reflect the higher stress required to transition to a new set of interdendritic or grain boundaries. Significantly different orientations of the dendritic microstructure can be seen between weld passes. The crack path clearly followed interdendritic or grain boundaries, as documented in Figure 6.30(c). Tight secondary cracks meander along, and end on, the convoluted weld metal boundaries.

Figure 6.30 Etched Microstructures in A5 Cross-Section Sample: (a) montage showing full length of crack; (b) example of more open crack near/at weld pass interfaces; and (c) example of cracks following convoluted boundaries

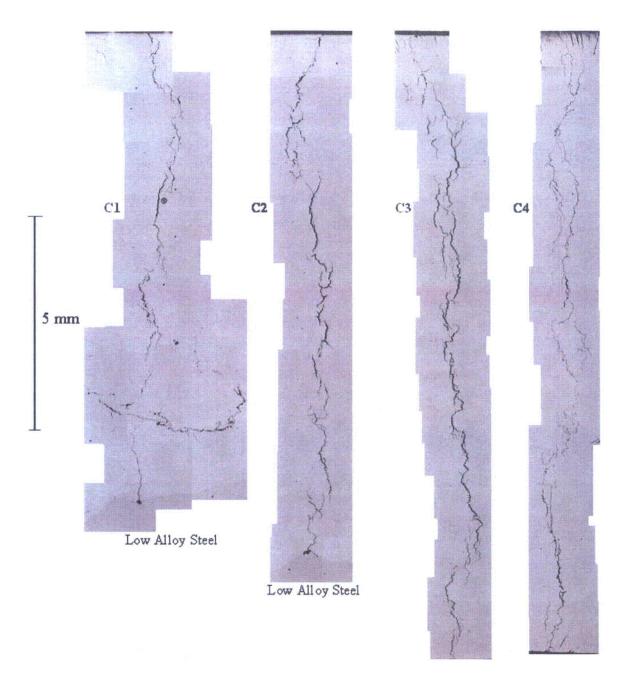
The approach for metallographic characterization of the A cross sections was repeated for the C and E cross sections. Cracking was found to extend from the low-alloy steel interface all the way into the Alloy 600 tubing in the C samples, as indicated by the earlier optical examinations (e.g., Figure 6.17) before sectioning. This observation is confirmed in Figures 6.31, 6.32, and 6.33, where crack montages are shown for cross-section slices C1–C4, C5–C7, and C8–C10, respectively. The cracks in sections C1 and C2 end at the low-alloy steel interface with the Alloy 182 butter passes. Scanning electron microscopy micrographs of this region are presented in Figure 6.34, documenting that no propagation occurred into the low-alloy steel. A small pit can be seen, but no significant corrosion of the low-alloy steel.

Figure 6.31 C1, C2, C3, and C4 Cross-Section Samples Showing the Main Crack Running to the Low-Alloy Steel Boundary in C1 and C2, While C3 and C4 Show Crack Propagating Through Entire Thickness in Alloy 182 Weld Metal

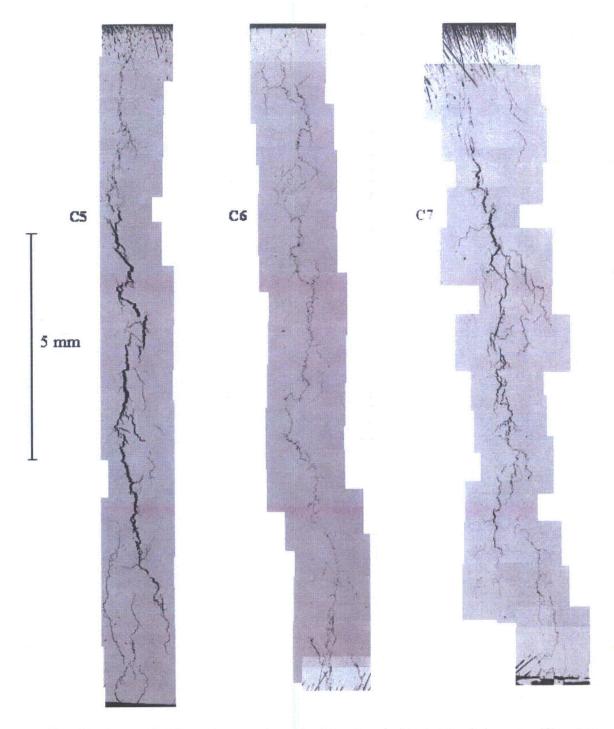
Figure 6.32 C5, C6, and C7 Cross-Section Samples Showing the Main Crack Running Through Entire Thickness for These Locations

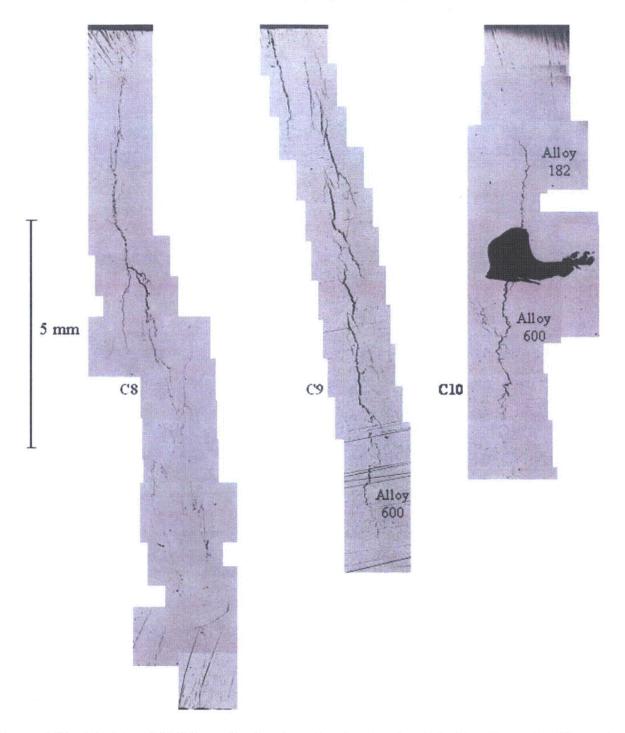
Figure 6.33 C8, C9, and C10 Cross-Section Samples Showing the Main Crack Running Through the Alloy 182 J-Groove Weld into the Alloy 600 Tube. The large hole in the C10 cross section appears to be a weld defect at the alloy fusion line between the Alloy 600 tube and the Alloy 182 weld metal.

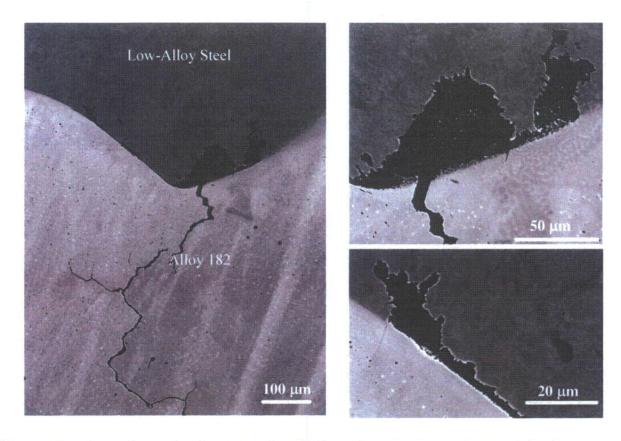
Figure 6.34 Stress Corrosion Crack in Alloy 182 Butter Pass Ending at the Low-Alloy Steel Interface and Creating Small Corrosion Pits

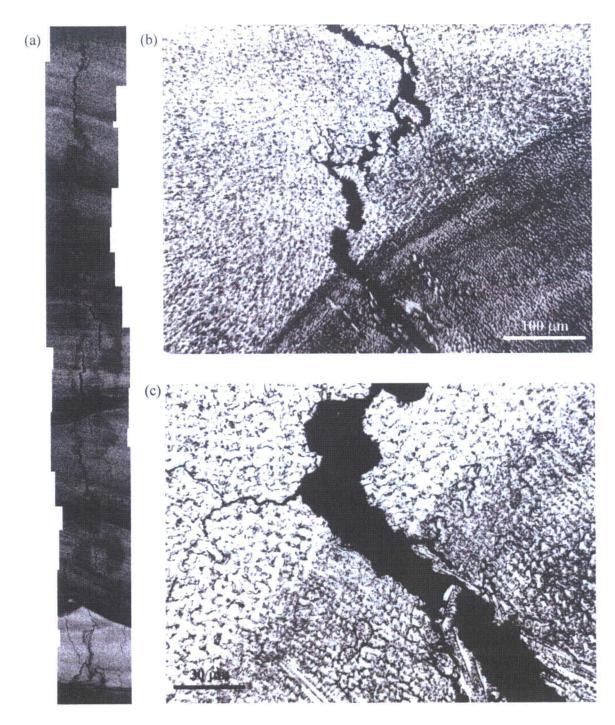
Similar to the microstructures documented for cross-section A5 (Figure 6.30), section C5 also was given an electrolytic etch using nital and orthophosphoric solutions. Although the exposure produced a heavy etch in places, the general microstructural features and the crack path could be recorded as illustrated in Figure 6.35. Once again, the SCC morphology is clearly interdendritic or intergranular following the convoluted boundaries in the Alloy 182 weld metal. Consistent with A5, wider crack openings were typically seen at the weld pass interfaces, with cracks often turning along the interface to find better-oriented boundaries for continued propagation. An example of this behavior is shown in Figures 6.35(b) and (c).

Figure 6.35 Etched C5 Cross Section Showing Crack Propagating Through Many Alloy 182 Weld Passes

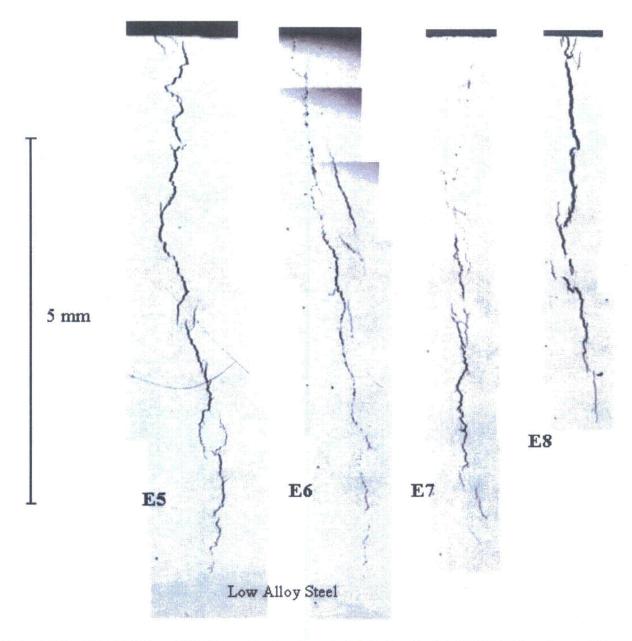
The final sequence of metallographic cross sections for piece E is given in Figure 6.36. This piece is split between the Alloy 182 butter passes and low-alloy steel plate. As a result, cracks are seen in only cross-sections E4 to E8 and propagate in only the Alloy 182 part of the way through the thickness before intersecting the low-alloy steel. Because the adjacent Alloy 600 tube was removed during initial cutting, E8 was the last slice that could be examined. The next sequential observation of the crack is from the exit surface into the interference-fit gap shown in Figure 6.23.

Figure 6.36 E5, E6, E7, and E8 Cross-Section Samples Showing the Main Crack Running to the Low-Alloy Steel Boundary. Only a very small crack was seen in sample E4, and E8 was the closest slice to the gap surface.

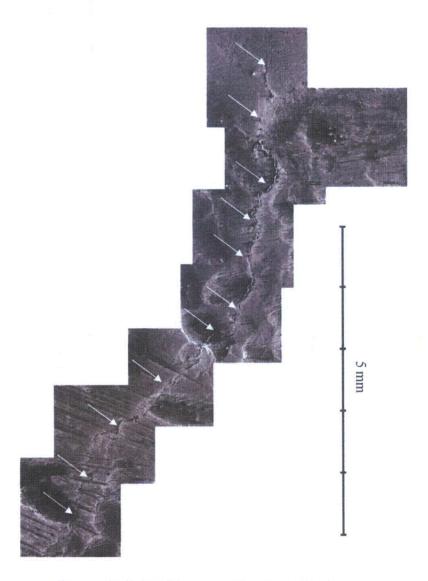
The cracks at 225, 210, and 255 were imaged using SEM to determine their length and crack opening displacement. The crack at 225 is shown in Figure 6.37. The crack at 225 was found to have a length of 8.7 mm (0.34 in.) and a maximum COD of 30 μ m (0.0012 in.). The crack at 210 was found to be less than 6 mm (0.24 in.) deep via sectioning, but as it showed up in both PT and ET it was examined with SEM. The crack at 210 degrees has a COD of between 2 μ m (0.00008 in.). The crack at 210 degrees is shown in Figure 6.38.

Figure 6.37 SEM Image of Crack at 225 Degrees

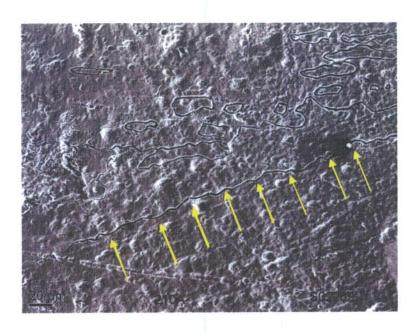
Figure 6.38 SEM Image of Crack at 210 Degrees

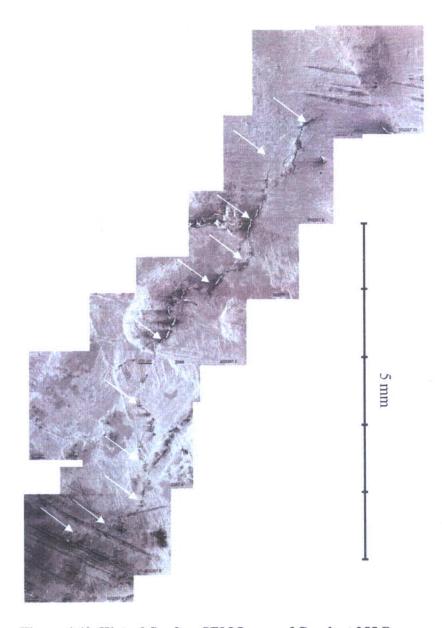
An SEM image of the 255-degree crack reveals a crack length of 7.6 mm (0.3 in.) and a COD of 40 μ m (0.0016 in.). The crack has a very broken profile, closing at several points along its length. The SEM image of the 255-degree crack is shown in Figure 6.40.

Figure 6.40 Wetted Surface SEM Image of Crack at 255 Degrees

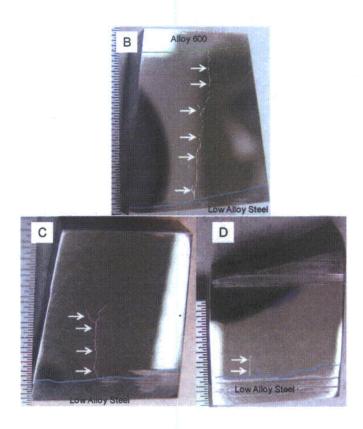
Figure 6.42 Crack Locations at the Wetted Side Faces of Sections B, C and D of the 255-Degree Crack

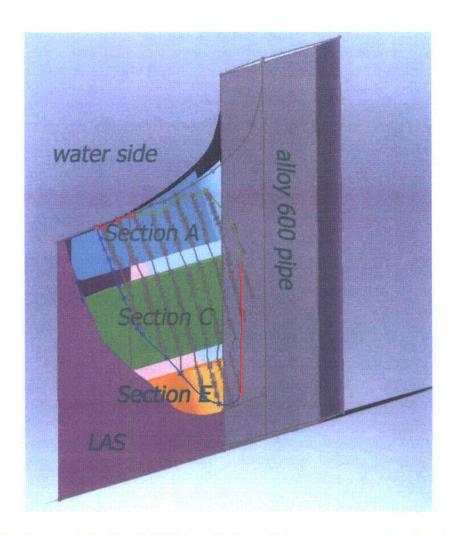
An overall image of the rendering that includes pieces A, C, and E is shown in Figure 6.43. One face of the weld section has been left out to allow viewing of the sections. As noted from the metallographic examinations, the crack rapidly expands from the initiation location on the PWR primary-water surface and spreads across the Alloy 182 weld metal reaching the low-alloy steel and Alloy 600. The green line indicates the boundary of the crack in the Alloy 182 weld metal, while the blue line indicates the crack

boundary where it arrested at the low-alloy steel interface. Red lines along the crack boundary indicate the points where the crack reaches the Alloy 600 interface and the interference gap (not shown) above the J-groove weld.

Figure 6.43 Rendering of the Crack Within a Section of the Component Showing the Locations of Sections A, C, and E

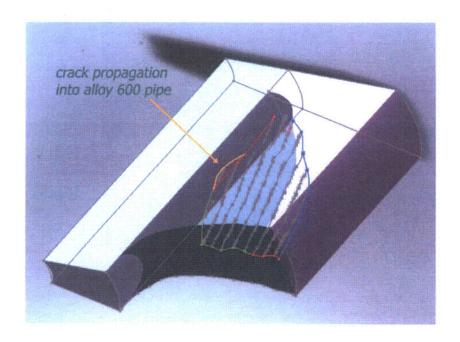
Figure 6.45 Component Section Viewed from a Tilted Orientation Where the Propagation of the Crack into the Alloy 600 Pipe Can Be Seen

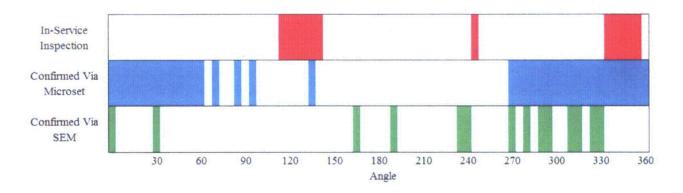
Figure 7.1 Crack Indication Locations at Outer Region of J-Groove Weld

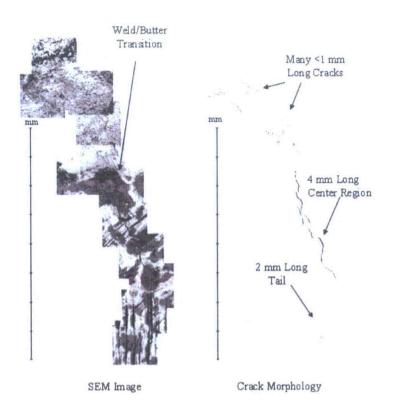
Figure 8.1 Crack Image and Crack Morphology

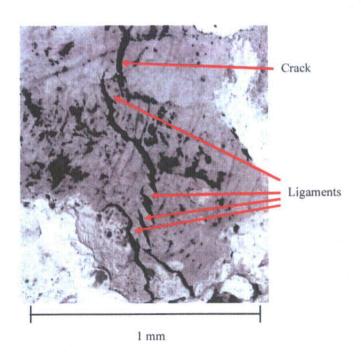
Figure 8.2 Expanded Section of the Crack Showing Ligaments Bridging the Two Sides of the Crack

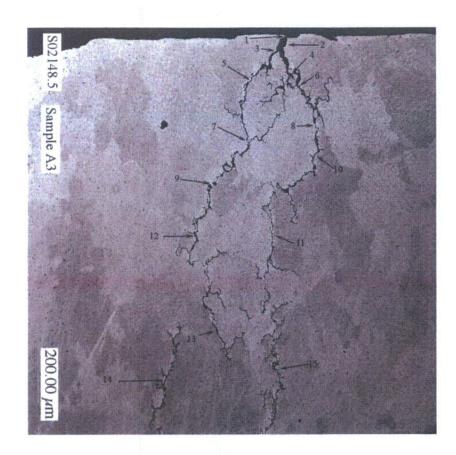
Location	COD (µm)
1	10
2	29
3	6
4	2
5	6
6	6
7	2
8	Closed
9	Closed
10	4
11	2
12	9
13	7
14	3
15	2

Figure 8.4 Crack CODs at Several Points Close to the Surface

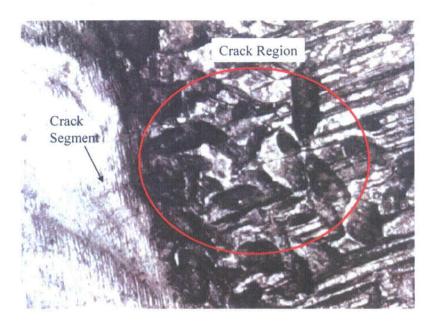
Figure 8.7 Cracked Region with Poor Crack Detection Because of Surface Features and Oxides

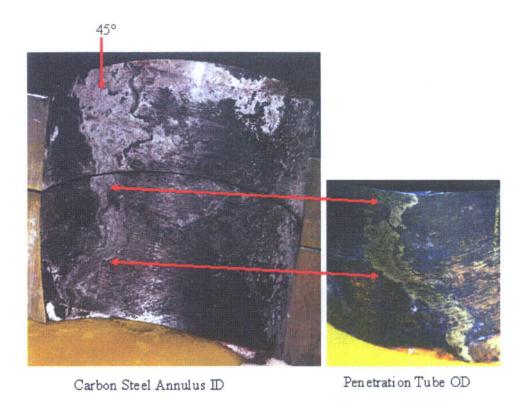
Figure 8.8 Mirror-Image Damage to the Carbon Steel Annulus and a Section of the Alloy 600 Penetration Tube. The wetted surface is toward the top of the samples.

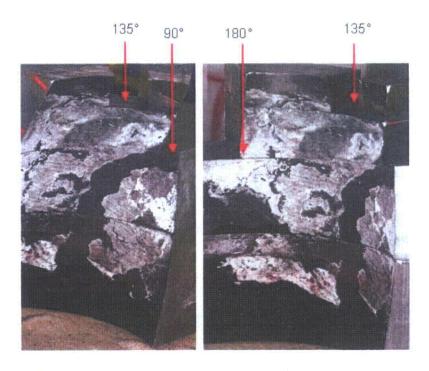
Figure 8.9 Boric Acid Deposits on the Carbon Steel from 90–180 Degrees. The wetted surface is toward the top of the samples.

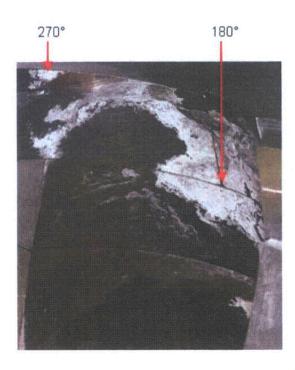
Figure 8.10 Boric Acid Deposits on the Carbon Steel from 180–270 Degrees. The wetted surface is toward the top of the samples.

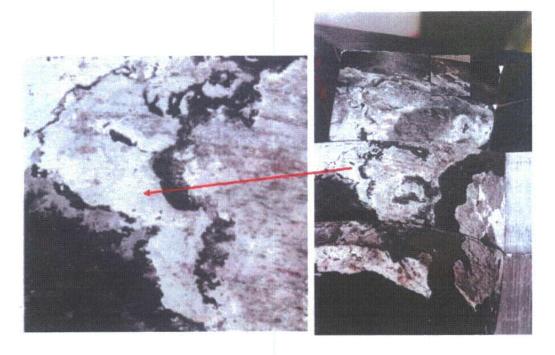
Figure 8.11 Enlarged Region Showing Damage to the Metal in the Boric Acid-Filled Region

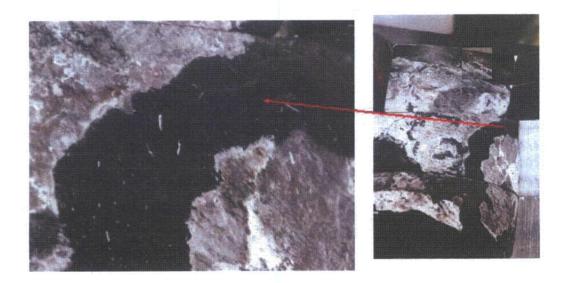
Figure 8.12 Apparent Water Flow Damage in the "Clean" Region of the Annulus

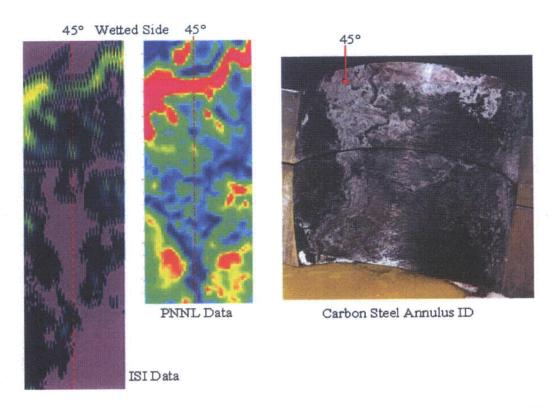
Figure 8.15 Comparison of the UT Data and the Apparent Wastage of the Carbon Steel Near 45 Degrees
