NUCLEAR REGULATORY COMMISSION

Title: Advisory Committee on Reactor Safeguards

Plant License Renewal Subcommitee Prairie Island Nuclear Generating Station

Date: Tuesday, July 7, 2009

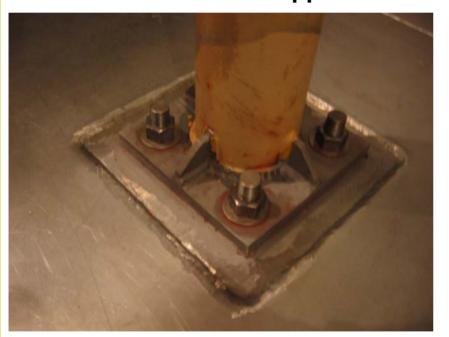
Typical Reactor Vessel Internals Stand Support

As a result of that root cause evaluation, we determined the sources of leakage to be the embedment plates for the reactor internal stands which are in the lower cavity and then the rod control cluster change fixture supports which are in the transport.

The leakage, we believe to be flowing the threads down past the nut. Once past the nut, there's a seal weld -- this is the RCC change fixture -- seal weld that was installed when this was originally put in.

That ground flush, we believe that there's a leakage path to that location that's allowing the refueling cavity water then to pass completely through the stud and then come out underneath the embedment plate.

and installation in that area. What we're performing now is a permanent repair so that we don't have to do that anymore. MR. WADLEY: It's not acceptable to continue to have this leak. Too many unknowns. CHAIRMAN RAY: Mike, I must say that that was hard to figure out from a lot of the rhetoric that was submitted here -- that it wasn't acceptable. 8 I'm glad to hear you say that. 10 MR. BARTON: Yes, thank you. MR. SKOYEN: The repair method that we're 11 12 going to employ is shown on this particular slide. As 13 you can see, on the right hand side of the slide is the existing configuration with an open nut. 14 We will be installing blind nuts, as 15 16 noted on the lefthand side in the particular 17 locations where it's attainable to surface area and 18 the thread engagement. 19 Then putting a seal weld all the way around the location, that will eliminate the leak 20 21 path that could occur there. 22 We'll also be putting a seal weld between 23 the base plate and the embedment plate to eliminate that leak path. 24 25 We believe that by doing this, we will

permanently eliminate the leakage that occurs from both the internal stands and the RCC change fixture support stands. MEMBER ARMIJO: There was no seal weld there initially? MR. BARTON: There was initially. said down here, they think that --8 MEMBER ARMIJO: Yes, just around the threads. 10 11 MR. SKOYEN: Yes. Just around the threads. 12 So we believe this to be a much more 13 robust design than was the original. It also allows us to inspect these welds going forward and identify 14 15 any concerns with those in repair. 16 It also, from a dose consideration, 17 perspective, is we receive far less dose employing 18 this method of repair than going back to the original 19 drawing. 20 So for a number of reasons, we believe 21 this is the correct method for repair. 22 CHAIRMAN RAY: I take for granted that 23 there aren't any leak chases on the seams of the cavity and so on. 24

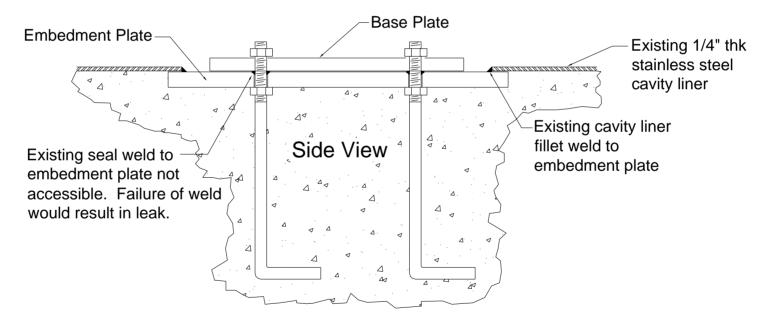
Refueling Cavity Leakage Leak Locations

The cumulative leak rate that we see from the refueling cavity is approximately one to two gallons per hour. It's most commonly seen in the ECCS sump and then in the regenerative heat exchanger room.

The leak rate that we see in this particular location is approximately one gallon per hour -- up to one gallon per hour. It has been the last -- depending on our success with mitigation.

We have also seen evidence of leakage in our regenerative heat exchanger room, which is directly below the lower refueling cavity. That particular leakage will travel and once it's underneath the liner. It can follow hairline cracks in the concrete and then seep through the sealing in the walls in that particular room.

There is evidence of leakage in the sump under the reactor vessel only in that there's a stain in the wall that originates from a construction joint and comes down the wall. Actual leakage has never been witnessed because that sump is not accessible when the pool is flooded.

You can also see on the diagram there that the one horizontal line coming over to the sump directly under the reactor vessel is just to indicate that there is a stain on the wall there.

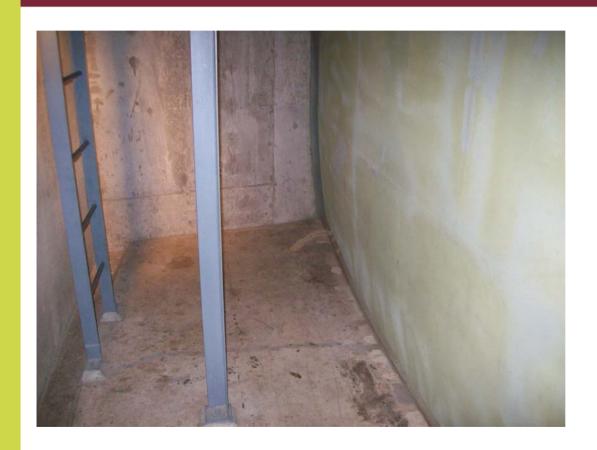
Shield Building Annulus

UT exam of containment vessel from annulus was performed. Scanned 18' long x 2' high area with all readings above 1.5 inch nominal plate thickness.
