# TENNESSEE VALLEY AUTHORITY WATTS BAR NUCLEAR PLANT UNIT 2

**Refurbishment Program**

**August 6, 2009**

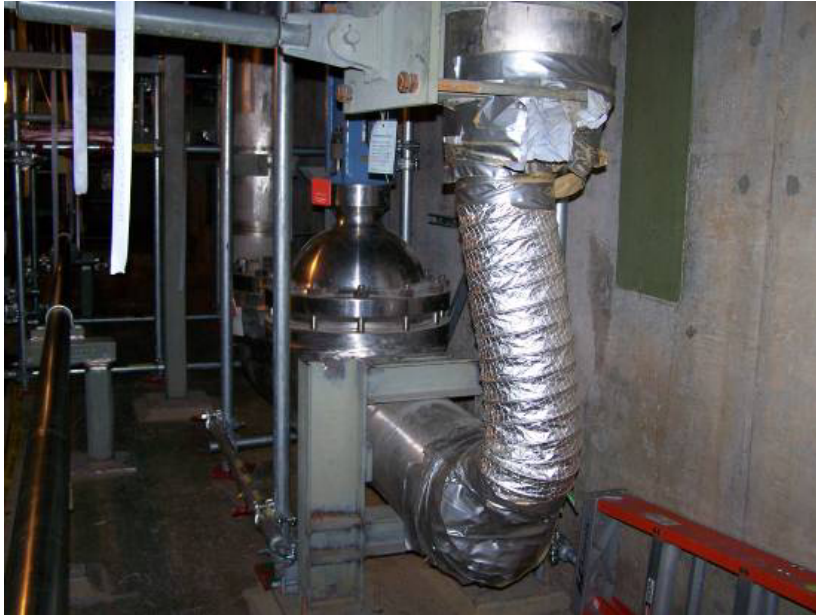
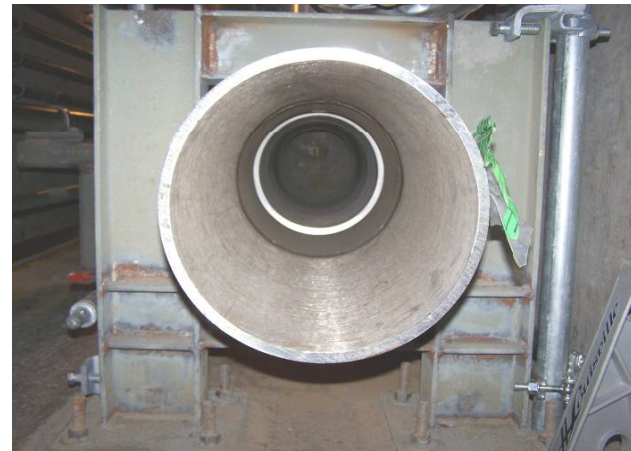
Containment Spray Piping – 676' Pipe Chase

As-found condition of internal piping shown below.

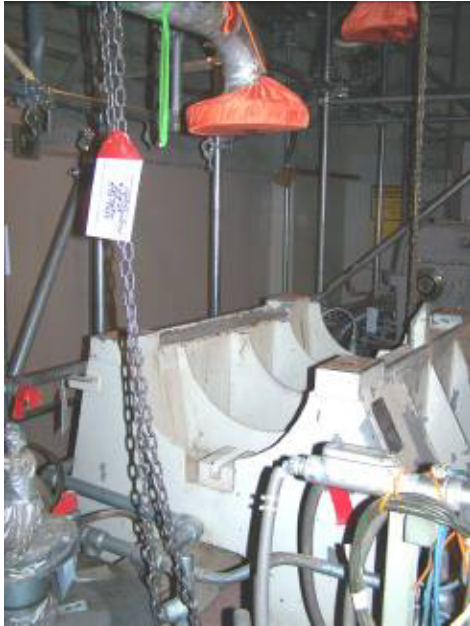
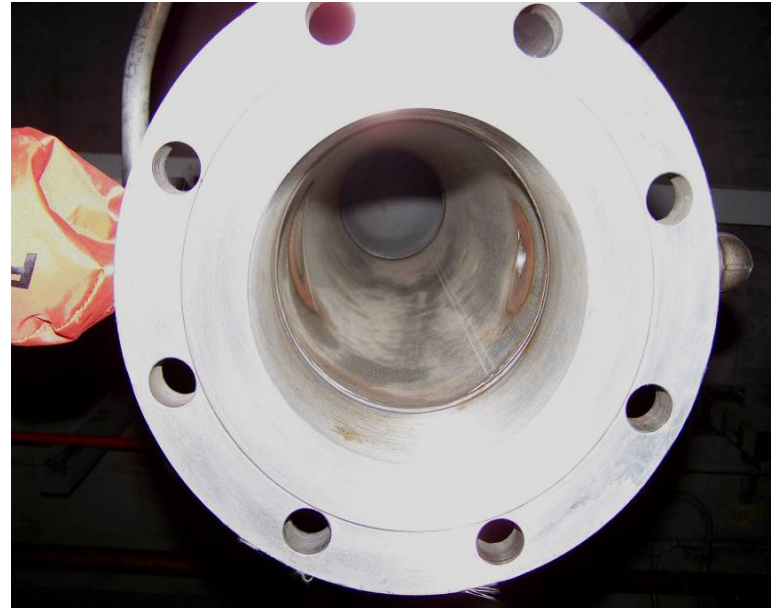
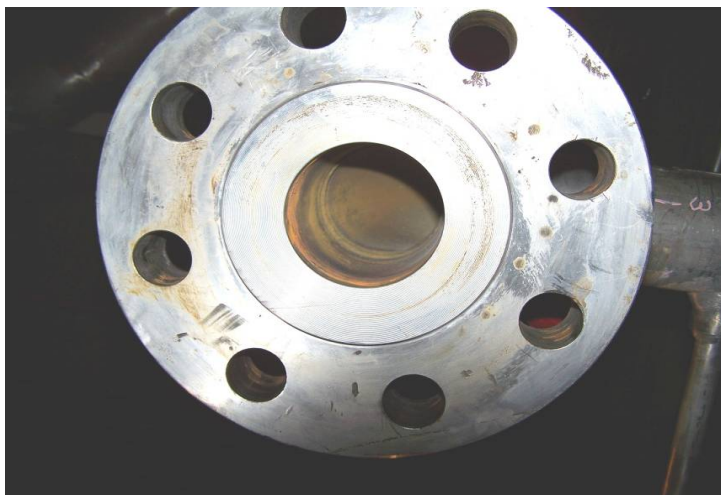
Centrifugal Charging Pump  
2B-B

Pump recently removed for refurbishment. Internal suction piping shown above and discharge at left.

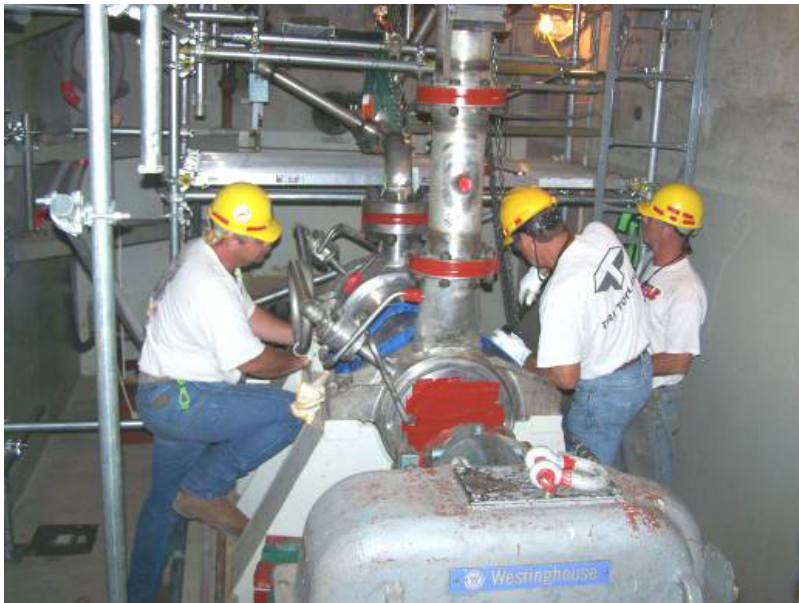
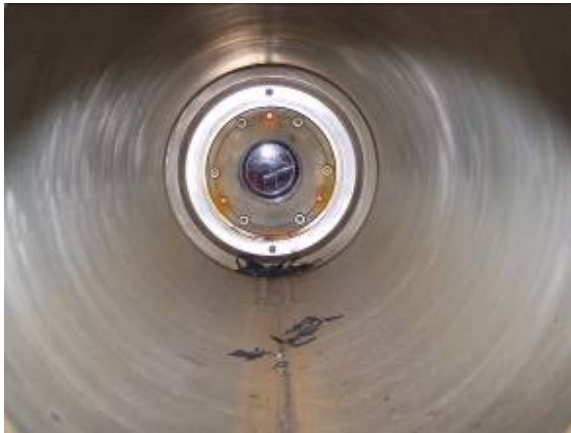
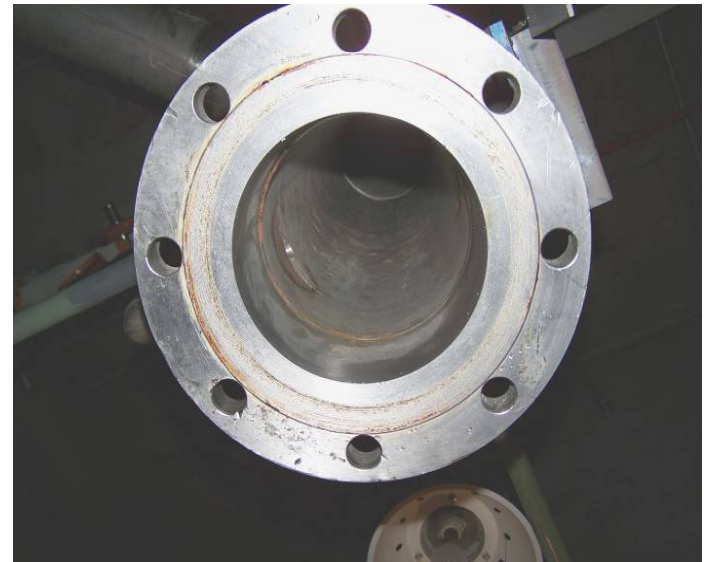
Centrifugal Charging  
Pump 2A-A

Pump is currently  
being removed for  
refurbishment.  
Internal pump  
casing shown at left  
and suction piping  
at right.

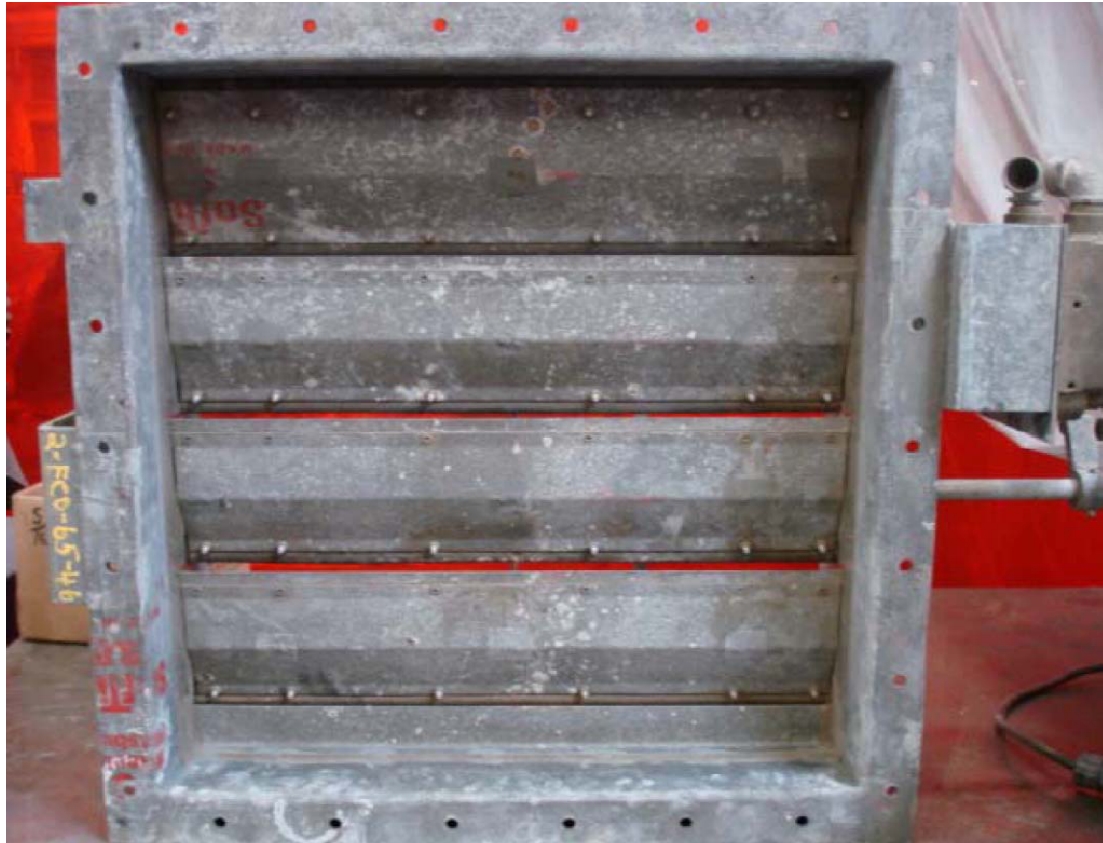
Ventilation Damper

Damper sent off-site to vendor facility for inspection, evaluation and recommended refurbishment and testing requirements.

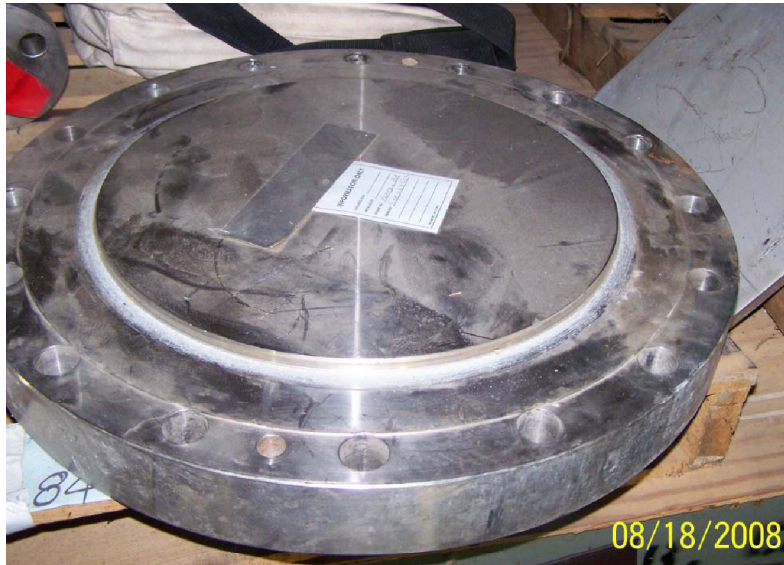
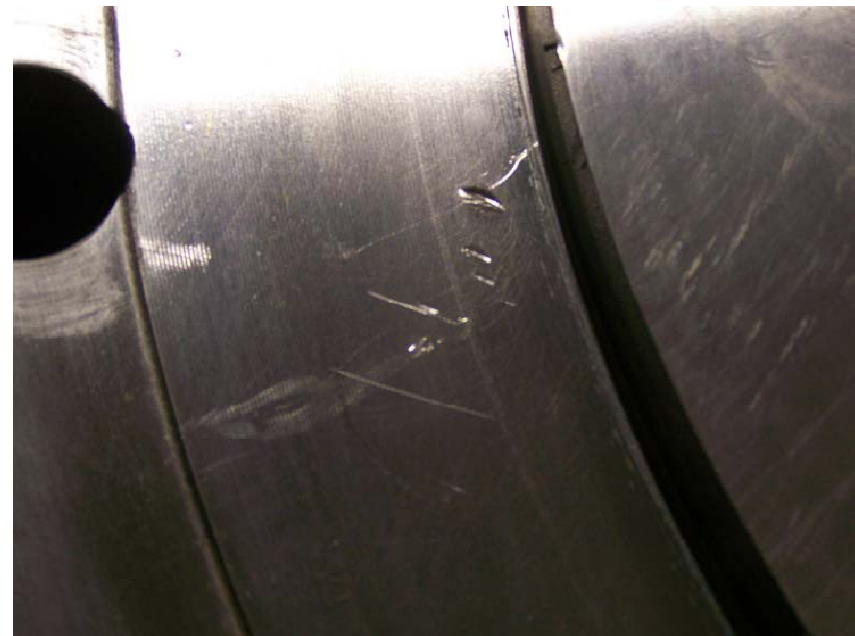
12" Swing Check Valve

The refurbishment activity has identified surface indications (right) which could affect the pressure boundary in the bonnet gasket area which will likely require a Code repair.

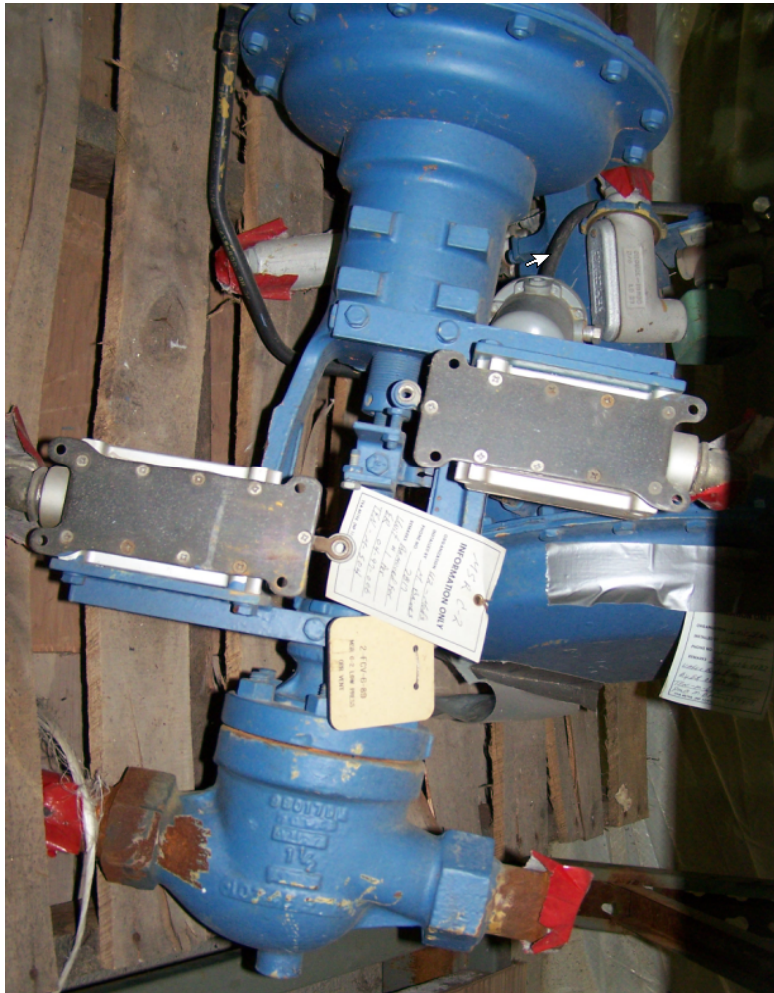
This valve is a 1 1/2", Hammel-Dahl, Globe valve with an A-40 Pneumatic Diaphragm type actuator. The items subject to refurbishment are the actuator diaphragm and valve packing
