### Seismic Walkdown Checklist (SWC)

Project: Byron 2 SWEL

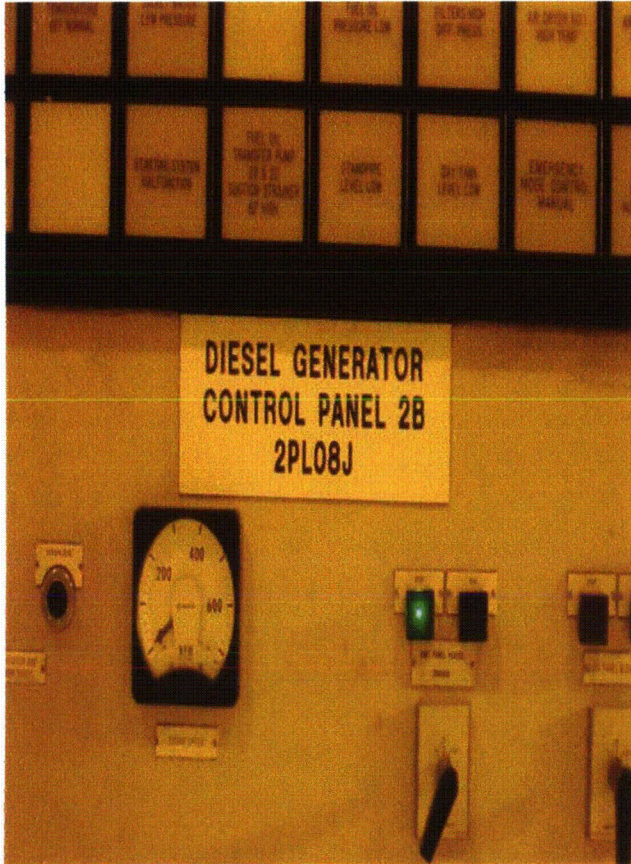
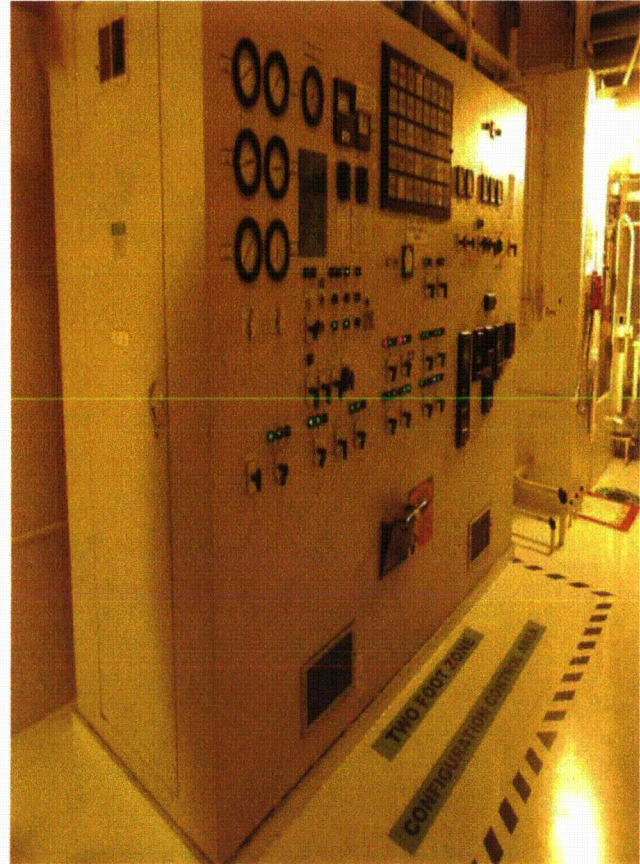
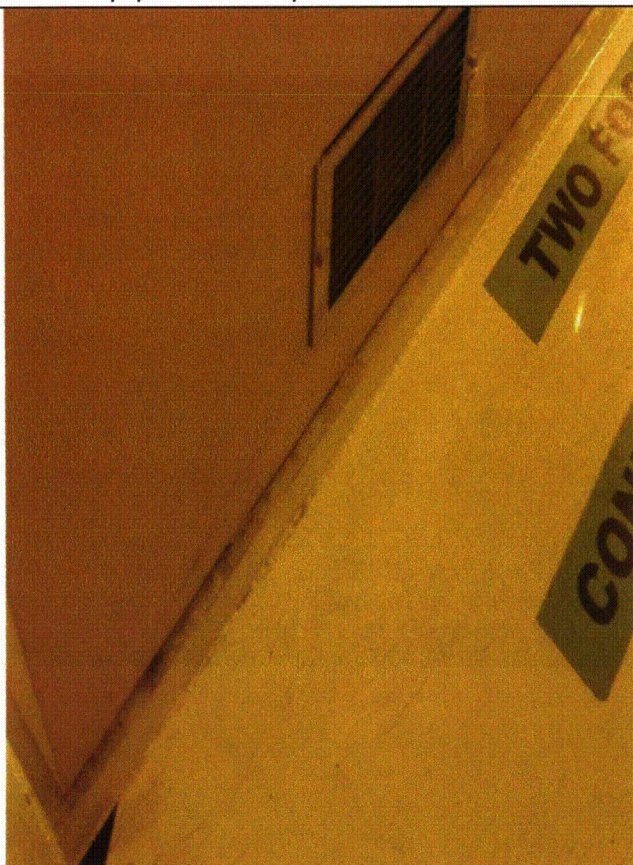
*Loose screw on bottom back of panel - not a structural/seismic issue. IR 1397684 written to repair condition.*

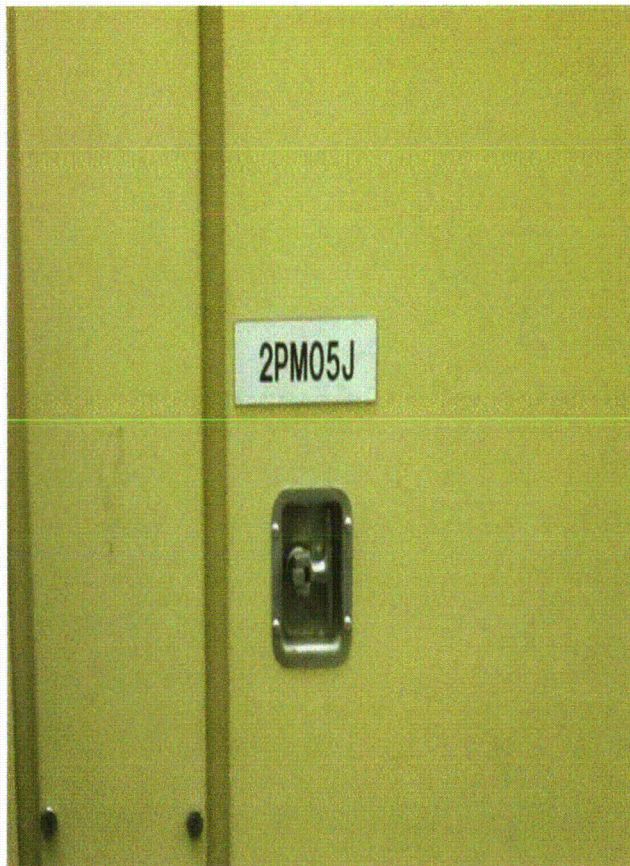
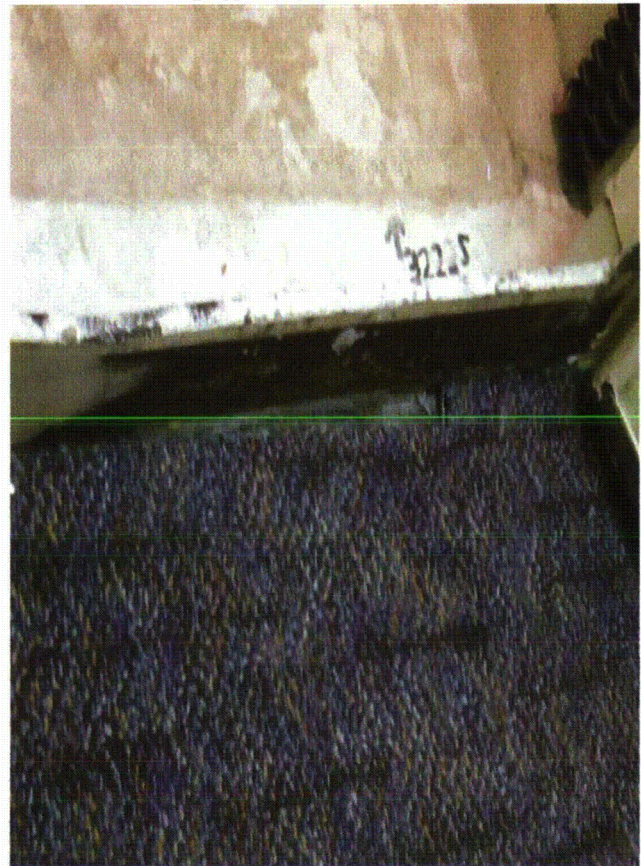
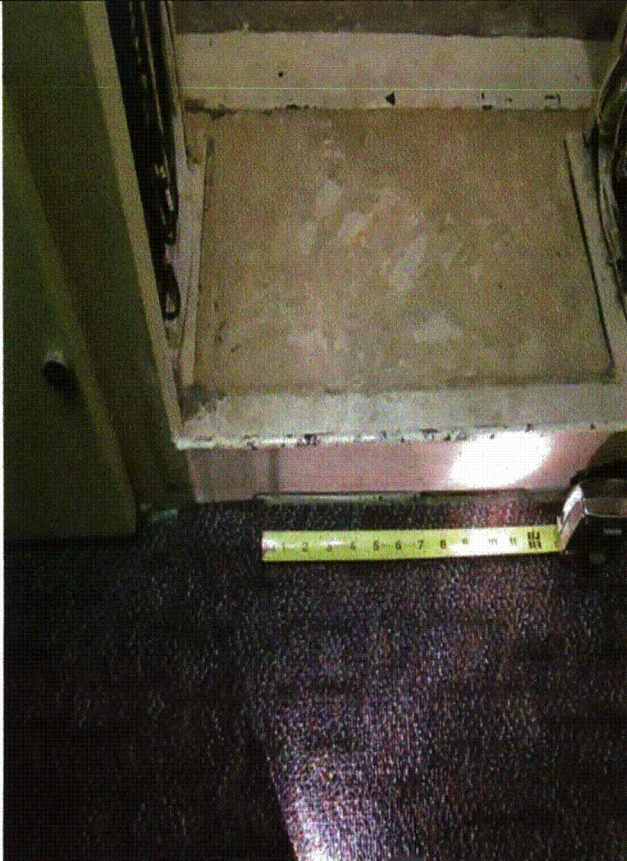
11. Have you looked for and found no adverse seismic conditions that could adversely affect the safety functions of the equipment? Yes  
*Thumb screw loose on back panel. Not a structural/seismic issue. IR 1397697 written for repair.*

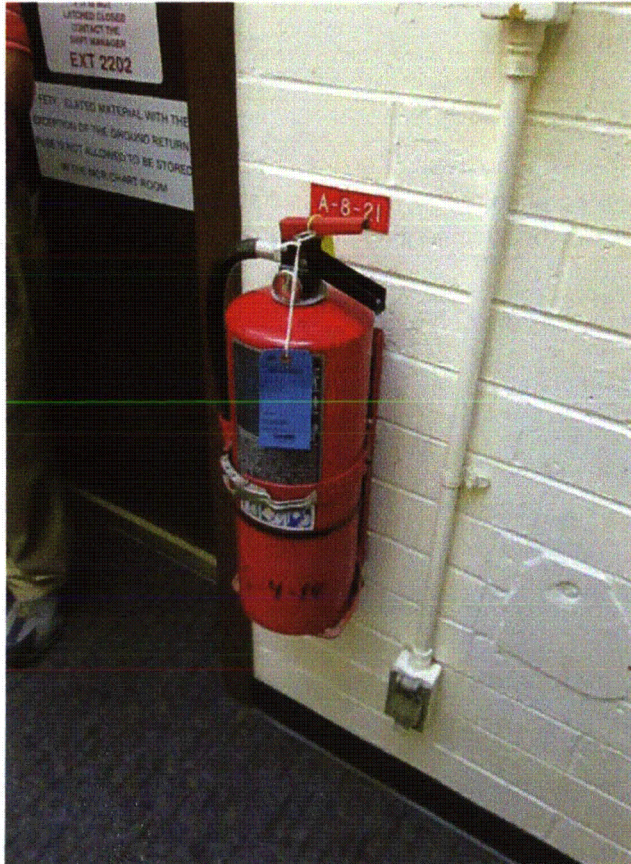
2PM06J - FIRE EXTINGUISHER SIEMIC MOUNTING  
Byron 1 & 2 005

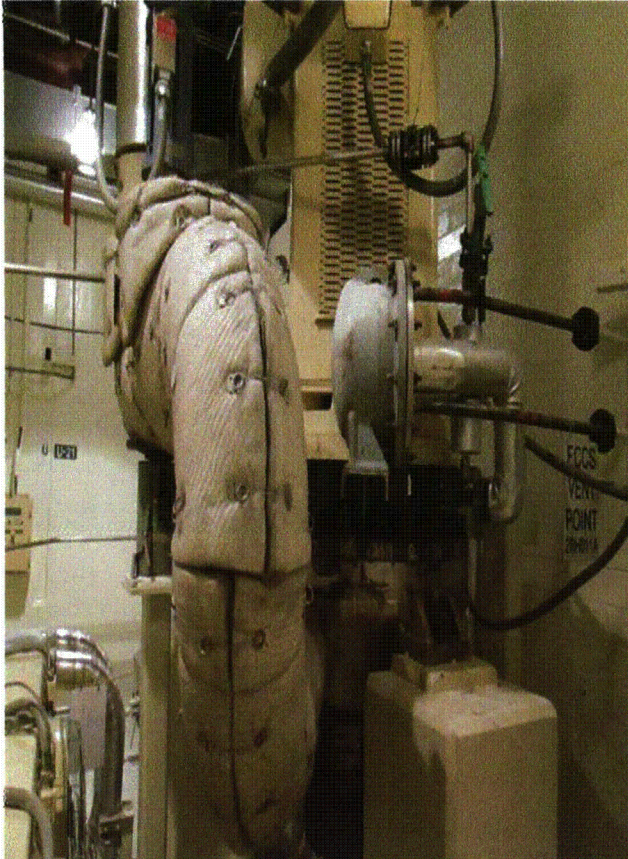
2RH01PA ( CHIPPED GROUT PAD) Byron 1 & 2 8-21-12 049

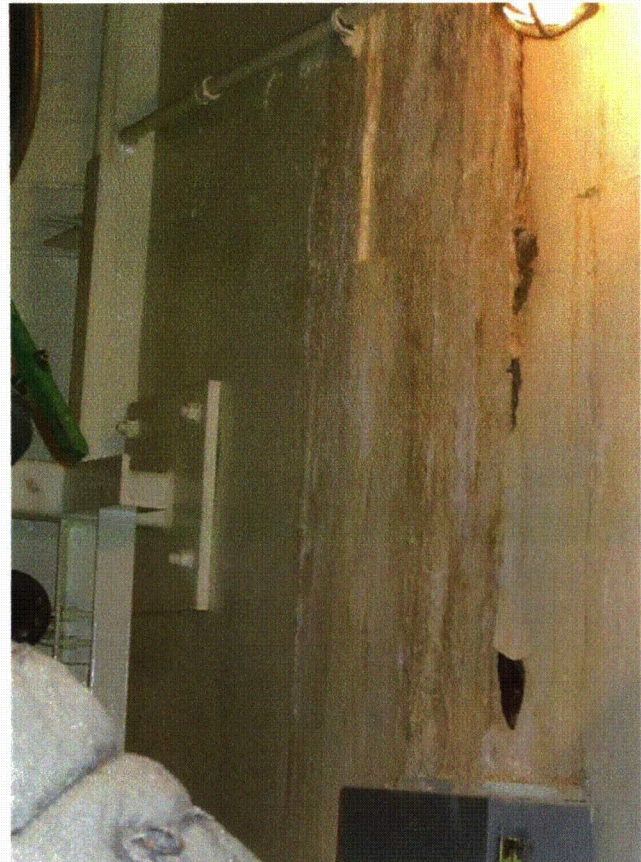
2RH01PA (WALL WATER LEAK) Byron 1 & 2 8-21-12 050

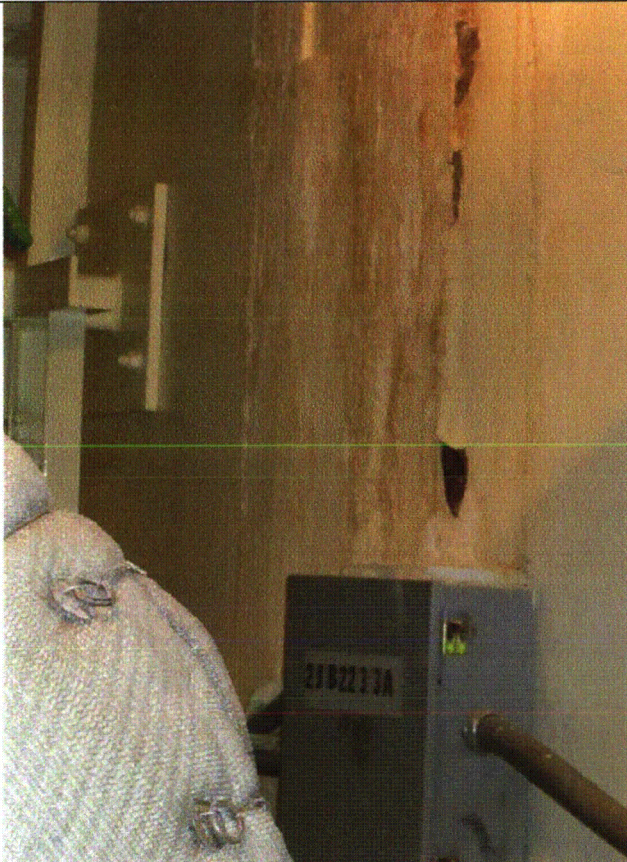
2RH01PA (WALL WATER LEAK) Byron 1 & 2 8-21-12 051
