UNITED STATES
NUCLEAR REGULATORY COMMISSION
OFFICE OF NUCLEAR REACTOR REGULATION
OFFICE OF NEW REACTORS
WASHINGTON, DC 20555-0001

October 3, 2013

NRC INFORMATION NOTICE 2013-20: STEAM GENERATOR CHANNEL HEAD AND
TUBESHEET DEGRADATION

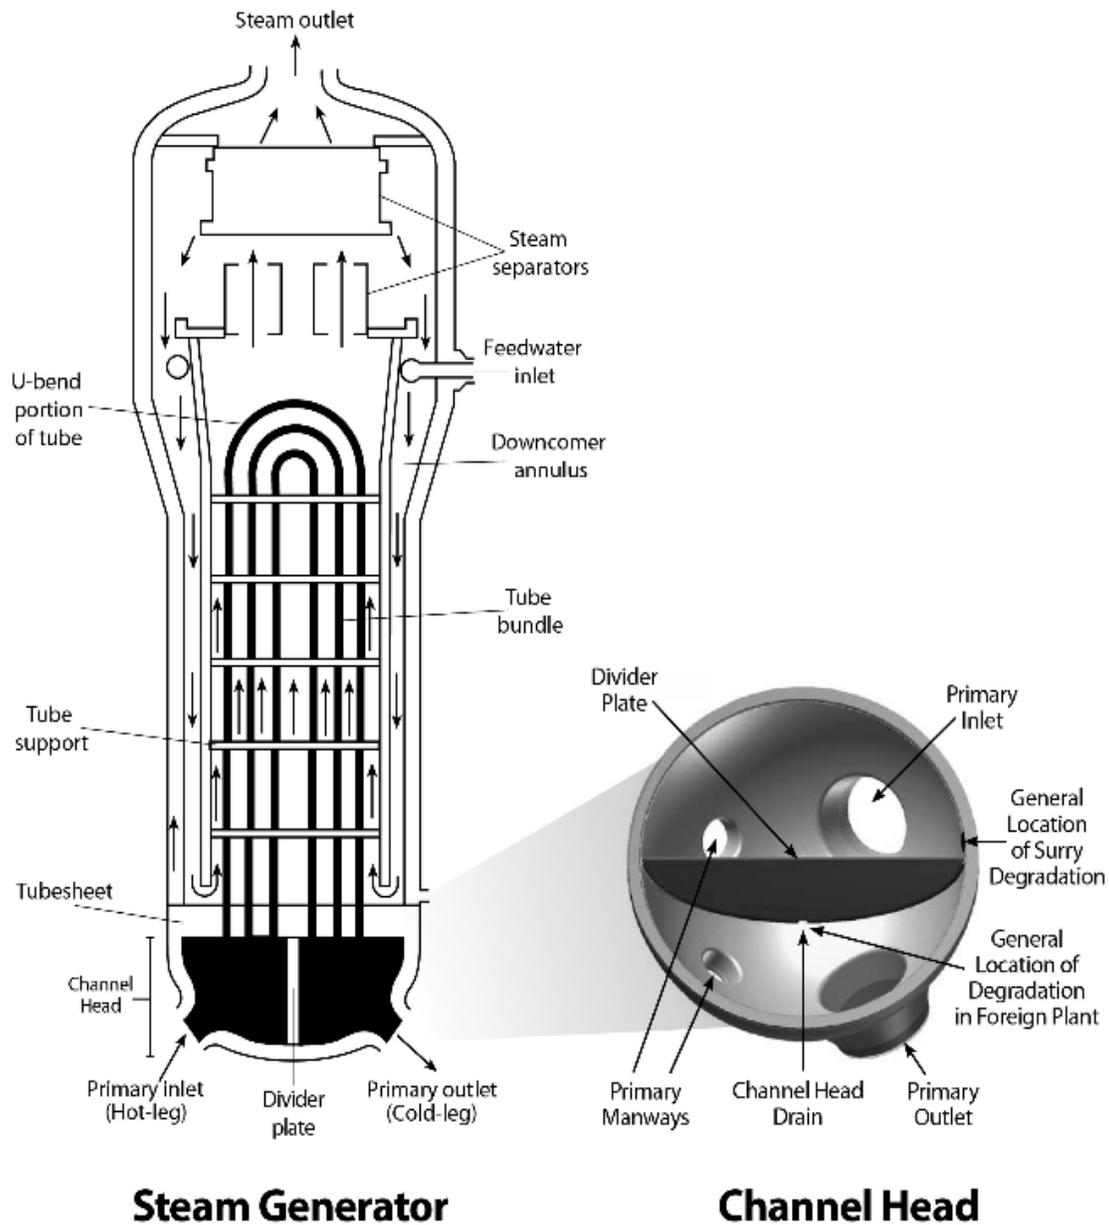
Figure 1: Steam Generator Channel Head Assembly

The primary side of a recirculating steam generator consists of several components, including the channel head, divider plate, tubesheet, and tubes (refer to Figure 1). The channel head is hemispherically shaped and is divided into two chambers by a divider plate. One chamber receives the primary coolant from the reactor through the primary inlet (hot-leg) nozzle, and the divider plate channels this coolant through the tubes. After exiting the tubes, the primary coolant enters the other chamber of the channel head and exits the steam generator through the primary coolant outlet (cold-leg) nozzle(s) so that it can be pumped back into the reactor.
