Technical Letter Report

TLR-RES/DE/CIB-2019-01

**ADVANCED NON-LIGHT-WATER REACTORS MATERIALS AND
OPERATIONAL EXPERIENCE**

MARCH 2019

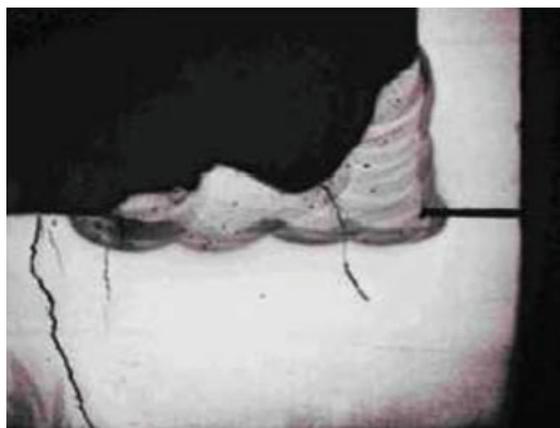
- (1) (Superphénix, 1987): A leak occurred in the sodium storage drum (about a 24 cubic meter (848 cubic ft) volume of sodium). Examinations showed both through-wall and partial through-wall cracks were pervasive in the wall-to-base welds. The cracking (shown in Figure 1) was primarily in the heat-affected zone; however, some cracks extended into the weld metal. Hydrogen embrittlement, enhanced by weld residual stresses,¹ created the cracks.

Figure 1 Storage drum cracking in Superphénix (from [9, Figure 17.9])

The storage drums were fabricated from 15D3, which is a low alloy ferritic steel consisting of iron (98–99 percent), manganese (0.5–0.8 percent), molybdenum (0.25–0.35 percent), silicon (0.15–0.3 percent), and chromium (0.0–0.3 percent). Similar cracking was found with 15D3 during the construction of the SNR-300² reactor in Kalkar, Germany [9, Chapter 17]. This material was subsequently found unsuitable for SFRs because of hydrogen embrittlement issues. Improper material selection in combination with inadequate welding procedures was the cause of the hydrogen cracking.

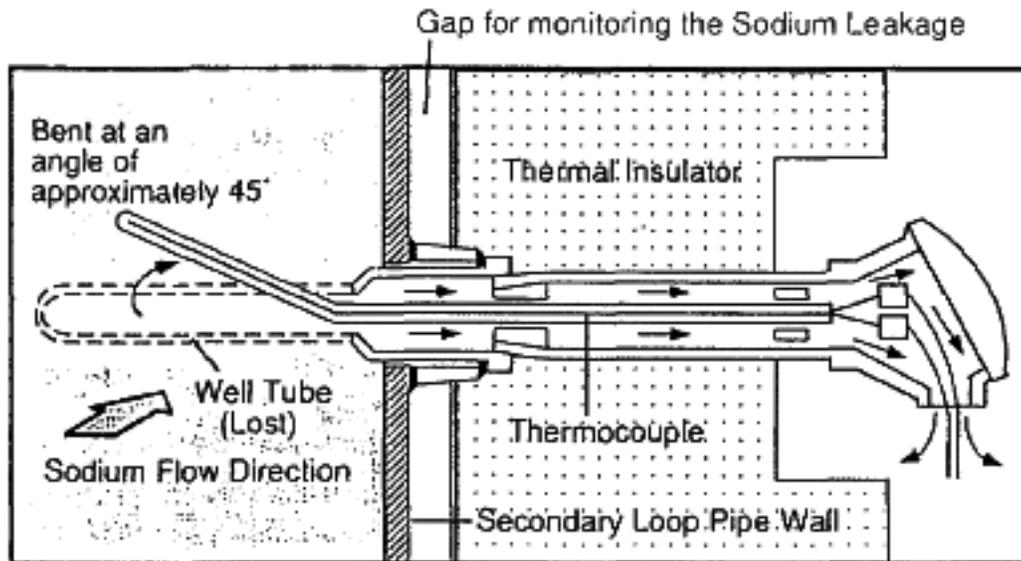
- (4) (Monju, December 1995): After a scheduled shutdown and the following plant startup [21], a sodium leak occurred in the secondary heat transport system of pipe loop C (a hot-leg geometry) and led to a serious fire when it interacted with oxygen and moisture. The leak melted steel structures in the room and resulted in a solidified sodium residue on the room floor almost 3 meter (m) (9 feet (ft)) in diameter and approximately 30 cm (1 ft) deep. The leak was located at a 3 mm (0.12 inch (in.)) diameter thermocouple penetration (Figure 2). The failure of the thermocouple well tube released the well tip and permitted sodium to flow through the thermocouple and into the room. The well tube failure was caused by high-cycle fatigue from flow-induced vibration caused by vortex shedding in the direction of the sodium flow. Figure 2 shows the microscopic investigation of the fracture surface, which indicates fatigue striations. The designers had inappropriately applied the ASME Performance Test Code³ to the Monju tube thermocouple weld because the thermocouple was used in a location where vortex-induced vibrations can occur. Secondary measurement devices (e.g., thermocouples) must be properly designed to prevent leaks. Flow-induced vibrations and complex fluid flows in these areas can cause failure and sodium leaks.

Figure 2 Bent thermocouple and missing well tube in Monju (from [21, Figure 5])

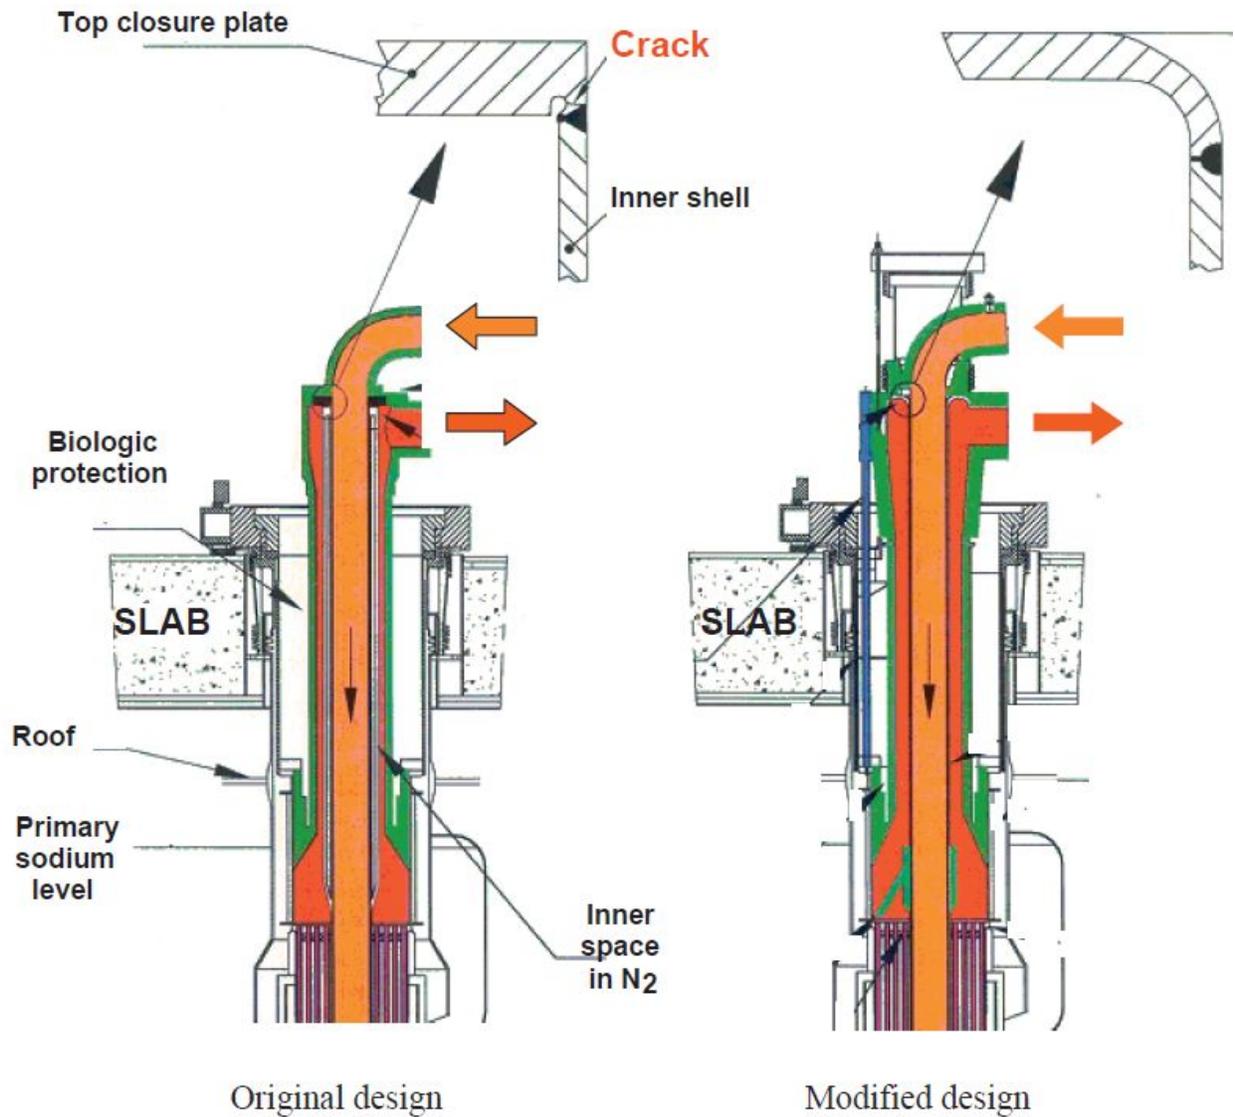
- (9) (Phénix, general): Phénix experienced 11 sodium leak events during its 35 years of operation. These problems were solved using various design modifications. An example of the only significant issue is the sodium leak into the inner space at the secondary sodium outlet header [10, 20, 24]. Different thermal expansion loads between the inner and outer shells that were underestimated in the original design caused the leak. Figure 3 illustrates the problem and solution; the redesign improved both the mixing of the secondary sodium outlet from the tube bundle (i.e., improving accommodation for thermal expansion) and the flexibility of the IHX hot header between the top closure plate and the inner shell (i.e., the upper right portion in Figure 3). Control of structural constraints in SFRs in regions of thermal expansion mismatch is an important design feature and must be considered during the license assessment of the plants.

Figure 3 Modified design of secondary sodium outlet header (from [24, Figure 2.26])

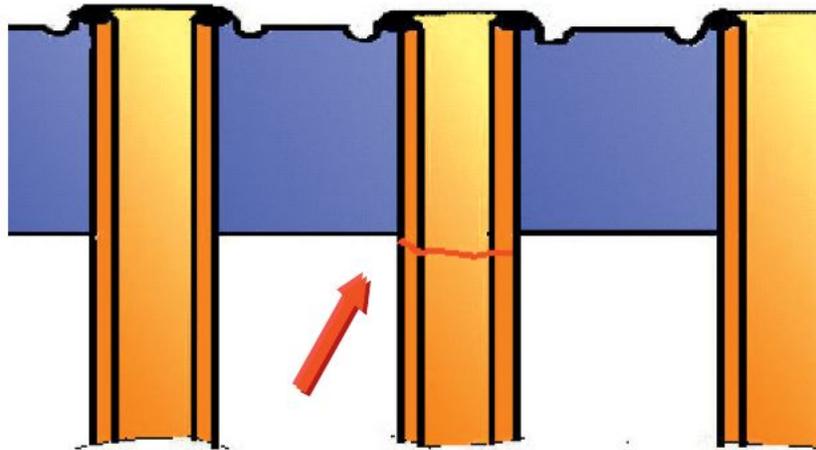
- (10) (Phénix, November 1998, December 2000): Sodium leaks were found in the IHX of Phénix. The leaking tubes were near the upper tubesheet (see Figure 4). A metallurgical analysis revealed that caustic stress corrosion from the presence of polluted sodium (sodium hydroxide from air ingress) caused the cracking. The sodium was contaminated during testing of the IHX (i.e., air ingress during work on the secondary loop between 1995 and 1997). Proper procedures during repairs must be carefully maintained.

Figure 4 Tube leaks in Phénix (from [24, Figure 2.27])

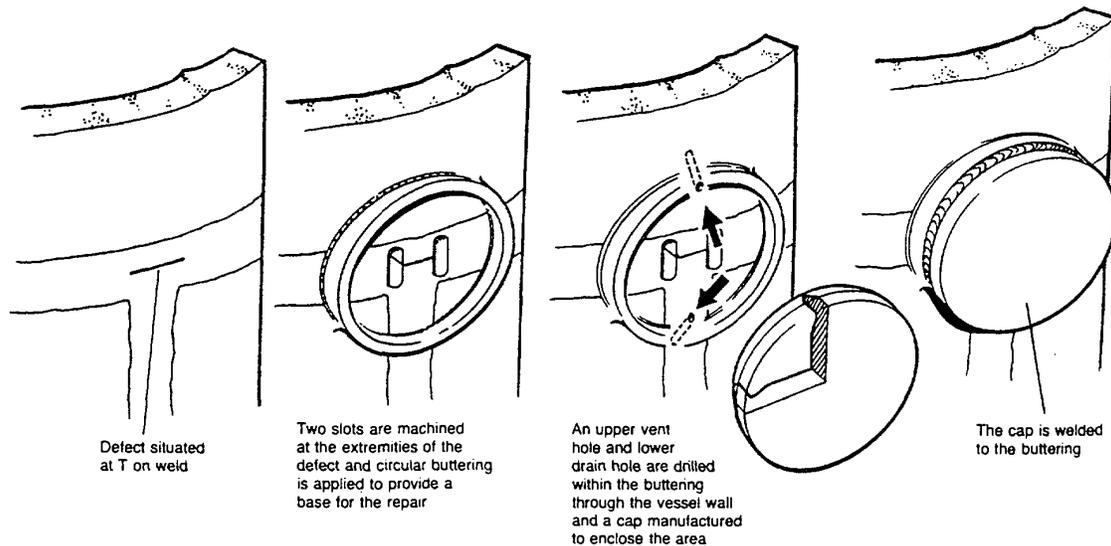
- (12) (PFR, general): Cracking in PFR SG containment vessels was observed during maintenance activities. The evidence indicated that a delayed reheat mechanism driven by residual stresses in non-stress-relieved welds initiated cracking in PFR SGs. Weld repairs (Figure 5) made during the manufacturing process gave rise to conditions that favored cracking.⁴ Weld residual stresses must be properly managed in systems where creep may occur and where corrosion may take place.

Figure 5 SG vessel repair methods (from [19, Figure 3.2])

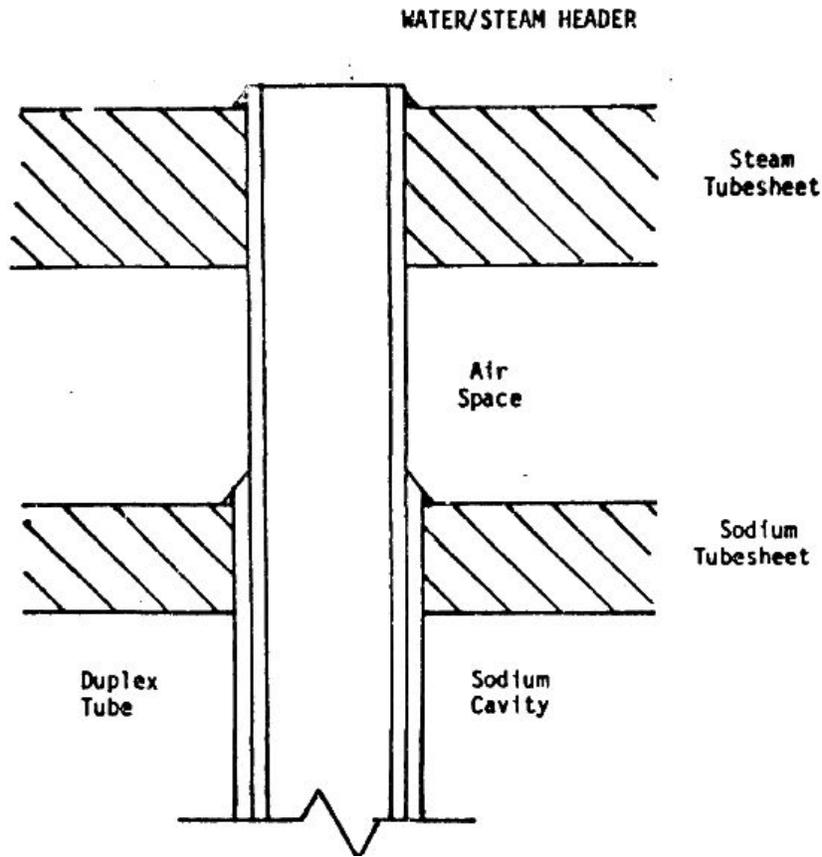
- (13) (EBR-II, February 7, 1965): During a shutdown period with the SG system at ambient temperature, the operating crew reported liquid water between the steam and sodium tubesheets at the upper end of an evaporator (Figure 6). The double-tube design was made to minimize the possible interaction of sodium with water and steam. The source of water was traced to a crater crack in one of the tube-to-tubesheet welds (2-1/4Cr-Mo steel). It was a fabrication defect that the original helium leak test had not detected, but it was manually repaired. Access was gained by removing a section of the steam riser from the evaporator. No additional leaks were detected on any of the SGs. After this incident, additional inspections were made seven times from 1969 to 1978. Although there was some discoloration, there was no evidence of corrosion or fatigue cracking at the tube-to-tubesheet welds. Initial fabrication defects during construction must be identified.

Figure 6 EBR-II steam generator tube cracking (from [23, Figure 7])

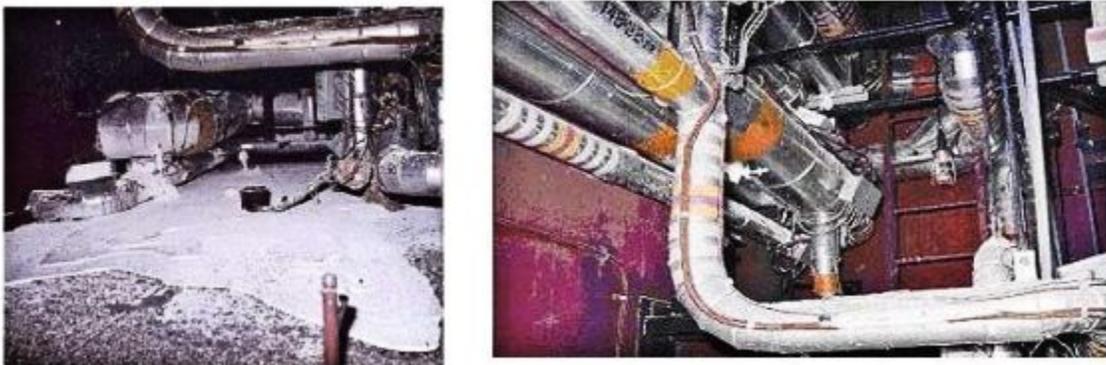
- (4) (FBTR, April 2002): While the reactor was operating at 17.4 MW_t, 75 kg (165 lb) of primary sodium leaked from the purification circuit [26]. The leaked sodium froze on the floor and pipelines. The sodium was manually removed under inert gas purging. The leak came from the body of a bellows-sealed valve through one of the three blind holes used by the manufacturer for machining the valve body (Figure 7). Sodium leaked inside a purification compartment from a hole in the valve body. Because the problem was generic to that specific valve, all valves with that make were inspected and rectified by welding tightly fitting plugs. The leaked sodium converted to sodium hydroxide, which was neutralized by phosphoric acid and disposed of as active liquid effluent. The material thickness of the valve was 0.1 mm (0.004 in.). This thickness was sufficient to hold sodium for 17 years, which indirectly indicates that minimal corrosion occurs between SS and high-purity sodium. In a similar incident, sodium leaked past the failed bellows and went through a crack in the weld joint of the nipple used for mounting a spark plug detector. A faulty valve was later cut and replaced with a new valve (see Figure 7). Proper valve design and accurate estimates of valve reliability will minimize sodium leaks.

Figure 7 FBTR valve leakage failure (left) and sodium leakage on the floor and piping (right) (from [26, Figure 12])

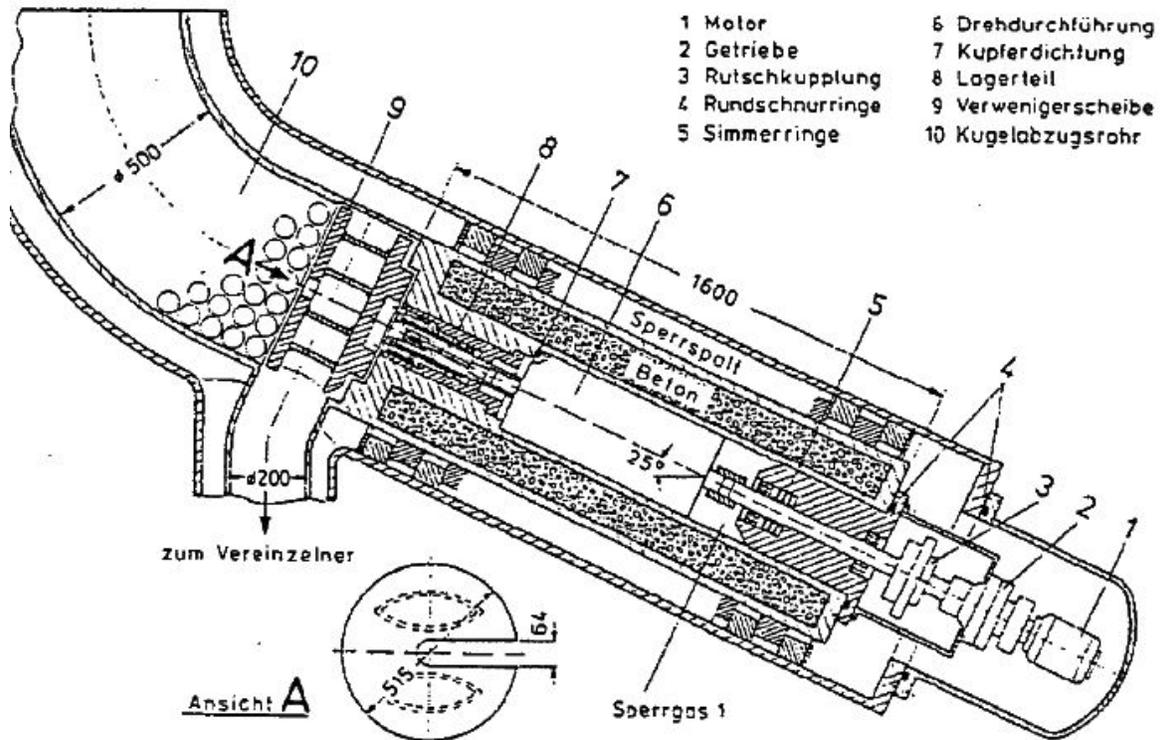
- (5) (AVR, 1971–1981): The reducer in the AVR was a slowly rotating slotted double disk at the end of the pebble extraction pipe (Figure 11). The fuel pebbles move through the disk and down the pipe. As the disk rotates, the pebbles are statistically distributed into the core. Numerous problems with this device occurred over the years. In January 1971, increased internal friction caused the drive motor to fail. In October 1974, a drive cam shear failure caused the reducer to malfunction. In July 1976, the bearing shield became loose, preventing the reducer from rotating and dispensing fuel. In

August 1976, a feather key sheared off in the reducer drive, stopping the reducer entirely. In December 1981, the drive no longer turned because of corrosion caused by water condensation. The repeated failure of the reducer, in addition to other components of the AVR, can be attributed to poor design [49]. Although these malfunctions did not necessarily endanger the public, the plant was shut down numerous times. Reference [49] discusses the numerous problems and incidents with the reducer that caused the plant to shut down. Other mechanical issues with the fuel dispensing and storage system that also occurred indicate a poor design of the entire system.

Figure 11 AVR reducer (from [49, Figure 13.3-2])

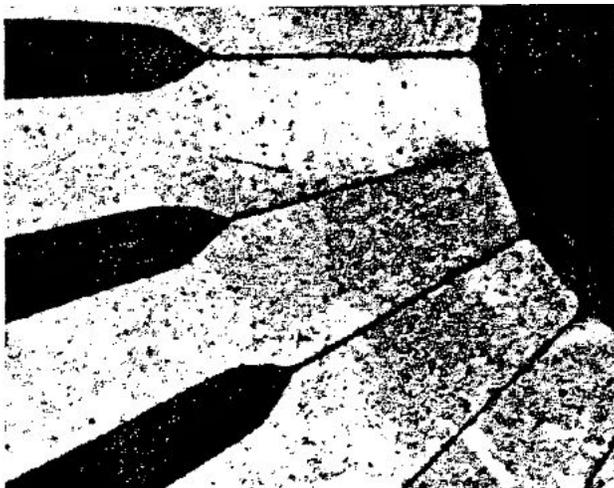
- (4) (AVR, 1984): In 1984, AVR went through a rigorous inspection (after about 10 years of service) of the core structure to determine whether damage had occurred [49, Chapter 13], with special attention paid to examining the graphite. The inspection revealed little damage (Figure 12) to the graphite from material abrasion, corrosion, or shrinkage [49]. Graphite damage can be minimized through proper reactor design and quality control of graphite fabrication.

Figure 12 Graphite damage in an AVR reflector after service (from [49, Figure 13.1-3])

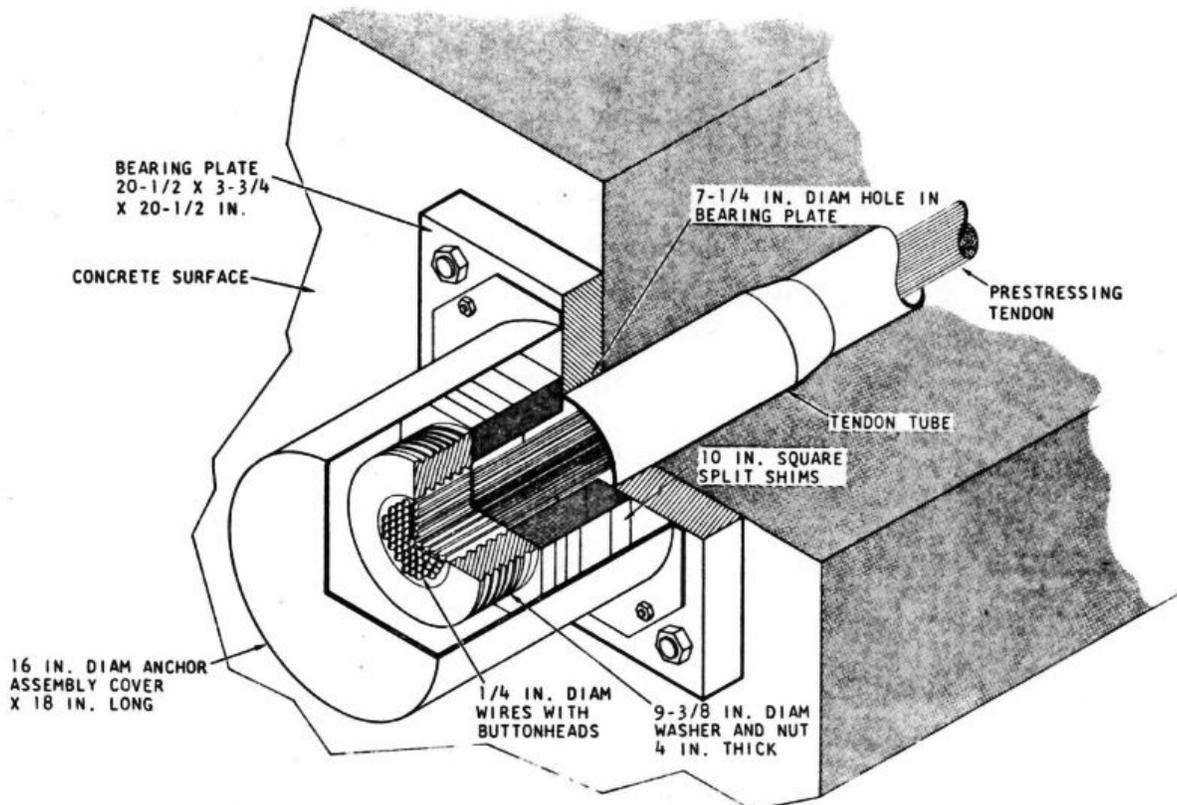
- (3) (FSV, 1984): The PCRV tendon wires in the liner revealed significant corrosion issues [36]. The PCRV system consisted of 448 tendons, each made of 3.87 meters (12 feet 10-1/4 in.) wires. Load cells were used to detect any loss of prestress. The licensee [36] found broken or corroded tendon wires in at least six tendons. The tendons are stored in sealed boxes to prevent moisture from entering. Prestress was used to produce compression in the PCRV liner (Figure 13). The material was steel containing 0.72- to 0.93-percent carbon, 0.4- to 1.10-percent manganese, 0.1- to 0.35-percent silicon, and 0.04-percent (maximum) phosphorous and sulfur, and it met the requirements of ASTM A421, "Standard Specification for Stress-Relieved Steel Wire for Prestressed Concrete," issued 1970 [43]. Sulfonate grease used on the tendon wires combined with oxygen from air ingress created acetic acid, which corroded the tendons. Several possible sources of corrosion were determined and summarized in Reference [36]. One example of tendon wire corrosion was traced to grease missing from the ends of tendon wires in combination with moisture in the sealed boxes where the tendon wires were stored before construction. Later, the plant found that microbiological attack had also contributed to the corrosion and damage to the wires [44]. PCRVs are subject to degradation mechanisms that traditional RPV steels do not encounter in service.

Figure 13 Prestressed tendon wires affected by corrosion damage (from [44])

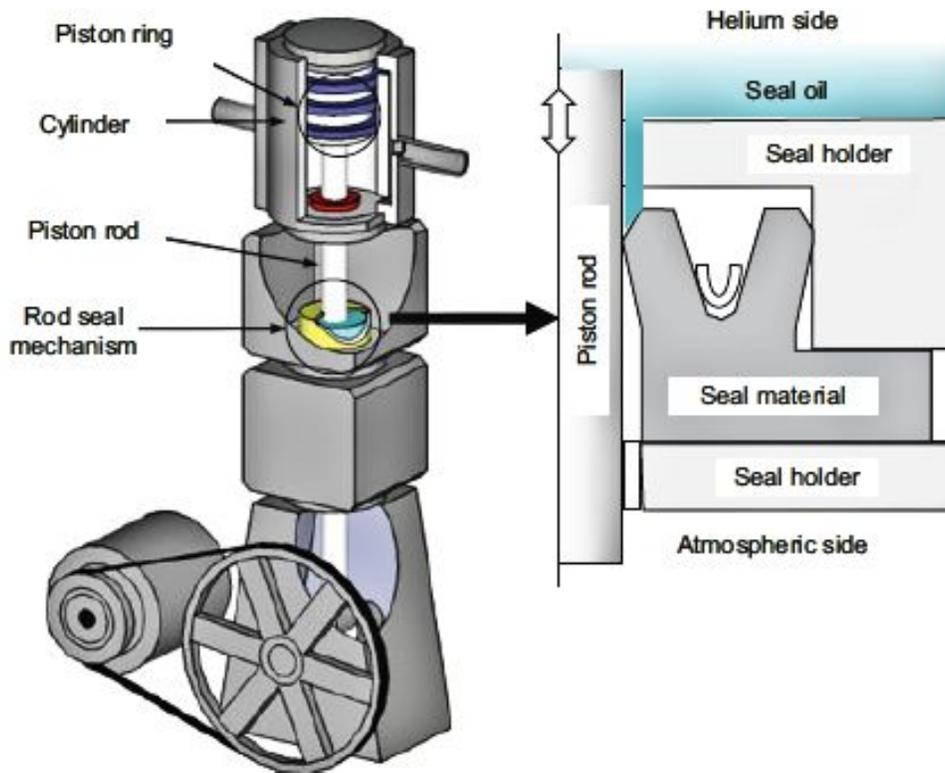
- (7) (HTTR, lifetime): The helium gas compressors (HGCs) in Japan's HTTR had problems similar to Germany's AVR [45]. The HTTR has 14 HGCs for circulating helium coolant in the helium purification system, helium gas sampling system, helium storage and supply systems, and the radioactive waste treatment system. These reciprocating-type compressors are specific to HTGRs. Degradation in compressor performance occurred repeatedly in the HTTR. In one incident in 2004, the volumetric flow rate of the HGCs decreased during operation. Inspections revealed that piston rings were abnormally abraded (Figure 14), which degraded the performance of the piston-ring seals. Further, the resulting graphite dust from the piston rings circulated in the primary cooling system. This dust increased differential pressures in the filters of the primary helium gas circulators [46], which increased pressures in the filters and overloaded them on the primary HGCs. As result, the HGCs had to be replaced often (this issue also occurs in the AVR). Originally, the replacement of these filters was not considered to be necessary throughout the lifetime of the design. To solve the abnormal abrasion of the piston rings, the tolerance for wear was optimized so that the flow rate of the HGCs did not fall significantly until the abrasion of piston rings reached the design limit. This also effectively prevented increases in differential pressures in the filters of primary gas circulators. Graphite dust should be minimized in HTGRs.

Figure 14 Schematic of the exterior and internal mechanisms of a reciprocating HGC (from [45, Figure 4])

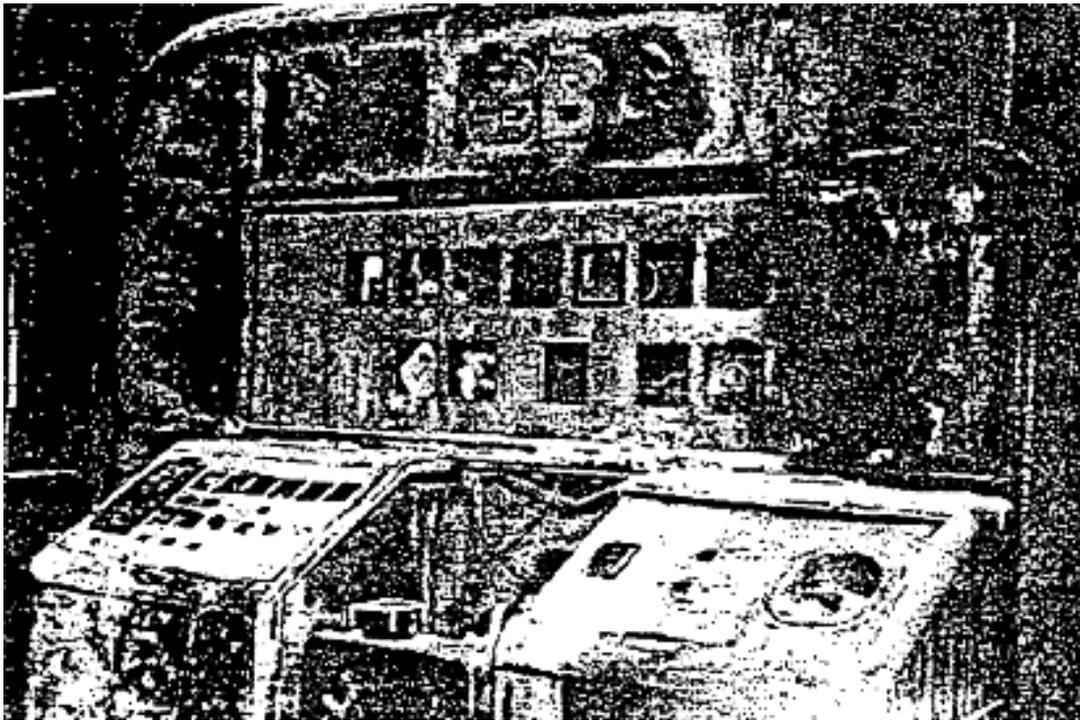
- (4) (AVR, 1971): The fuel oil line broke on a control accelerator for one of the two main steam turbine shutoffs in the AVR [49]. The fuel leak led to a fire, which spread rapidly until the turbine emergency switch was turned off. The fire was extinguished after 15 minutes. The instruments and electrical installation of the engine console in front of the turbine were destroyed. Figure 15 shows the fire damage to the control stand of the turbine. The problem was traced to the fabrication of a clamped screw assembly. The bore of the union nut had sharp edges and had been pushed into the pipe, causing a small starter flaw. Line vibrations and thermal fatigue subsequently grew this crack to a critical size, leading to rupture. To prevent similar failures in the future, several design modifications were made. Among other design changes, welded-on cone couplings replaced the former couplings, and more elastic pipe loops replaced the rigid pipe connections to reduce vibrations.

Figure 15 Fire damage in the turbine building (from [49 Figure 10.1-1])
