UNITED STATES  
NUCLEAR REGULATORY COMMISSION  
OFFICE OF NUCLEAR REACTOR REGULATION  
WASHINGTON, DC 20555-0001

December 17, 2020

NRC INFORMATION NOTICE 2020-04: OPERATING EXPERIENCE RELATED TO FAILURE  
OF BURIED FIRE PROTECTION MAIN YARD PIPING

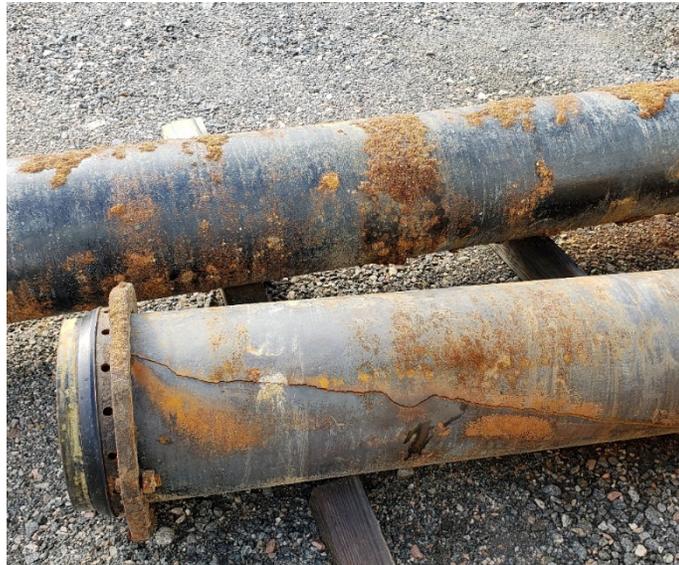
The fire protection main yard piping was made of gray cast iron, internally lined with cement mortar and externally protected with a bituminous coating. Initial investigation into the rupture found a 10-foot longitudinal crack along the bottom surface of the pipe, and a second circumferential crack on an adjacent pipe segment that was apparently caused by uplift forces from flow through the

initial longitudinal crack. Subsequent evaluations determined that long standing exposure to moist or wet soil had resulted in the external reduction in wall thickness at several locations due to graphitic corrosion. The thin asphalt coating could not protect the pipe from the highly corrosive environment. The piping was approximately 49 years old. The licensee modified its selective leaching aging management program to increase the number of examinations that it performed to identify selective leaching. Additional information can be found in Virginia Electric and Power Co., Supplement to Subsequent License Renewal Application, dated October 31, 2019 (ADAMS Accession No. ML19310E716).

July 2019 Surry Power Station Fire Main Yard Loop Piping Rupture  
(ADAMS Accession No. ML20056D677)
