Subject: 10 CFR Part 21 Report – ½" 1878 Piston Check Valve with adjustable  
cracking pressure SN: 96CEE at Duke, Catawba Flowserve Evaluation #113

½" 1878 Piston Check Valve with adjustable cracking pressure SN: 96CEE at Duke,  
Catawba

### Enclosure 3: Description of Evaluation

Subject: Drawing 12-69520-01, Cracking Pressure Evaluation, RMA SO 141990

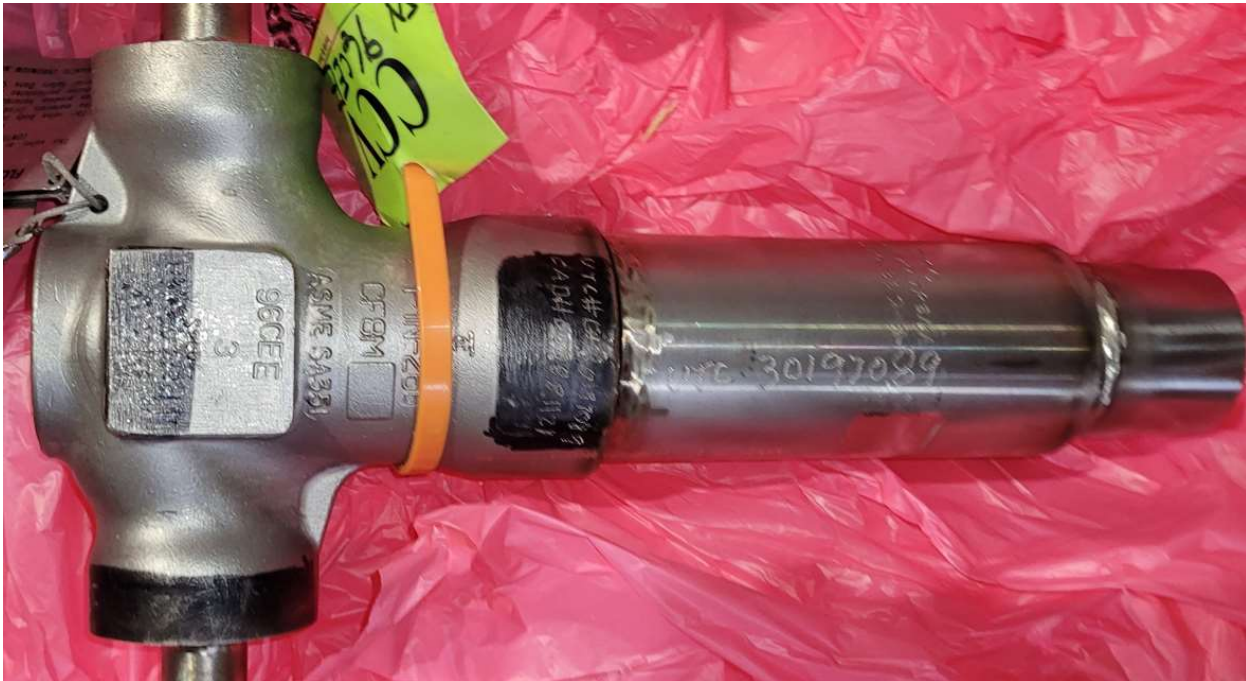
The valves were received with the seal welds on the bonnet cap cut.

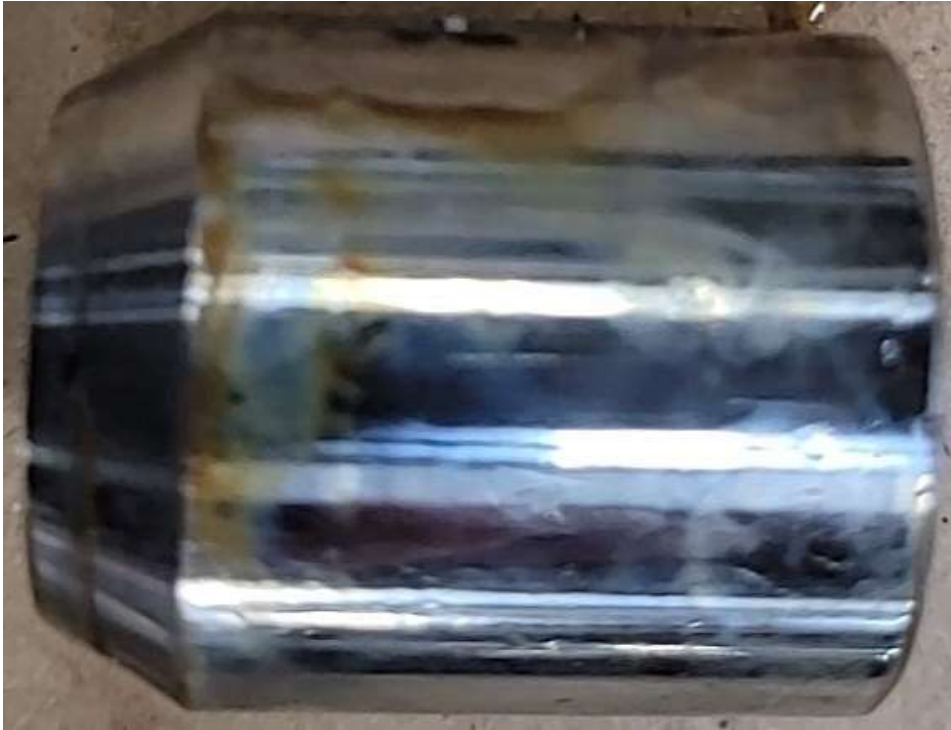
The valve was disassembled to evaluate the internal components. It was noted that the disc had some scale around the lower OD and at the seat contact area. The OD was consistent at 1.119-1.120 inches all with the drawing tolerances. The disc OD and body bore has a tight fit, with a design clearance of .005-.011 inches, this is the former product line standard, which had been increased to .008-.014 inches in 2003 due to a reported instance that had particulate trapped. This design was kept at the .005-.011 clearance due to the buckling potential of the long, high strength spring. It was not believed that the scale, fit or any foreign material was to cause any sticking which would increase the cracking pressure.

The valve was tested in Flowserve's shop to determine a cracking pressure, but a cracking pressure was not able to be determined in the received condition due to increased leaking past the seat as under seat pressure was built-up. A distinction between leakage and cracking could not be determined. Leakage was presumed to be from the observed scale around the seat.

Valve closure and seat leakage test were performed with pressure over the seat in accordance with MS-7259 to quantify the leakage and determine the acceptability of the seat; test pressure could only go up to 1500 psi due to the temporary O-ring seals placed between the body, bonnet cap and cover. A leakage of .1-.2 cc in one minute (vs. a 0167cc original factory acceptance) and 1.2 cc in five minutes (vs .0833 cc) were observed, confirming the bad seat condition.

The body and disk seats were lapped. Valve closure and seat leakage tests were re-performed and zero leakage was observed with 1500 psig of pressure over the seat. The cracking pressure tests were re-performed; cracking was observed at 450-470 psig. The cracking pressure determination was performed with the valve full of water, and applying a pressure source under the seat, pressure was slowly increased until water was seen leaking-by or flowing through the outlet. There was zero leakage observed until the 450-470 psig range was reached, at which point a steady rise of water was observed in the outlet water column. To verify this cracking pressure, the pressure was further increased and the inlet end isolated; after isolation the pressure on the inlet side of the valve dropped and stabilized (held steady) once it reached 450 -470 psig.
