SOLIDSTATE CONTROLS

Attention: Document Control Desk
Subject: Notification of Potential Defect - 10CFR Part 21
Product: Regulating Transformer Model 85-IS0150-14

AMETEK Solidstate Controls Inc. is submitting the following Final Report of a Potential Defect discovered on 10/29/2024 in accordance with the requirements of 10CFR Part 21. This is associated with the interim report originally submitted on 12/28/2024 (Log No. 2024-37-00 / Accession No. ML24365A117).

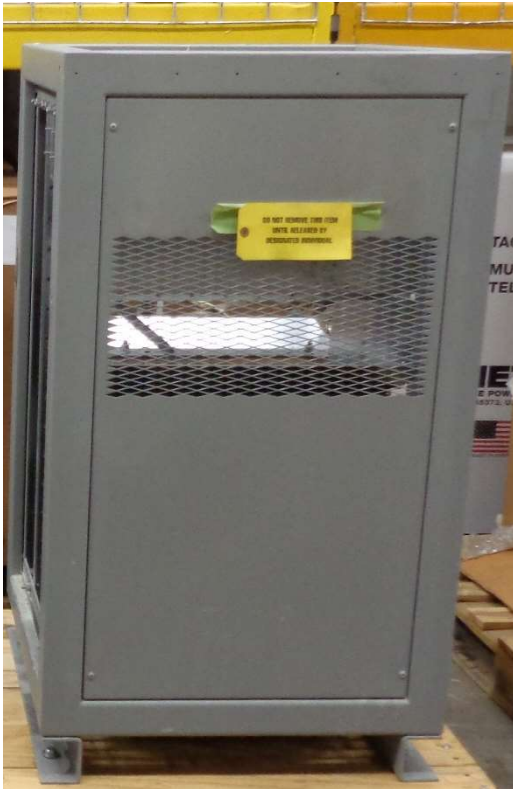
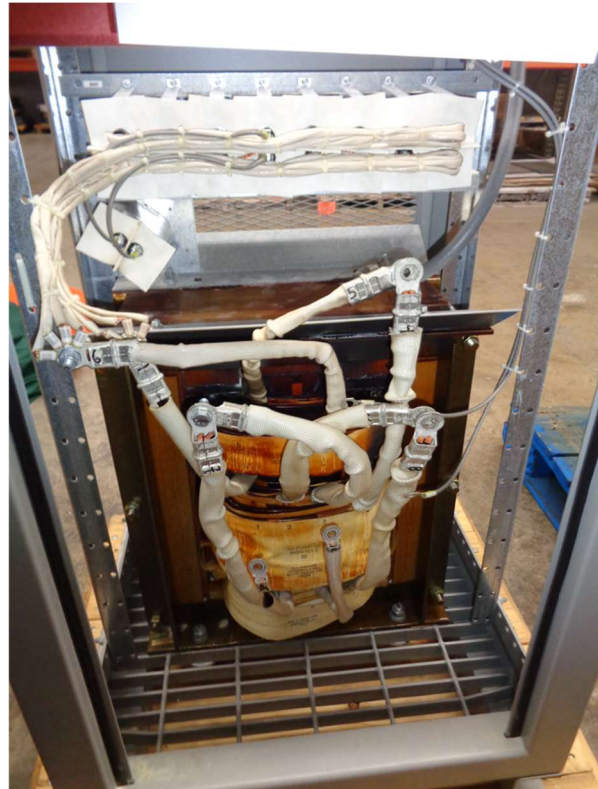
96000101-0415 – 85-IS0150-14

Dielectric testing was performed on this unit and a short was found from taps 1 and 2 of the secondary coil to ground. Due to this and the condition of the transformer as received, no functional testing could be performed. A destructive teardown was then performed to identify the source of the failure within the transformer.

The apparent source of the failure in system 96000101-0415 was a short-circuit between the secondary coil of the transformer and the magnetic shunts and center leg of the transformer core. A teardown showed evidence that the short started on the top left of the secondary coil, entered and traveled through the left magnetic shunt, then exited the right side of the shunt into the center leg of the core. From there the short circuit entered the right magnetic shunt and exited through the bottom of the shunt back to the secondary coil on the right side of the transformer. Evidence of this path is shown in the photos in appendix B with the small pin holes (photos 1 and 2) demonstrating the suspected arc point, the welding points showing the travel between the shunt and core (3,4), the blowout showing the exit point into the right shunt (5,6), and finally the blow out showing the return of the current from the shunt to the secondary coil (also 6).

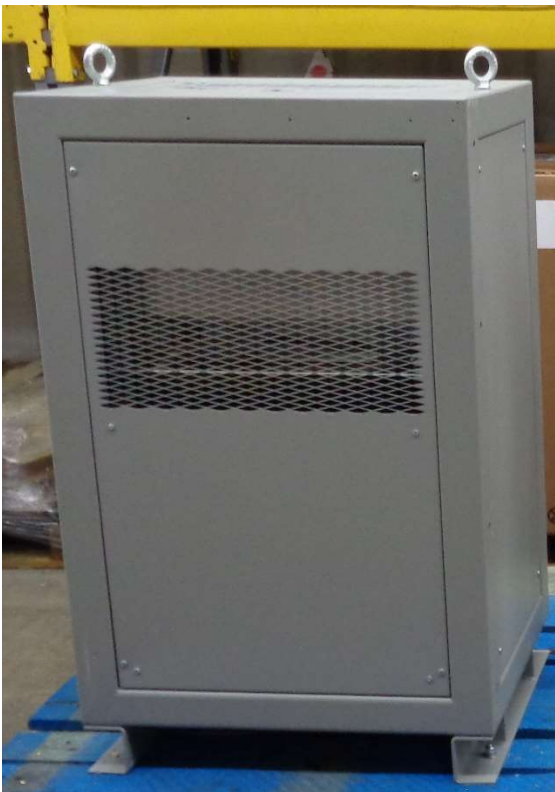
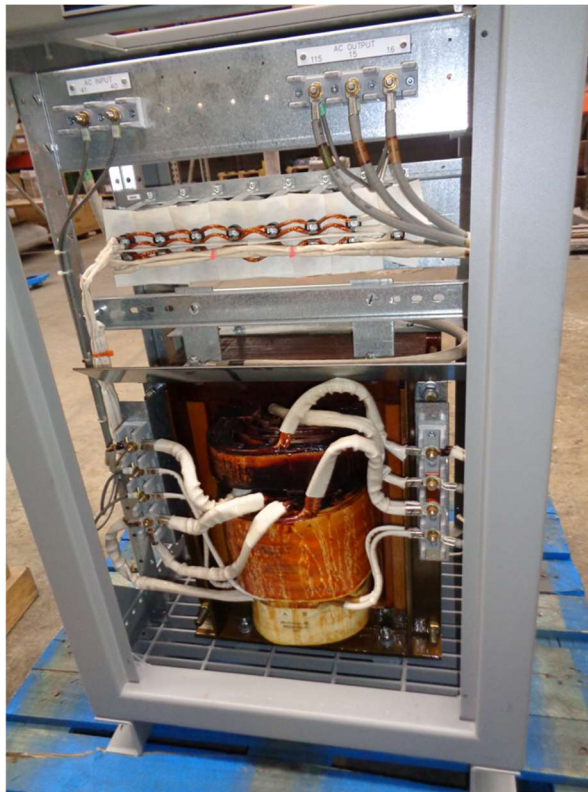
96000101-0915 – 85-IS0075-12

Further testing of unit 96000101-0915 (model 85-IS0075-12) did not yield a failure mode similar to the one reported except through extraordinarily unusual condition. The unit was run in typical ambient conditions (~20°C) both loaded and unloaded and reached a peak hot spot

temperature of 172°C. After partially blocking the unit vents and repeating the testing the unit had a peak temperature of 179°C. Next, the unit's vents were fully blocked and the ambient temperature for the enclosure was increased to approximately 50°C, and testing was repeated. During this test the highest peak temperature was observed, as the harmonic coil reached 201°C after 8 hours. After completion of this testing the transformer was found to still be operating within expected ranges, however, the extreme conditions and insufficient airflow caused 6 of 8 capacitors in the unit to fail as they had exceeded their rated temperature. Finally, after replacing the capacitors the unit was once again retested in typical conditions. The unit operated nominally with the exception of the transformer being noticeably louder. All dielectric testing was performed and no shorts were found.

The results of the testing unit 96000101-0915 leads to the conclusion that except in certain extreme conditions the 85-IS0075-12 model is expected to continue to operate within its design parameters and that the darkening originally noted is a symptom of increased temperature, but not a sign of impending failure.
