# **Integrated Chemical Effects Test Project: Test #2 Data Report**

**Los Alamos National Laboratory**

**U.S. Nuclear Regulatory Commission  
Office of Nuclear Regulatory Research  
Washington, DC 20555-0001**

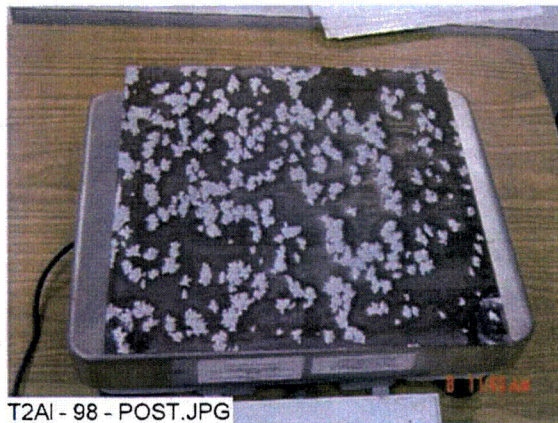
According to SEM/EDS results, the dominant corrosion products on the submerged aluminum coupons are likely aluminum hydroxide with other substances containing silicon, calcium, sodium, magnesium, phosphorus, carbon, and oxygen. In addition, evidence was found that some copper deposited on the submerged aluminum coupon surfaces. Comparing the redox potential ( $E^0$ ) of  $\text{Al}^{3+}$  and  $\text{Cu}^{2+}$ , which is  $-1.662$  and  $0.3419$  V (Ref. 6), respectively,  $\text{Cu}^{2+}$  in the solution may oxidize aluminum metal. As a result, aluminum metal may be oxidized into  $\text{Al}^{3+}$  and released to the solution. Correspondingly  $\text{Cu}^{2+}$  is reduced into metallic copper and subsequently deposits at the aluminum coupon surface.

**Figure 4-7. AI-98 submerged, post-test.**

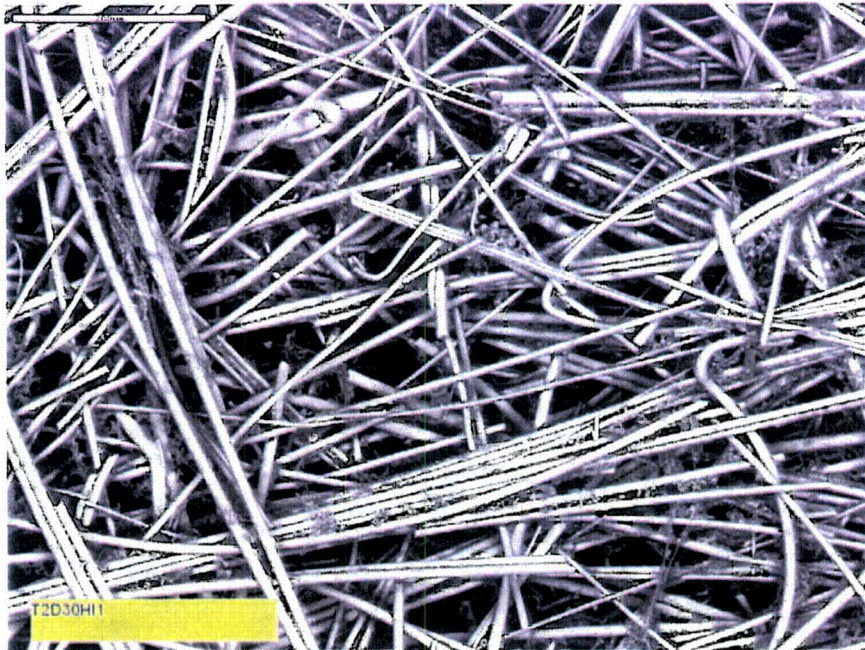
In the Day-30 high-flow fiberglass samples, significantly fewer particulate deposits were found on the interior samples than on the exterior samples. However, there is no apparent

Figure 4-55. ESEM image for a Test #2, Day-30 high-flow interior fiberglass sample. It seems that the interior fiberglass is cleaner than exterior samples.

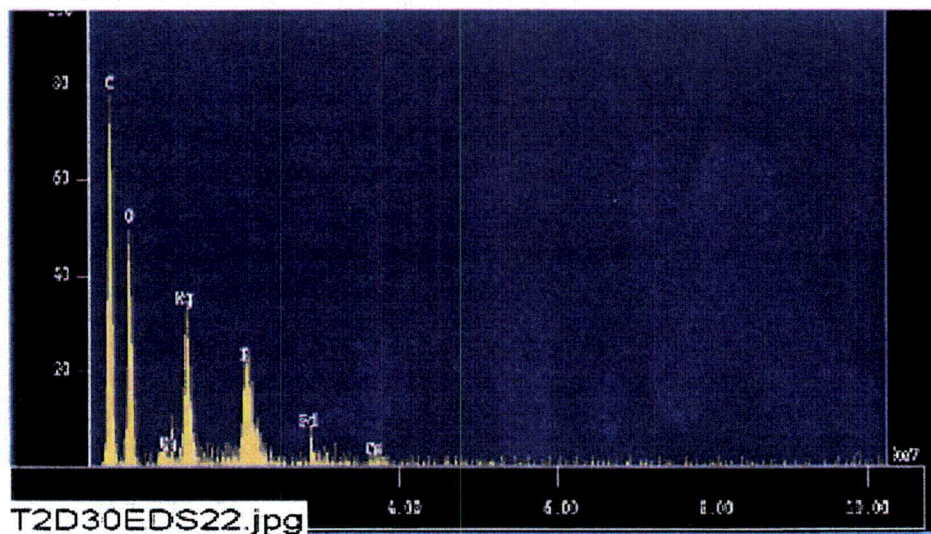
**Figure 4-59.** EDS counting spectrum for the lathlike crystal on the lower left side of Figure 4-58. From left to right, the element peaks are carbon, oxygen, sodium, magnesium, phosphorus, palladium (coating substance for SEM analyses), and calcium.

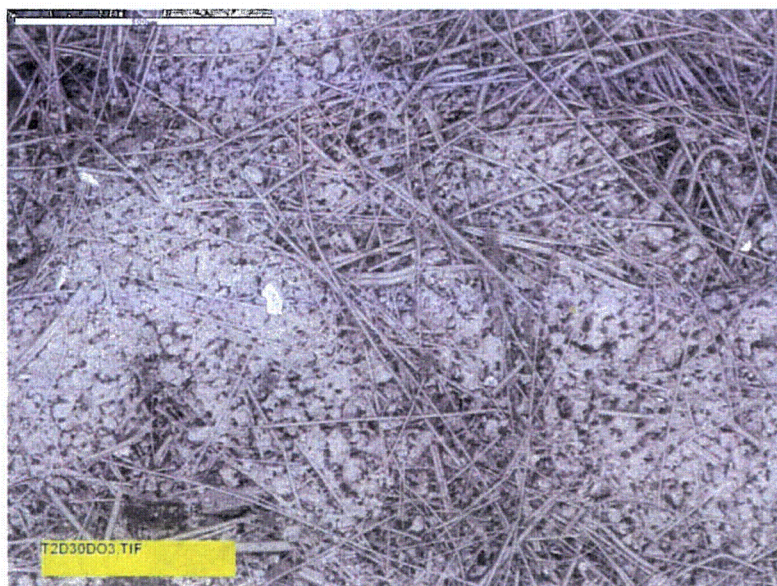
**Figure 4-63.** ESEM image of a Test #2, Day-30 exterior fiberglass sample on the drain collar (away from the drain screen). The image shows a great amount of particulate deposits on the fiberglass.

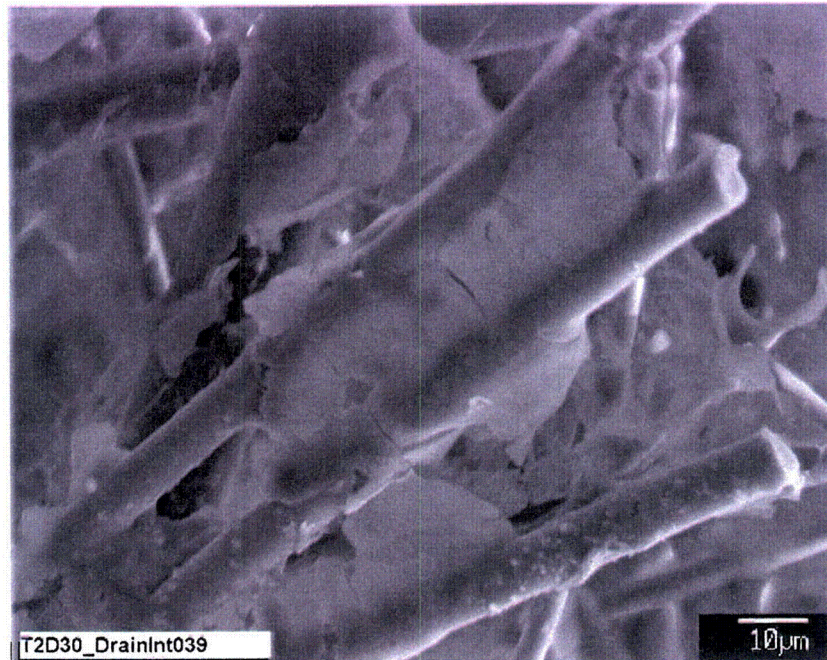
**Figure 4-69.** Higher-magnification SEM image of a Test #2, Day-30 interior fiberglass sample on the drain collar. The image shows flocculence or growth on the fiberglass.

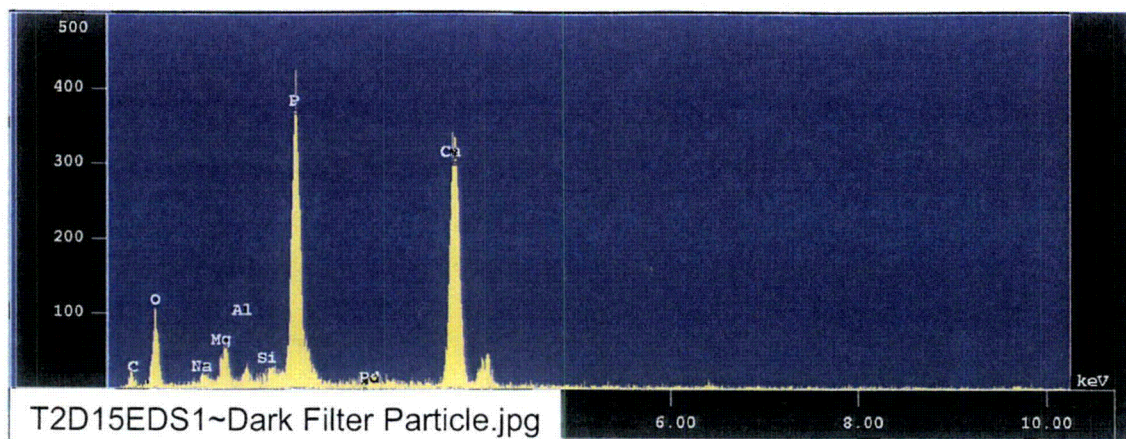
**Figure A-3.** EDS counting spectrum for the darker filtrate material shown in Figure A-2, indicating that the dark material is rich in calcium and phosphorus. (T2D15EDS1~Dark Filter Particle)

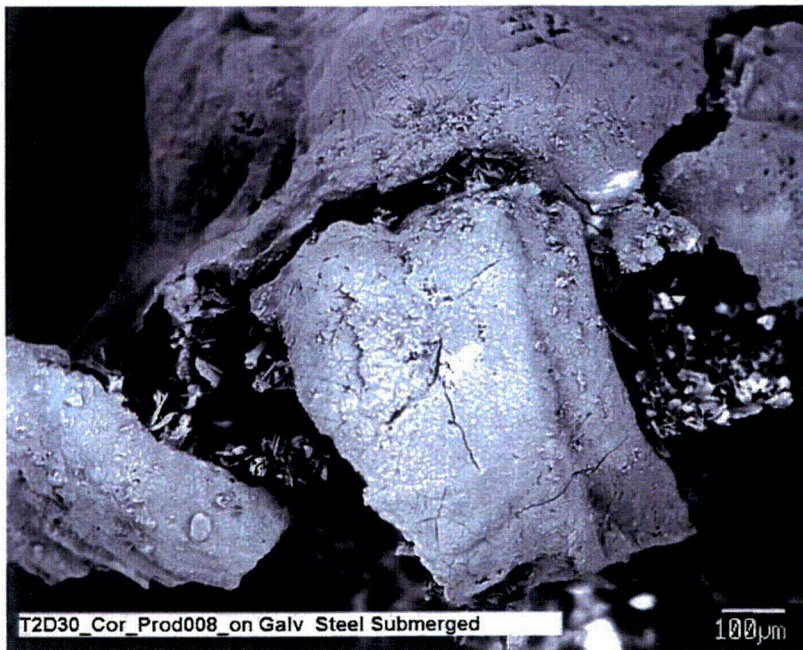
Figure B-11. Backscatter SEM image at 95× magnification of a Test #2, Day-30 sample of corrosion products on a submerged GS coupon. (T2D30\_Cor\_Prod008\_on Galv Steel Submerged)

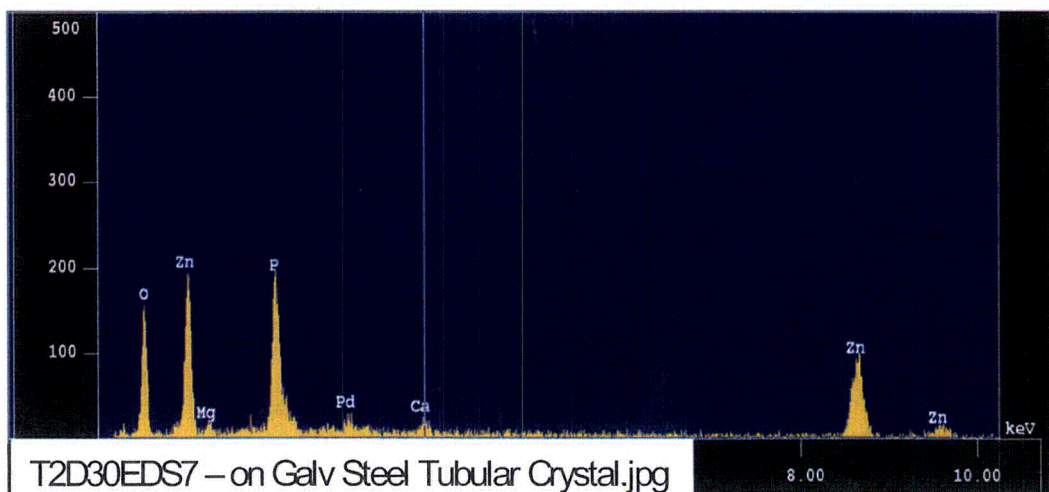
Figure B-15. EDS counting spectrum for small tubular crystals in Figure B-11, suggesting that the corrosion products of galvanized steel are rich in zinc, phosphorus, and oxygen [possible presence of  $\text{Zn}_3(\text{PO}_4)_2$ ].

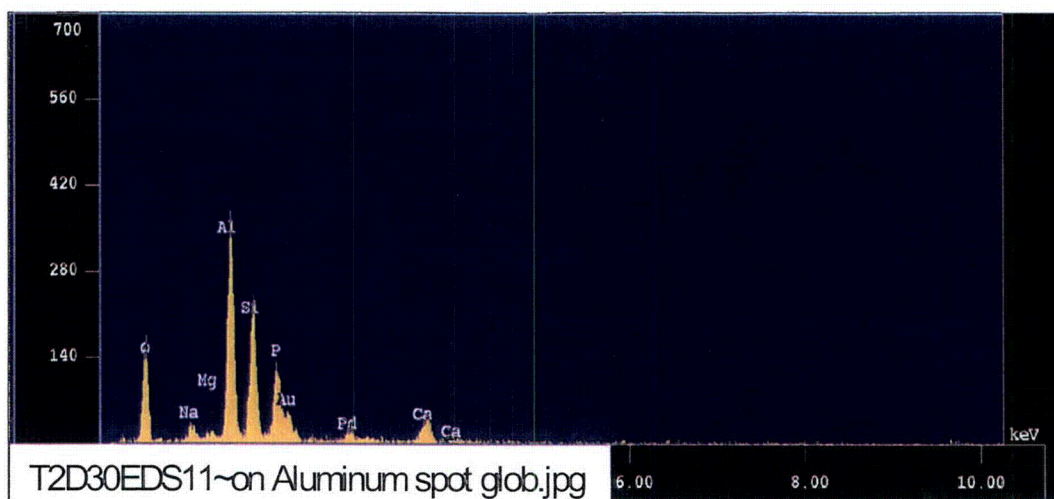
Figure B-22. EDS counting spectrum for upper right spot in Figure B-21, suggesting that the corrosion products of aluminum are rich in aluminum, silicon, phosphorus, and oxygen. (T2D30EDS11~on Aluminum spot glob)

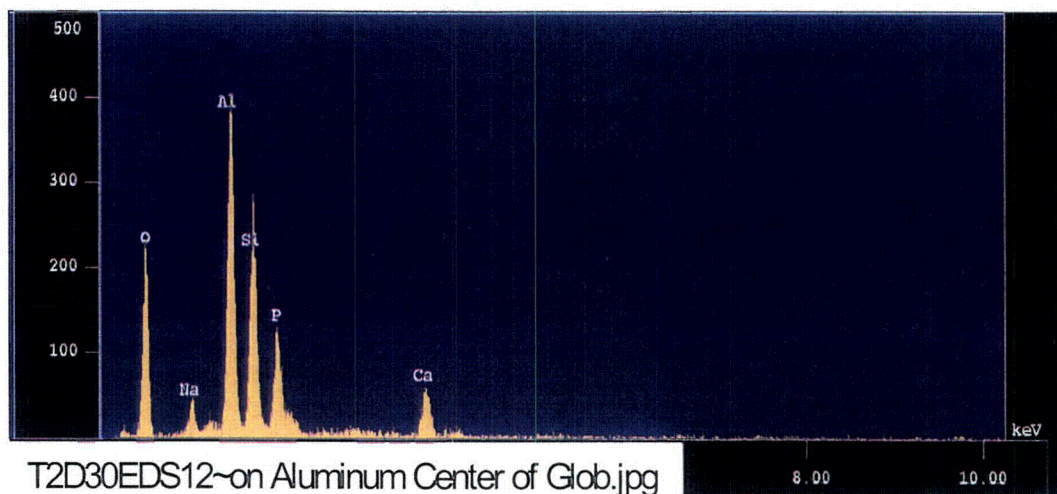
Figure B-24. EDS counting spectrum on the center of Figure B-23, suggesting that the corrosion products of aluminum are rich in aluminum, silicon, phosphorus, and oxygen. (T2D30EDS12~on Aluminum Center of Glob)
