# **Proceedings of the Conference on Vessel Penetration Inspection, Crack Growth and Repair**

**Held at  
Gaithersburg Marriott at Washington Center  
Gaithersburg, MD  
September 29 – October 2, 2003**

**U.S. Nuclear Regulatory Commission  
Office of Nuclear Regulatory Research  
Washington, DC 20555-0001**

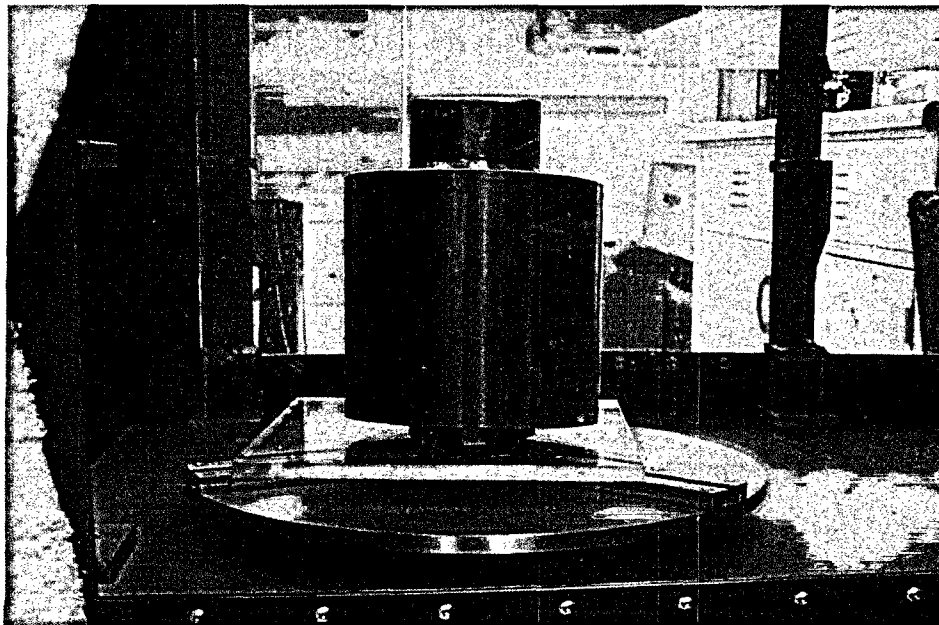
**Figure 1. Midland CRDM after machining and located in water immersion tank prepared for UT inspection.**

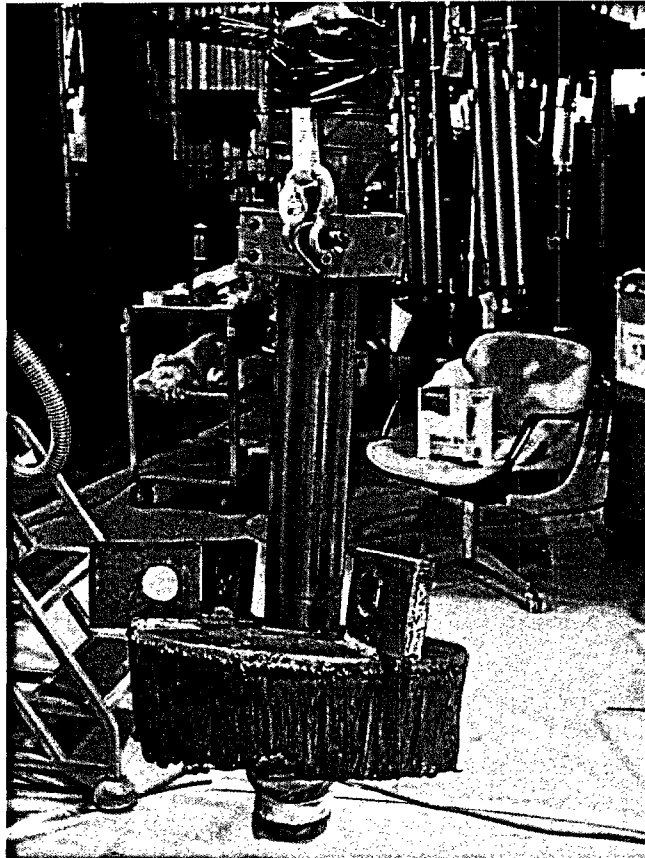
**Figure 3. North Anna 2 CRDM that has been decontaminated and is ready for moving to a stand for NDE inspections.**

Figure 3 shows a CRDM that has been decontaminated and is being readied for transit to a stand where it will reside during NDE inspections. Four CRDMs will be inspected by the commercial NDE vendors. The really fantastic opportunity that the North Anna 2 CRDMs offer is realistic NDE studies on service induced PWSCC coupled with flaw validation. This will allow us to fully understand how effective the NDE is in detecting PWSCC at all of the locations found in these samples. For the first time, we will also know what was found and what was not found. In addition we will for the first time understand how accurate the NDE techniques are in sizing the PWSCC.

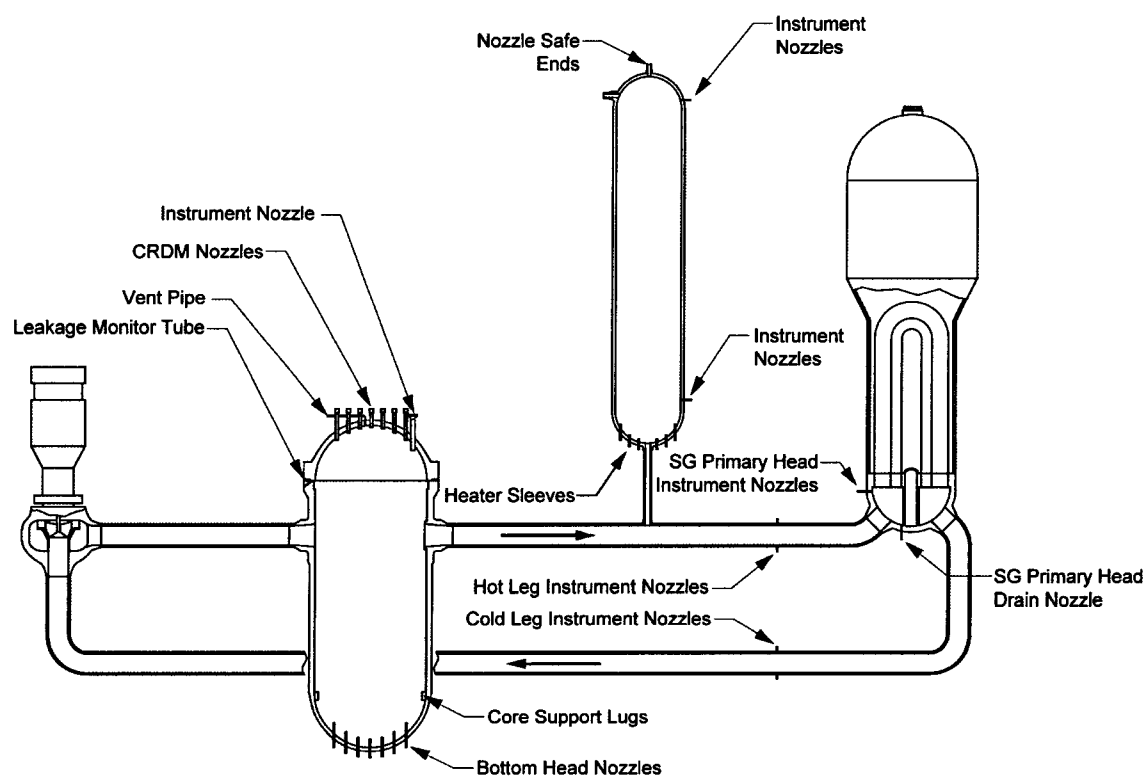
Figure 1  
Locations of Thick-Section Alloy 600 Materials

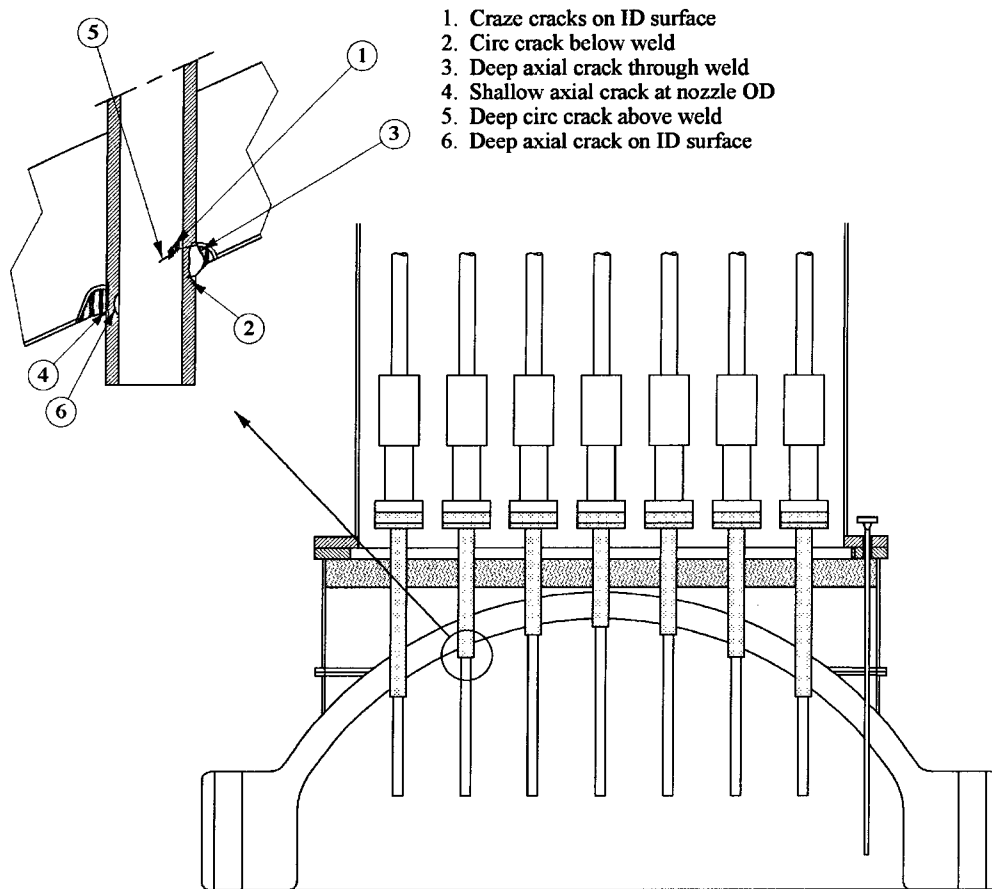
Figure 2  
Location of Typical RPV Head PWSCC

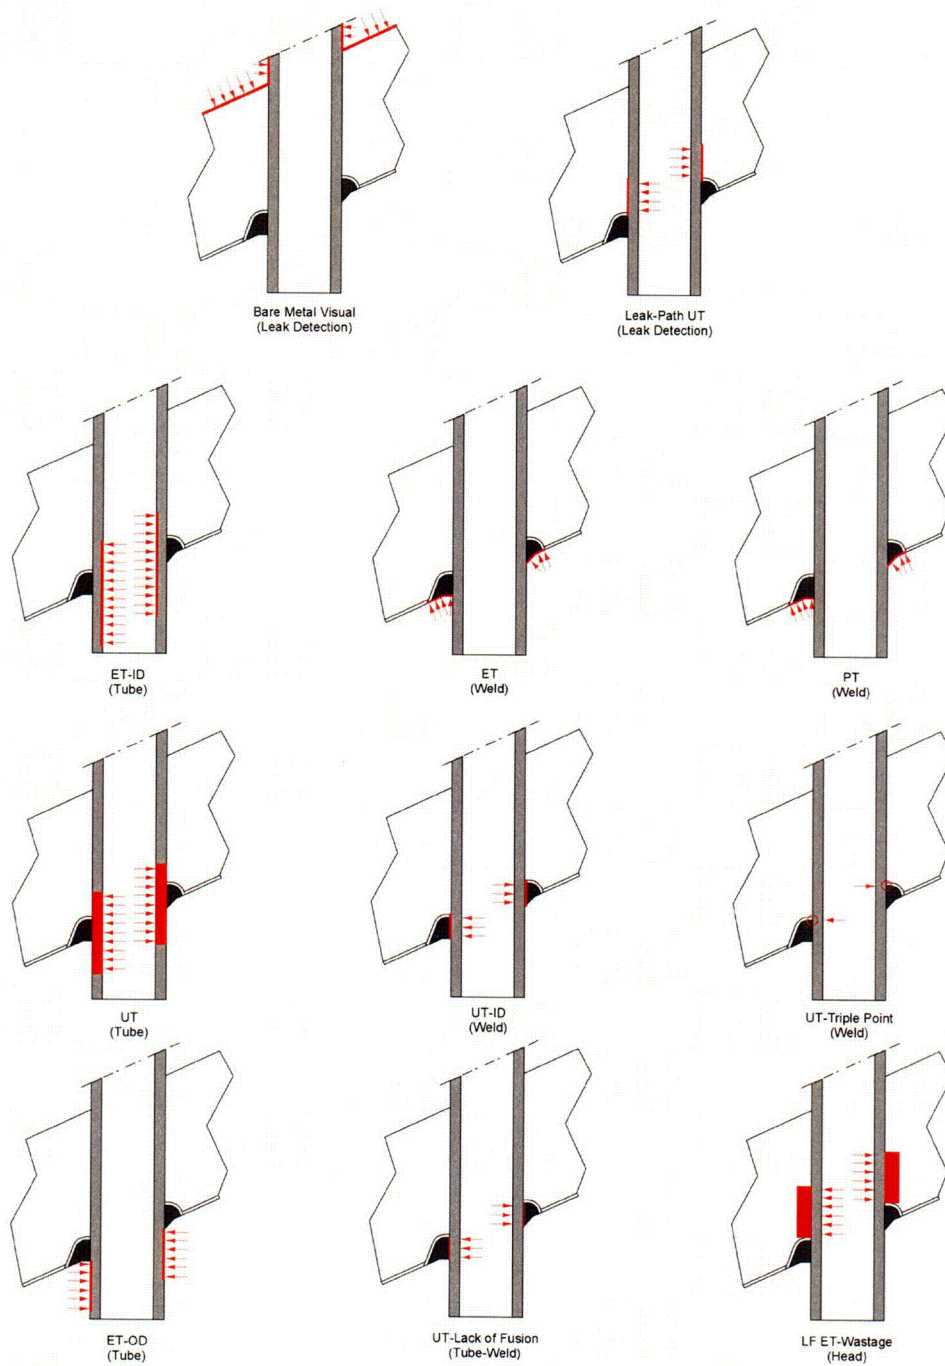
Figure 4  
Summary of RPV Head Nozzle Inspection Techniques

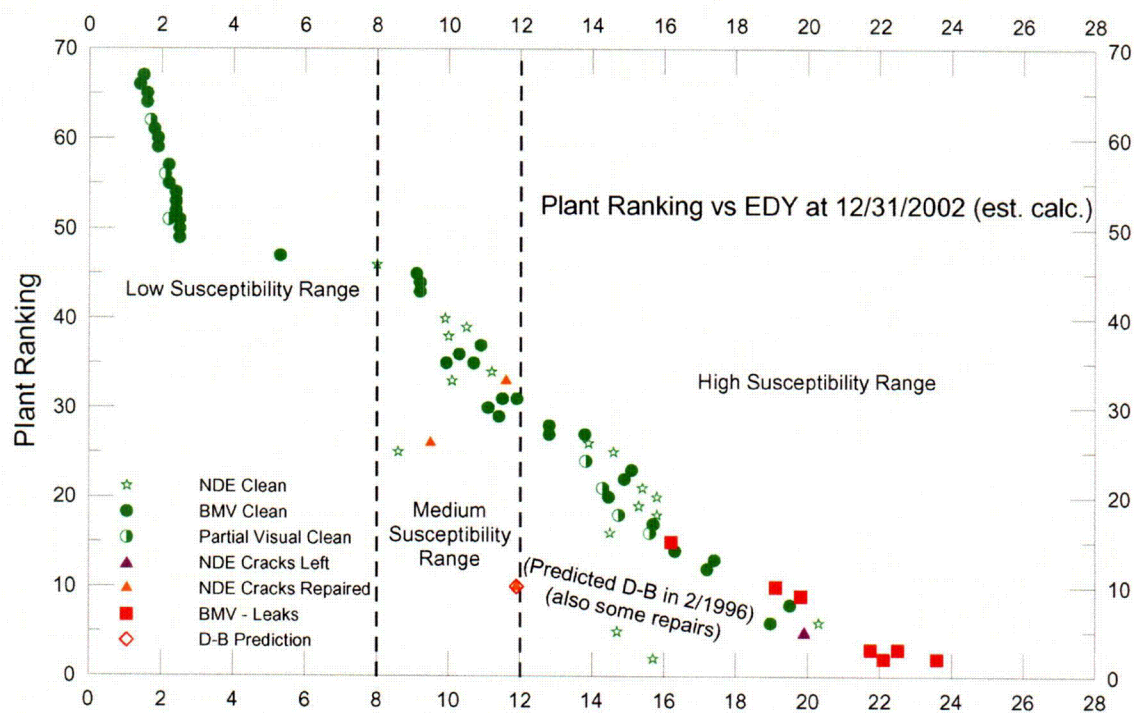
Figure 1. Ranking of domestic plants according to the EDY formula, showing results of inspections, evidence of leakage, and repairs. Many plants are shown with multiple symbols, indicating a "clean" inspection at inspection opportunity, followed by a different finding at a subsequent inspection (e.g., Oconee 2: clean NDE @ EDY=15.7, leaks and circ. flaws @ 22.1)

Figure 5  
NRC Chart for Tracking Inspection Results<sup>1</sup>

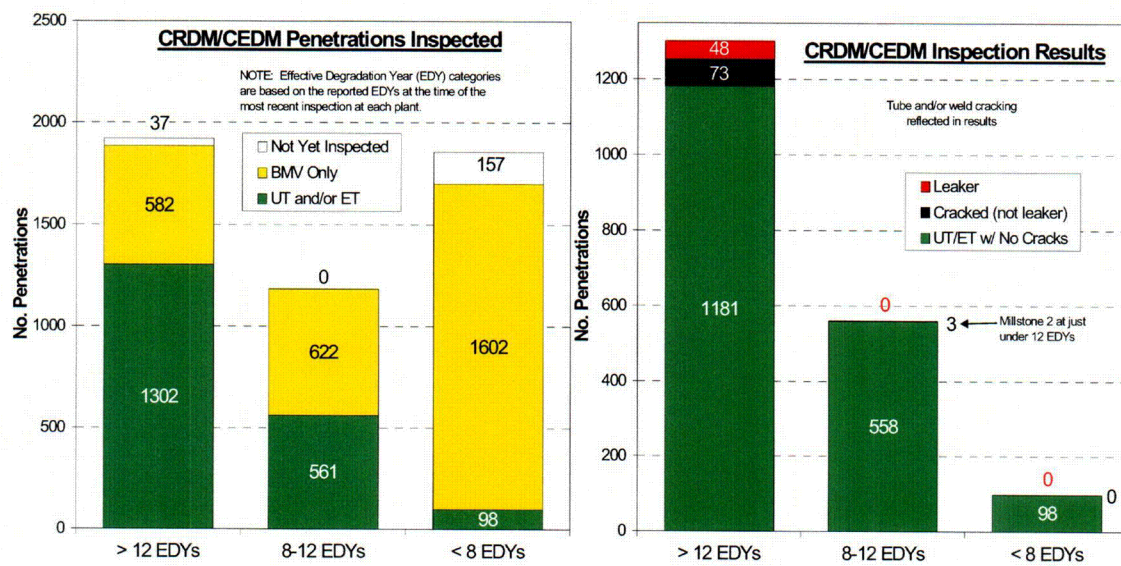
Figure 6  
RPV Head Inspection Statistics – by EDY Group

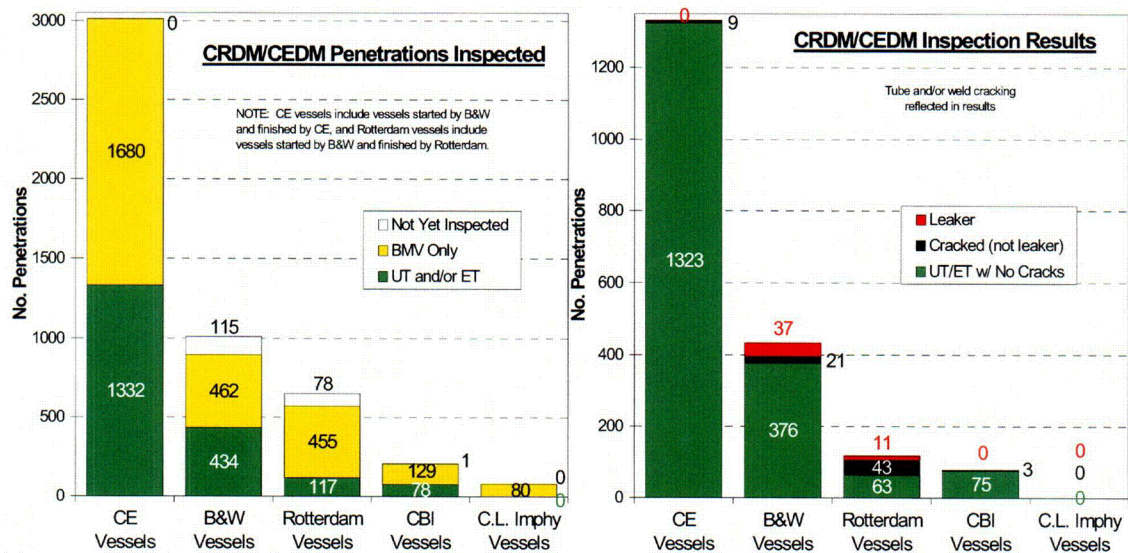
Figure 7  
RPV Head Inspection Statistics – by Head Fabricator (All EDYs)

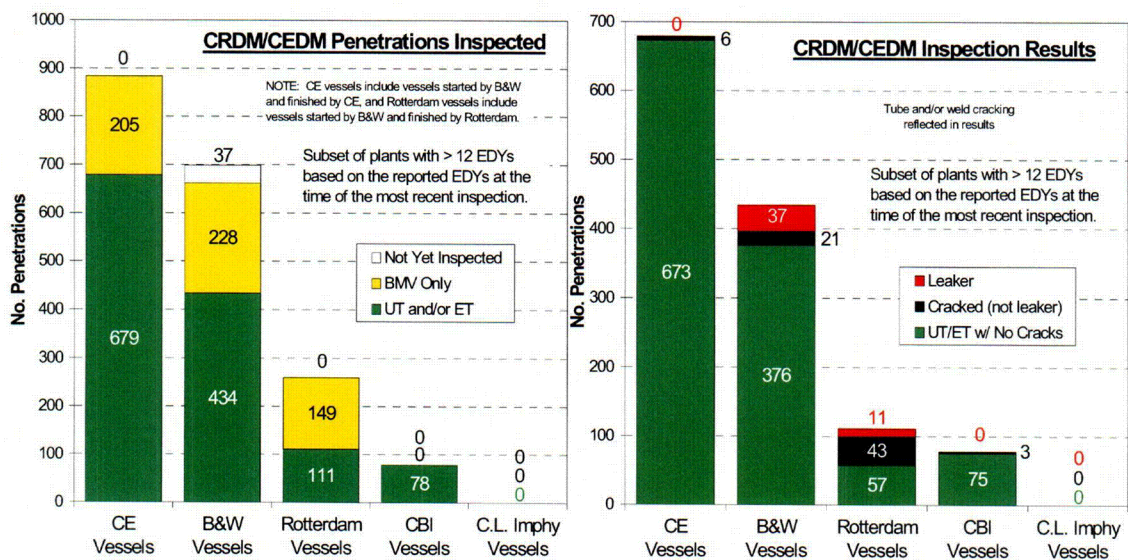
Figure 8  
RPV Head Inspection Statistics – by Head Fabricator (>12 EDYs)

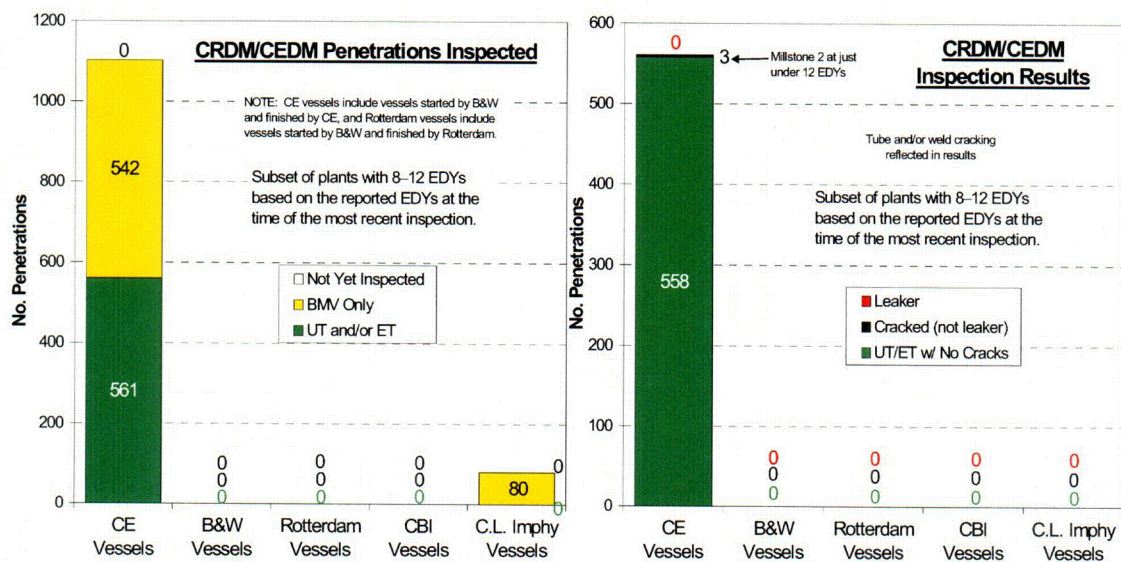
Figure 9  
RPV Head Inspection Statistics – by Head Fabricator (8-12 EDYs)

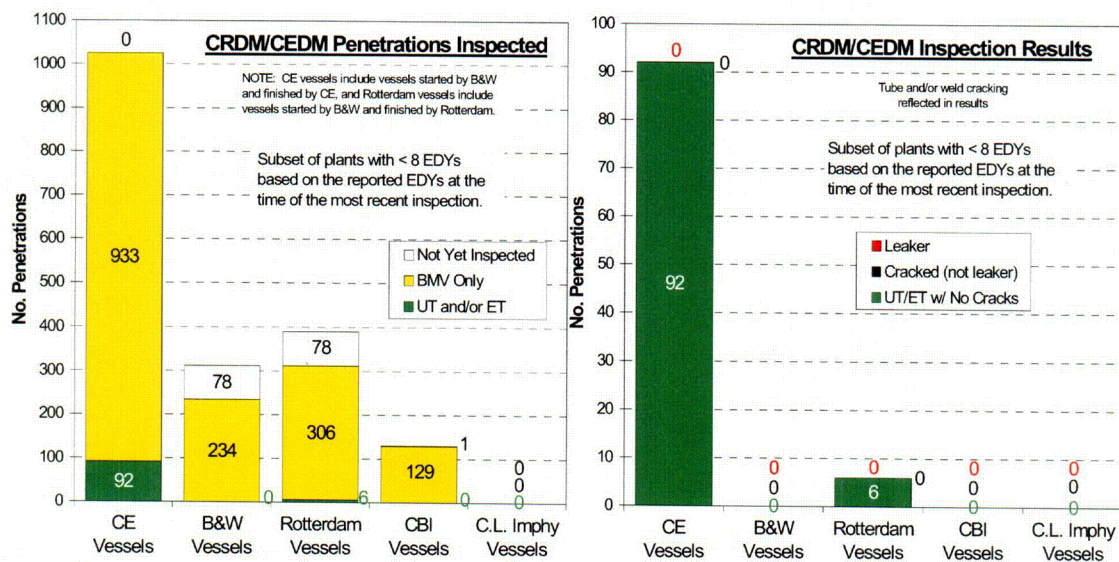
Figure 10  
RPV Head Inspection Statistics – by Head Fabricator (<8 EDYs)

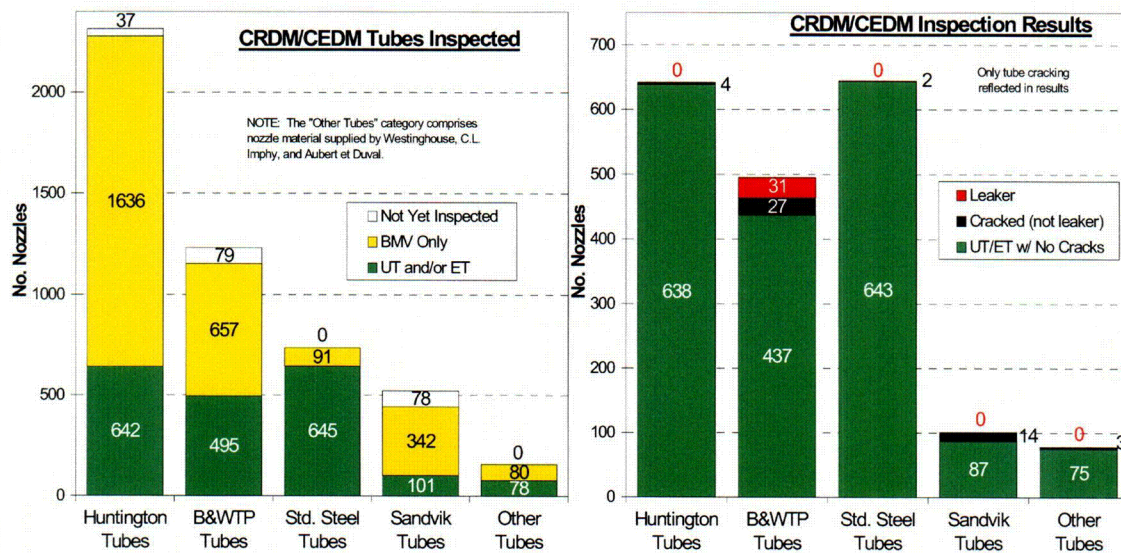
Figure 11  
RPV Head Inspection Statistics – by Nozzle Material Supplier (All EDYs)

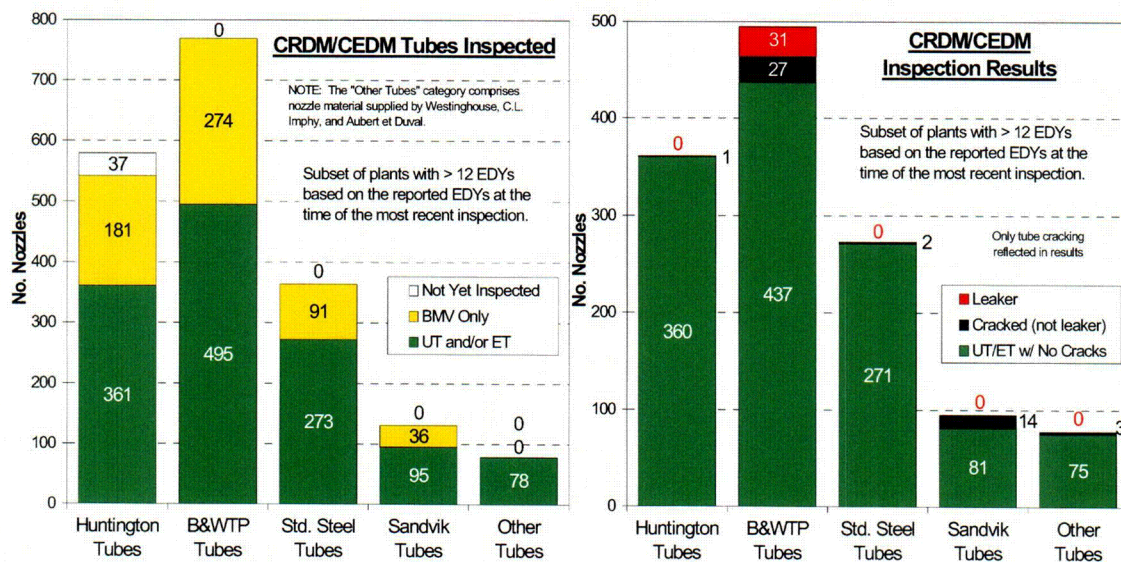
Figure 12  
RPV Head Inspection Statistics – by Nozzle Material Supplier (>12 EDYs)

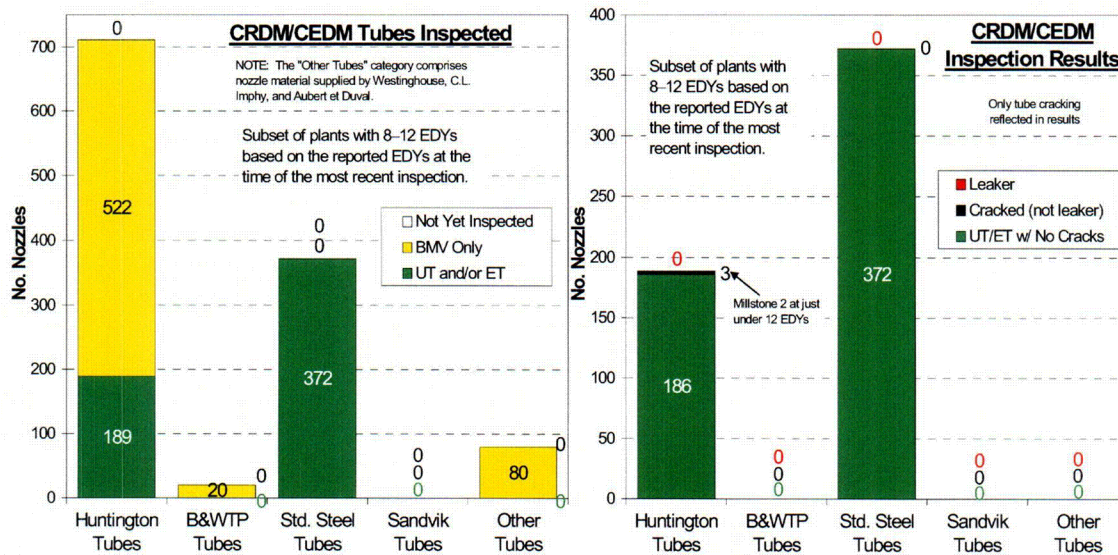
Figure 13  
RPV Head Inspection Statistics – by Nozzle Material Supplier (8-12 EDYs)

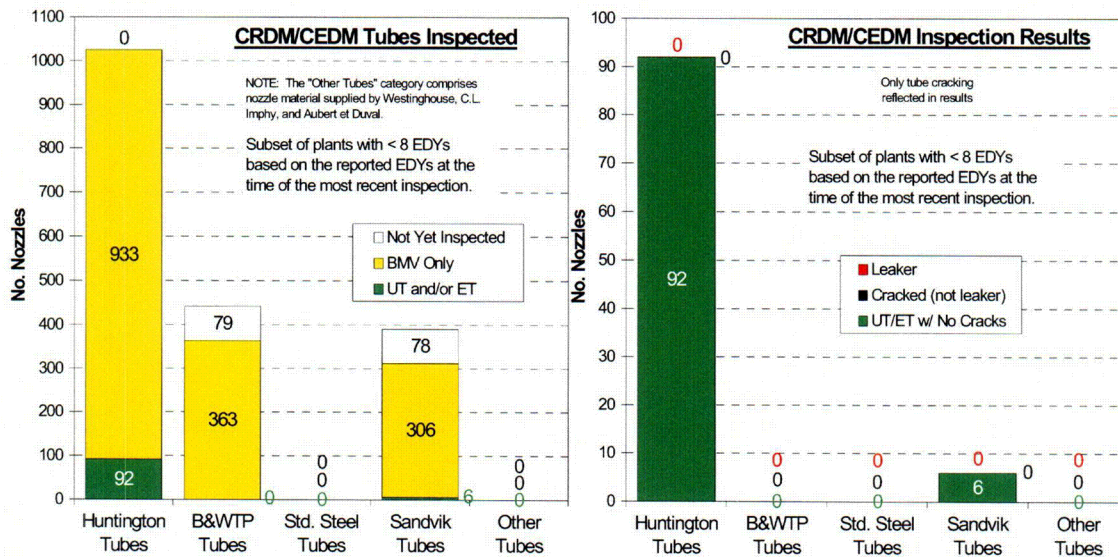
Figure 14  
RPV Head Inspection Statistics – by Nozzle Material Supplier (<8 EDYs)

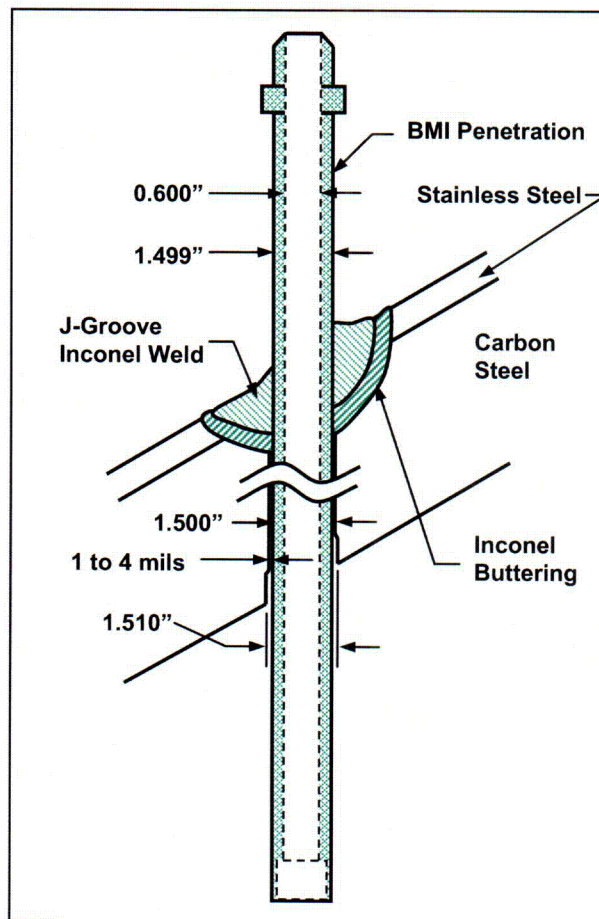
Figure 1: BMI general configuration

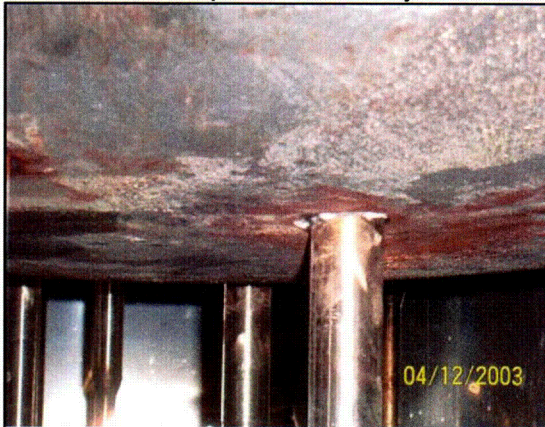
Figure 2: STP penetration 1

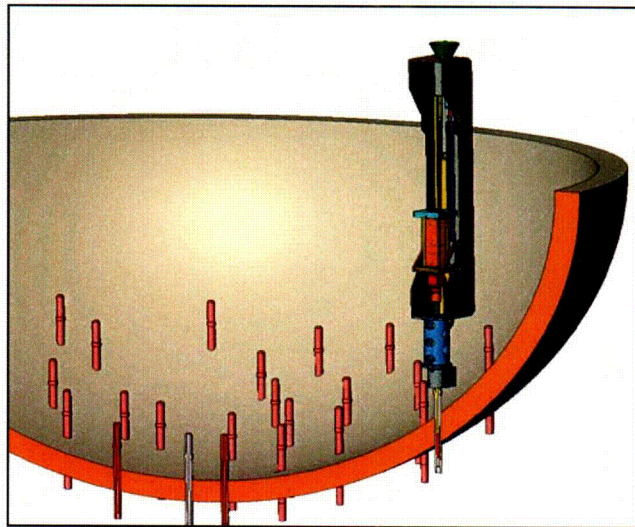
Figure 4: Representation of UT tool engaging with BMI penetrations

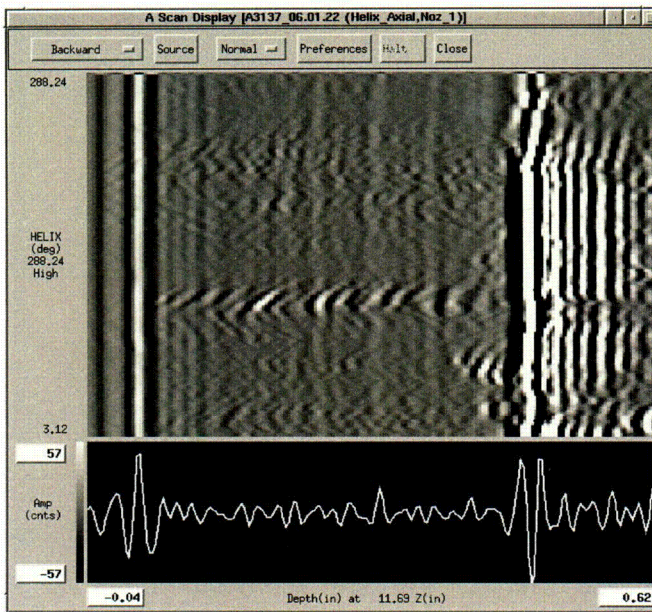
Figure 6: Penetration 1 axial probe with three axial indications and one full-penetration leak path

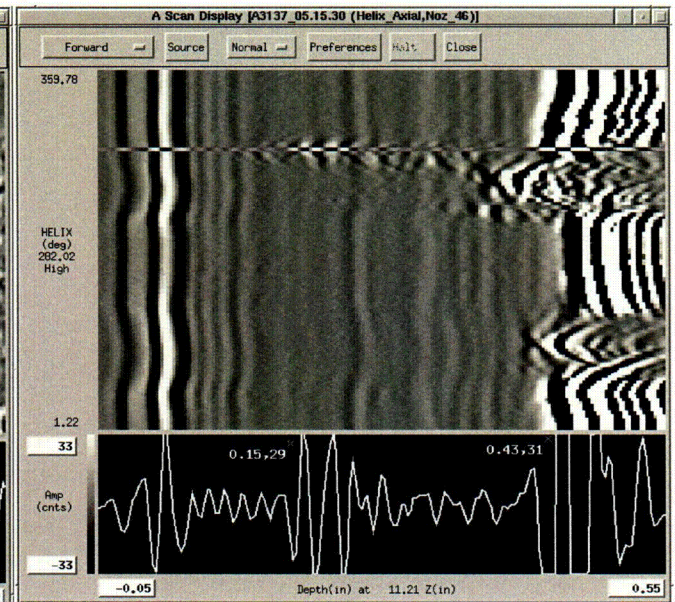
Figure 7: Penetration 46 with 2 axial indications and one leak path.

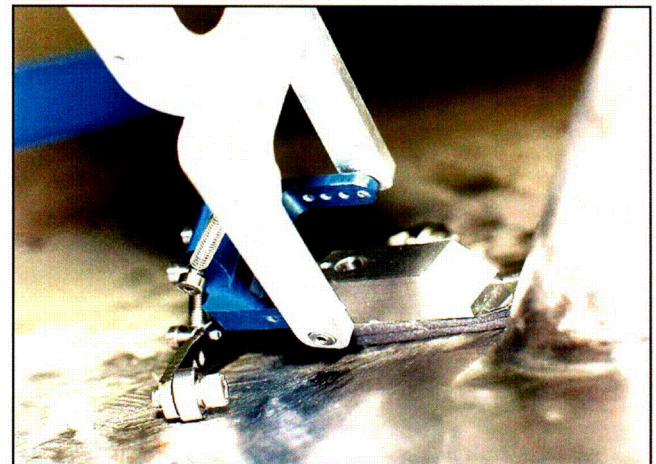
Figure 8: Compliant eddy current transducer pressed against shell and into weld fillet.

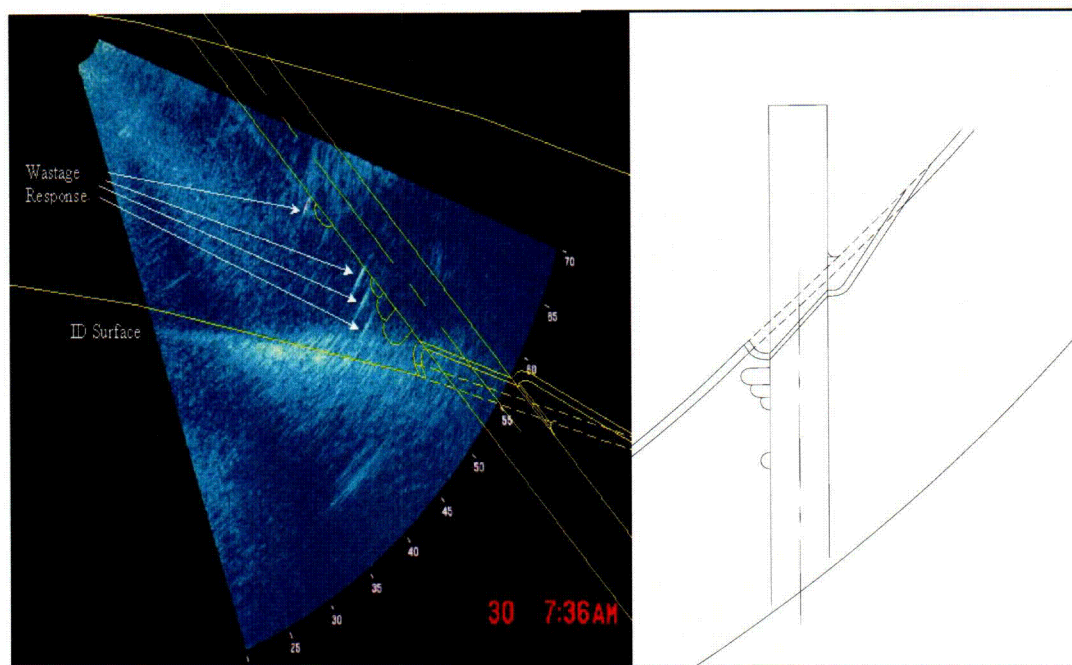
Figure 9: Phased array sector scan of shell volume calibration standard demonstrating sensitivity to wastage between surfaces.

One of the concerns with a boric acid leak was presence of wastage of the carbon steel material. Although difficult to understand how this can occur for the lower head configuration without being evident from the OD, Framatome ANP has observed limited wastage of the interior region of the upper head shell without significant wastage on either the ID or OD surface. A UT test was developed to examine the shell region where the penetration normally has no intimate contact with the shell. The technique uses a portable phased array instrument suitable for a manual scan of the shell area near the nozzle. The phased array transducer is manually moved radially around the penetration with the sector scan reflecting off the penetration bore. Any erosion or volumetric degradation is indicated as an enlarged void area between the tube and the shell bore. Sensitivity to this type of degradation was demonstrated with a calibration standard that included drilled holes (Figure 9).

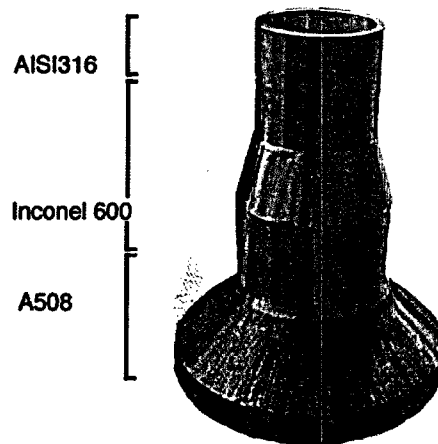
**Figure 1** Core spray nozzle mock-up with Inconel 600 safe-end.

This paper introduces flaw production to a full-size core spray nozzle, safe-end mock-up (BWR-type nuclear power plant). Figure 1 shows the nozzle consisting of three different materials: A508 carbon steel, Inconel 600 and AISI 316 type austenitic stainless steel. There is a buttering and a joint weld between the carbon steel (with cladding on the inner surface) and Inconel 600 safe-end, and a butt weld between Inconel 600 safe-end and AISI 316 austenitic stainless steel pipe. Both welds were made with Inconel 182 filler material with Inconel 82 root pass. After welding the working allowances were machined away. The finishing machining removed the root pass so, that the welds of the ready-made mock-up are Inconel 182.

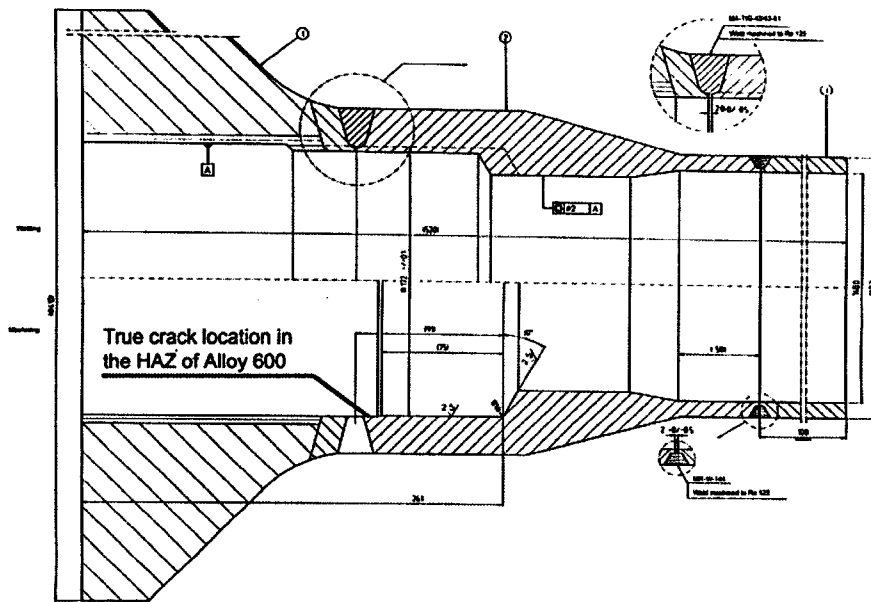
**Figure 2** Drawing of the core spray nozzle and location of the produced crack in Inconel 600 safe-end in the heat affected zone of the buttering weld.

Figure 2 shows the drawing of the nozzle mock-up and the intended location of the flaw production. The intended location is in Inconel 600 in the HAZ of the buttering weld. The wall thickness of the Inconel 600 safe-end in the intended location is 23 mm. Nozzle was received as ready-made and no machining or welding was allowed. Flaw was to be produced to the inner surface in as-received condition of the nozzle. The specimen was nondestructively tested after flaw production and no destructive tests were performed.

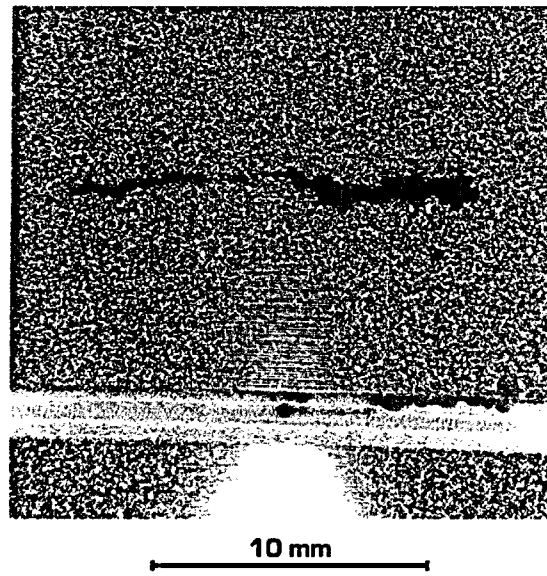
**Figure 4** Dye penetrant indication of the produced realistic crack in Inconel 600 safe-end in the heat affected zone of the buttering weld.

A realistic crack was produced in the inner surface of the nozzle. Figure 4 shows the dye penetrant indication of the produced single crack in Inconel 600 safe-end in the heat affected zone of the buttering weld. The weld is located in the upper part and Inconel 600 base material in the lower part of the figure. The length of the crack is 14.2 mm and the depth is 5 mm, thus being about 22% through the wall. The maximum surface opening of the crack varies locally between 30 – 45  $\mu\text{m}$ . In the figure, there is also a very small (less than 1 mm deep) secondary indication in the corner of the shoulder visible in the lower part of the figure. The initiation of the secondary crack was caused by the stress rising effect of the shoulder. Without vicinity of such a stress riser, there would have been no secondary cracking. The secondary indication does not affect the performance of ultrasonic testing as it is located about 7 mm away from the actual crack.

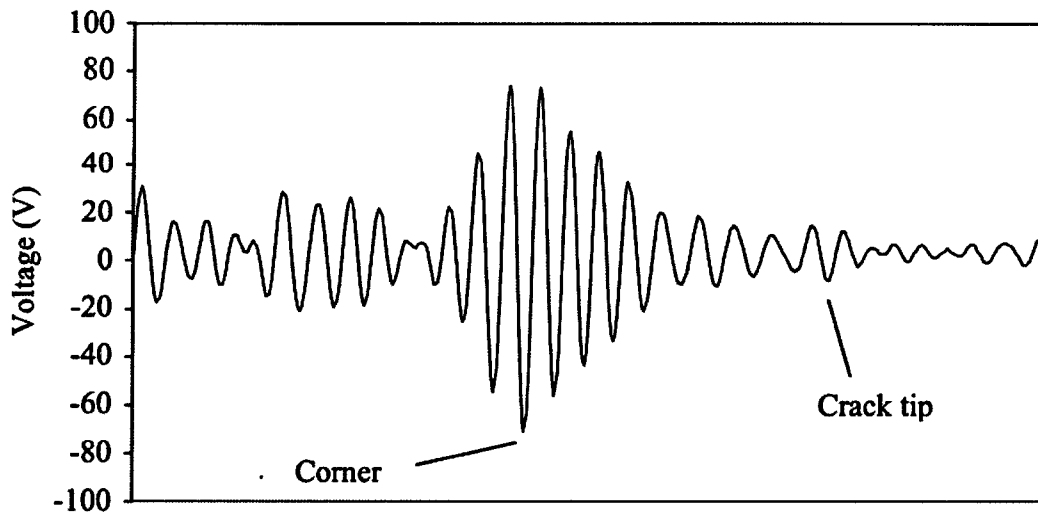
**Figure 5** A-scan obtained from the crack at room temperature (41°, 1.5 MHz, shear wave probe).

The size of the crack was controlled by process control during the production and confirmed by ultrasonic testing. The obtained signal from the crack at room temperature is shown in Figure 5. The reflections from crack opening corner and subsurface parts of the crack are visible in the figure. The ultrasonic inspection sized the crack to be 18 mm long and 6 mm deep. The measured length by ultrasonic testing is clearly bigger than the actual value as seen from Figure 4. Also the measured depth differs from the given process value, but it lies inside the production tolerances ( $\pm 1$  mm).

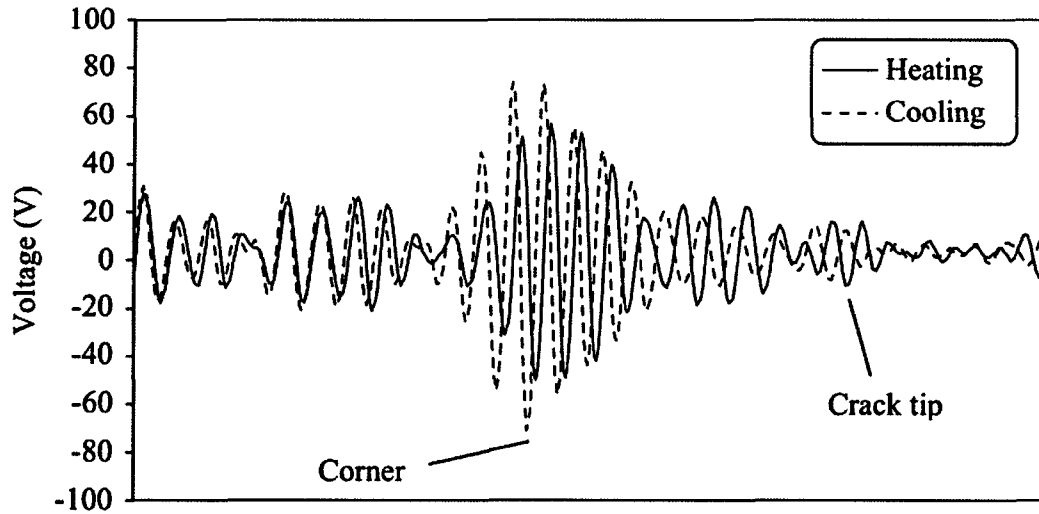
**Figure 6** A-scans from the crack in the end of cooling and in the end of heating of thermal fatigue loading cycle. Differences in ultrasonic response are related to the crack opening and closing behaviour.

The studies of ultrasonic response versus dynamical thermal loading resulted in a large amount of ultrasonic data. Figure 6 shows the ultrasonic signal obtained from the crack in the end of cooling and heating phases of cycle B2. The figure clearly shows the differences between different crack opening states. Results shown in the figure have been obtained in the turning points of surface temperature cycles.

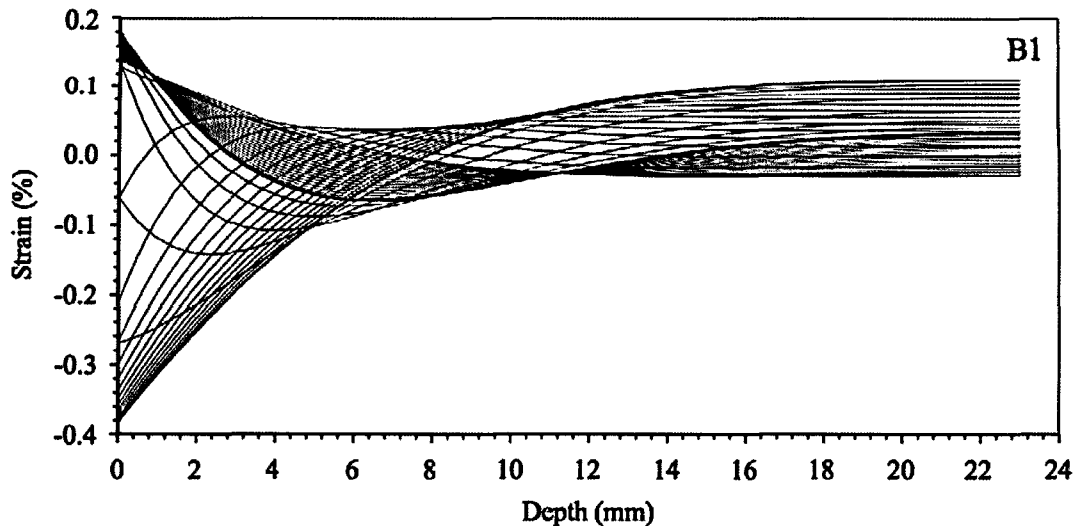
**Figure 7** Strain distribution for loading cycle B1. Nozzle ID on the left and OD on the right side of the figure.

Results of finite element modeling gave temperature and strain distributions through the wall thickness. Figures 7 and 8 show solved strain distributions for analysed cycles B1 and B2, respectively. Nozzle ID is in the left side and OD on the right side of both figures. The results clearly show the difference between the faster and slower loading rates.

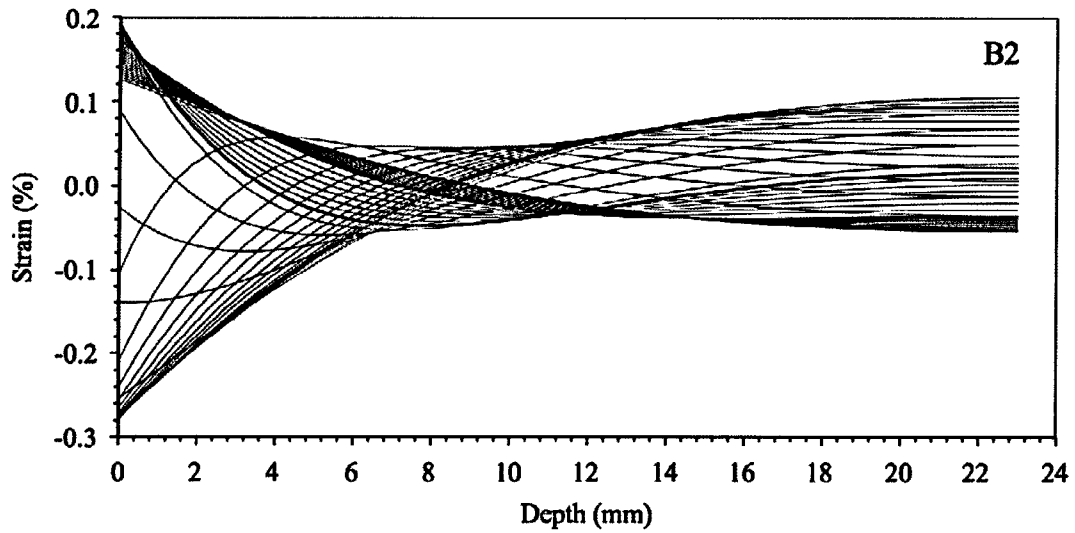
**Figure 8** Strain distribution for loading cycle B2. Nozzle ID on the left and OD on the right side of the figure.

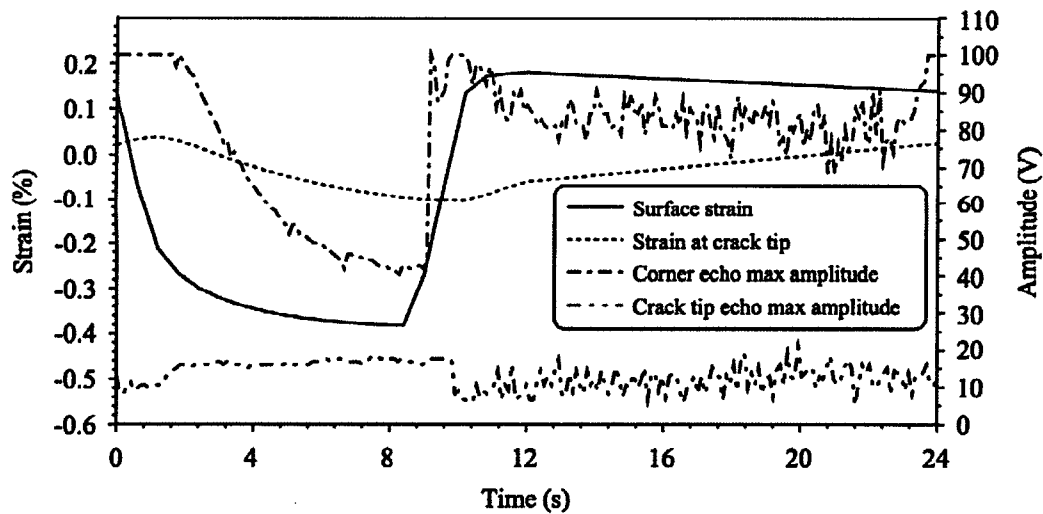
**Figure 9** Combined results of strain and ultrasonic amplitude variations from crack corner and tip caused by loading cycle B1.

The obtained ultrasonic signal amplitudes from corner reflection and crack tip varied during the loading. These variations are related to the opening behaviour of the different parts of the crack. Figures 9 and 10 show the combined results of strain variations from modeling and measured changes of ultrasonic amplitudes from corner reflection and crack tip for cycles B1 and B2, respectively.

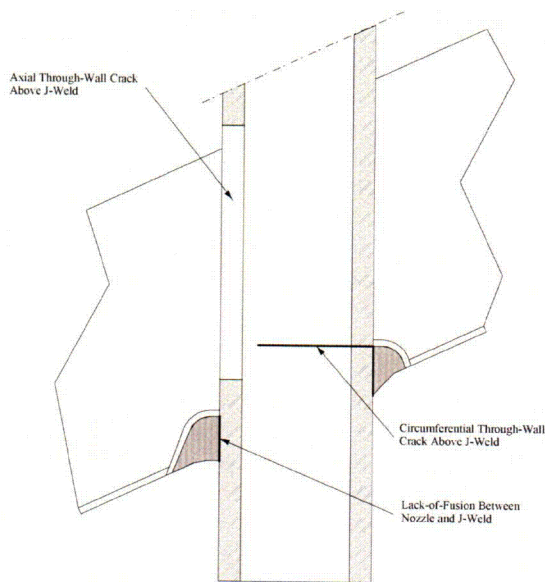
Figure 1  
Tolerance to Axial and Circumferential Cracks

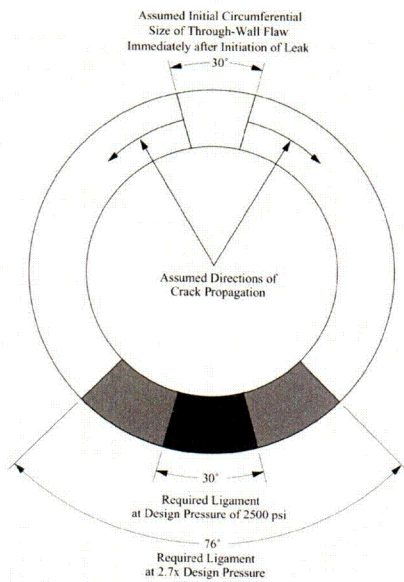
**Typical Critical Flaw Size of 330°**

Figure 3  
Crack Growth Around Nozzle Circumference

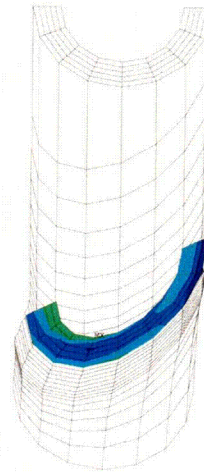
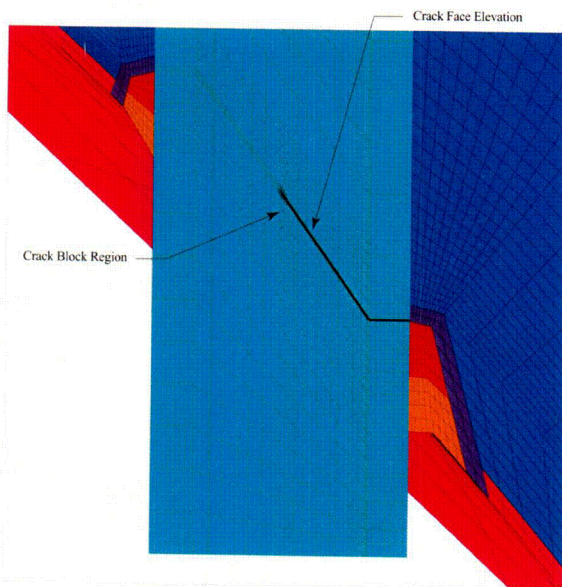
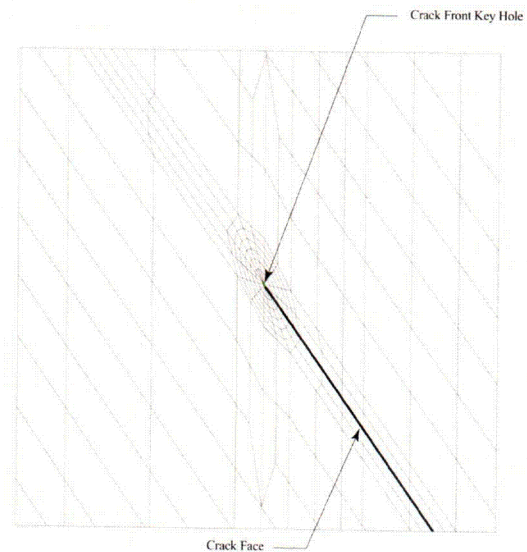
**180° Downhill-Centered Crack**

**Crack Mesh Detail**

Figure 4  
Example Fracture Mechanics Model for Nozzle Circumferential Cracks

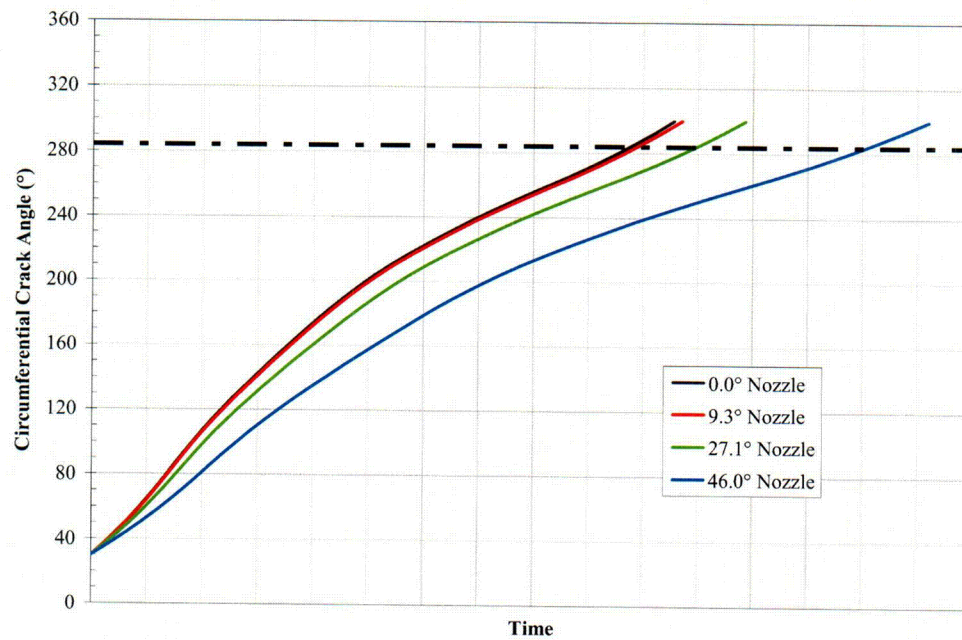
Figure 5  
Example Results for Growth of Circumferential Through-Wall Cracks
