# **Proceedings of the Conference on Vessel Penetration Inspection, Crack Growth and Repair**

**Held at  
Gaithersburg Marriott at Washington Center  
Gaithersburg, MD  
September 29 – October 2, 2003**

**U.S. Nuclear Regulatory Commission  
Office of Nuclear Regulatory Research  
Washington, DC 20555-0001**

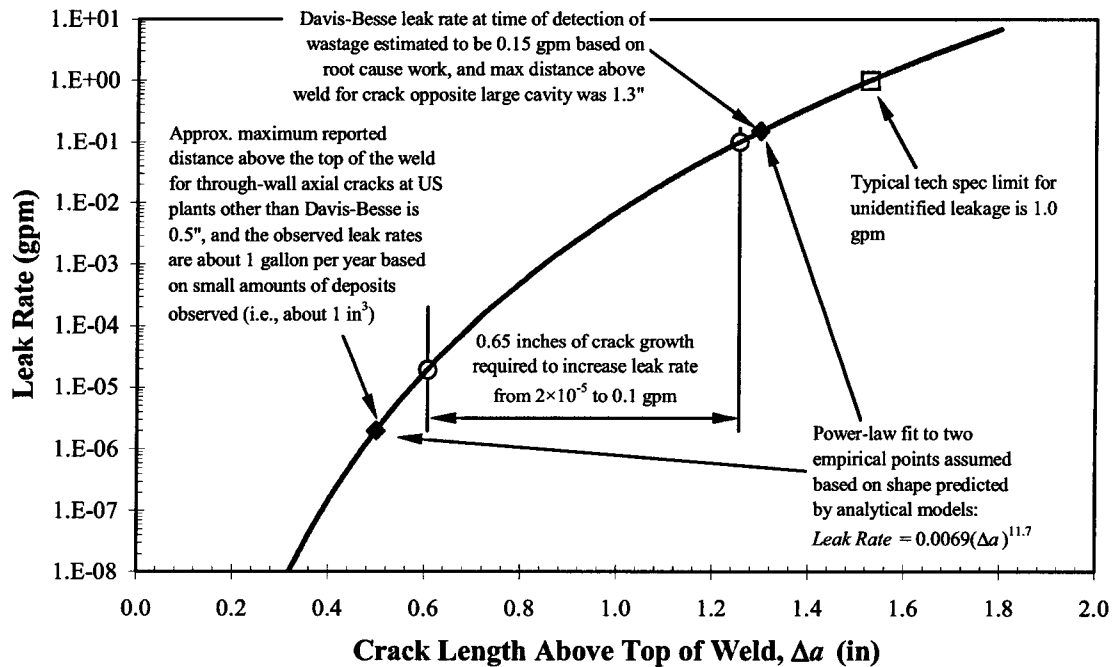
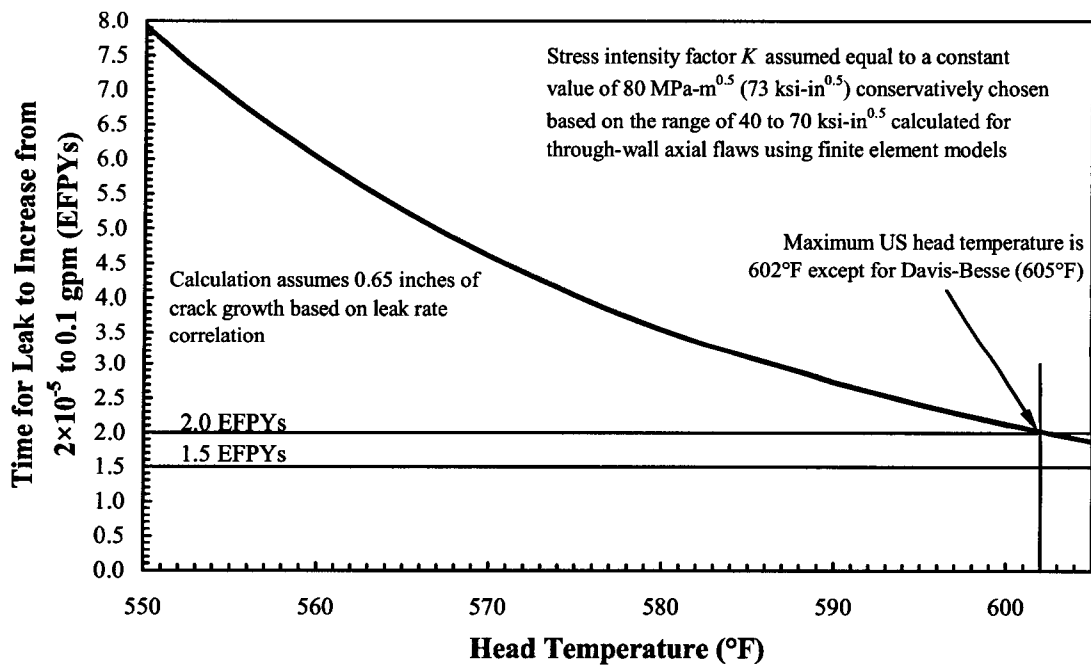
Figure 6  
 Deterministic Model for Boric Acid Wastage

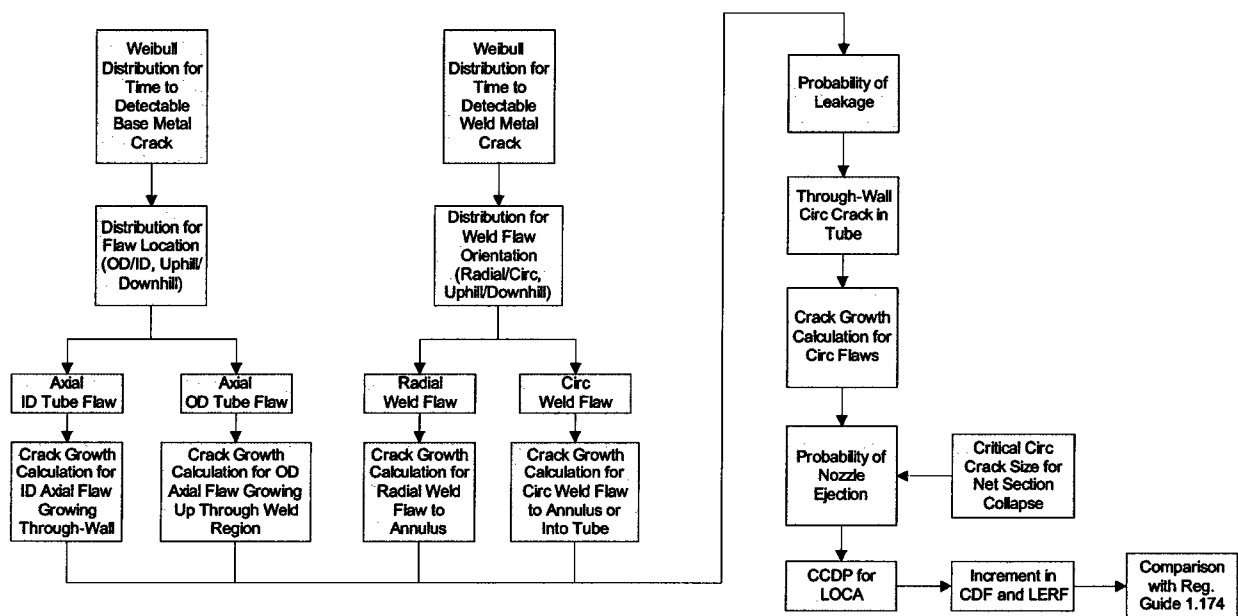
Figure 7  
Simplified Flowchart of Monte Carlo Risk Assessment Model

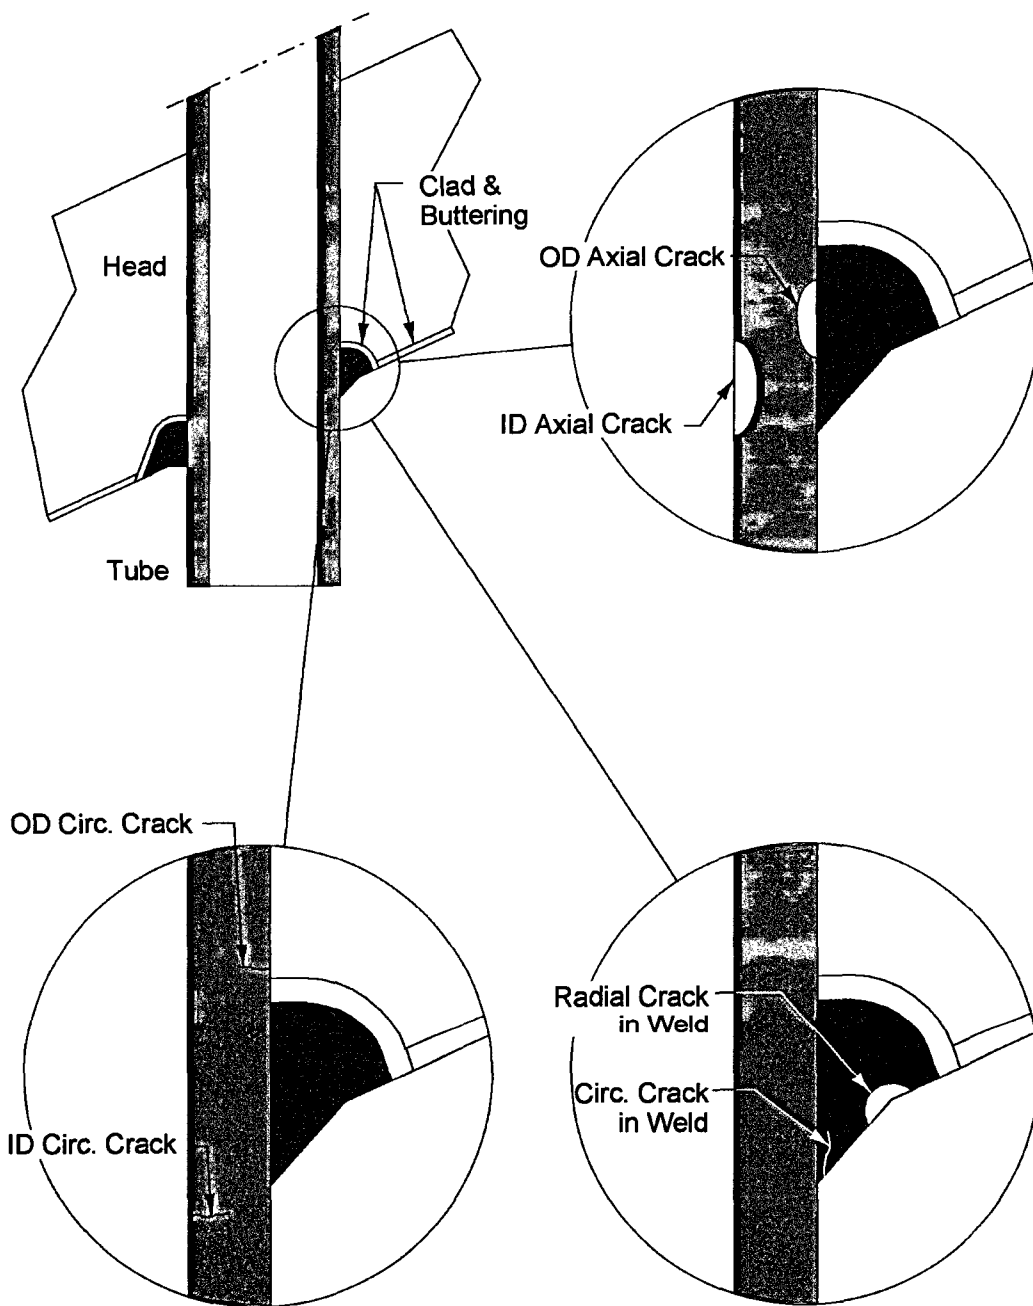
Figure 8  
Modeled Flaw Geometries

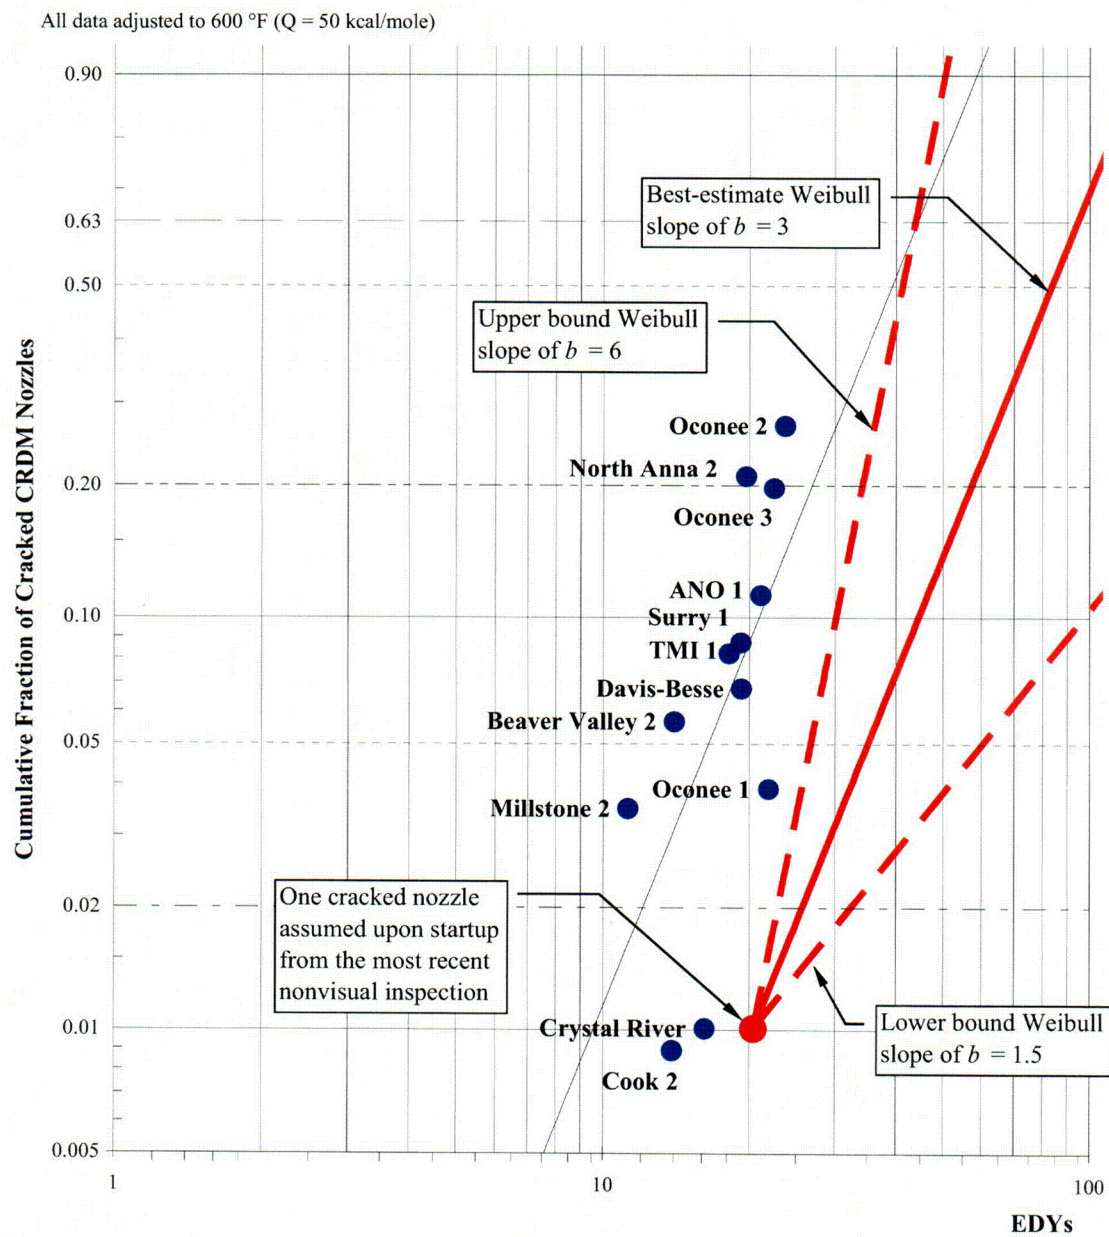
Figure 9  
Weibull Statistical Model for Crack Initiation

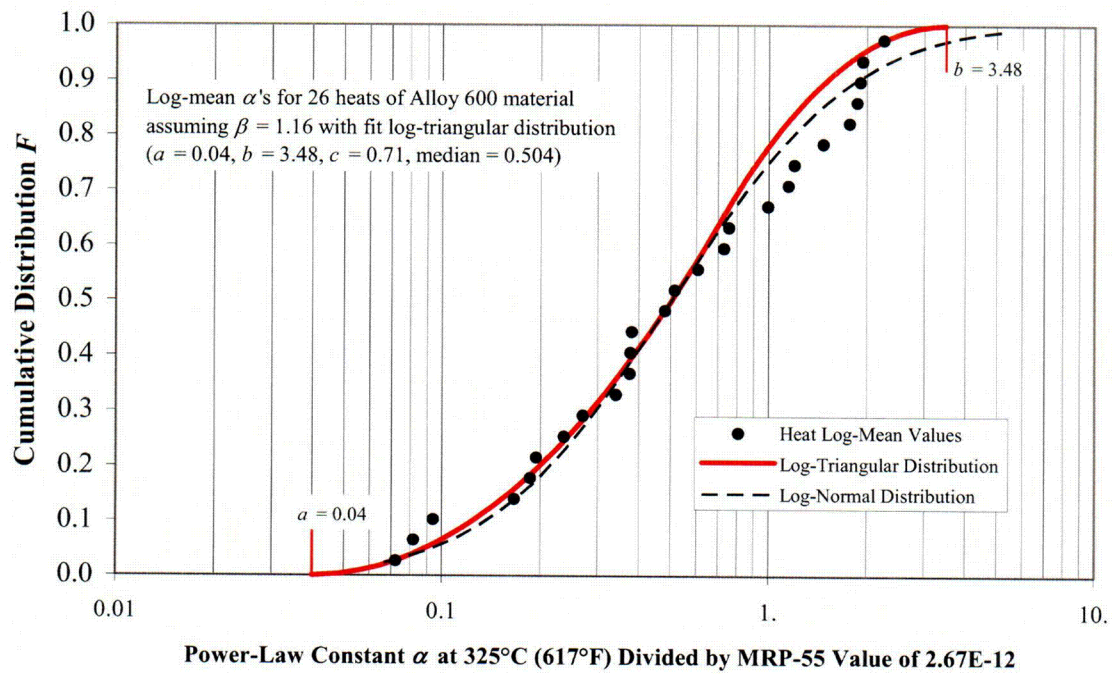
Figure 10  
Crack Growth Rate for Alloy 600 Base Metal (MRP-55)

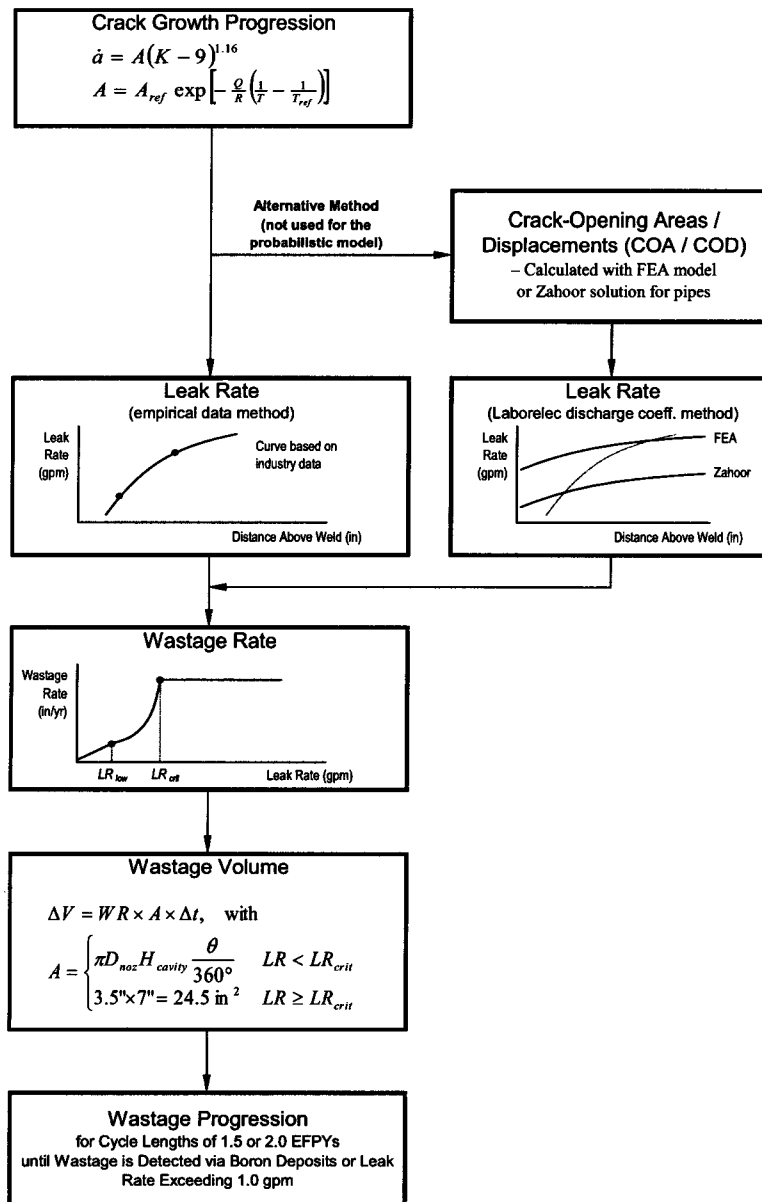
Figure 11  
Probabilistic Model for Boric Acid Wastage (MRP-75)

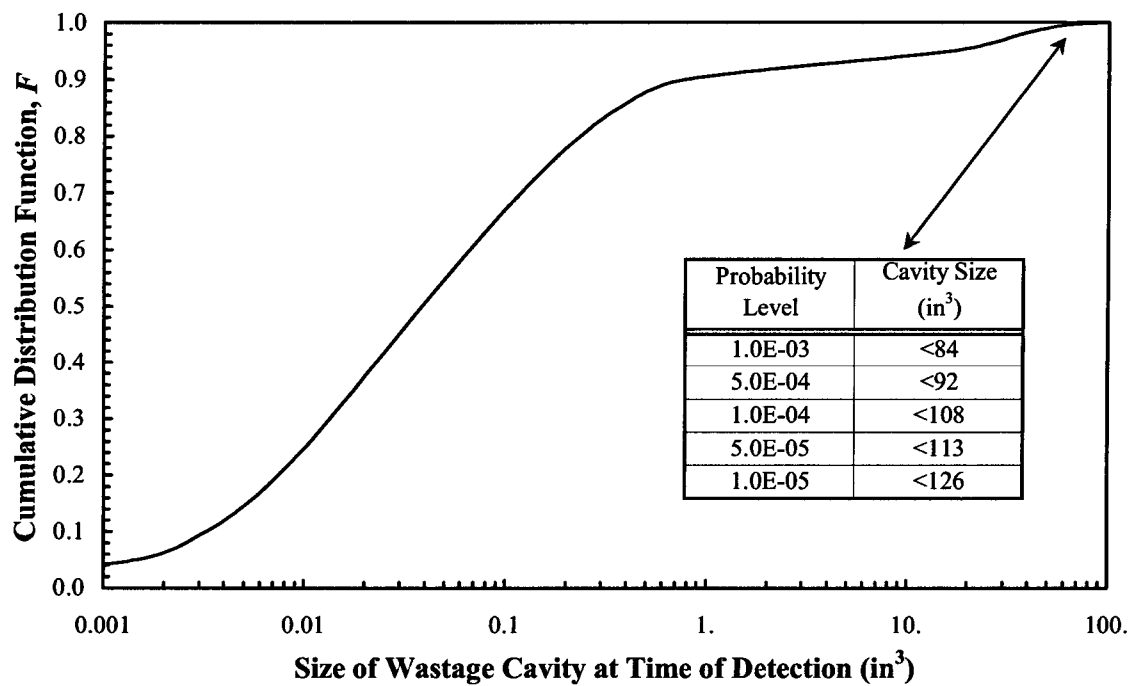
Figure 12  
Typical Results of Probabilistic Wastage Analysis for a Single Leaking Nozzle (Assuming Bare Metal Visual Inspections are Performed During Each Refueling Outage)

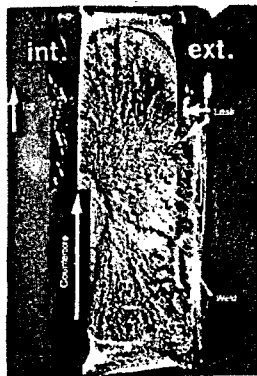
Fig. 1: TWE crack in T54 VH penetration

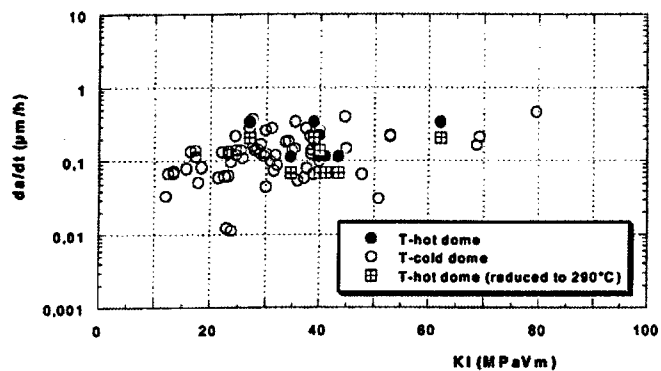
Fig 2 : Field data - T-hot dome data (300°C) reduced to 290°C with  $Q = 130$  KJ/mol and T-cold dome data (290°C)

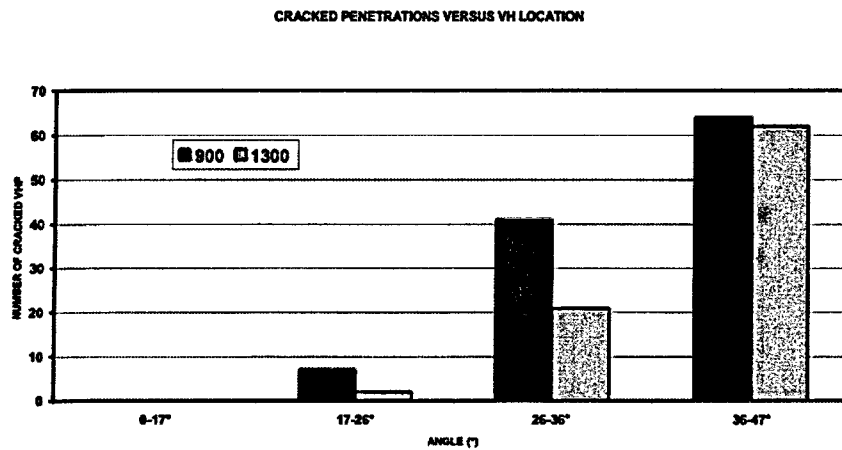
Fig. 5 : Importance of the "angle effect" versus VH penetrations cracking

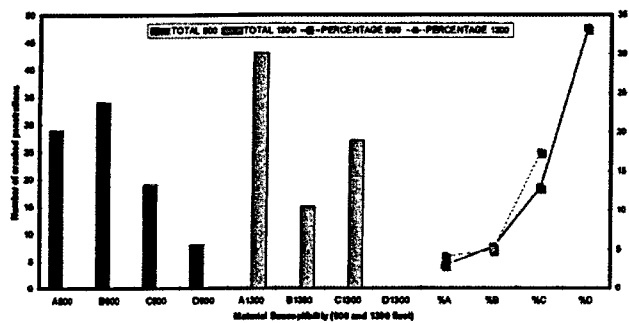
Fig 6 : Importance of the material susceptibility versus VH penetrations cracking (percentage values are given versus the total number of penetrations in standardized plant series 900 or 1300)

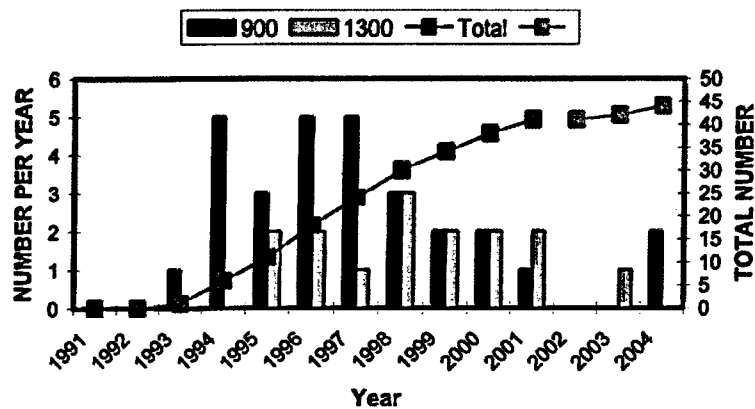
Fig. 7 : Vessel head replacement since 1993

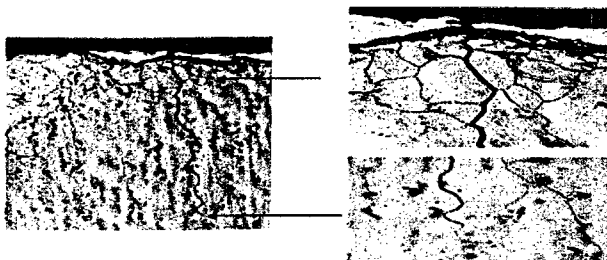
**Fig. 8 : Expertise from a removed part of a  
hammered steam generator channel.**

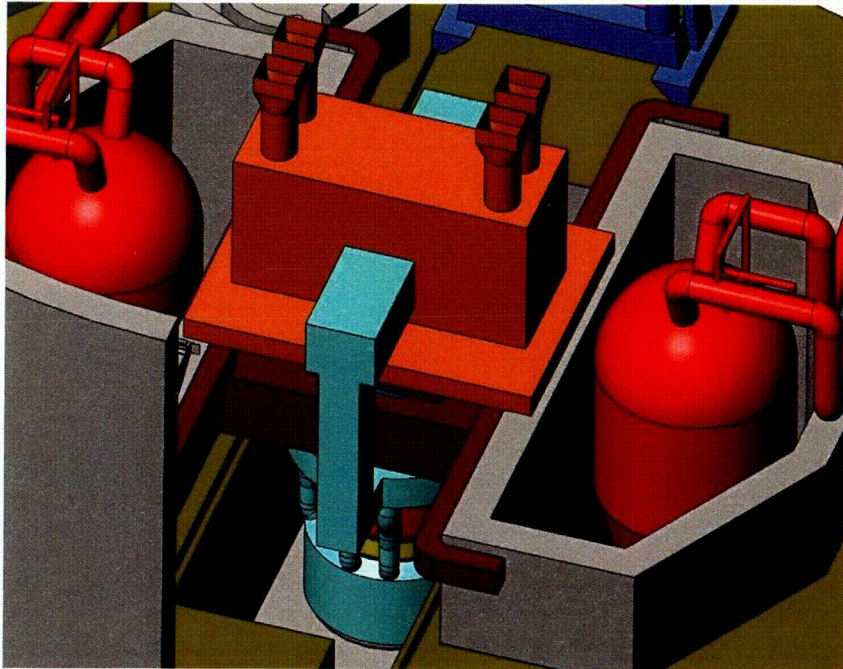
Typical Original Structure

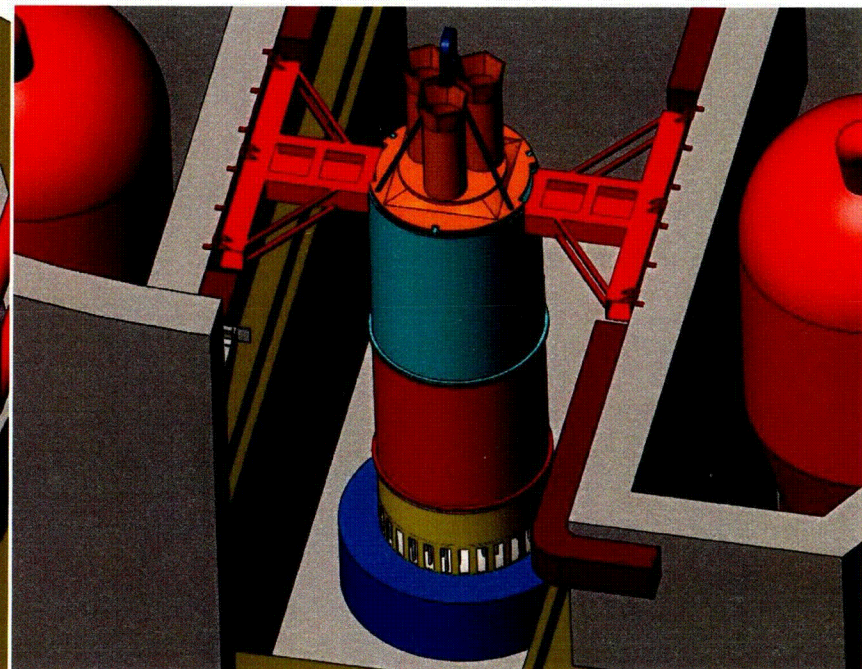
Conceptual Integrated Structure

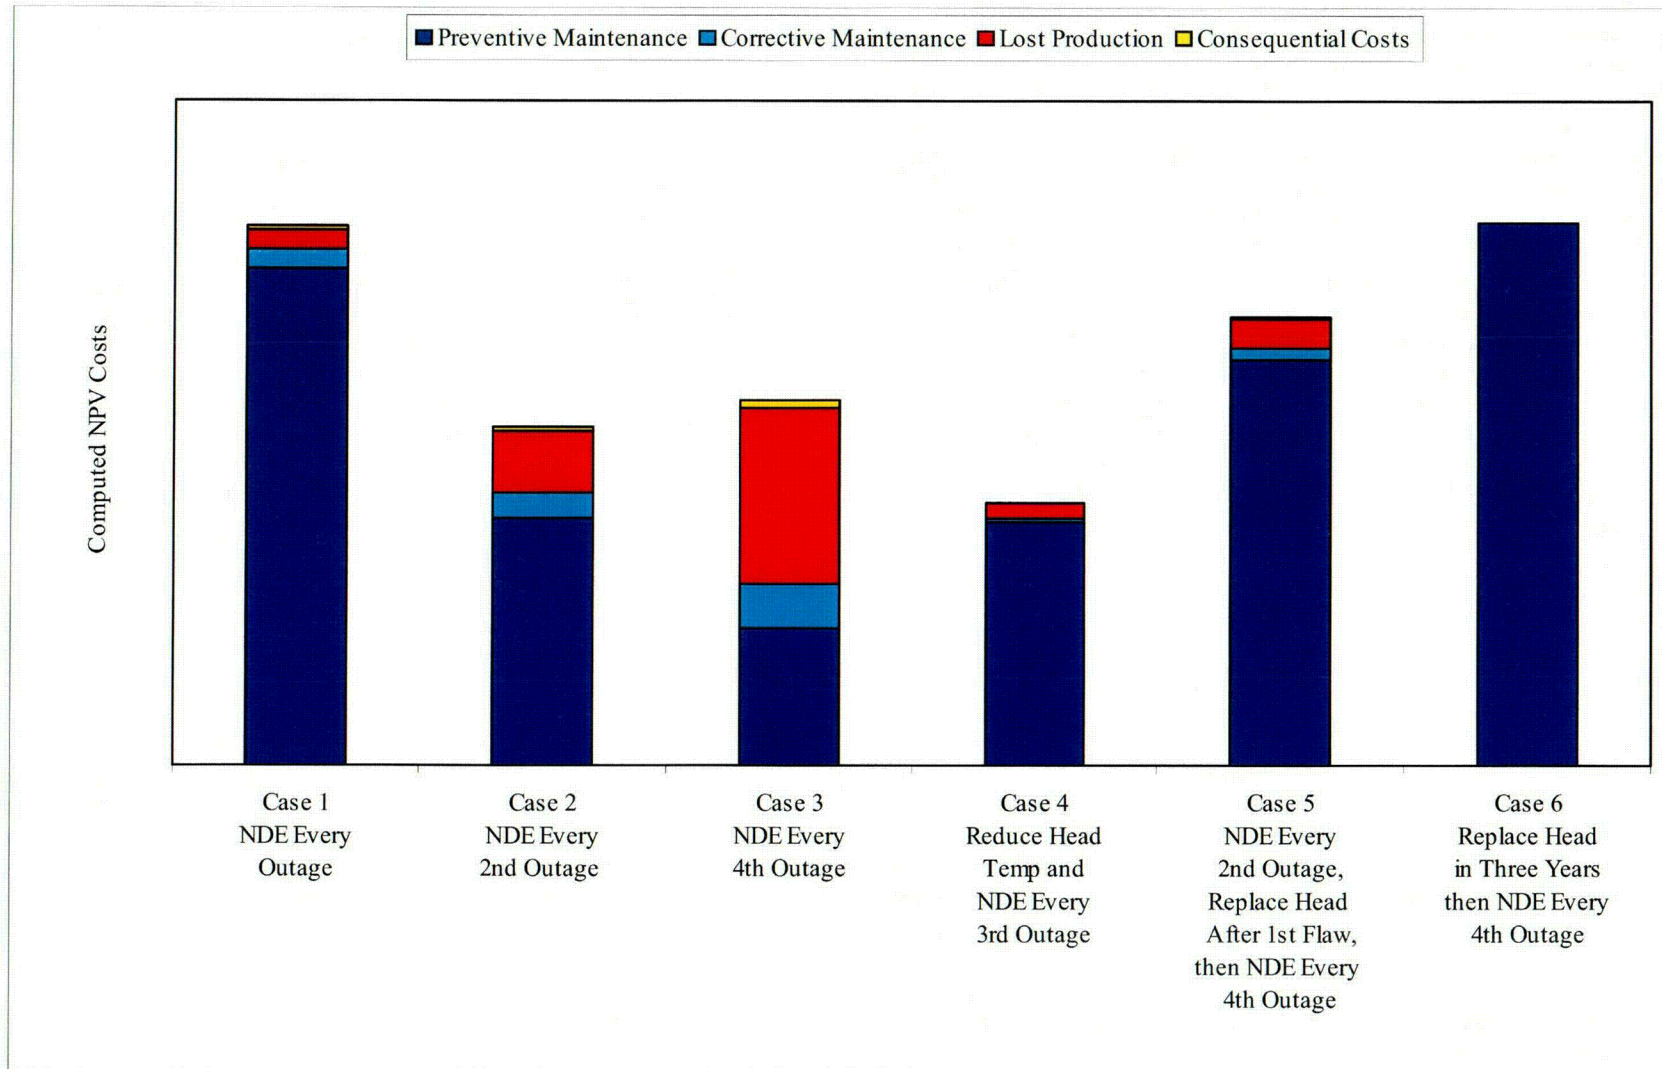
Figure 2  
Typical Strategic Planning Results for Moderate Susceptibility Plant With No PWSCC

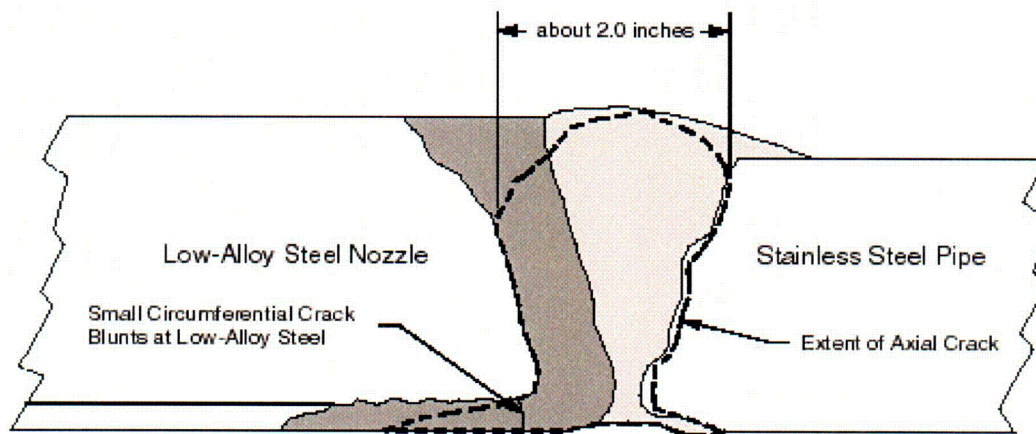
Figure 1  
Locations of Cracks in VC Summer Hot Leg Outlet Nozzle Weld

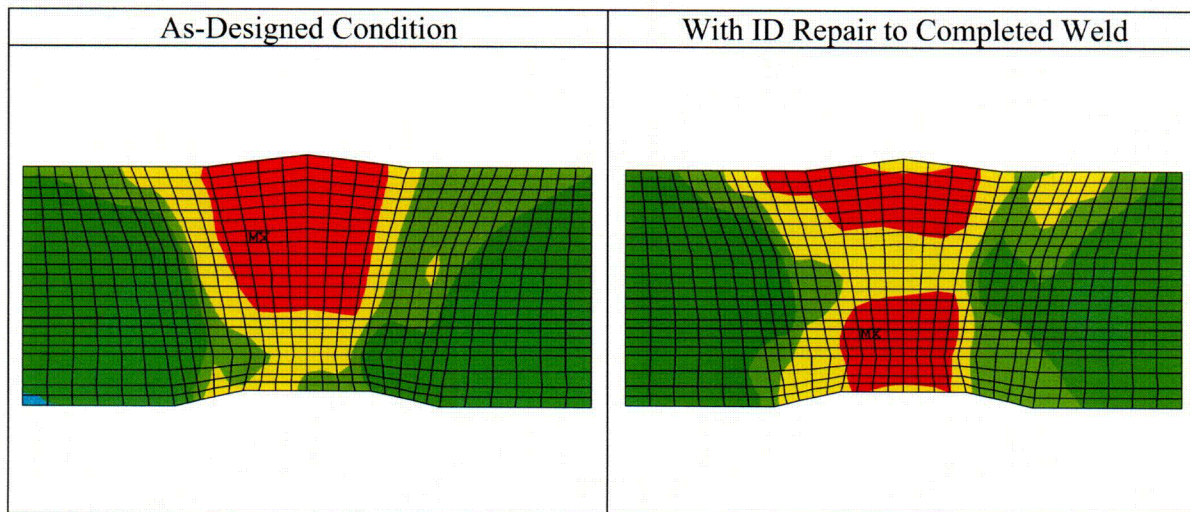
Figure 2  
Effect of ID Weld Repairs on Butt Weld Operating Hoop Stress

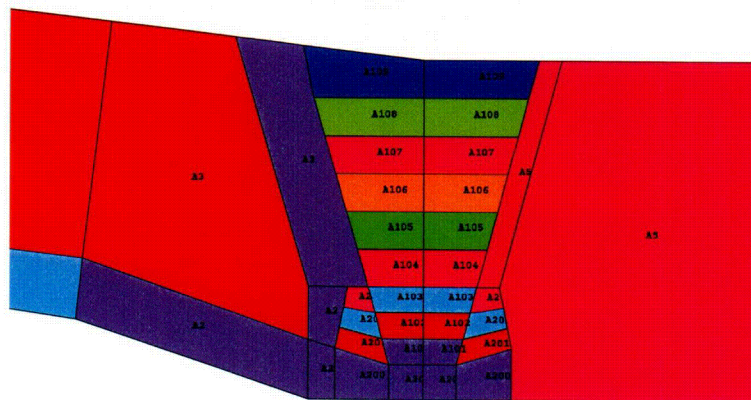
Figure 7  
Pressurizer Surge Nozzle – Weld Passes Modeled

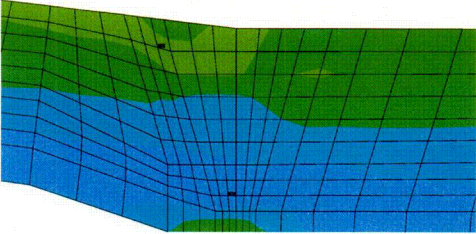
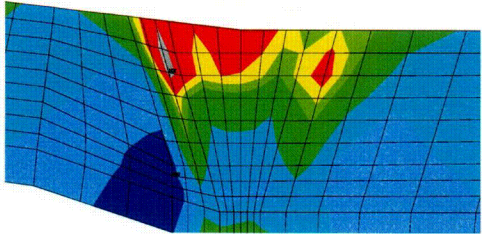
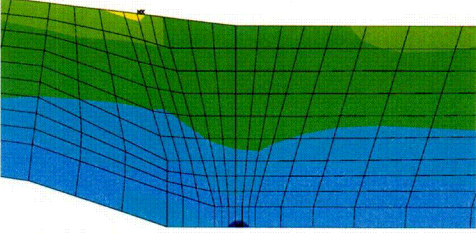
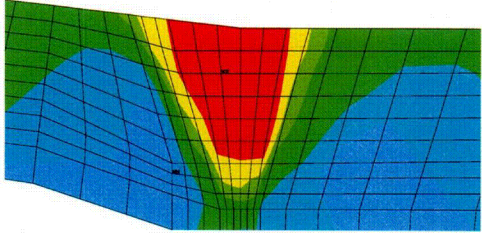
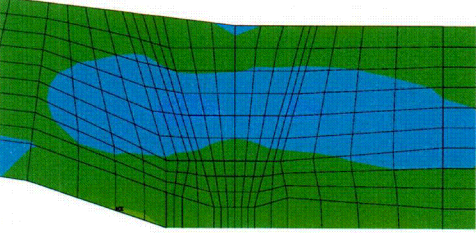
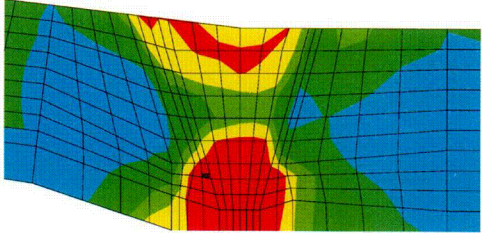
Figure 8  
Welding Residual and Operating Stresses With and Without 360° ID Weld Repair

| Condition | Axial Stress | Hoop Stress |
|---|---|---|
| Welding Residual and Operating Stresses – As Designed | <br>-2.7 ksi Max ID Stress | <br>9.0 ksi Max ID Stress |
| Welding Residual and Operating Stresses – With 360° ID Repair | <br>32.5 ksi Max ID Stress | <br>52.8 ksi Max ID Stress |

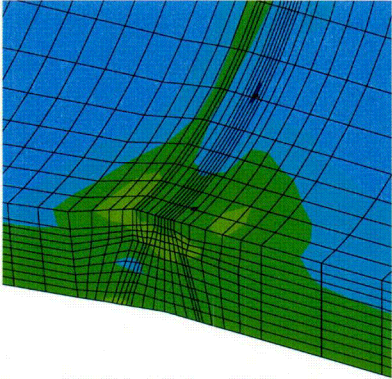
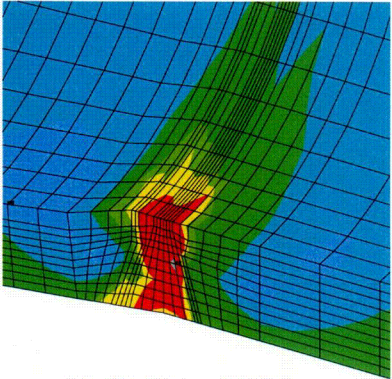
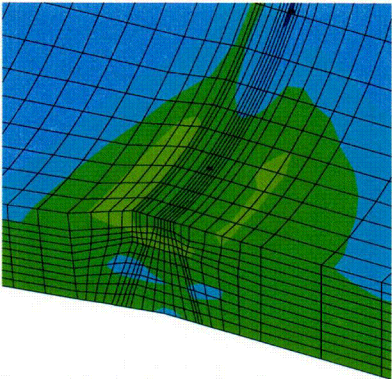
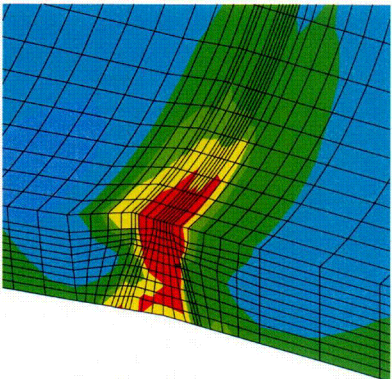
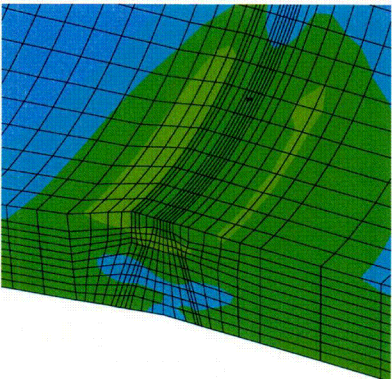
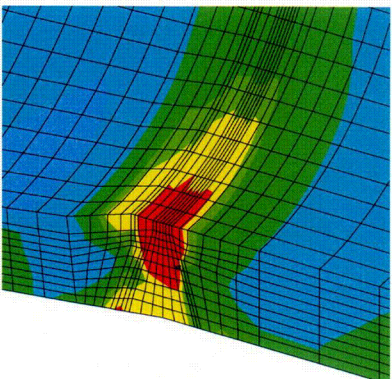
Figure 9  
Welding Residual and Operating Stresses With Partial-Arc ID Weld Repairs

| Condition | Axial Stress | Hoop Stress |
|---|---|---|
| Welding Residual and Operating Stress 30° Arc ID Repair | <br>39.9 ksi Max ID Stress | <br>54.6 ksi Max ID Stress |
| Welding Residual and Operating Stress 60° Arc ID Repair | <br>38.6 ksi Max ID Stress | <br>52.6 ksi Max ID Stress |
| Welding Residual and Operating Stress 90° Arc ID Repair | <br>40.2 ksi Max ID Stress | <br>52.0 ksi Max ID Stress |

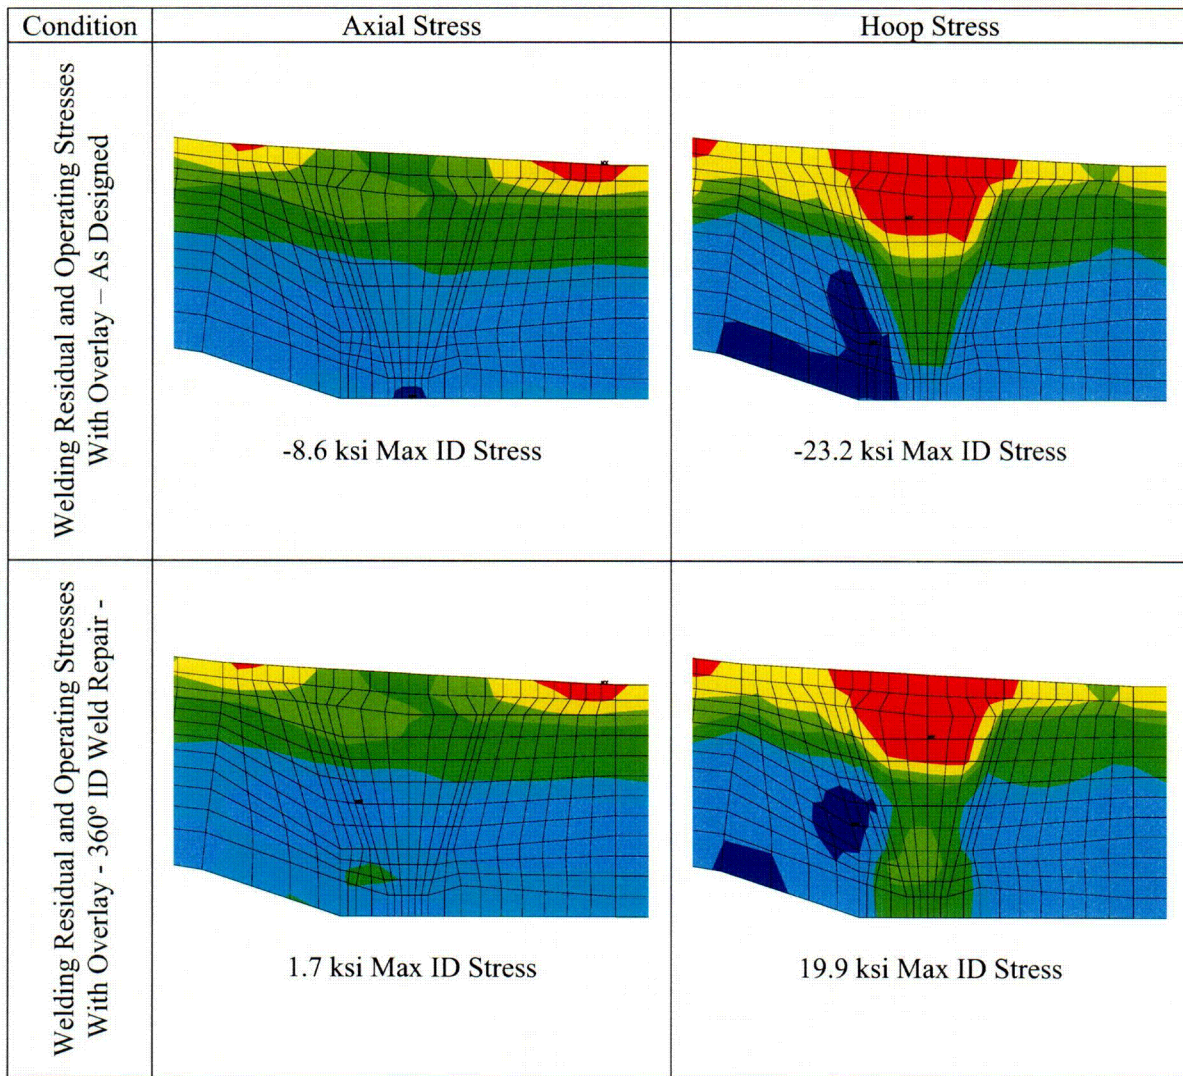
Figure 10  
Welding Residual and Operating Stresses With Overlay Deposit
