Analysis of Alloy 600 Stress Corrosion Cracking with an Artificial Neural Network.

CONFERENCE ON VESSEL HEAD PENETRATION INSPECTION, CRACKING AND REPAIRS Gaithersburg, MD – Sept. 29-Oct. 2, 2003

Metallurgical Investigation and Root Cause Assessment of the Reactor Vessel Head Penetration Alloy 182/82 J-Groove Weld Cracking in Two Rotterdam Vessels

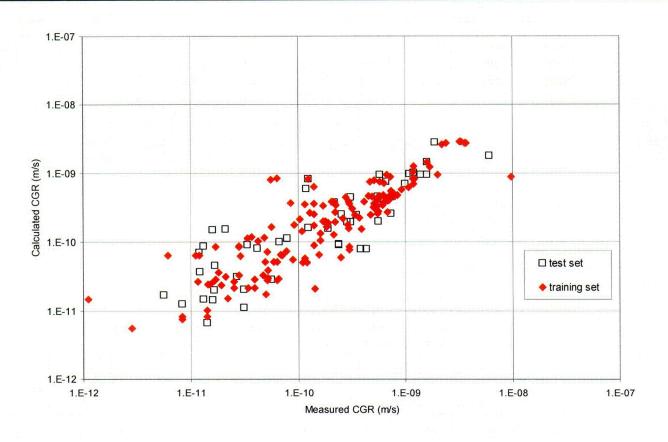
Comparison of Measured and Predicted Data

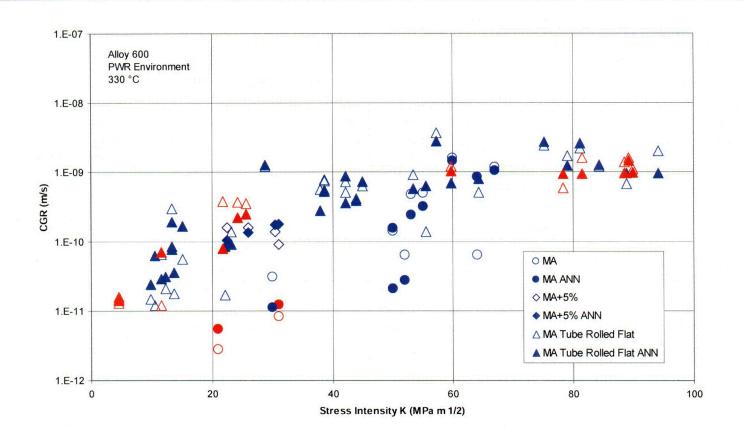
CGR vs. Applied Stress

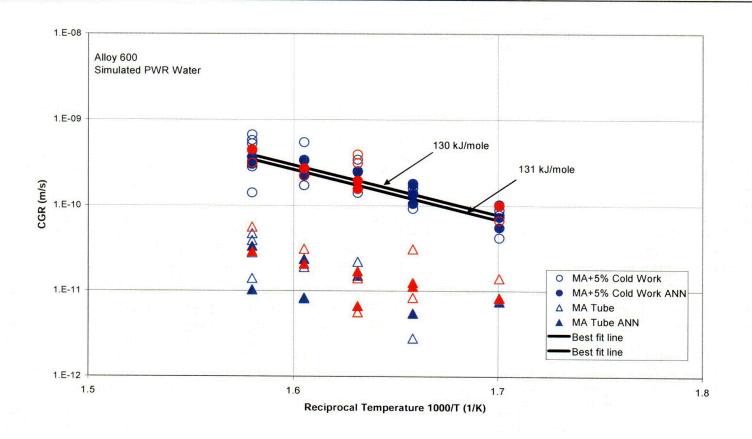
CGR vs. Temperature

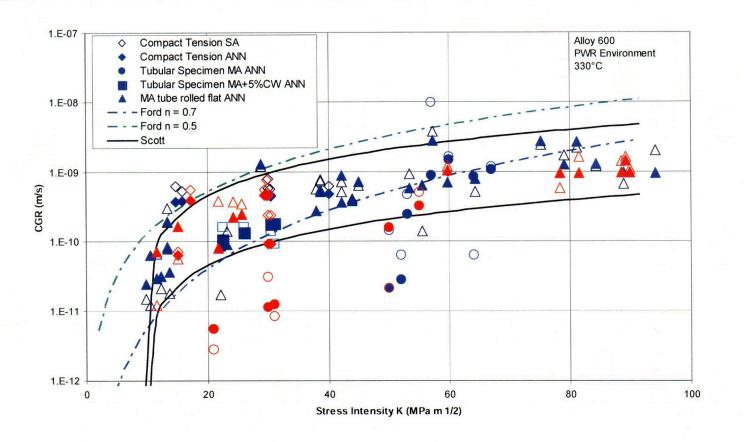
Comparison with Correlations - 330°C

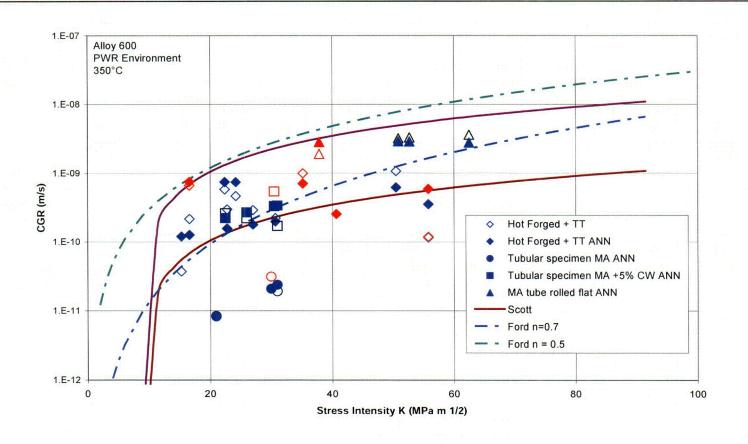
Comparison with Correlations - 350°C

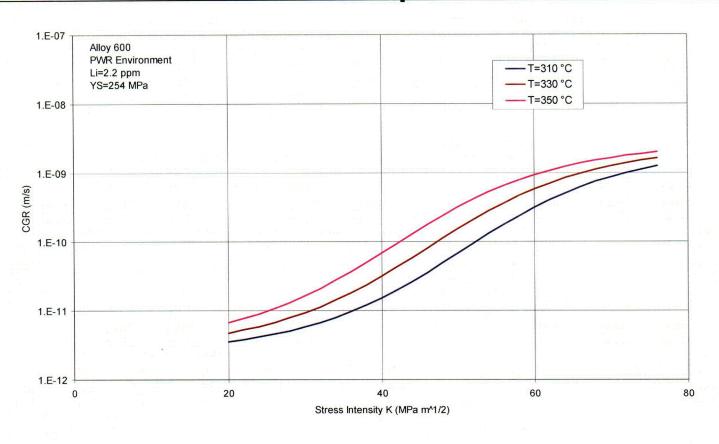
Variation of CGR with Stress for Different Temperatures

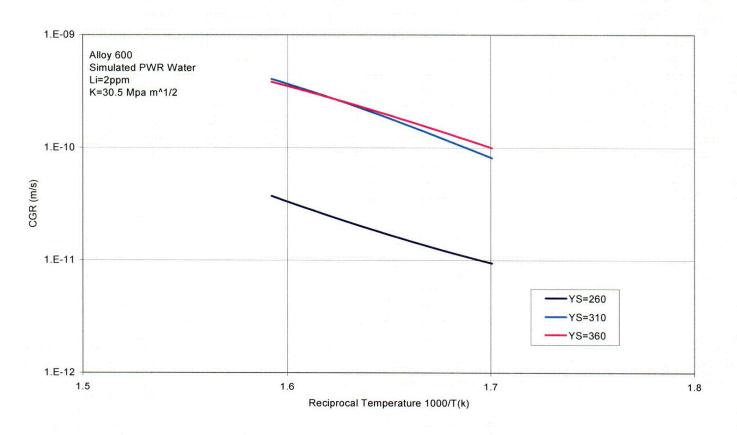
Variation of CGR with Temperature for Different Yield Strengths

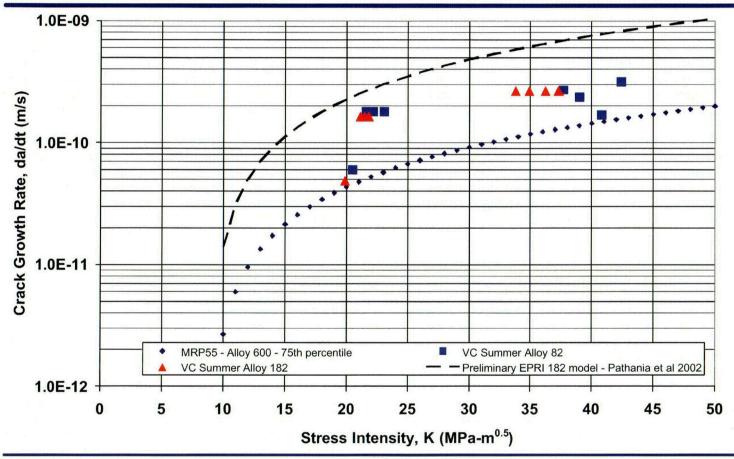
Comparison of VC Summer Alloys 82 and 182 Results with EPRI Models

- Only relatively small differences were observed in the crack growth rates in the Alloy 82 and Alloy 182 specimens.
- The crack growth rates were measured to be between the 75th percentile curve for Alloy 600 (EPRI-MRP) and the curve presently proposed in a preliminary EPRI model for Alloy 182 (PWR MRP-21; TR-1000037).

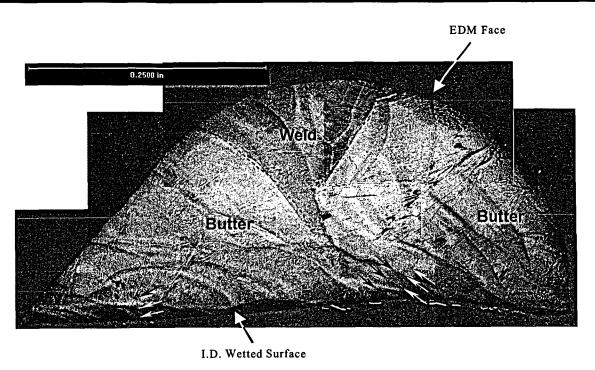
NORTH ANNA 2 BOAT SAMPLE

Metallography with Identified Butter and Weld Regions By EDAX Analysis, North Anna 2 Boat

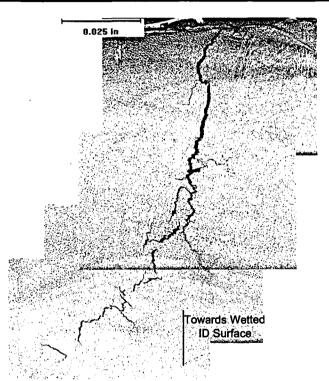
NORTH ANNA 2 BOAT SAMPLE

Axial Section of North Anna 2 Boat, Showing PWSCC Crack Progressing from EDM Cut Fact to the Wetted ID Face of RVH

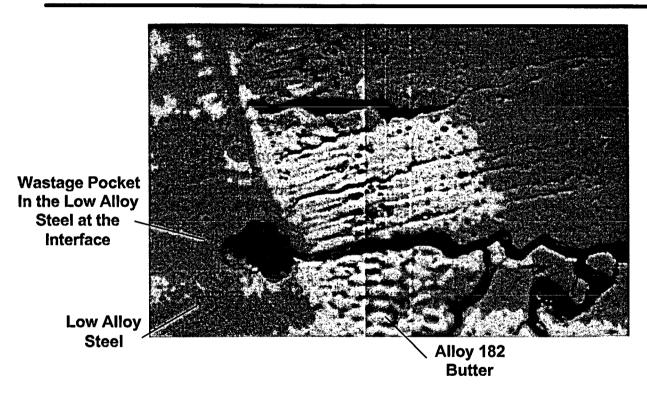
Crack Termination at the Cladding

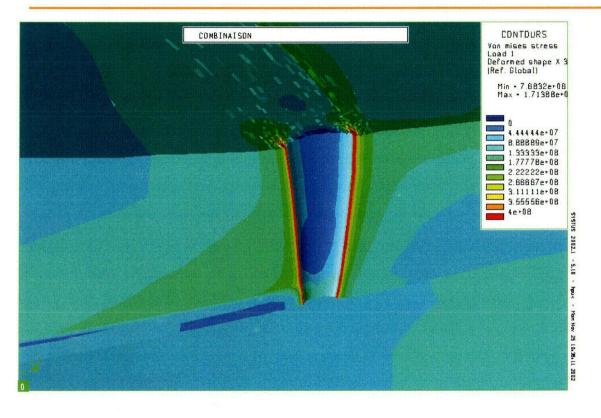
Through-wall defect analysis in RPV inlet nozzle (weld repaired in fabrication after stress relief in one unit)

Crack stable with margins

Very small leak rate (2 - 5 kg/h)

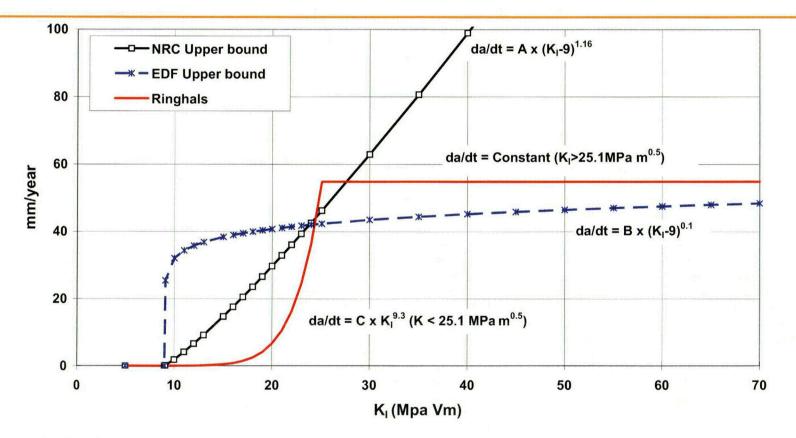
Crack growth rates - Inconel 182 at 345°C (Arrhenius with Q=130 kJ/mole)

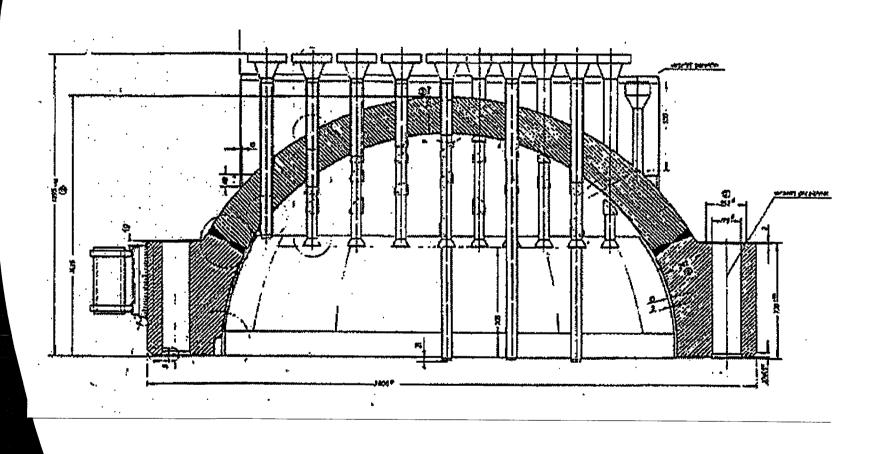
The NPP Obrigheim RPV Head Design

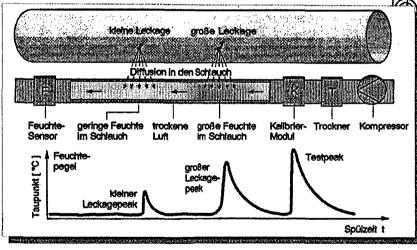
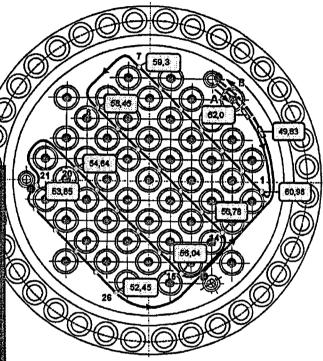
Local Leakage Detection System in RPV Head FLÜS

Humidity control system FLÜS in area of RPV penetrations YA01 M010 (sensor-hose)

- leakage-simulation point 1/2/3
- Ni-sinter tablet (diffusion point)

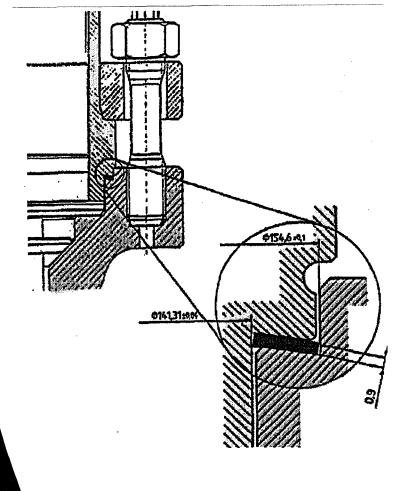
NPP KWO Flange Design

Gasket: material X10Cr13

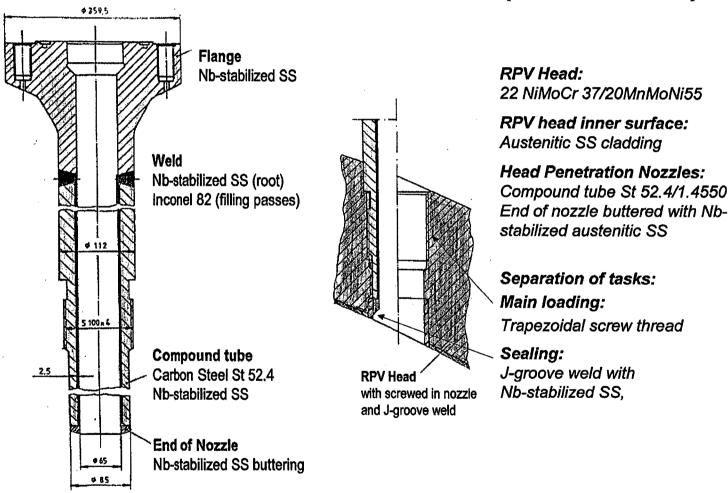
The Current Siemens/KWU Design of RPV CRDM Nozzles (since Stade)

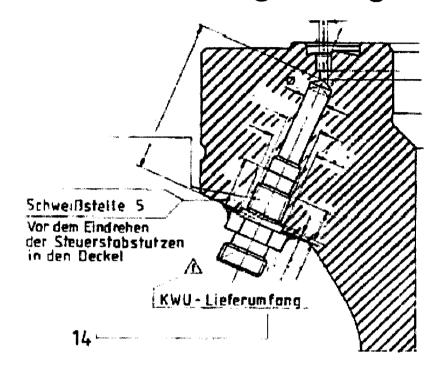
The Current Siemens/KWU Flange Design

- conical gasket: 2 seals
- material: 1.4541 (SS 321 typ.)
- vacuum testing after installation
- test pipe used for leak detection

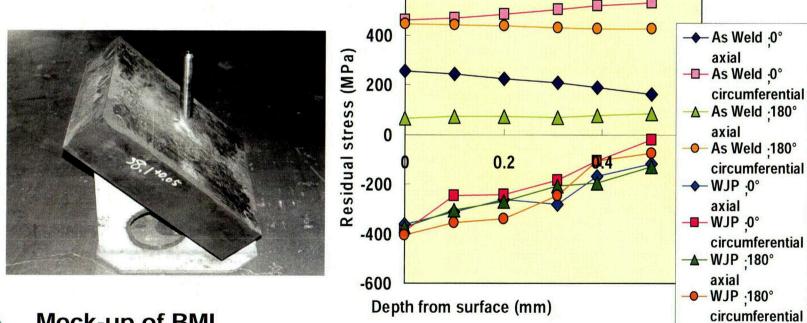
Improvement of Residual Stress by WJP Technology

Mock-up of BMI

Result of residual stress measurement

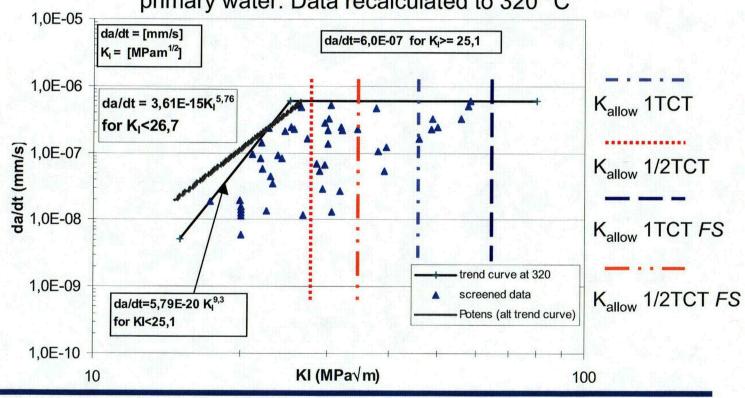
Screened data and bounding curves for Alloy 182 crack growth in PWR primary water. Data recalculated to 320 °C

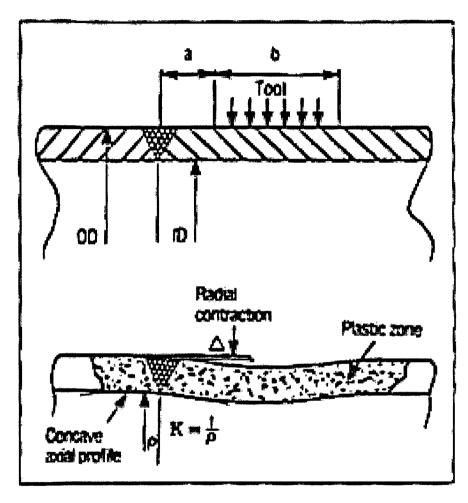
FIGURE 2 TOOL LOCATION AND DEFORMATION CONTOUR AFTER APPLYING MSIP

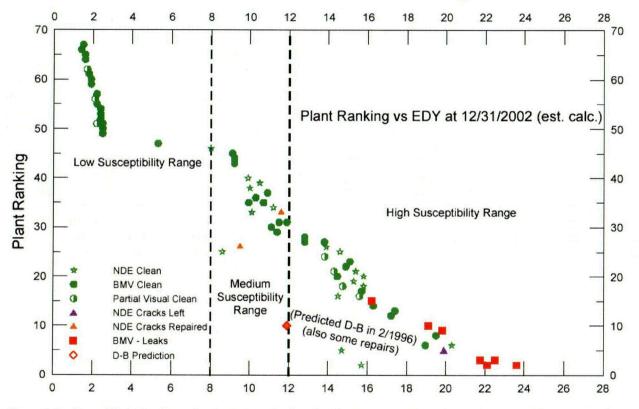
Figure 1. Ranking of domestic plants according to the EDY formula, showing results of inspections, evidence of leakage, and repairs. Many plants are shown with multiple symbols, indicating a "clean" inspection at inspection opportunity, followed by a different finding at a subsequent inspection (e.g., Oconee 2: clean NDE @ EDY=15.7, leaks and circ. flaws @ 22.1)

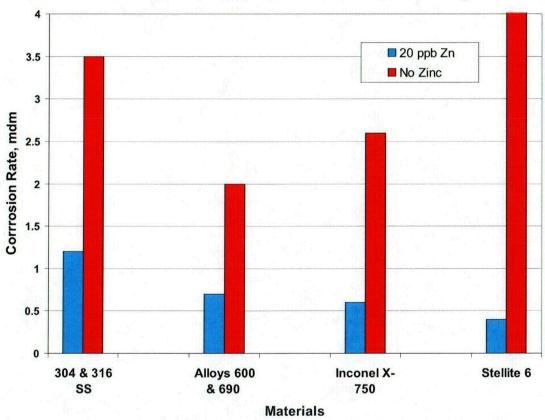
Corrosion Rate at 3.5 Months for Various Alloys

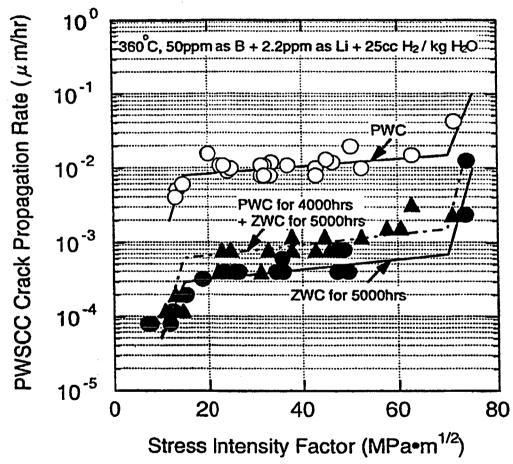
PWSCC Lab Data on CGR with and without Zn addition (10 ppb) to primary water

Kawamura et al. (1998) using DCB specimens from plate material

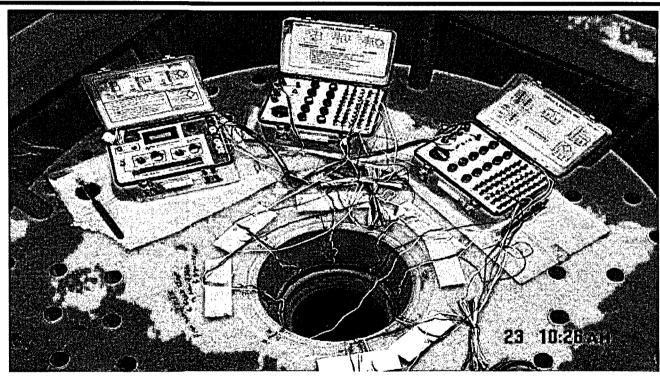
Illustration of the Installed Strain Gauges and the Strain Measuring Instrumentation at the Girard Site, Prior to MSIP Load Test

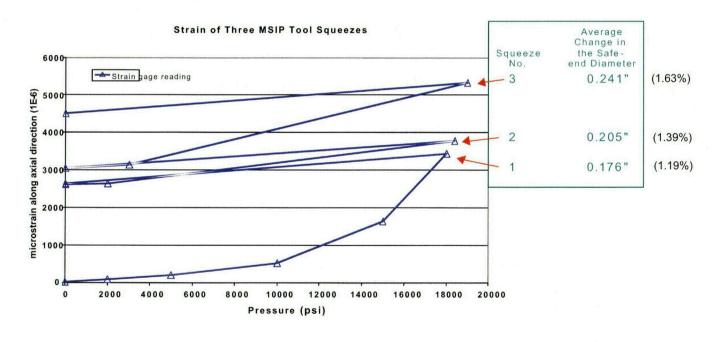
Safe-end Diameter Changes Associated with the Three MSIP Squeezes
