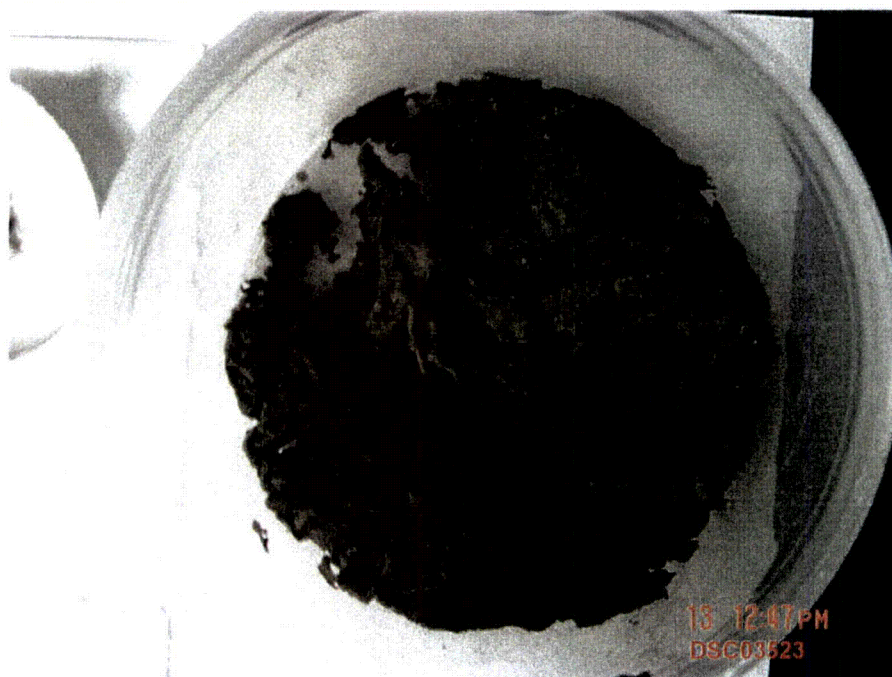
**Figure 4-74.** Sediment from south quadrant of tank after Test #1.

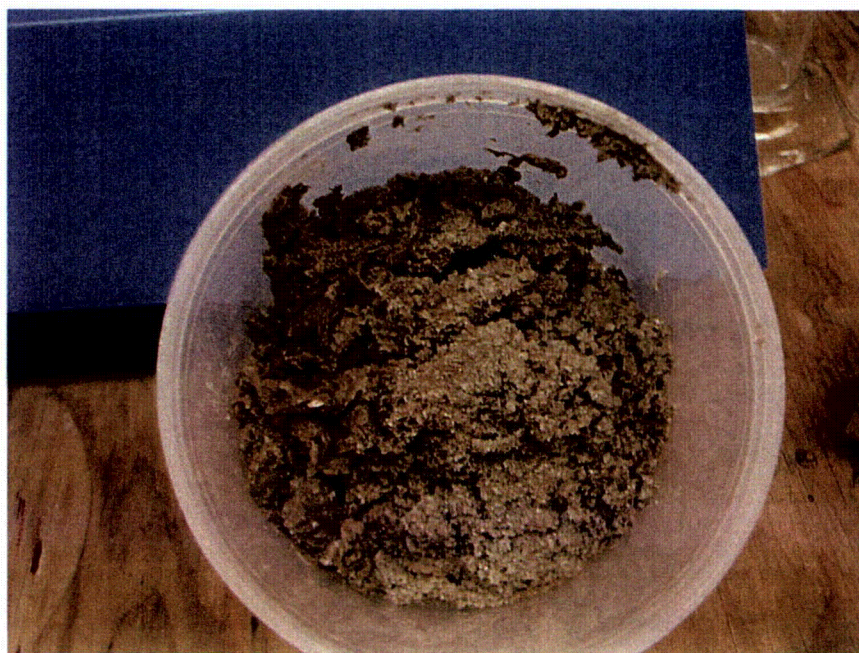
Figure 4-79. Picture of a Test #2, Day 30, sediment sample.

In Test #2, the latent debris and crushed concrete material were observed to settle completely on the bottom of the tank over the course of several days. This particulate, in combination with fugitive fiberglass debris, forms the basic substrate of the sediment layer recovered from the tank at the end of Test #2. A total of 256 g of wet sediment was recovered from the tank following the test. Figure 4-79 shows a photo of a Test #2, Day 30, sediment sample, which is composed of particulate deposits and fiberglass debris. Figures 4-80, 4-81, and 4-82 show SEM images and EDS spectra of Test #2 sediment samples. Because of the heterogeneous nature of the sediment, this sediment is likely composed of corrosion products, concrete debris, dirt, and fiberglass. As in Test #1, the highest elemental content of the Test #2 sediment was silicon (Table 4-6), which likely came from the fiberglass debris. The ratio of dry to moist sediment mass was determined to be 0.5, which is consistent with the ratio found for the Test #1 sediment.

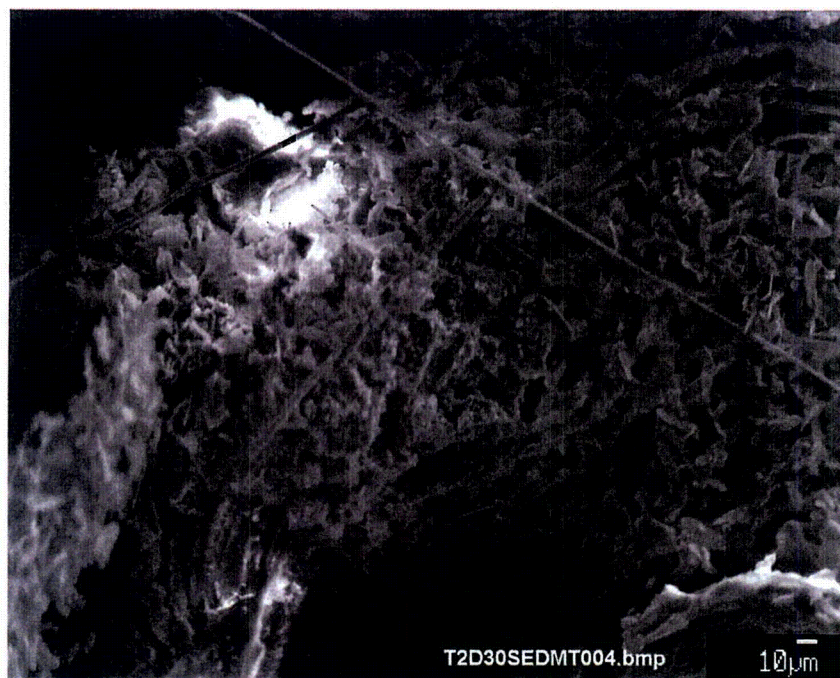
Figure 4-81. Higher-magnification SEM image of a Test #2, Day 30, sediment sample.

Figures 4-81 and 4-82 provide a higher magnification and an EDS spectrum of the same Test #2 sediment shown in Figure 4-80. Underlying fibers are visible in this image, and the dominant elemental constituents of the particulate deposits are oxygen, magnesium, phosphorus, calcium, aluminum, silicon, carbon, and zinc. The XRD result of Test #2 sediment is shown in Figure 4-83. Again, the presence of quartz is consistent with the fiberglass debris in the sediment.

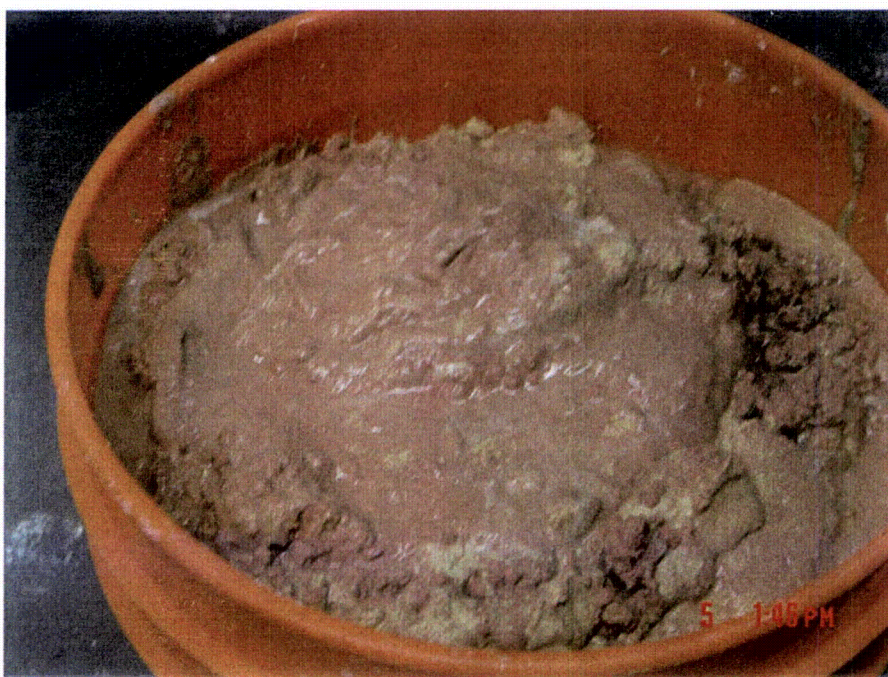
**Figure 4-84.** Sediment removed from the tank after Test #3.

Eighty percent of the fiberglass was replaced by cal-sil in Test #3. As a result, the cal-sil debris contributed significantly to the sediment, as shown in Figure 4-84, which is a photograph of the Test #3 sediment extracted from the bottom of the tank. The pink and yellow particles seen in the sediment correspond to baked and unbaked cal-sil. Over 78 kg of wet sediment were recovered

from the tank following the test (approximately 20 kg of dry cal-sil dust was initially added to the tank).

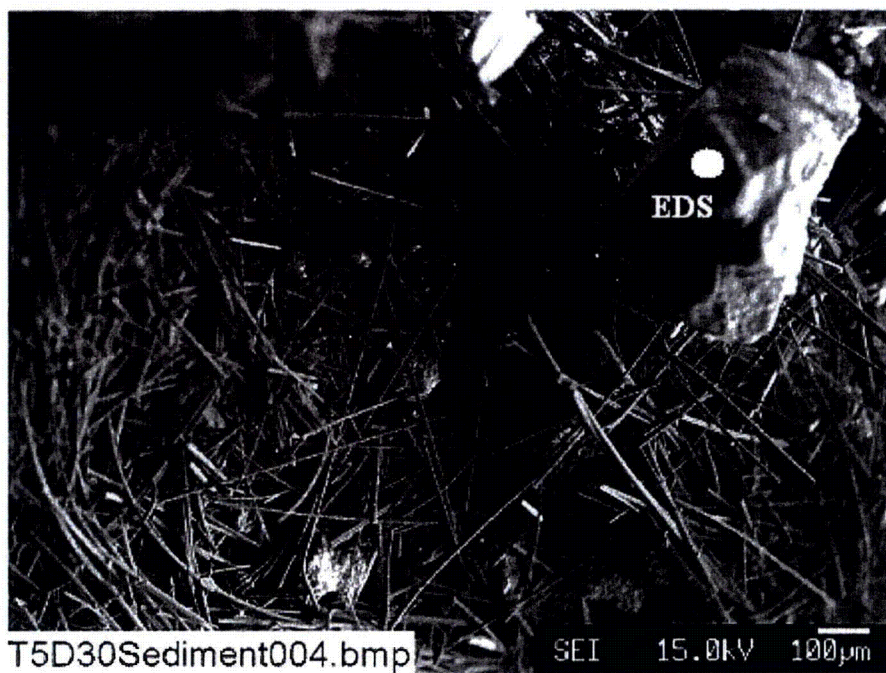
Figure 4-96. SEM image, magnified 70 times, of the Test #5, Day 30, sediment at the bottom of the tank.

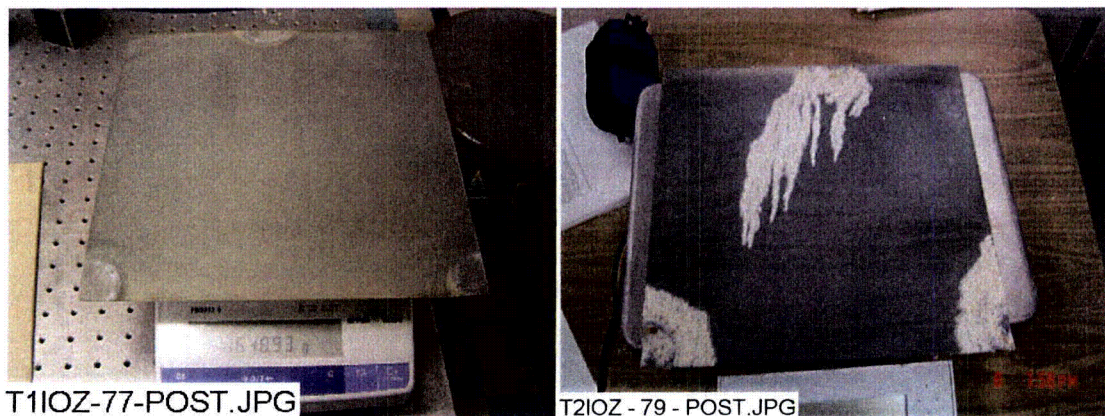
**Figure 4-107. ICET Test #1 IOZ-77 submerged, post-test (left); ICET Test #2 IOZ-79 submerged, post-test (right).**

Figures 4-107 through 4-109 are pictures of submerged IOZ-coated steel coupons from each test. Figure 4-110 shows an unused IOZ-coated steel coupon. The Tests #1 and #5 coupons developed a brownish hue, with the color of Test #1 being more pronounced. The Test #2 coupon shows a relatively large amount of white deposit originating in the areas where the coupon came in contact with the rack. The Test #3 coupon had a small amount of white deposit in the areas where the coupon was in contact with the rack, as well as a small amount of white precipitate distributed across the surface of the coupon. The Test #4 coupon developed a small amount of white precipitate on the top edge of the coupon; however, it was not significantly changed from its pretest appearance.

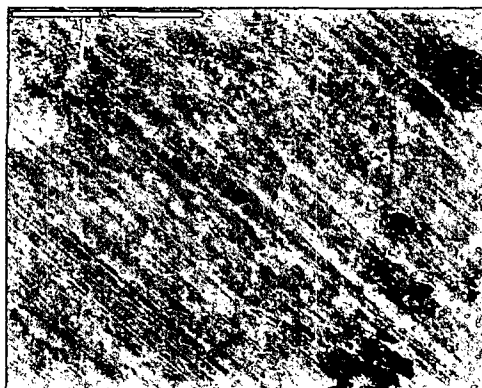
**Figure 4-147. Test #1 unsubmerged copper.**

As shown in Figures 4-147 through 4-149, limited corrosion occurred on the unsubmerged copper coupons. The coupons were affected by the test solution only during the 4-hour spray period on the first day of the tests and by the moist air throughout the tests. As discussed previously, the degree of corrosion was significantly less than on the submerged copper coupons because of the limited mass-transfer process.

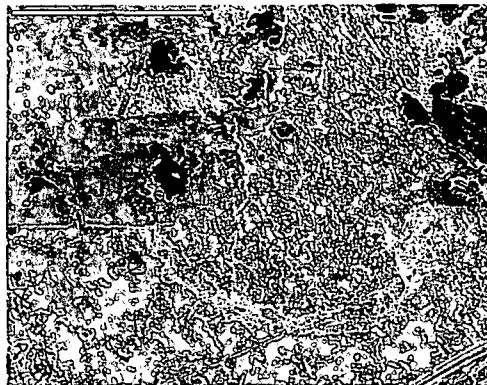
**Figure 4-159.** Test #1 unsubmerged carbon steel.

As shown in Figures 4-159 to 4-161, corrosion also occurred on the unsubmerged carbon steel coupons. As with the galvanized steel coupons, the degree of corrosion was not always greater for the submerged carbon steel coupons, especially for Tests #3 and #5. In those tests, the carbon steel corrosion rates in the moist oxygenated spray zone environment appeared to be greater than the submerged coupons.

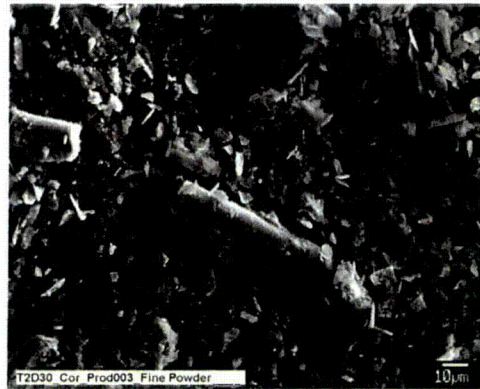
**Figure 4-172.** SEM image at 650× magnification of a Test #2, Day 30, sample of fine powder on a vertical piece of the submerged PVC rack. (T2D30\_Cor\_Prod003\_Fine Powder)

Figures 4-172 and 4-173 show the SEM images of the deposition products collected from a vertical section of the submerged CPVC rack. In Figure 4-172, the cylindrical debris appears to be fiberglass, which mixed with other corrosion/precipitation products and debris. EDS results from Figure 4-174 indicate that the deposition products shown in Figure 4-173 were composed mainly of oxygen, phosphorus, magnesium, and carbon, with small amounts of aluminum, silicon, calcium, and sodium. Because TSP was used in Test #2, a precipitate of phosphate salts such as magnesium phosphate may have deposited on the submerged CPVC rack, in addition to other carbonate and metallic salts precipitates.

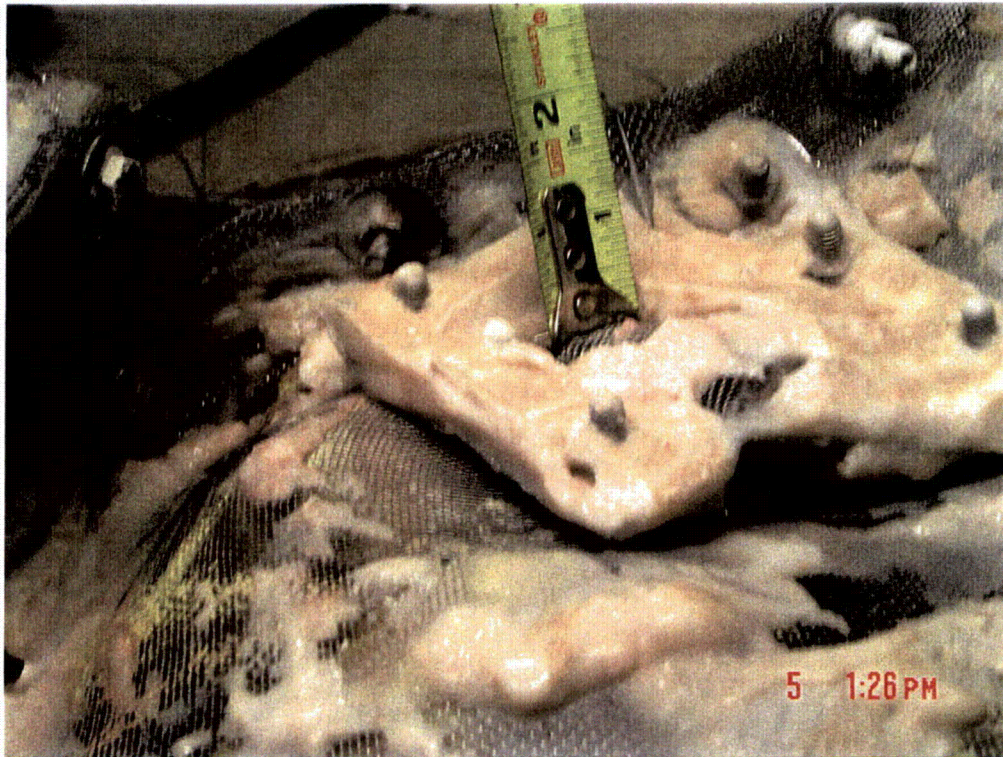
Figure 4-184. Stainless steel mesh covered with gel-like material.

There were two unique observations from ICET Test #3. First, a significant amount of white gel-like precipitates were observed in the test solution for several hours on the first day of the test during and after the injection of TSP. Looking through the tank's submerged view window, the test solution appeared to be nearly saturated with these precipitates that were moving robustly in a circular pattern. Second, when the test was completed, deposits of pinkish-white gel-like material were found on the top of the sediment and on other objects on the tank bottom. This material covered the majority of objects on the tank bottom including the birdcage, but it was not a continuous covering. Figures 4-184 and 4-185 are photographs of the gel-like material.

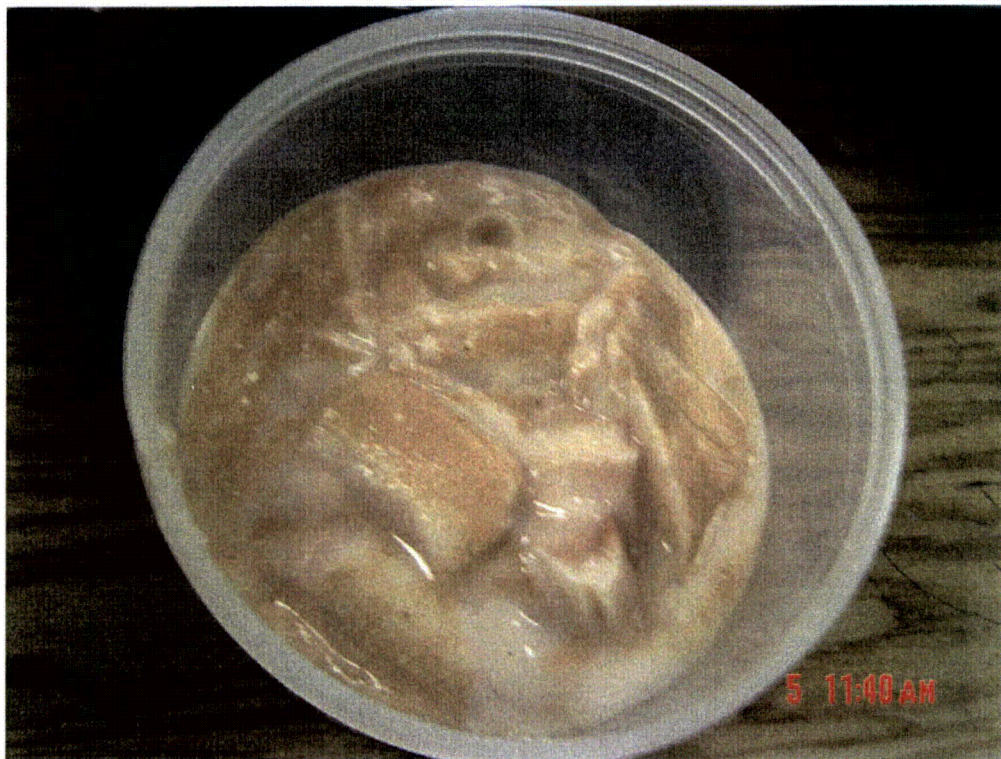
Figure 4-185. Gel-like material recovered from the bottom of the tank.
