Appendix D – Large-Scale Data Acquisition System Worksheets

Appendix G – Screen-Only Quick Look Reports

Appendix H – NUKON Only Quick Look Reports

Appendix I – CalSil-Only Quick-Looks

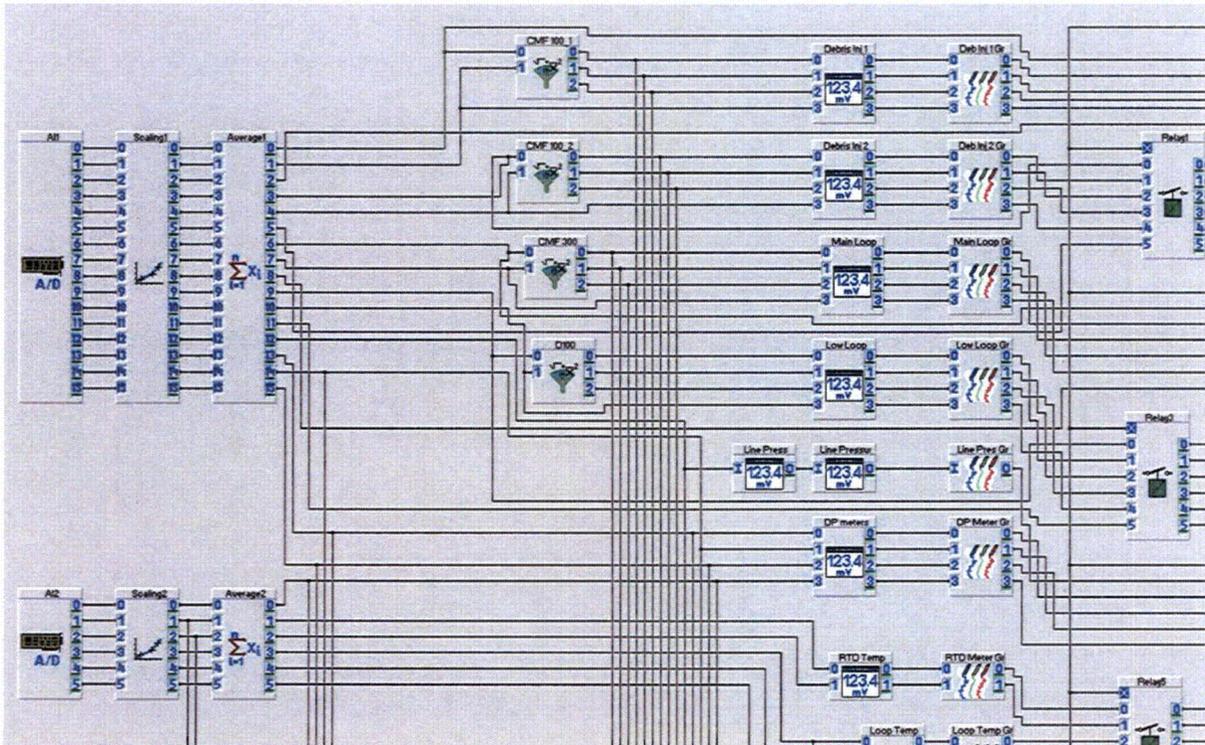
Figure D.1.1. Large-Scale DAS Worksheet, Top-Left Corner

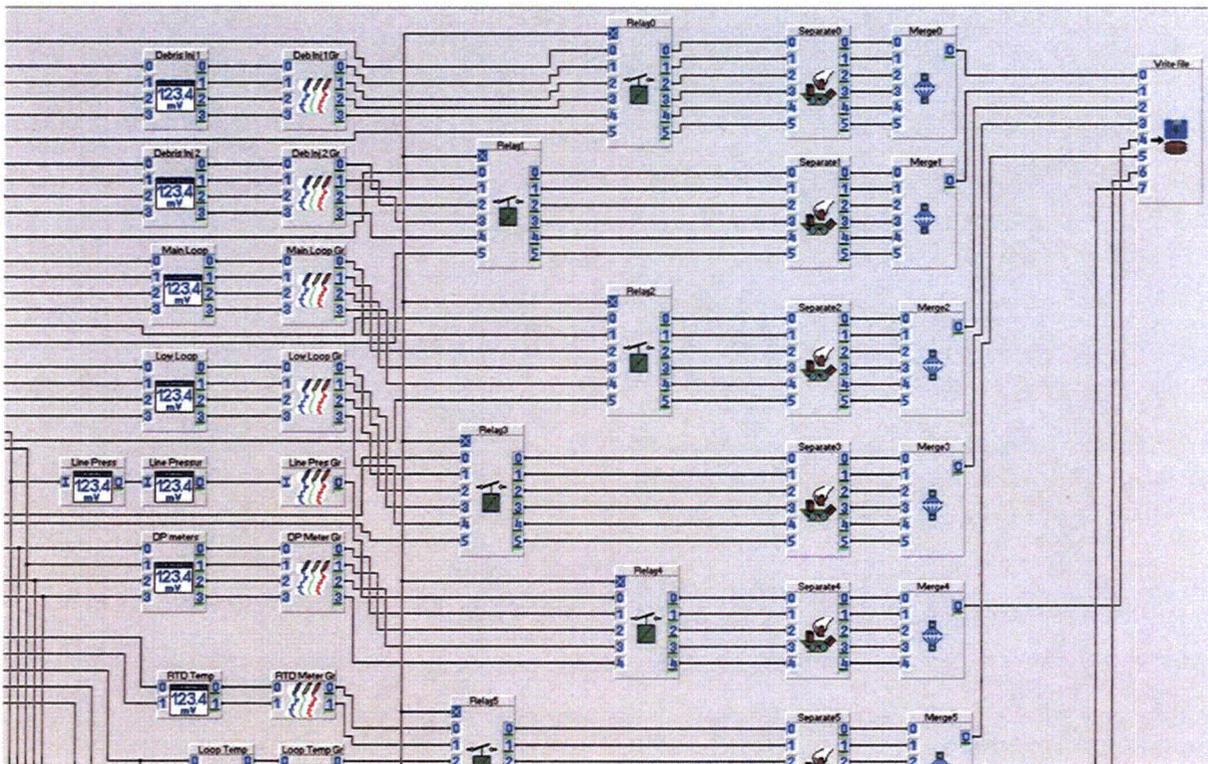
Figure D.1.2. Large-Scale DAS Worksheet, Top-Right Corner

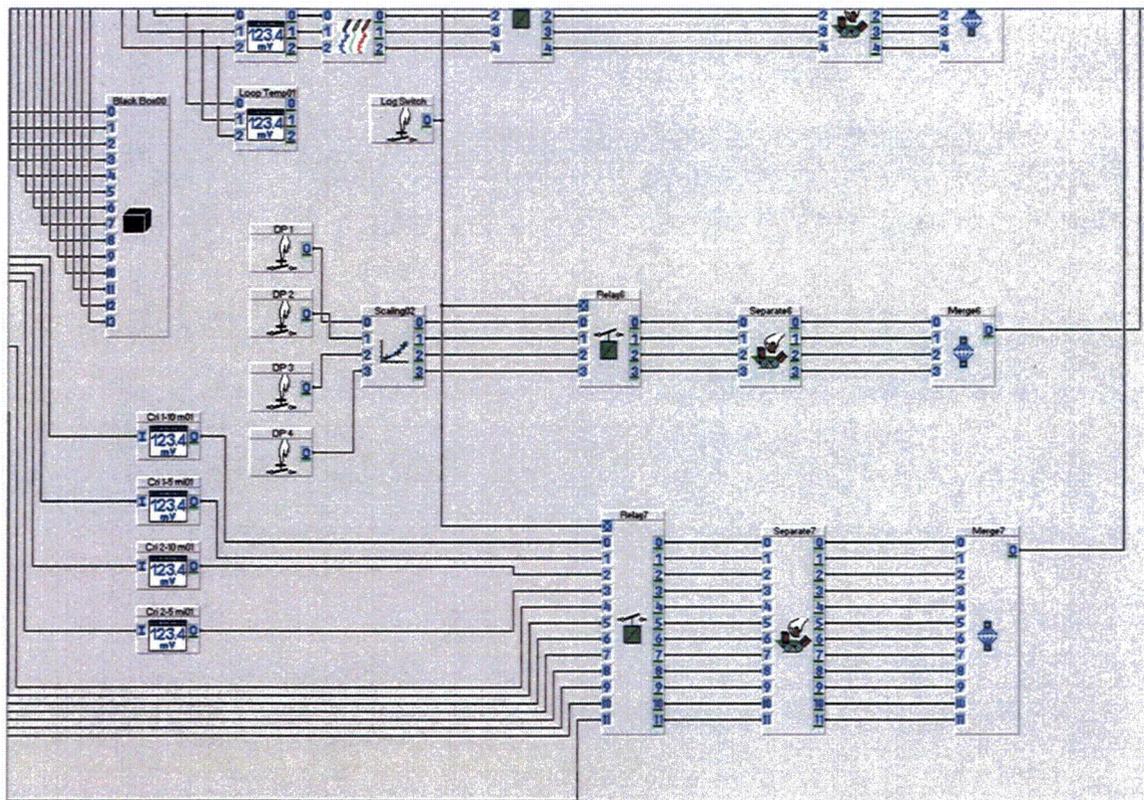
Figure D.1.3. Large-Scale DAS Worksheet, Lower Right Corner

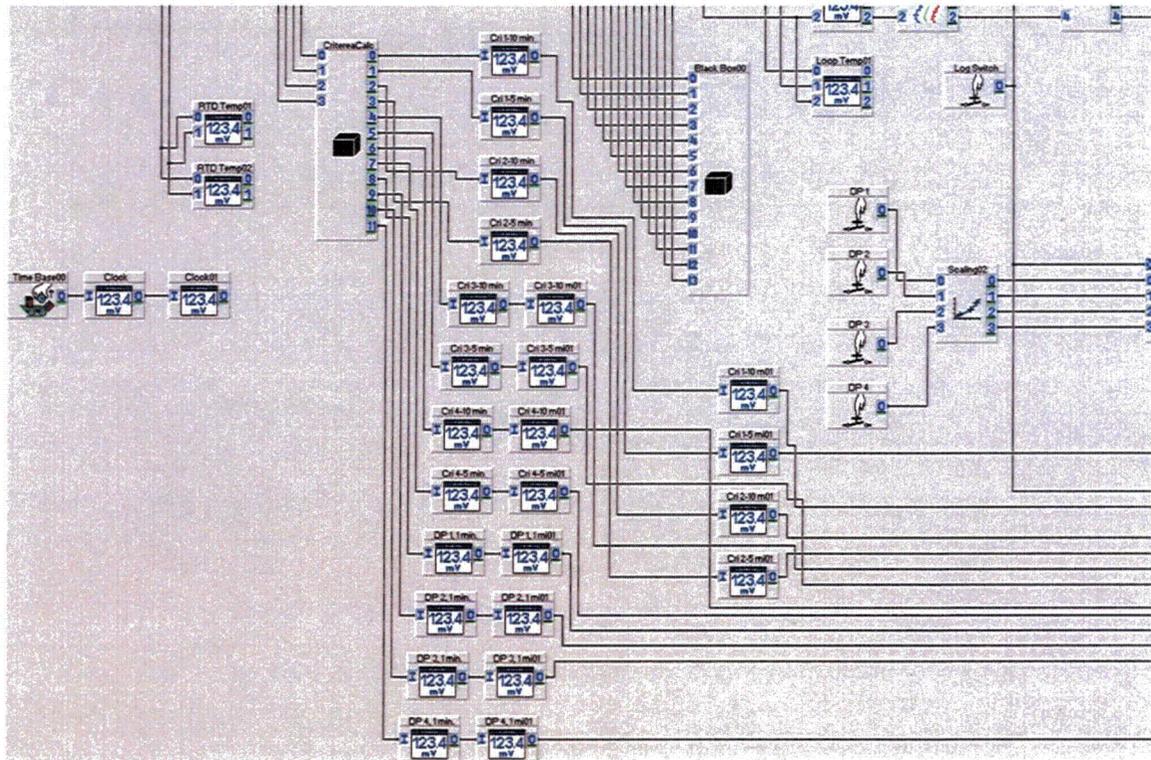
Figure D.1.4. Large-Scale DAS Worksheet, Lower Left Corner

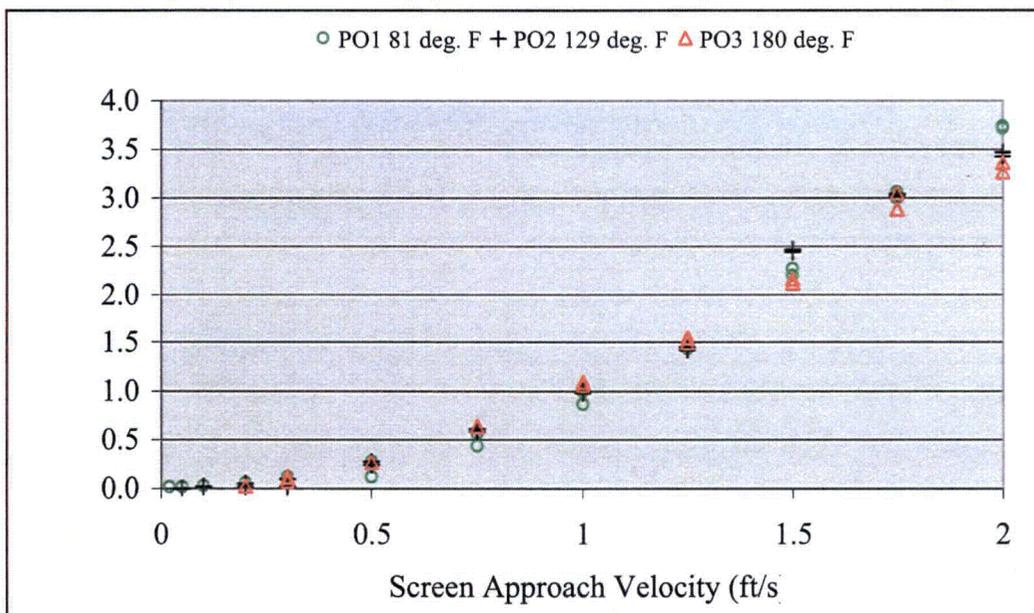
Figure G.2.1. Comparison of Head Loss Across the Bare Perforated Plate with 1/8-in. Holes as a Function of Approach Velocity for Nominal Temperatures of 81°, 129°, and 180°F Without Error Bars

Table G.2.1 contains the test conditions; the plate dimensions are presented in Table G.2.2. The preliminary experimental head loss data for all three tests are listed in Table G.2.3, and the preliminary measurements of head loss with temperature and zero corrections applied in Table G.2.4. The corrected measurements of head loss are plotted as a function of screen approach velocity in Figure G.2.1 without error bars and in Figure G.2.2 with the error bars.

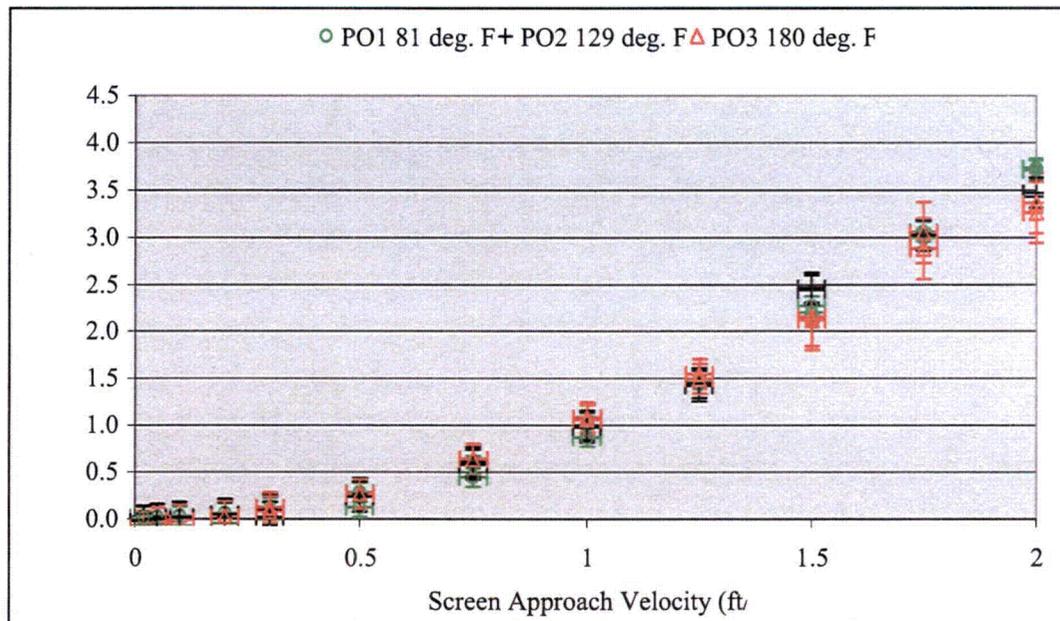
Figure G.2.2. Comparison of Head Loss Across the Bare Perforated Plate with 1/8-in. Holes as a Function of Approach Velocity for Nominal Temperatures of 81°, 129°, and 180°F with Error Bars

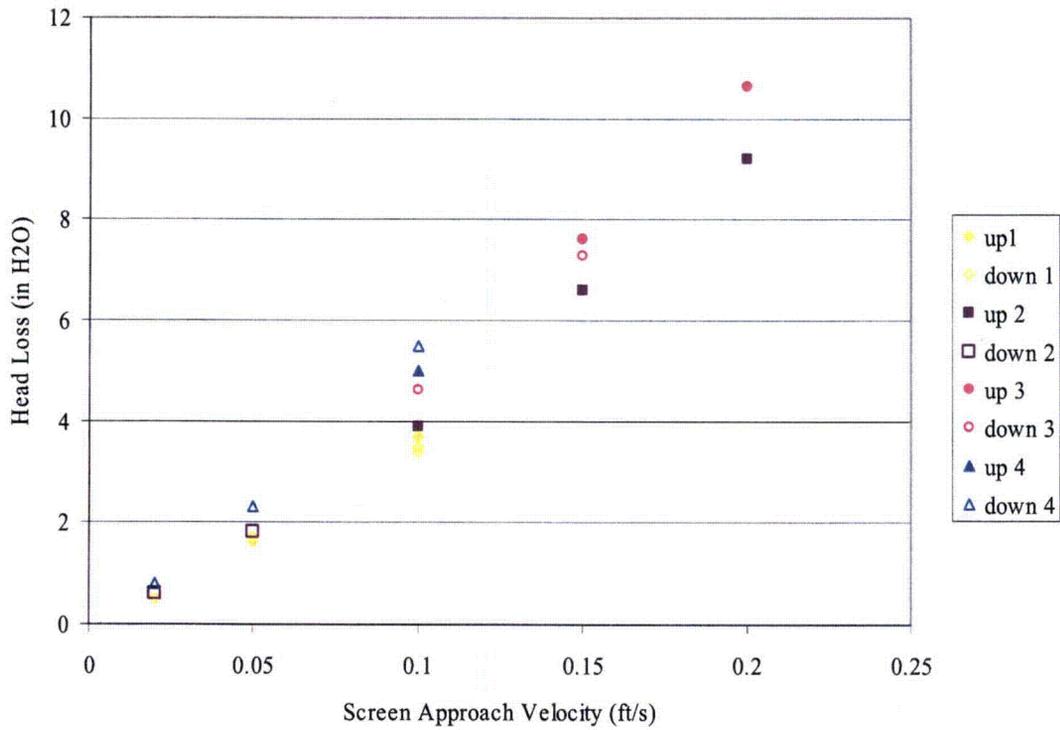
Figure H.1.1. Preliminary PNNL Data; 060321_NO_0405_LP1

Table H.1.1 lists the test conditions. Manual debris bed height measurements are reported in Table H.1.2 and Figure H.1.1. The top of the perforated plate assembly support ring was used as the reference datum to obtain the debris bed height measurements under flow conditions. The actual top of the perforated plate is approximately 0.0625 in. below this datum. Therefore, 0.0625 in. has been added to the reported measurements. The test apparatus during testing is shown in Figure H.1.2.

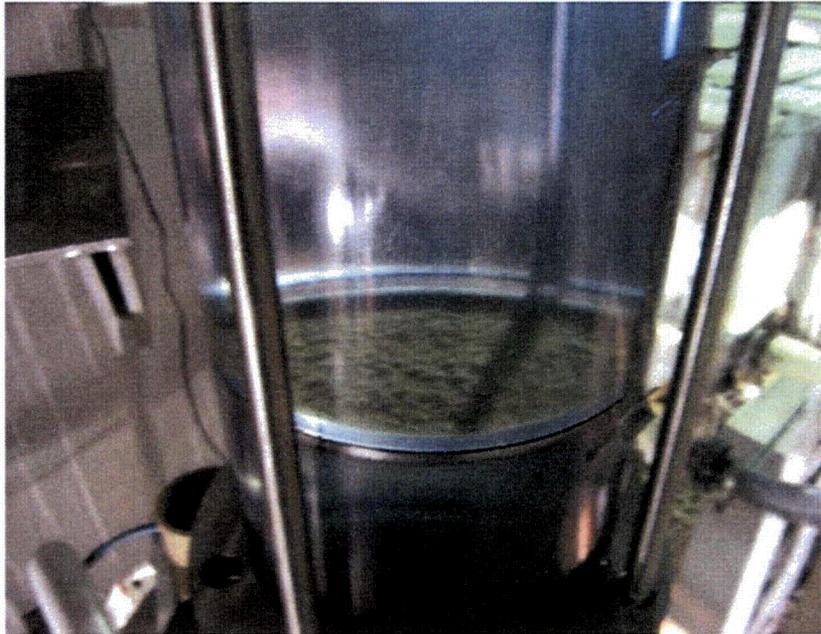
Figure H.1.2. Submerged 060321_NO_0405_LP1 Debris Bed During the Test

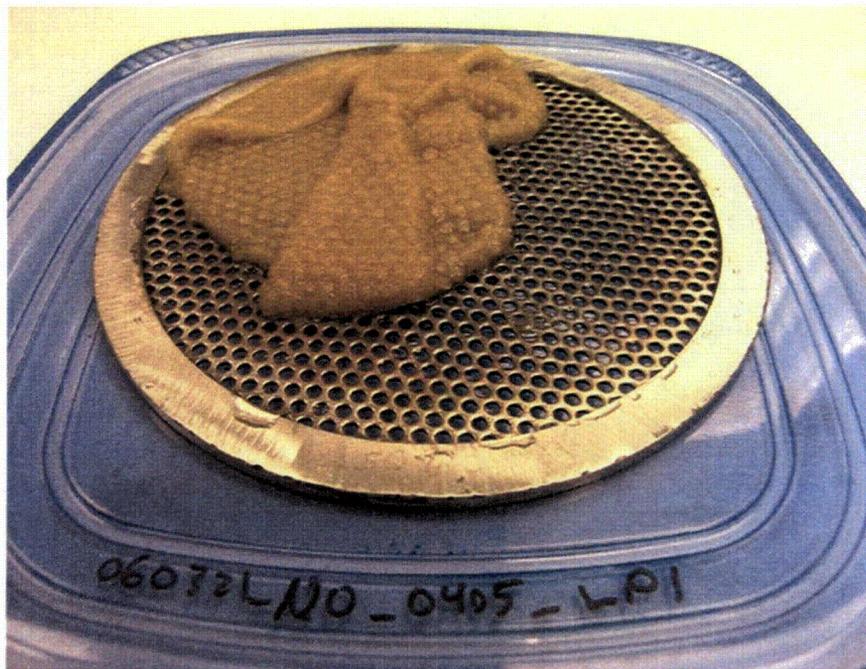
Figure H.1.3. 060321_NO_0405_LP1 Debris Bed After Retrieval. The disturbance consisted of the entire debris bed floating up under severely reduced flow conditions, flipping over and folding up, and then re-depositing on the plate once flow was increased. The debris bed was visually observed to remain essentially intact.

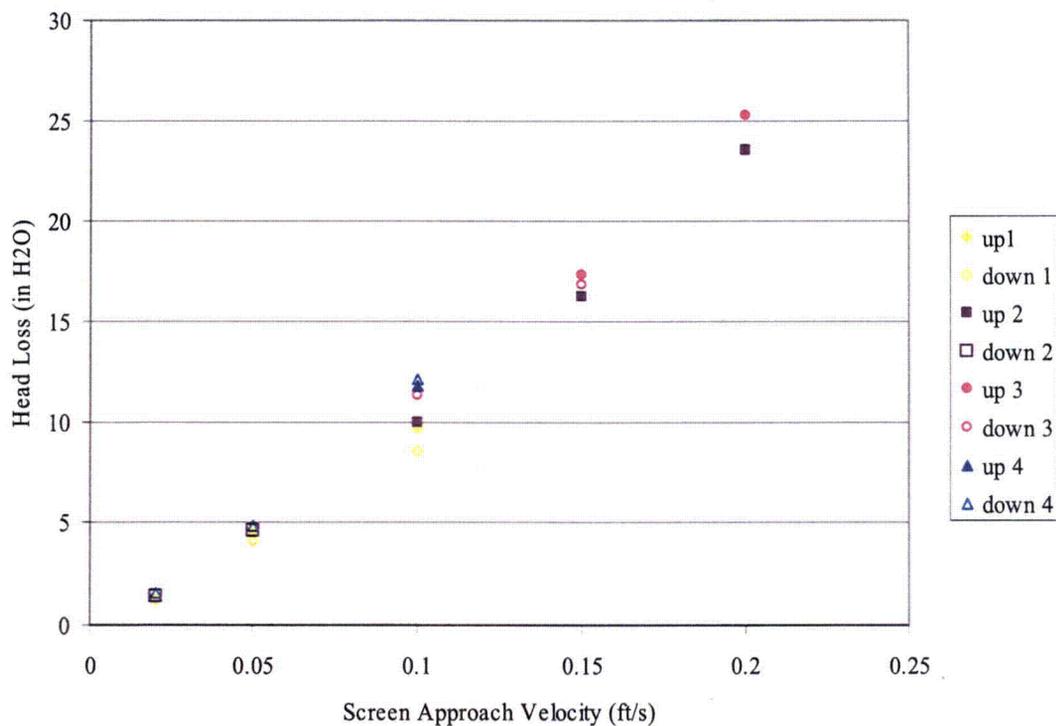
Figure H.2.1. Preliminary PNNL Data, 060313_NO_1349_LP1

Table H.2.1 contains the test conditions. Manual debris bed height measurements are reported in Table H.2.2 and Figure H.2.1. The top of the perforated plate assembly support ring was used as the reference datum to obtain the debris bed height measurements under flow conditions. The actual top of the perforated plate is approximately 0.0625 in. below this datum. Therefore, 0.0625 in. has been added to the reported measurements.

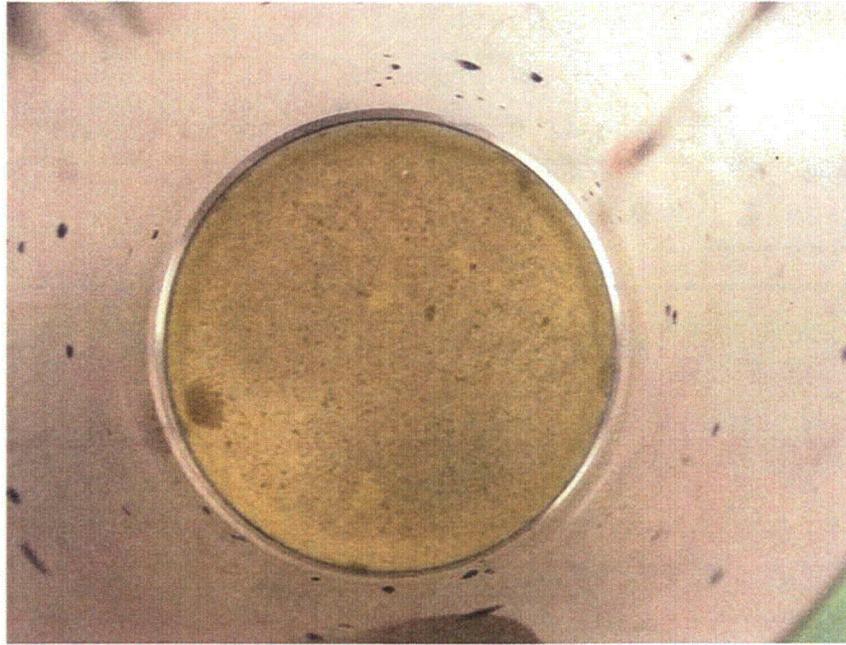
Figure H.2.2. 060313_NO_1349_LP1 Debris Bed in Test Section After Retrieval, Top View

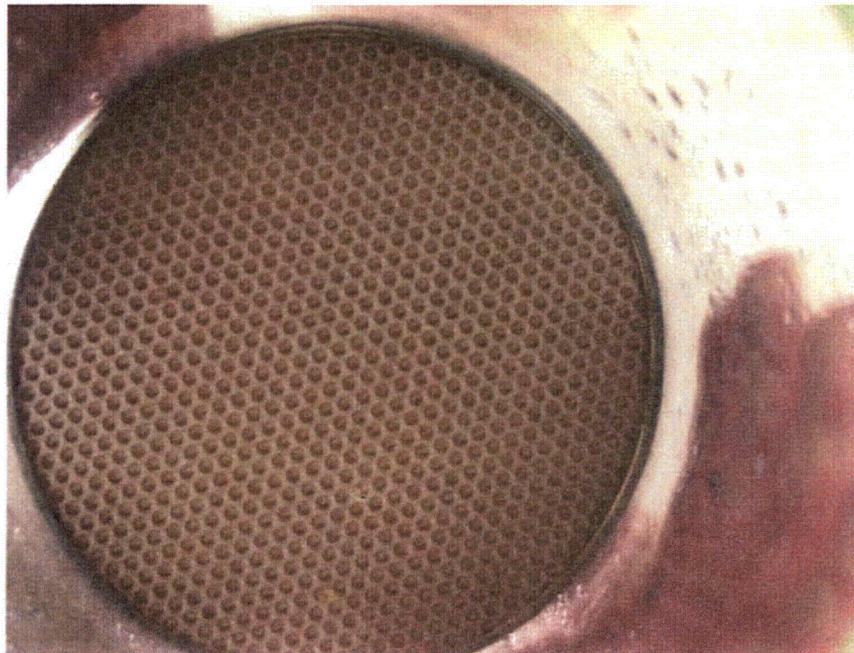
Figure H.2.3. 060313_NO_1349_LP1 Debris Bed in Test Section After Retrieval, Bottom View

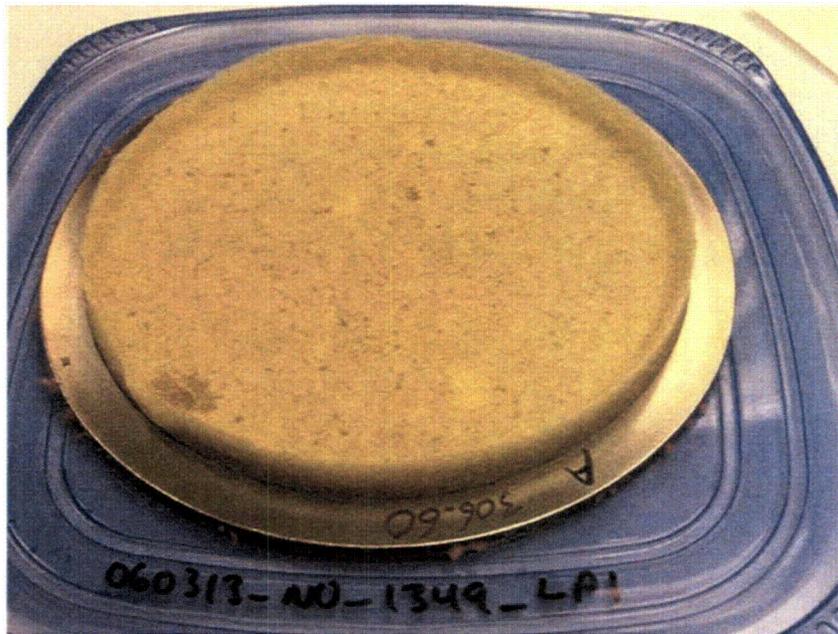
Figure H.2.4. 060313_NO_1349_LP1 Debris Bed After Retrieval from Test Section

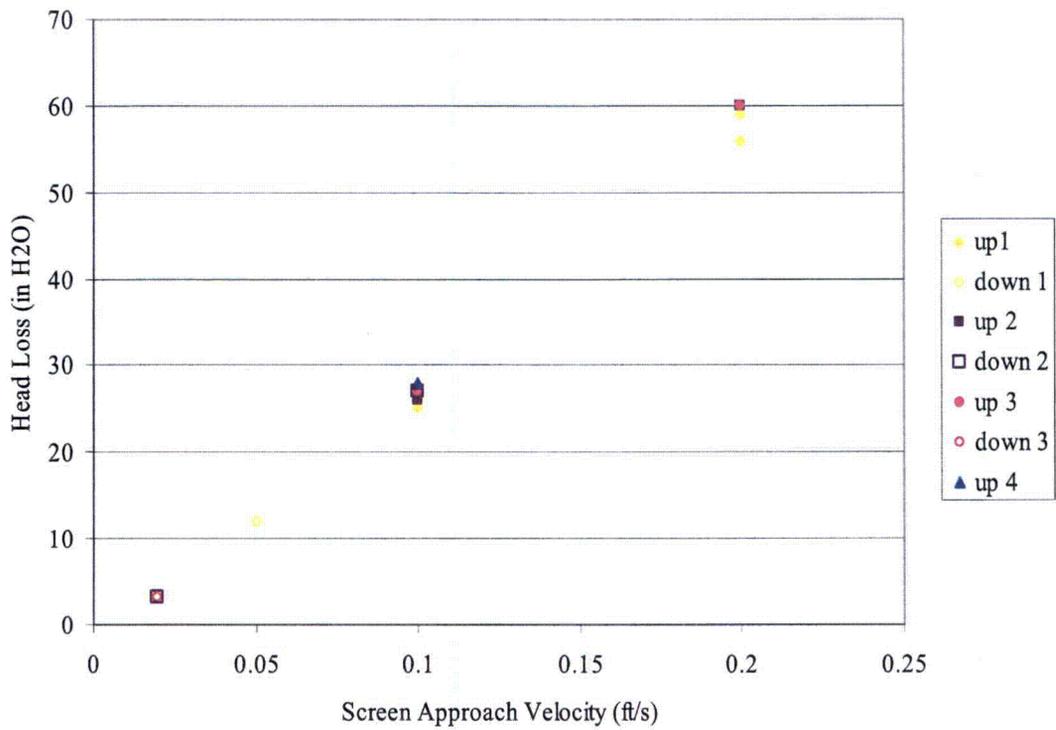
Figure H.3.1. Preliminary PNNL Data, 060425_NO_2703_LP1

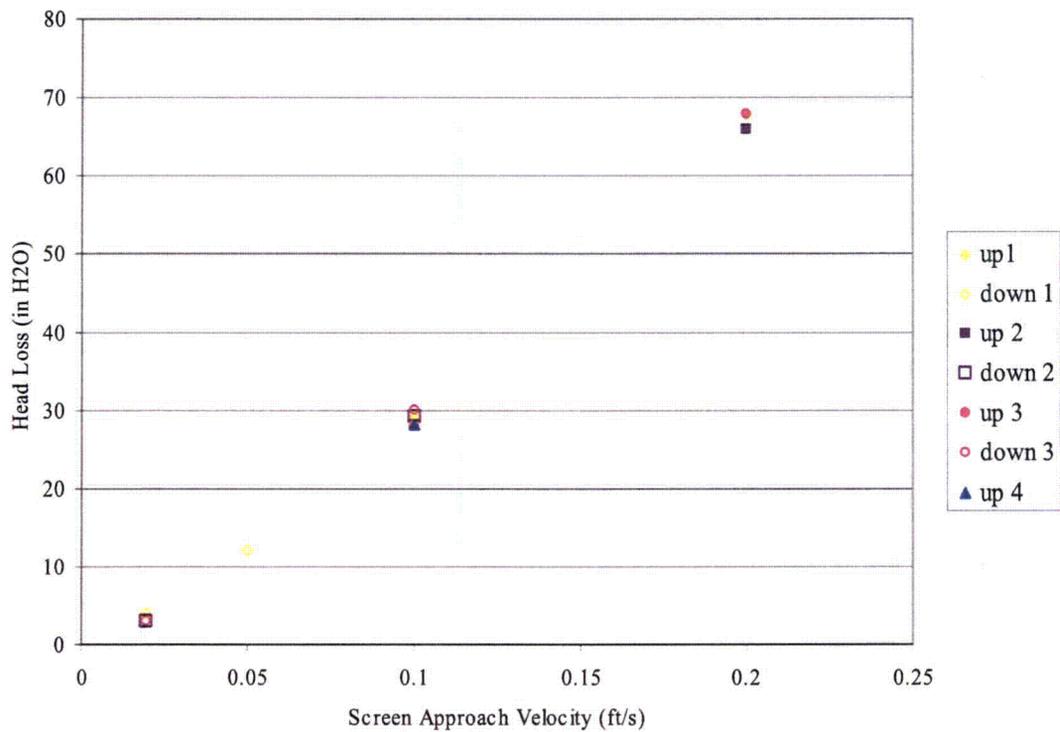
Figure H.3.2. Preliminary PNNL Data, 060425_NO_2703_LP2

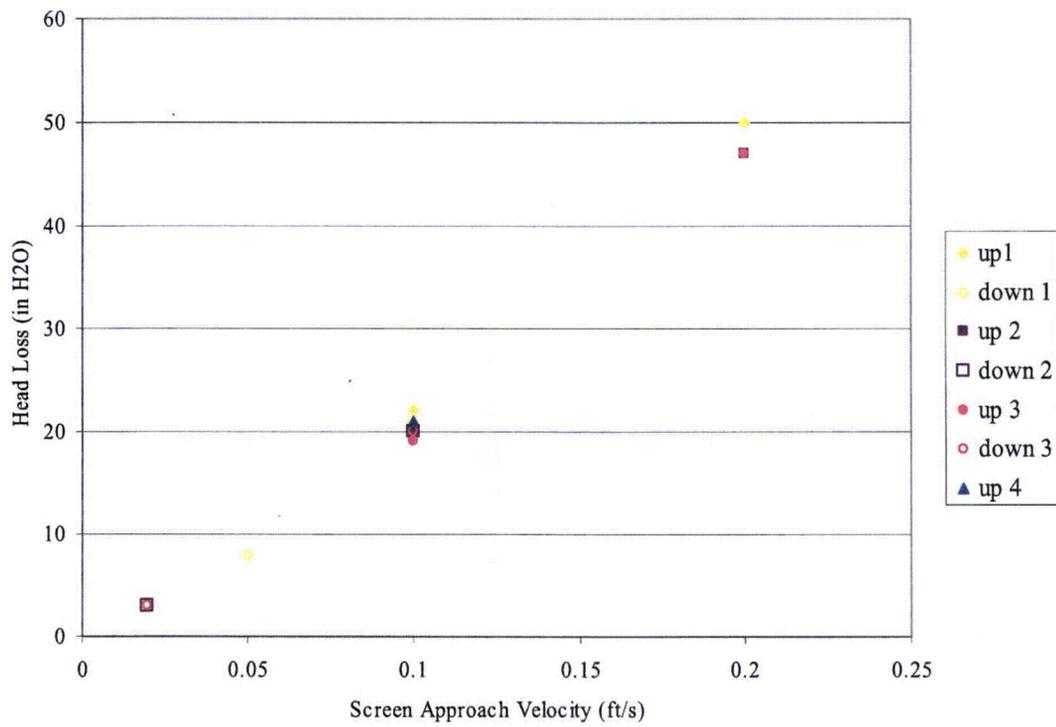
Figure H.3.3. Preliminary PNNL Data, 060425_NO_2703_LP3

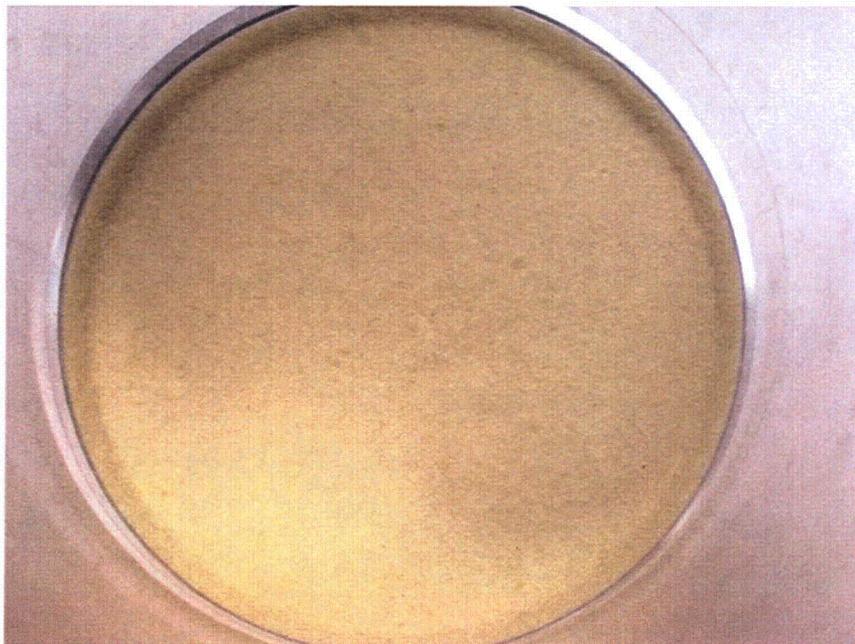
Figure H.3.4. 060425_NO_2703_LP1, LP2, LP3 Debris Bed in Test Section After Retrieval, Top View

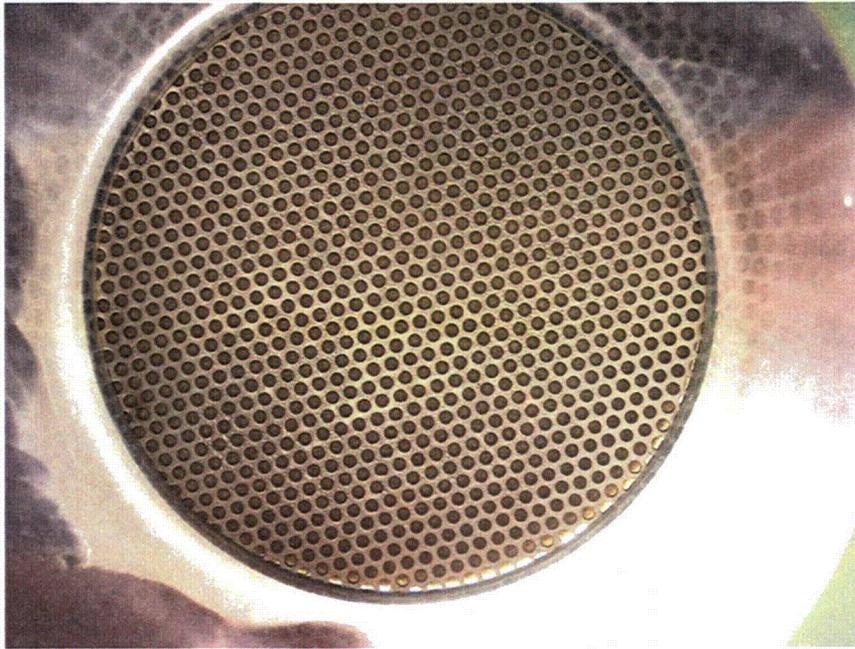
Figure H.3.5. 060425_NO_2703_LP1, LP2, LP3 Debris Bed in Test Section After Retrieval, Bottom View

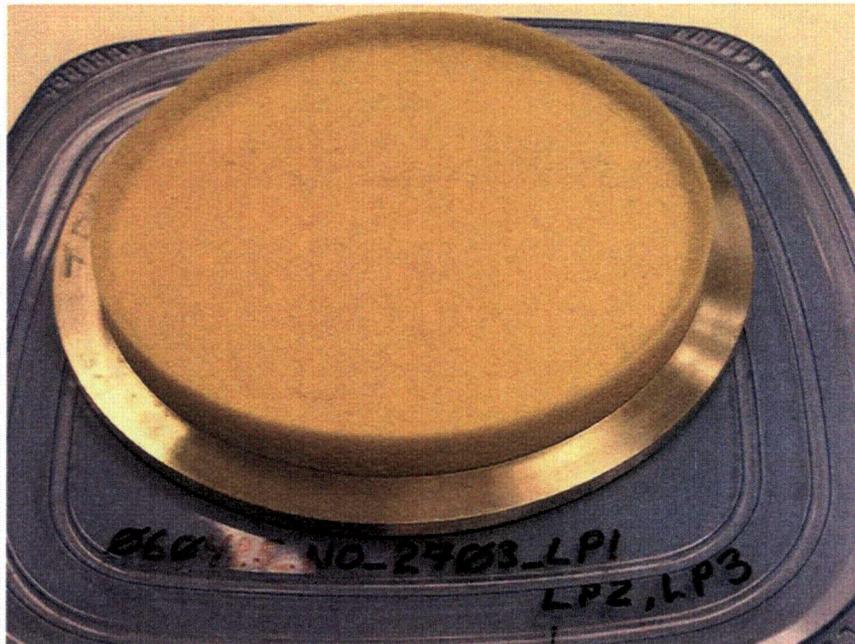
Figure H.3.6. 060425_NO_2703_LP1, LP2, LP3 Debris Bed After Retrieval from Test Section

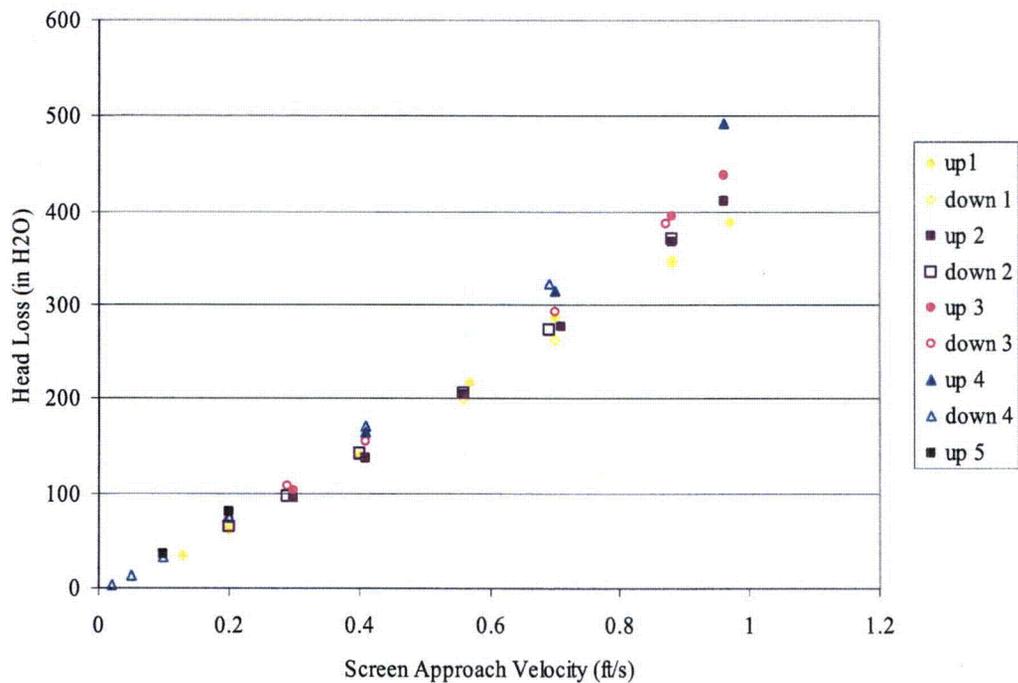
Figure H.4.1. Preliminary PNNL Data

Table H.4.1 contains test conditions. Manual debris bed height measurements are reported in Table H.4.2 and Figures H.4.1. Figure H.4.2 compares preliminary data to prior benchtop results. The top of the screen assembly support ring was used as the reference datum to obtain debris bed height measurements under flow conditions. The actual top of the screen is 0.06 to 0.08 in. below this datum; thus 0.06 in. was added to the reported measurements. Figure H.4.3 shows the test setup; Figures H.4.4 through H.4.6 show the debris bed after the test.

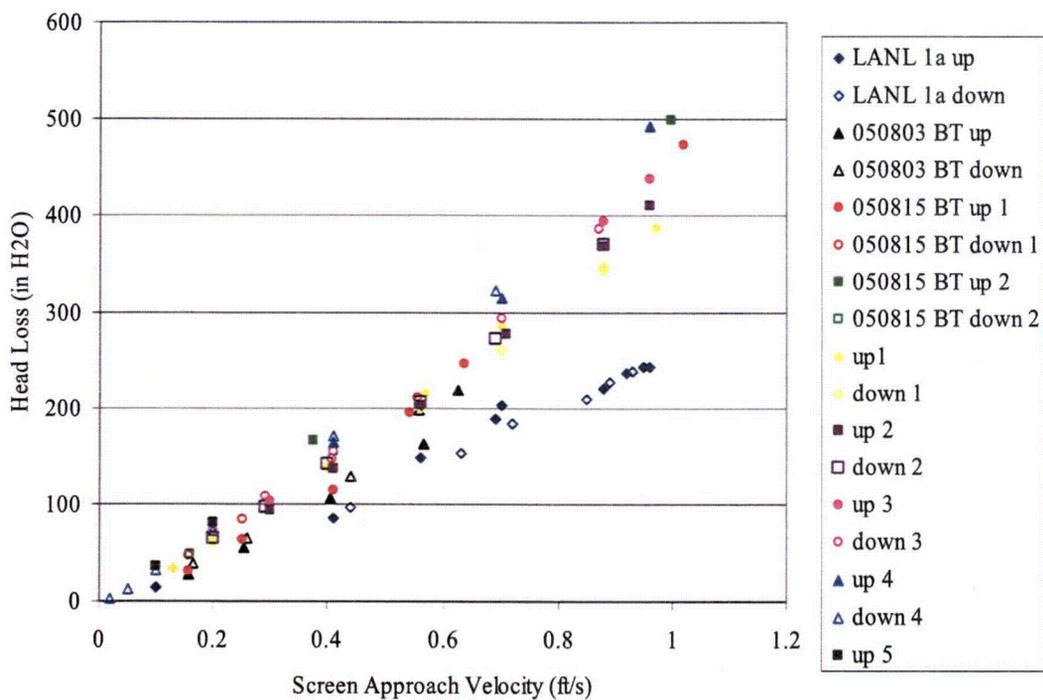
Figure H.4.2. Comparison of Preliminary PNNL Data with Previous Results (BT denotes PNNL benchtop)

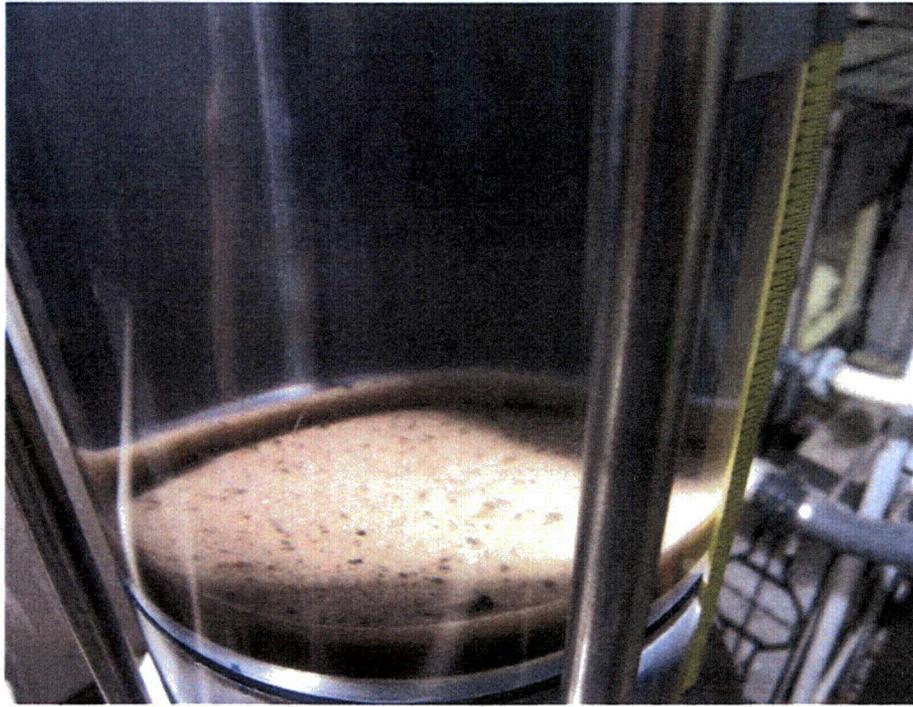
Figure H.4.3. Submerged 051108_NO_3067_L1 Debris Bed During Test

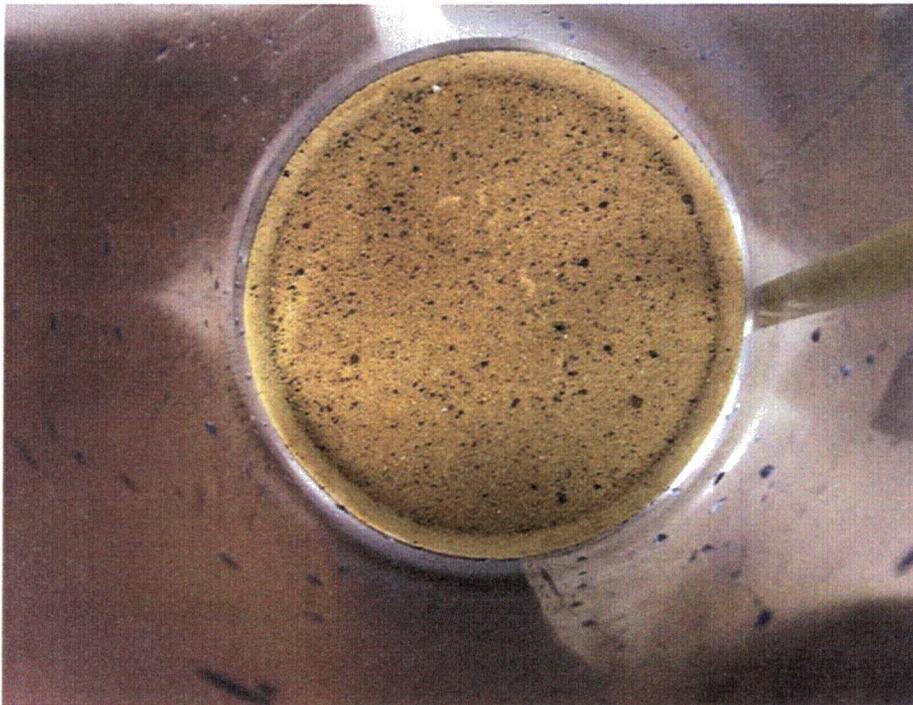
Figure H.4.4. 051108_NO_3067_L1 Debris Bed in Test Section After Retrieval, Top View

| (a) Metal/rust particulate from substitute gate valve is readily apparent on/in debris bed; see photographs, Figures H.4.4–H.4.6. | |

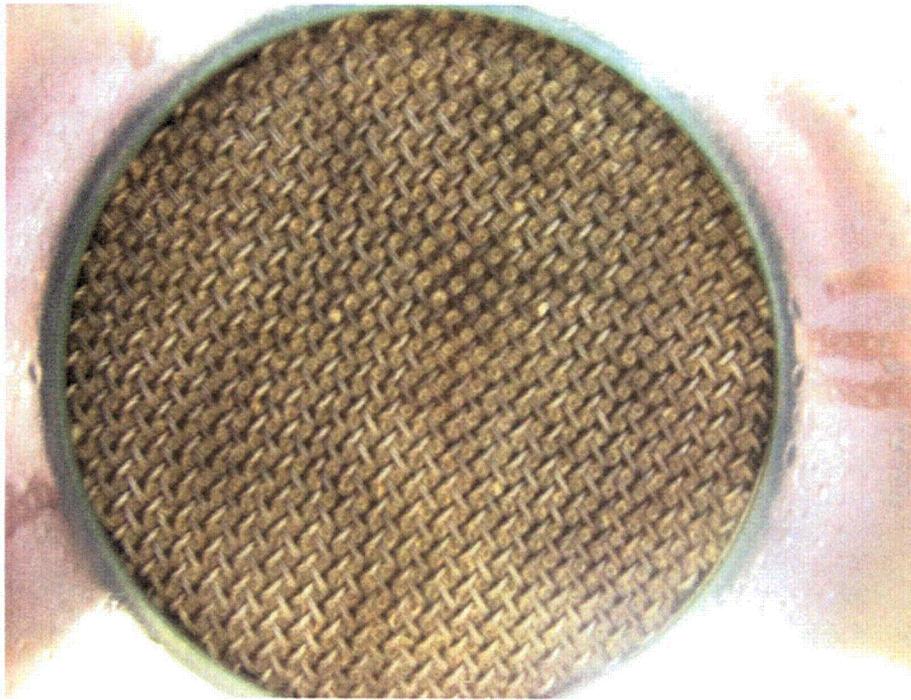
Figure H.4.5. 051108_NO_3067_L1 Debris Bed in Test Section After Retrieval, Bottom View

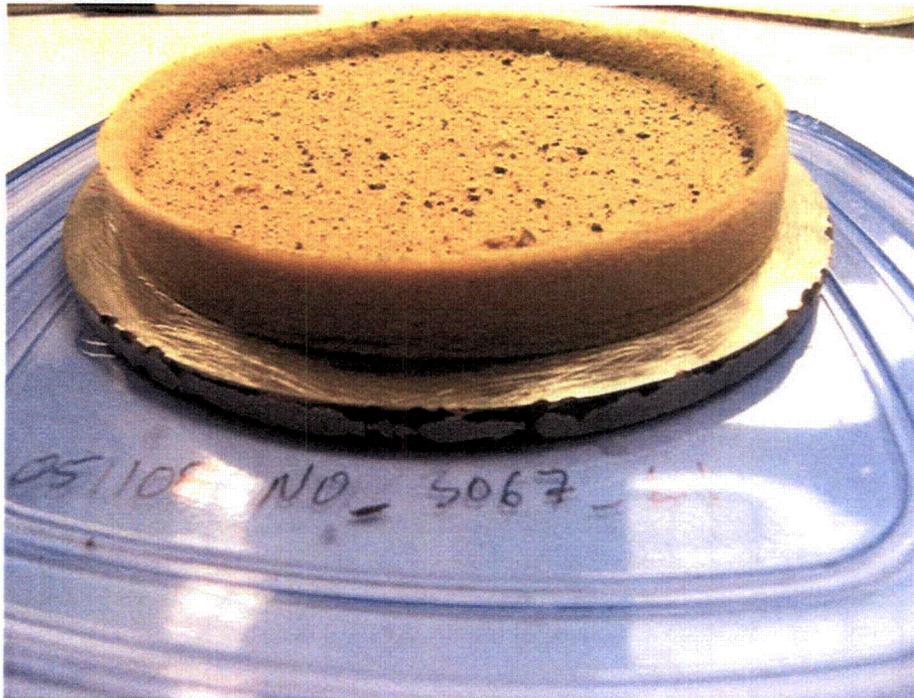
Figure H.4.6. 051108_NO_3067_L1 Debris Bed After Retrieval from Test Section

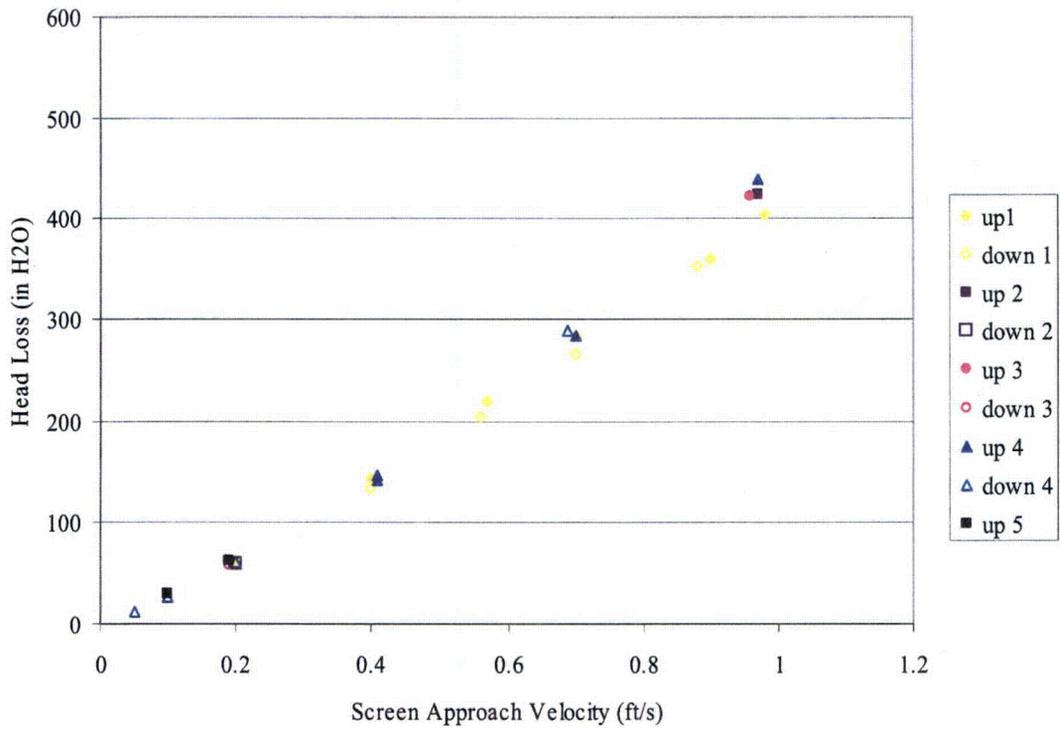
Figure H.5.1. Preliminary PNNL Data; 060125_NO_3067_L1

Manual debris bed height measurements are reported in Table H.5.3 and Figure H.5.1. Figure H.5.2 compares measurements made in several tests. The top of the screen assembly support ring was used as the reference datum to obtain the debris bed height measurements under flow conditions. The actual top of the screen is approximately 0.06 to 0.08 in. below this datum; therefore, 0.06 in has been added to the reported measurements.

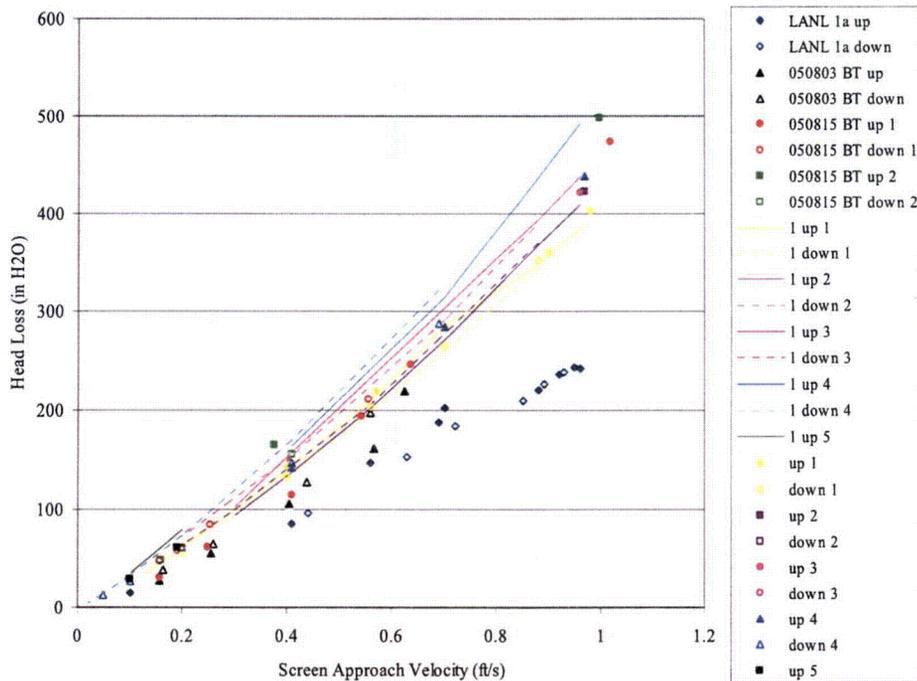
Figure H.5.2. Comparison of Preliminary PNNL Data from Test 060125_NO_3067L1 (denoted as "up" and "down") with Previous Results (BT denotes PNNL benchtop, 1 denotes Test 051108_NO_3067_L1)

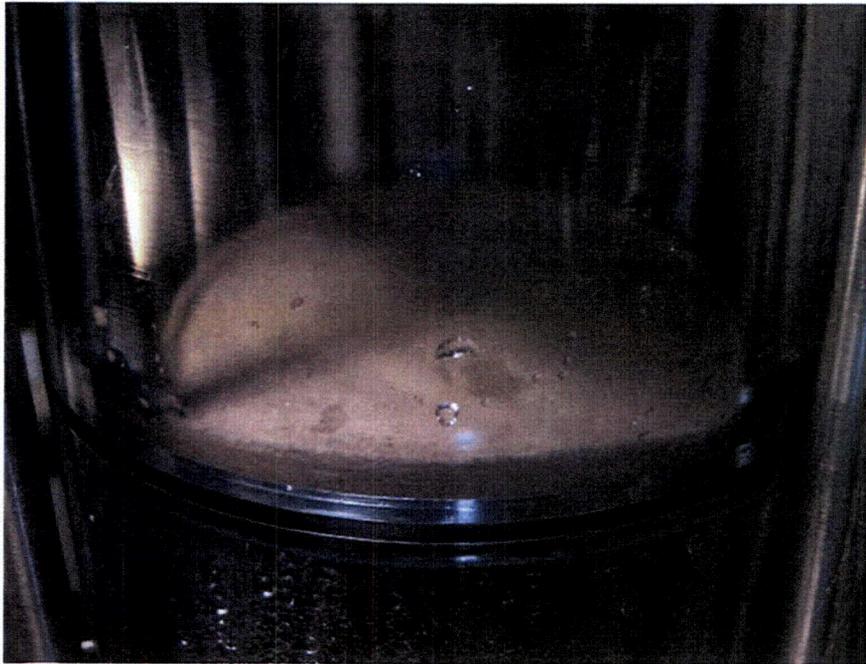
Figure H.5.3. 060125_NO_3067_L1 Debris Bed in Large Scale Loop After Draining

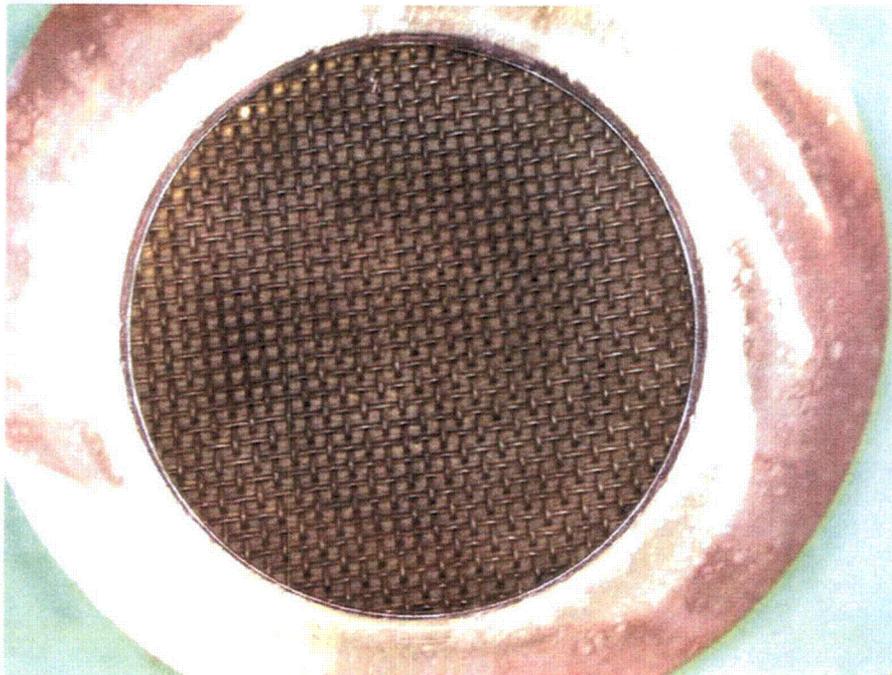
Figure H.5.4. 060125_NO_3067_L1 Debris Bed in Test Section After Retrieval, Bottom View

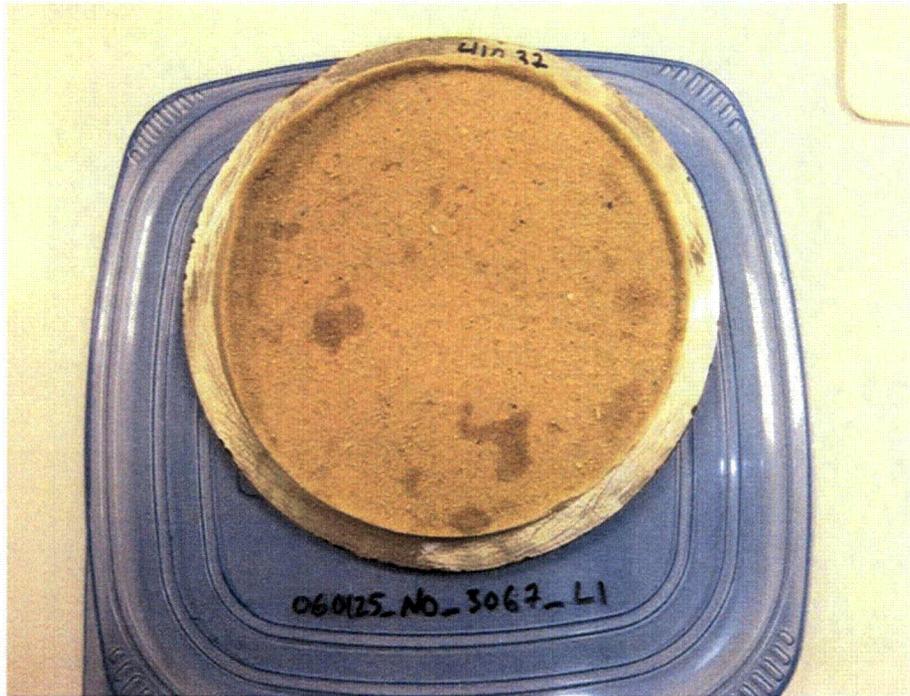
Figure H.5.5. 060125_NO_3067_L1 Debris Bed After Retrieval from Test Section

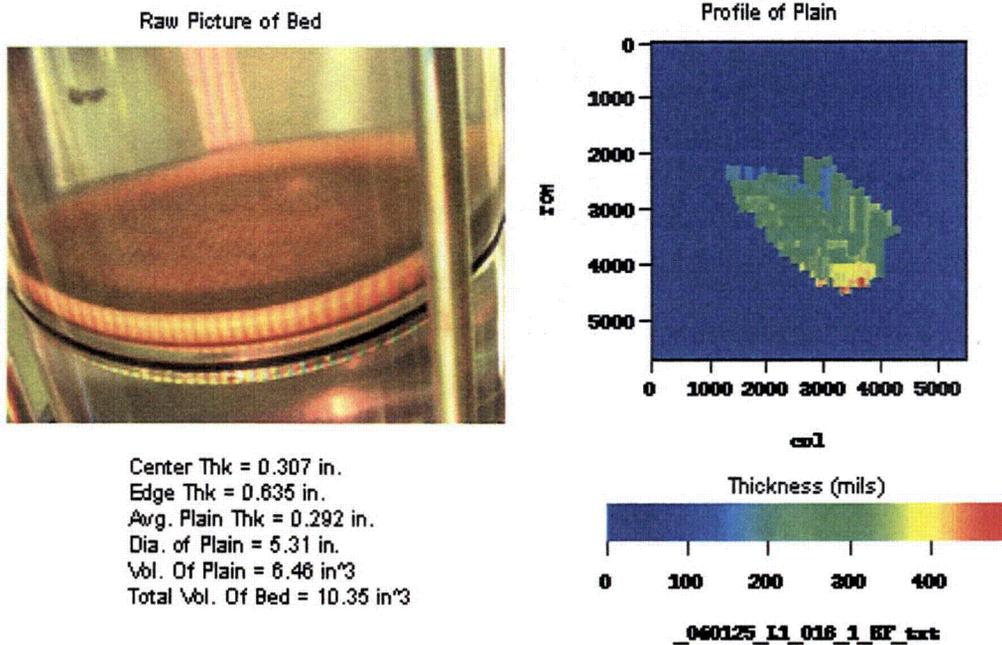
060125_L1_018_1_BF

Figure H.5.6. Contour Plots of Debris Bed Height

The debris bed height determined from the optical triangulation debris bed height measurements are reported in Table H.5.5. These data represent the points analyzed; additional points for evaluation are available. The picture/test condition denotes the test date (060125), the loop and test number in that loop on that date (L for PNNL large scale and 1 for 1st test), screen approach velocity (018 for 0.18 ft/sec, 098 for 0.98 ft/sec, etc.), picture number from camera, and test phase (BF for bed formation, RU1 for first rampup, RU4 for fourth rampup, and RD4 for ramp down 4). The apparent effect of flow condition as indicated by the data in Table H.5.5 suggests that comparison to the post-test measurements in Table H.5.4 is not meaningful. Contour plots of the debris bed height are provided at the end of the photograph section of this report (Figures H.5.6 through H.5.9).
