Appendix D – Large-Scale Data Acquisition System Worksheets

Appendix G – Screen-Only Quick Look Reports

Appendix H – NUKON Only Quick Look Reports

Appendix I – CalSil-Only Quick-Looks

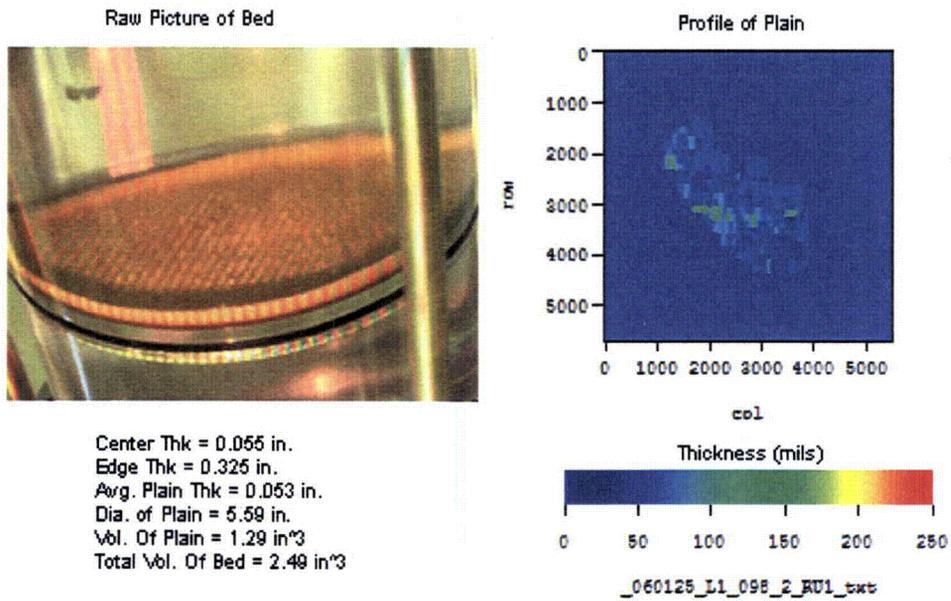
060125_L1_098_2_RU1

Figure H.5.7. Contour Plots of Debris Bed Height

The debris bed height determined from the optical triangulation debris bed height measurements are reported in Table H.5.5. These data represent the points analyzed; additional points for evaluation are available. The picture/test condition denotes the test date (060125), the loop and test number in that loop on that date (L for PNNL large scale and 1 for 1st test), screen approach velocity (018 for 0.18 ft/sec, 098 for 0.98 ft/sec, etc.), picture number from camera, and test phase (BF for bed formation, RU1 for first rampup, RU4 for fourth rampup, and RD4 for ramp down 4). The apparent effect of flow condition as indicated by the data in Table H.5.5 suggests that comparison to the post-test measurements in Table H.5.4 is not meaningful. Contour plots of the debris bed height are provided at the end of the photograph section of this report (Figures H.5.6 through H.5.9).

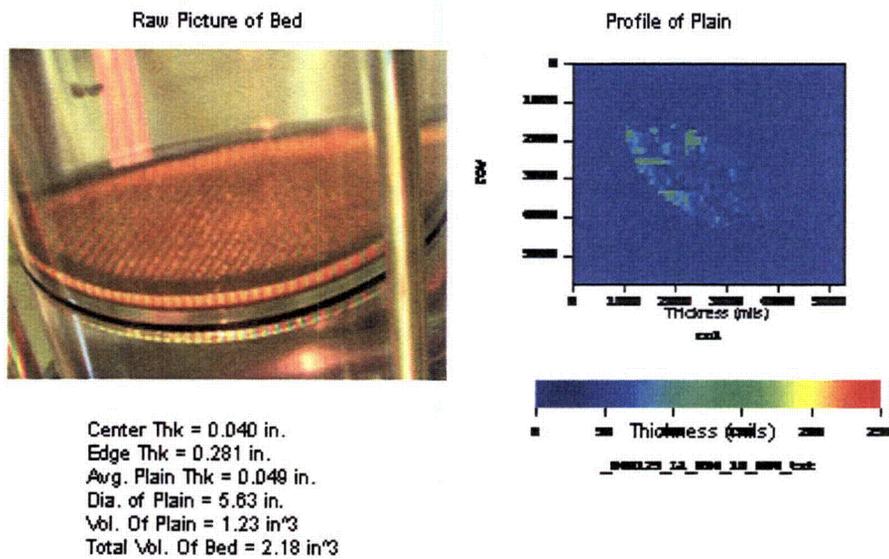
060125_L1_096_10_RU4

Figure H.5.8. Contour Plots of Debris Bed Height

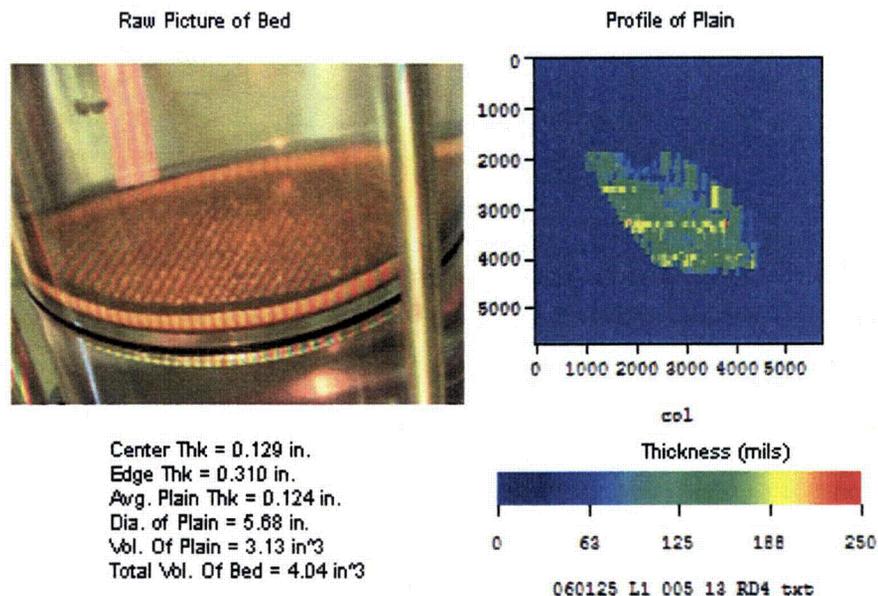
060125_L1_005_13_RD4

Figure H.5.9. Contour Plots of Debris Bed Height

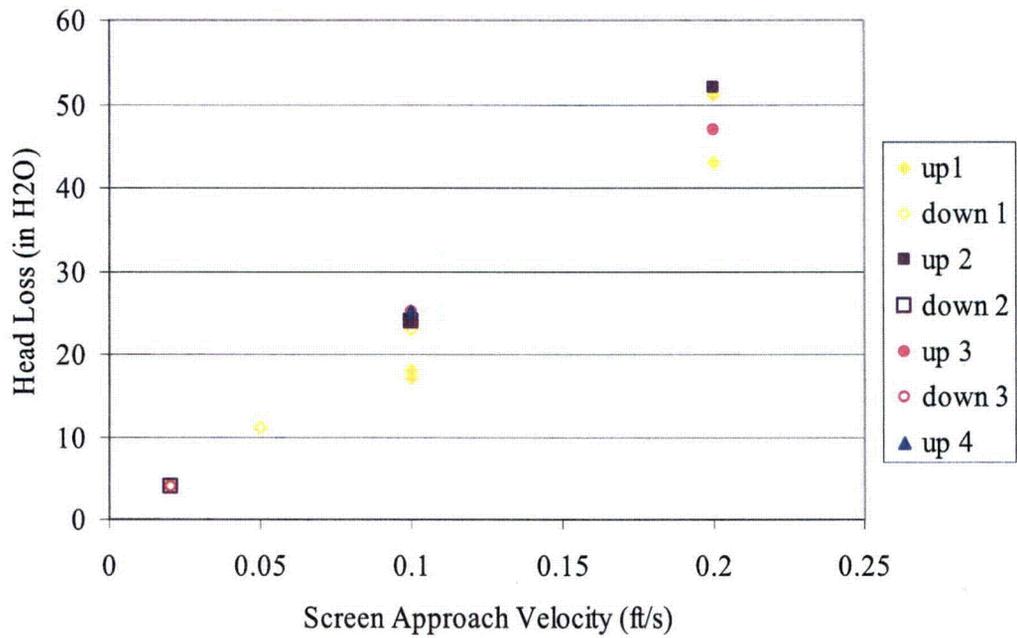
Figure H.6.1. Preliminary PNNL Data, LP1

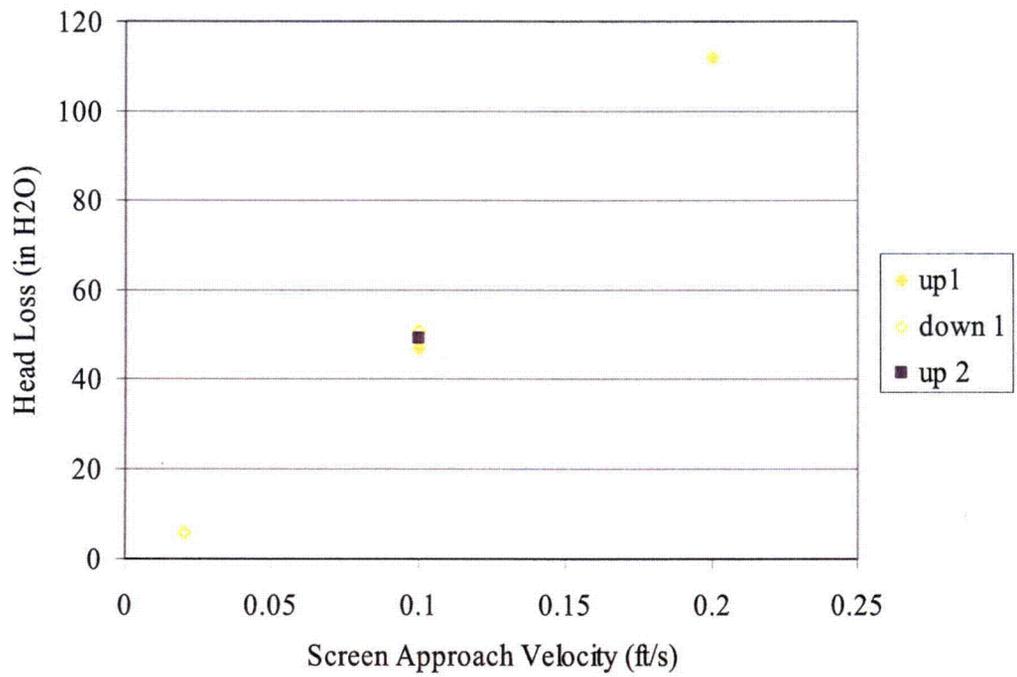
Figure H.6.2. Preliminary PNNL Data, LP2

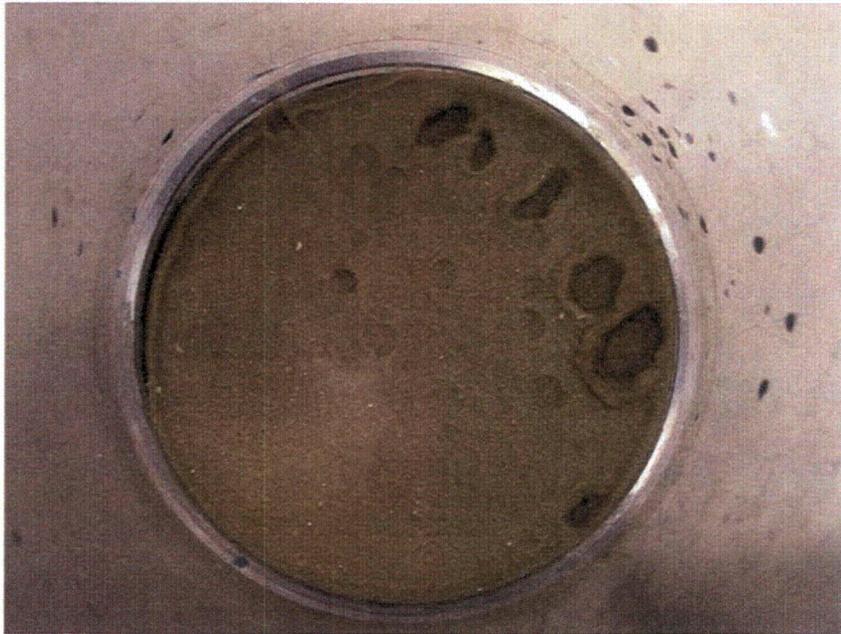
Figure H.6.3. Debris Bed in Test Section After Retrieval, Top View. Disturbed post-test.

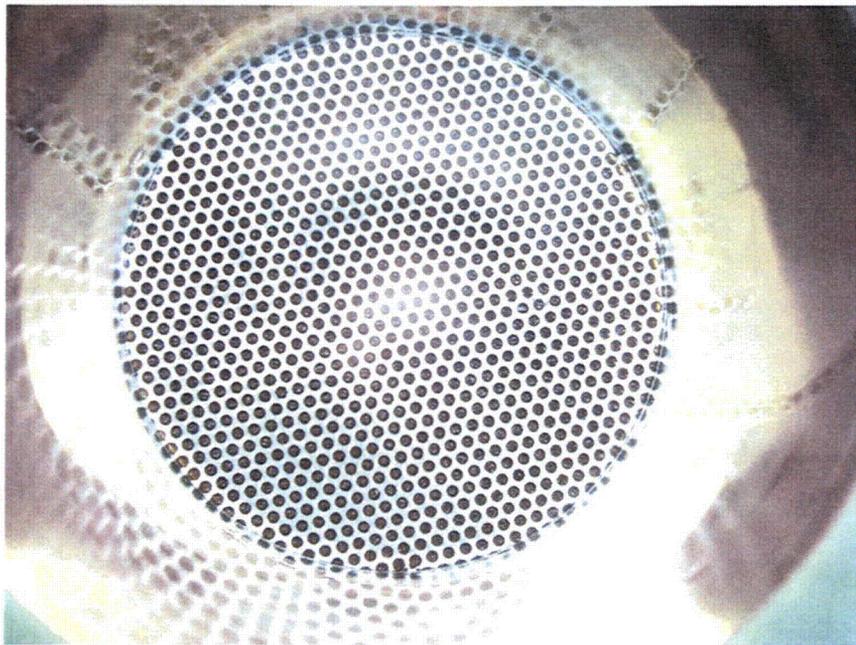
Figure H.6.4. Debris Bed in Test Section After Retrieval, Bottom View.

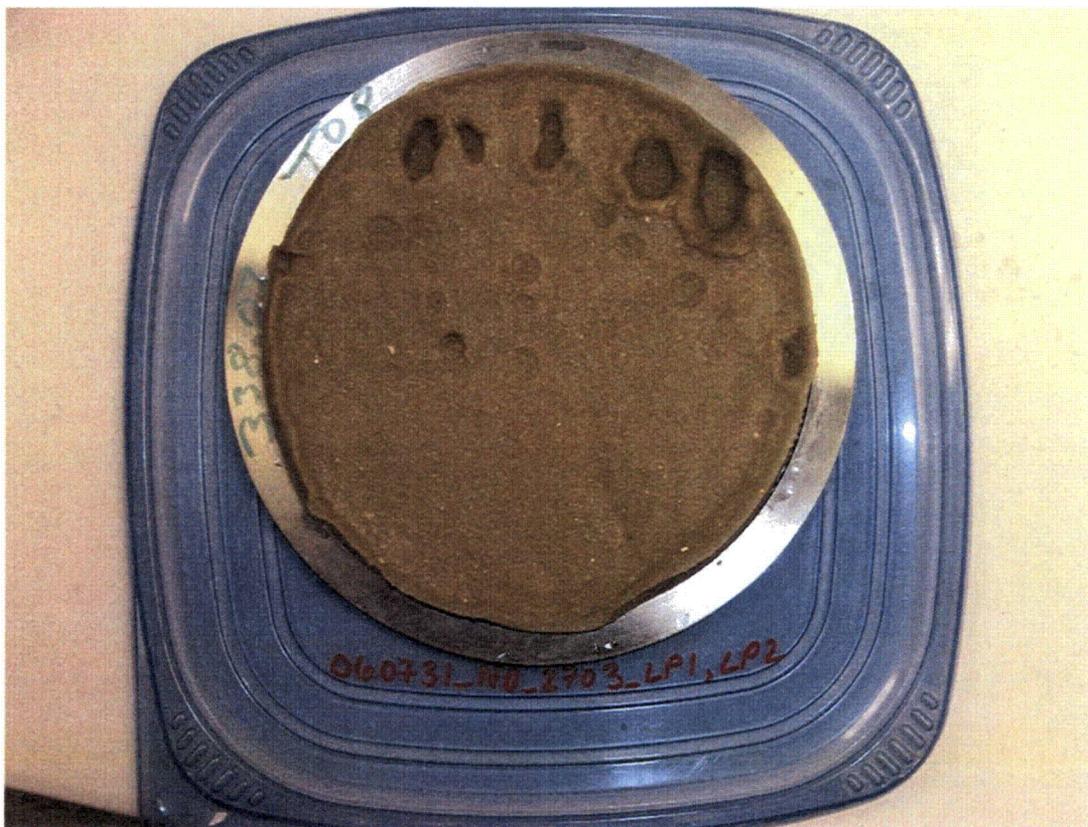
Figure H.6.5. Debris Bed After Retrieval from Test Section, Disturbed Post-Test

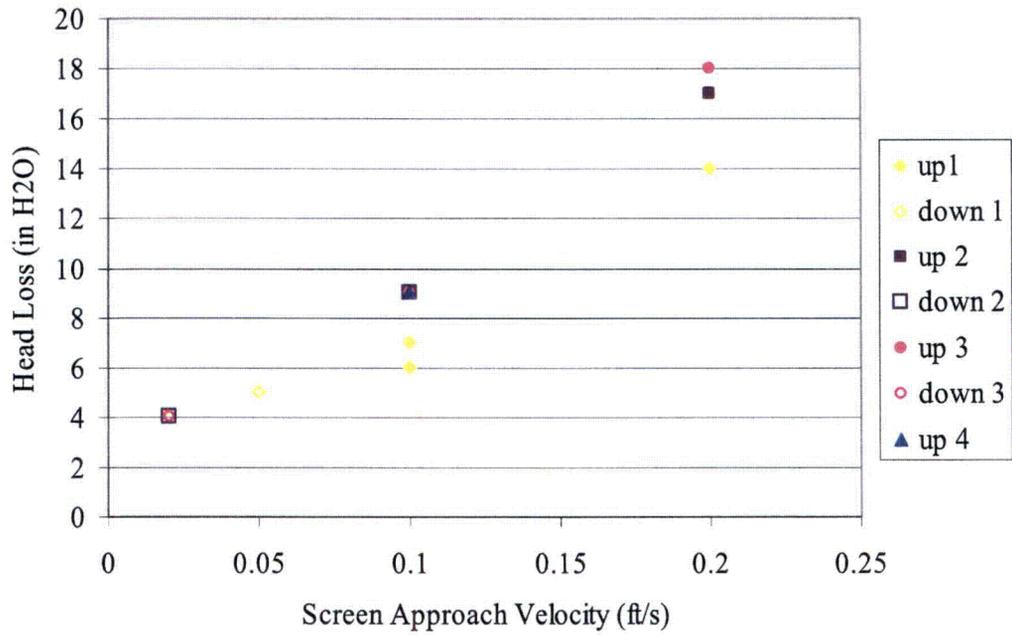
Figure H.7.1. Preliminary PNNL Data, LP1

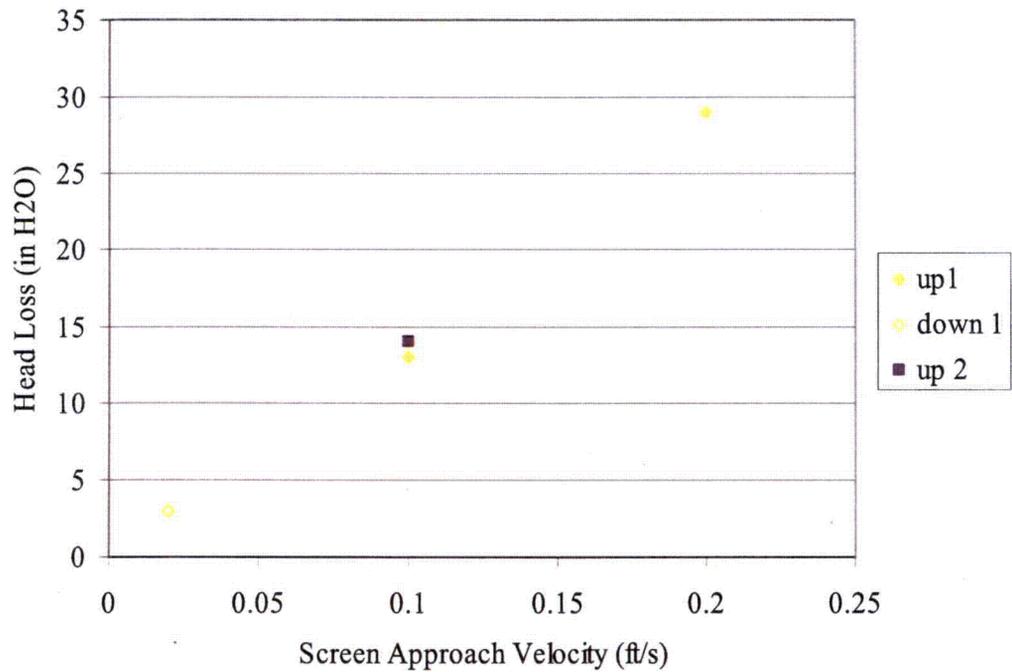
Figure H.7.2. Preliminary PNNL Data, LP2

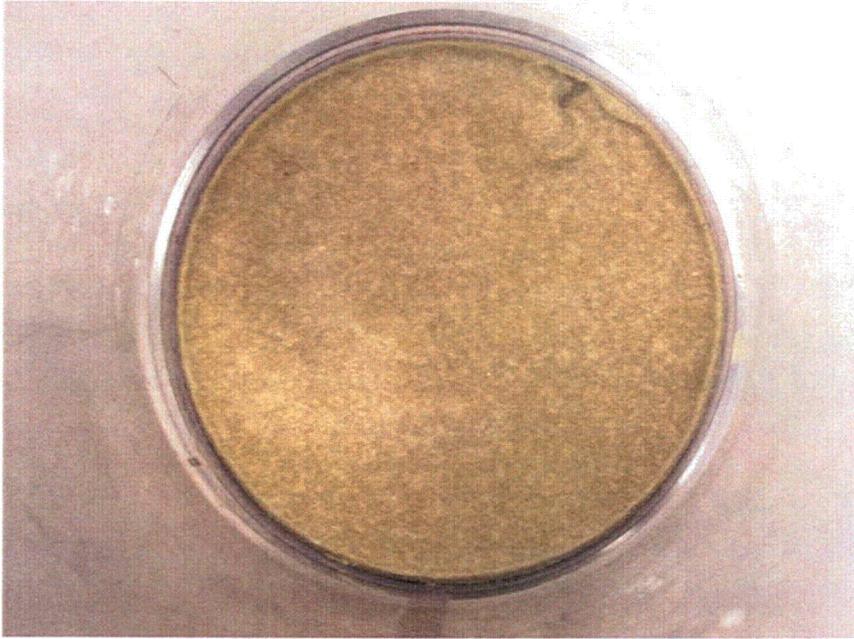
Figure H.7.3. Debris Bed in Test Section After Retrieval, Top View. Disturbed post-test.

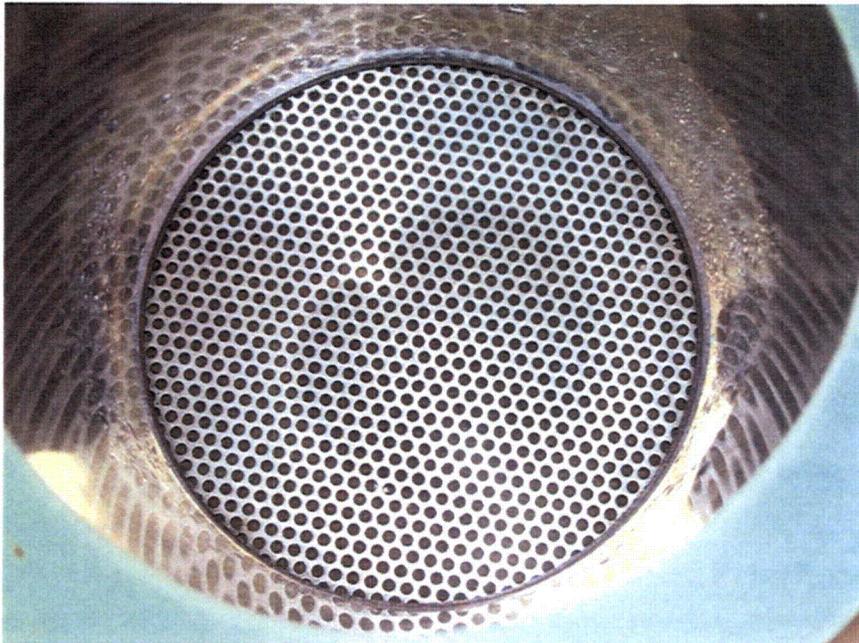
Figure H.7.4. Debris Bed in Test Section After Retrieval, Bottom View

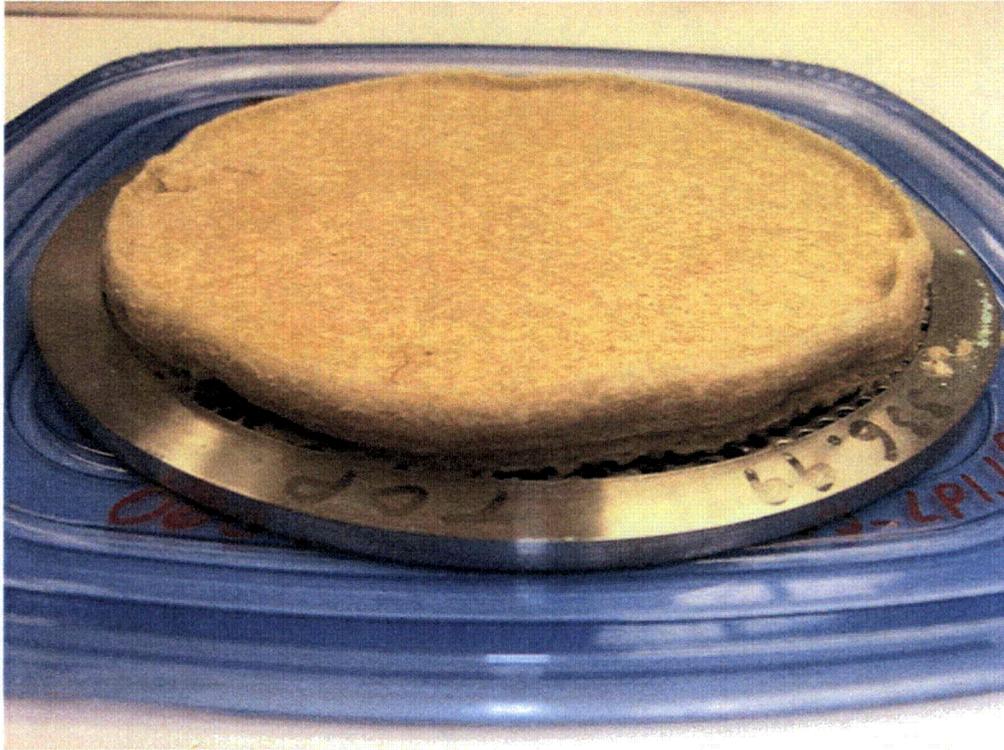
Figure H.7.5. Debris Bed After Retrieval from Test Section. Disturbed post-test.

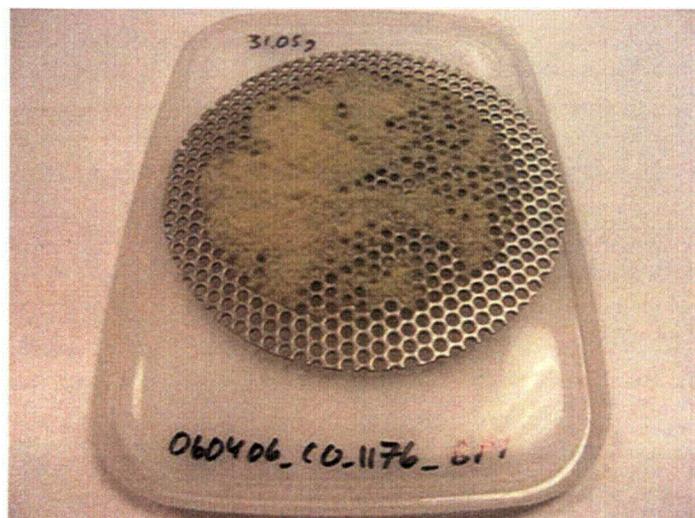
Figure I.1.1. 060406_CO_1176_BP1 Debris Bed Post-Retrieval

For debris bed removal, the standard procedure was used. Because there was little to no head loss, the test section water may have been removed too fast (compared with completely formed minimum loading NUKON-only debris beds), and a potentially significant portion of the retained CalSil debris was observed to be flushed off the screen. The area of plate exposed due to lost debris can be described as that portion exposed on the right side of Figure I.1.1 (prior to retrieval, this screen area may have been covered) that still has some residual debris and is within the flow area. The total plate diameter is approximately 5 in., and that exposed to the flow is 4 in. With water being observed to be removed at an accelerated rate, it may be assumed that there were holes already in the debris bed before retrieval, creating relatively small restriction to flow.

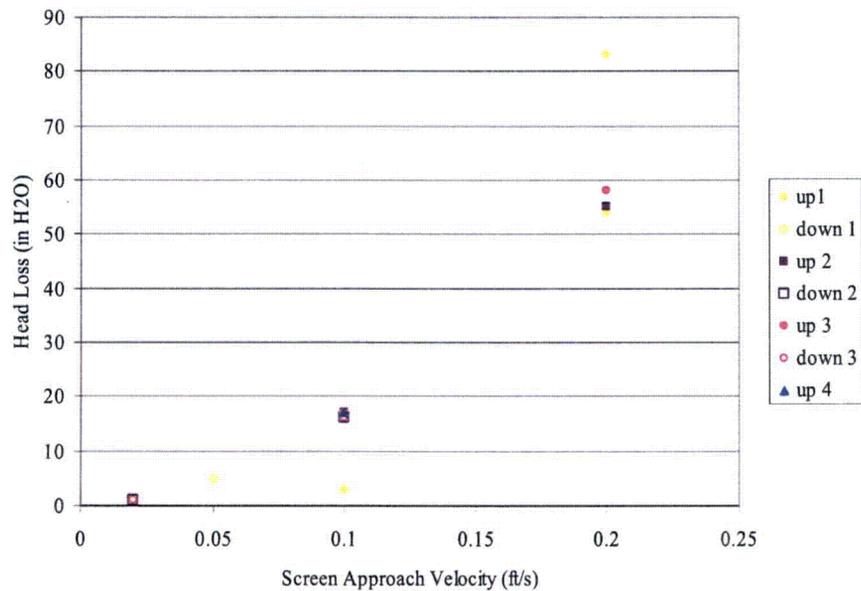
Figure I.2.1. Preliminary PNNL Data; 060512_CO_8108_LP1

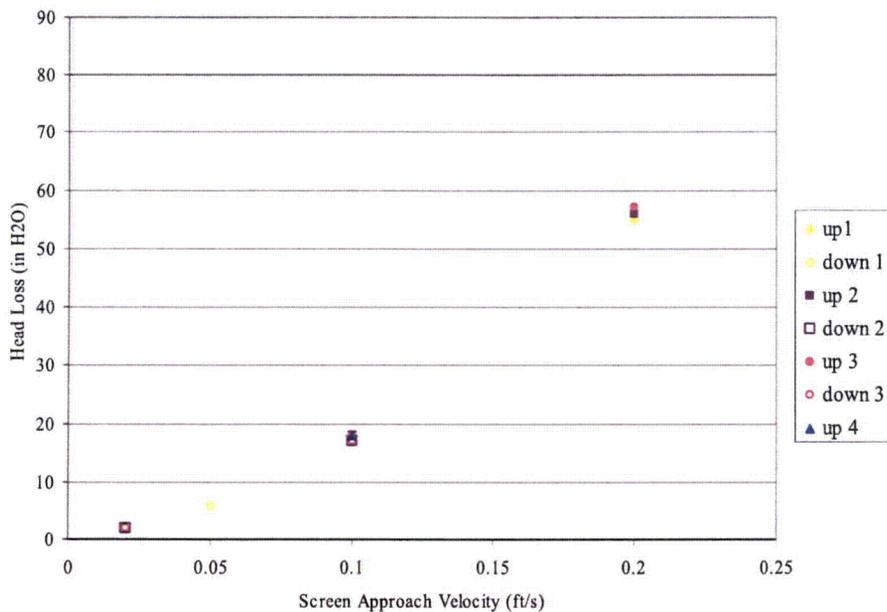
Figure I.2.2. Preliminary PNNL Data; 060512_CO_8108_LP2

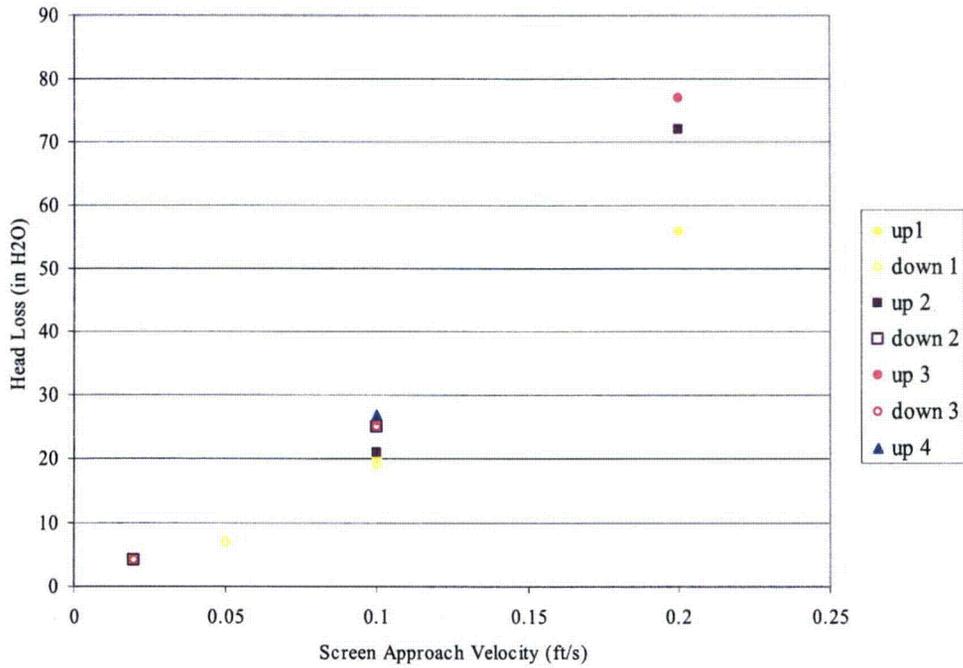
Figure I.2.3. Preliminary PNNL Data; 060512_CO_8108_LP3

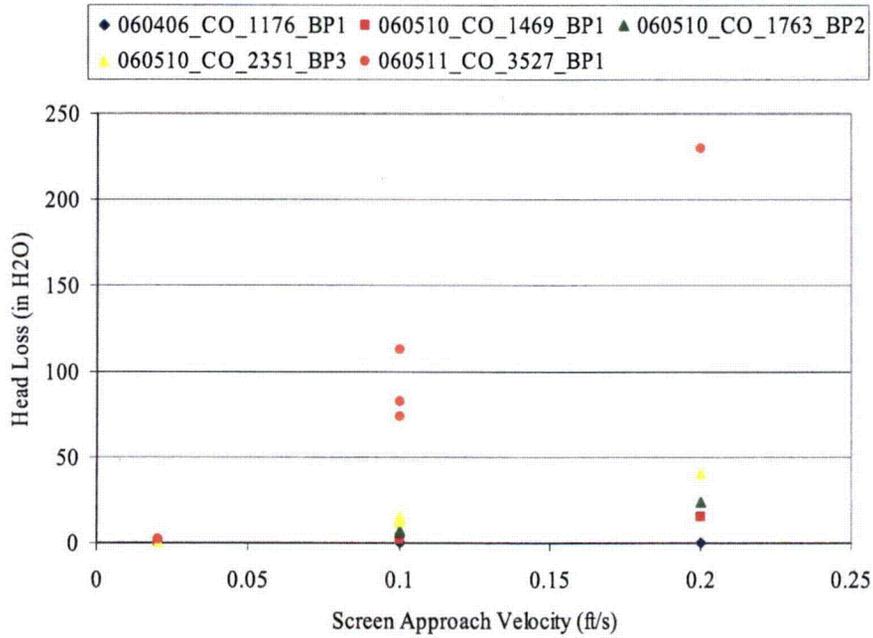
Figure I.2.4. Preliminary PNNL Data, Priority 2, Benchtop Loop

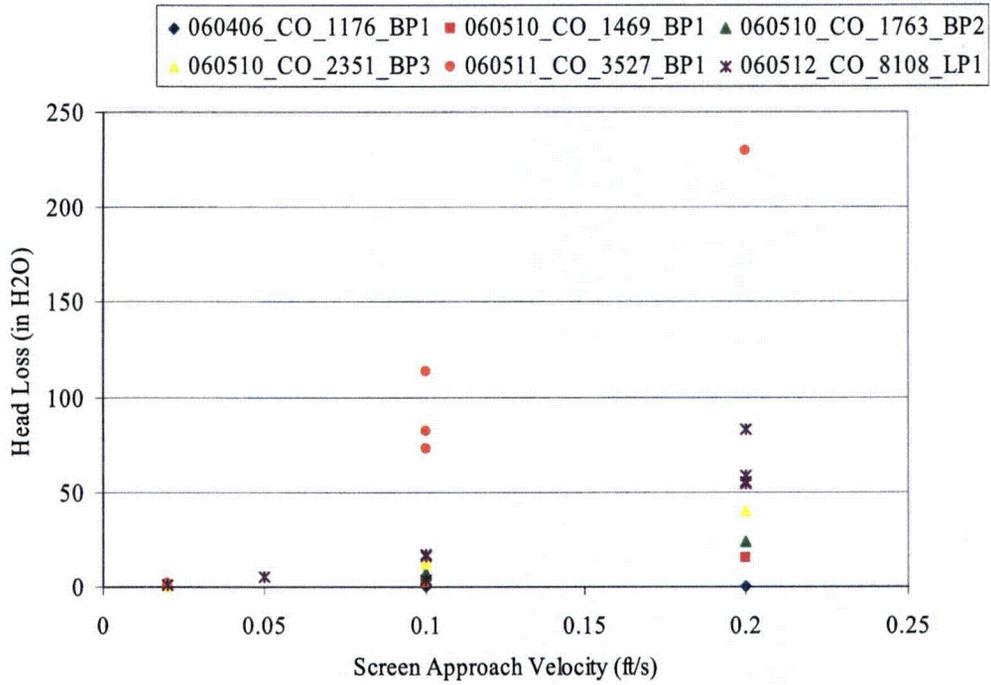
Figure I.2.5. Preliminary PNNL Data, Priority 2, Benchtop Loop and 060512_CO_8108_LP1

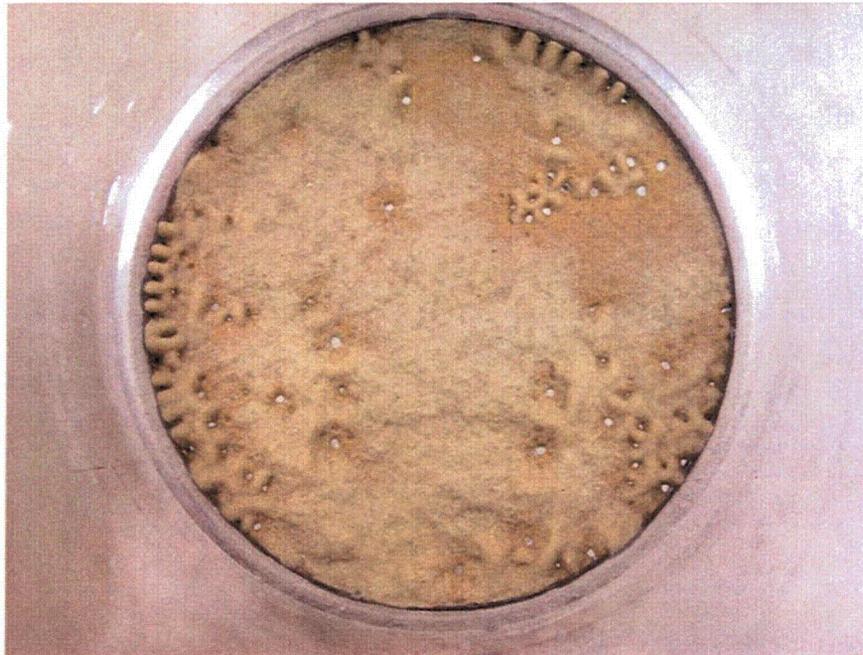
Figure I.2.6. 060512_CO_8108_LP1, LP2, and LP3 Debris Bed in Test Section After Retrieval, Top View

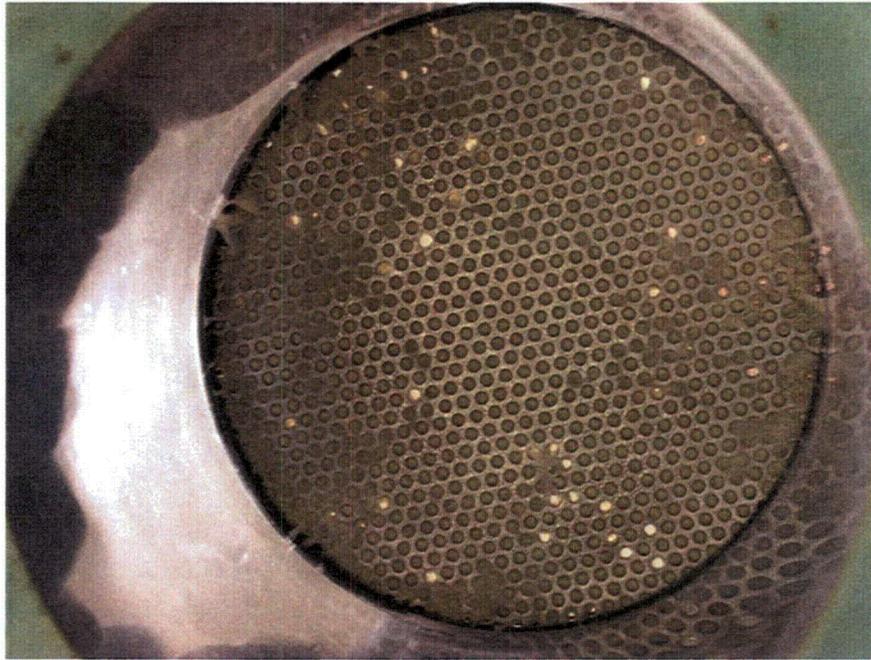
Figure I.2.7.060512_CO_8108_LP1, LP2, and LP3 Debris Bed in Test Section After Retrieval, Bottom View

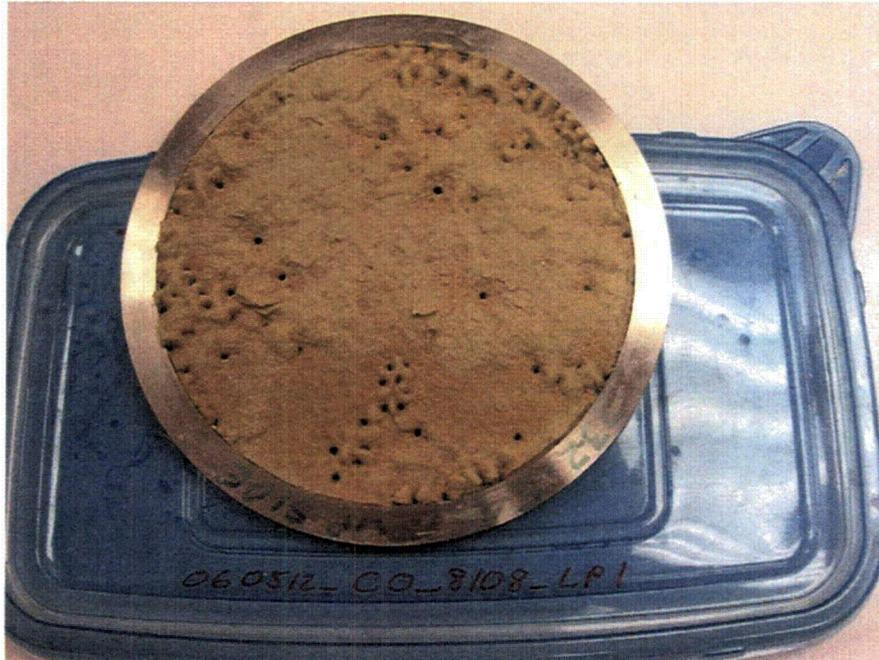
Figure I.2.8. 060512_CO_8108_LP1, LP2, and LP3 Debris Bed After Retrieval from Test Section

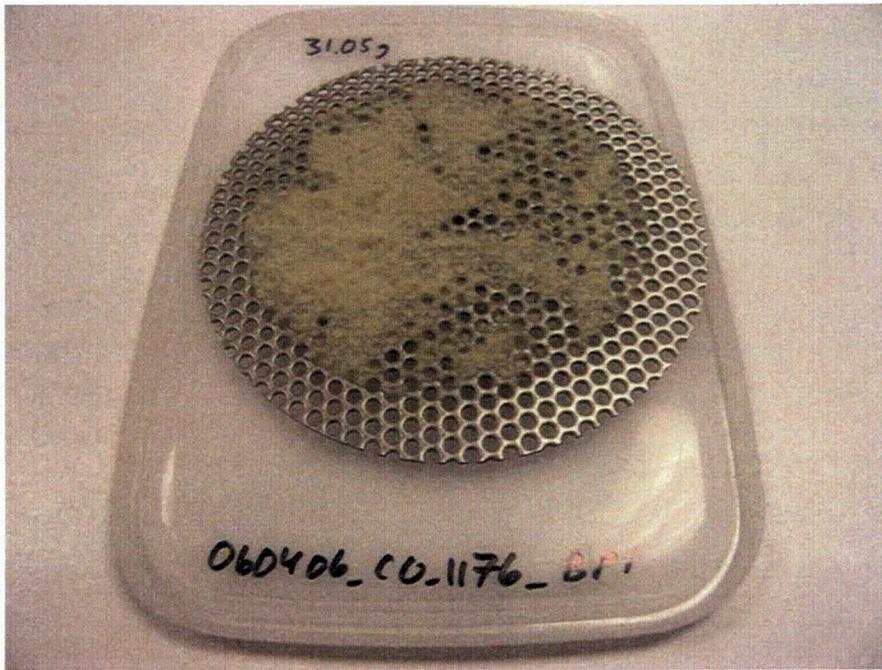
Figure I.2.9. 060406_CO_1176_BP1 Debris Bed Post-Retrieval (see Figure I.1)

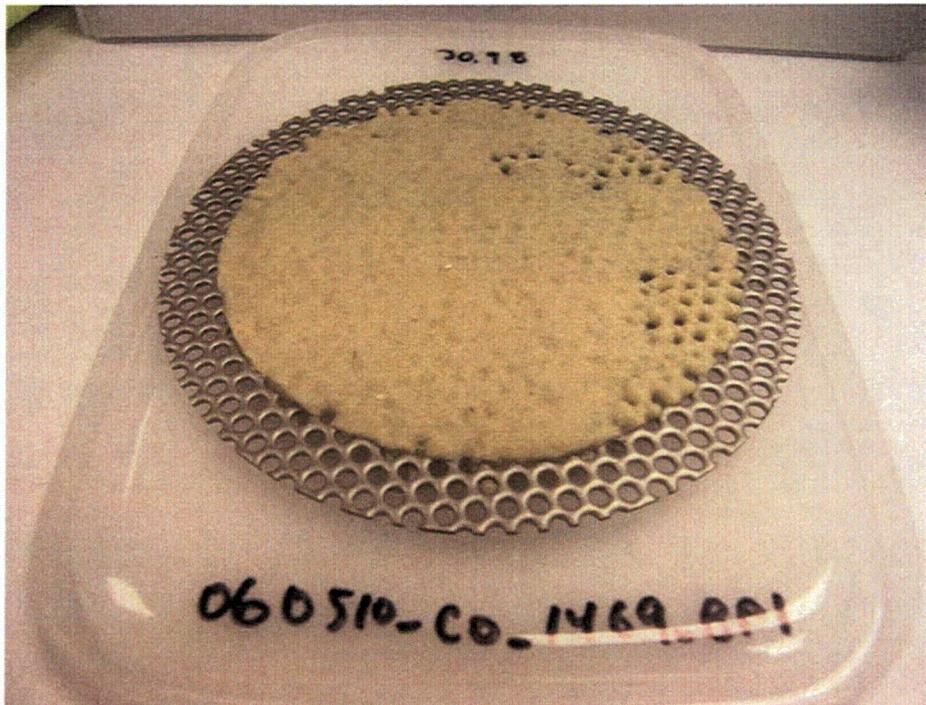
Figure I.2.10. 060510_CO_1469_BP1 Debris Bed Post-Retrieval

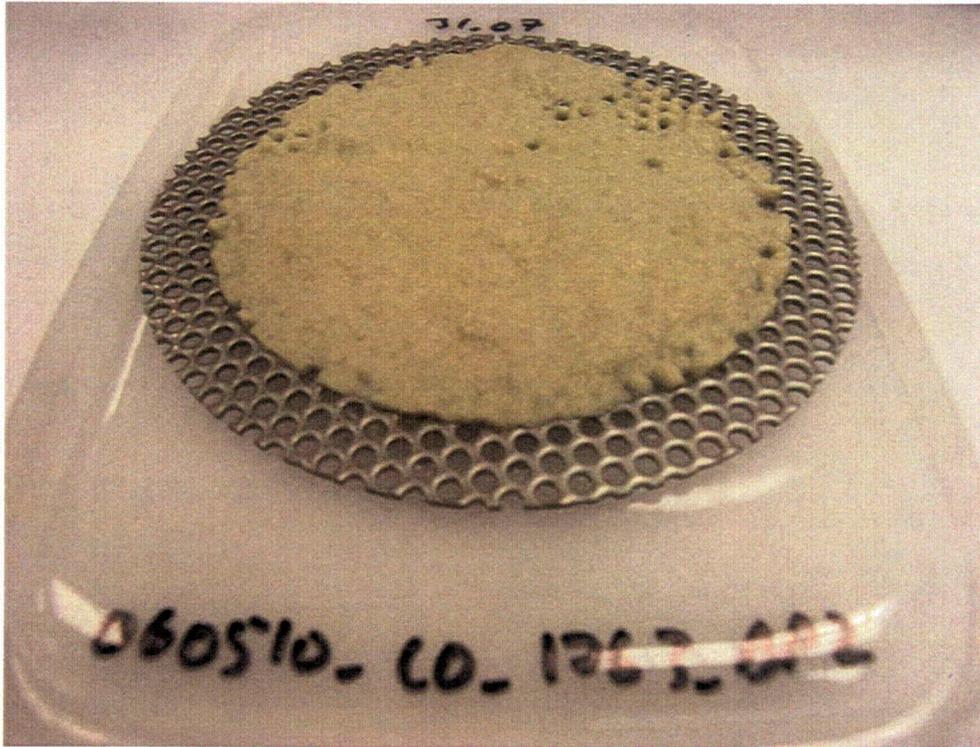
Figure I.2.11. 060510_CO_1763_BP2 Debris Bed Post-Retrieval

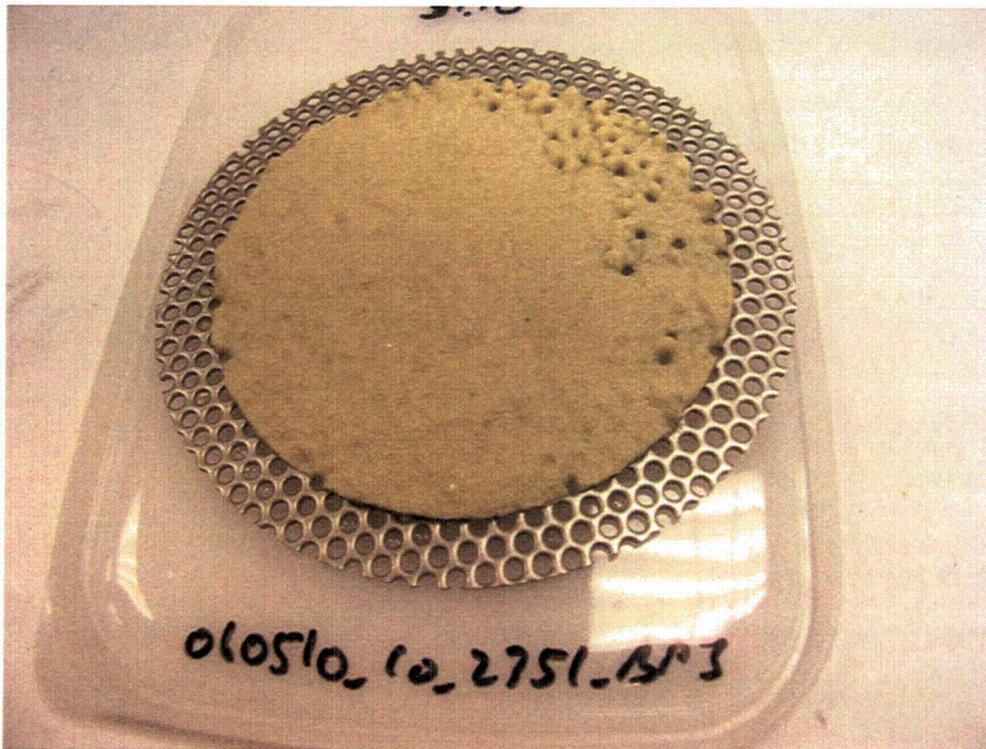
Figure I.2.12. 060510_CO_2751_BP3 Debris Bed Post-Retrieval

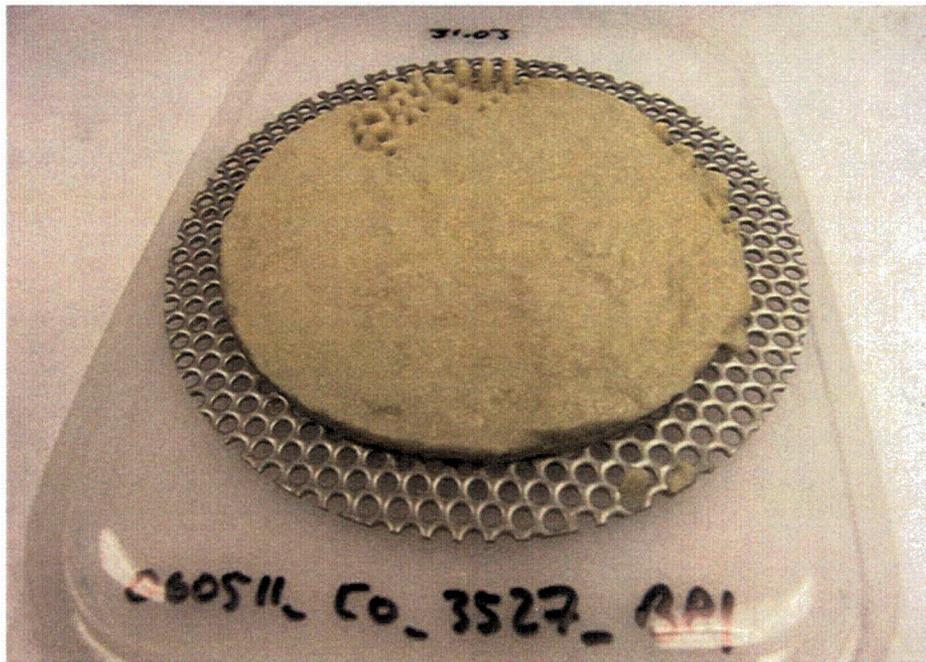
Figure I.2.13. 060511_CO_3527_BP1 Debris Bed Post-Retrieval
