Photo 5. December 4, 2007- Vibromax 1105 vibratory smooth drum roller used to compact test pad fill.

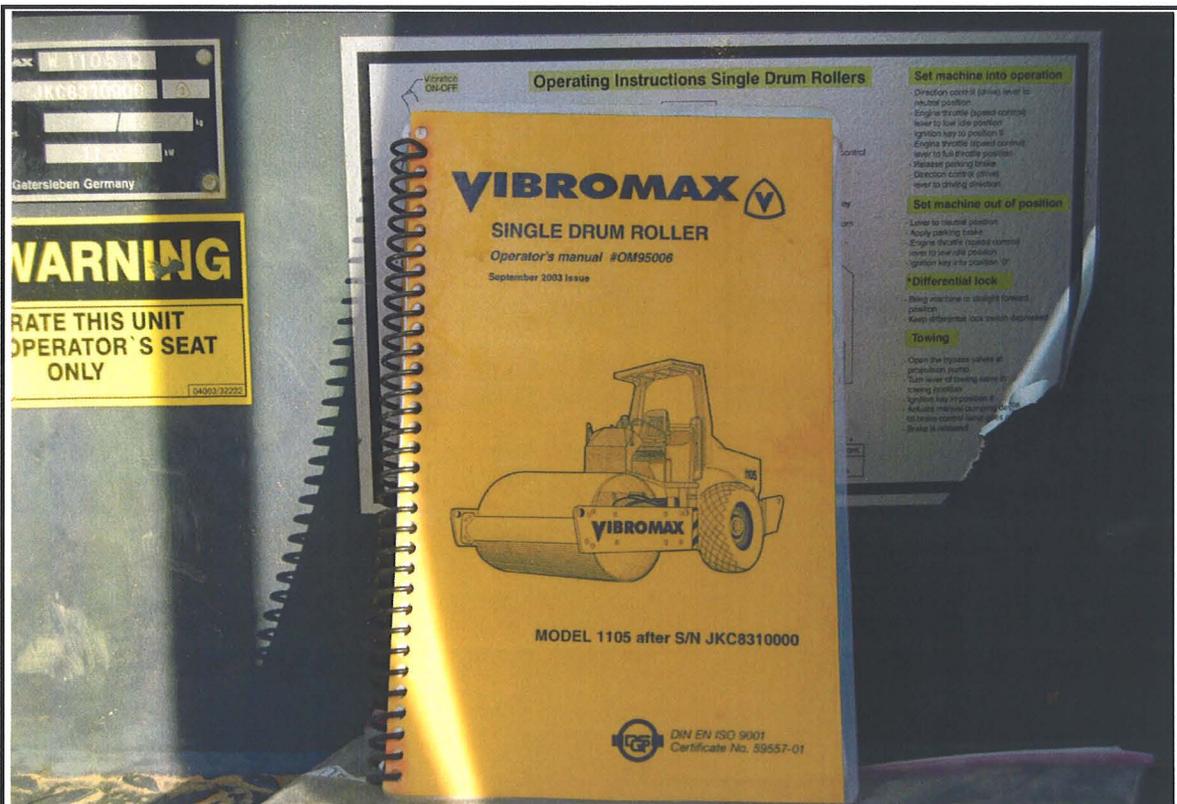
Photo 6. December 4, 2007- Cover of the Operations Manual for the Vibromax 1105 roller used during compaction of test pad fill.

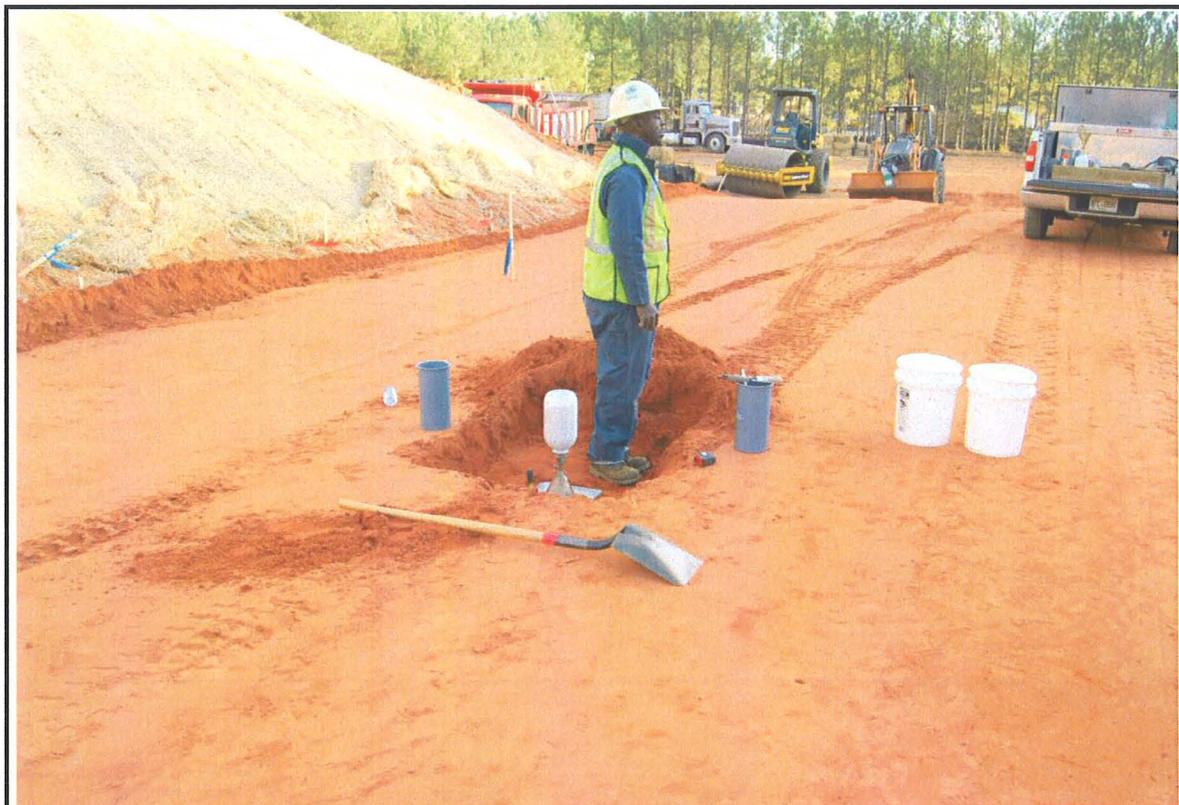
Photo 8. December 4, 2007 – Sand cone density test is underway by Roger Blalock. Two 5-gallon bulk samples will be obtained from the density test layer for testing.

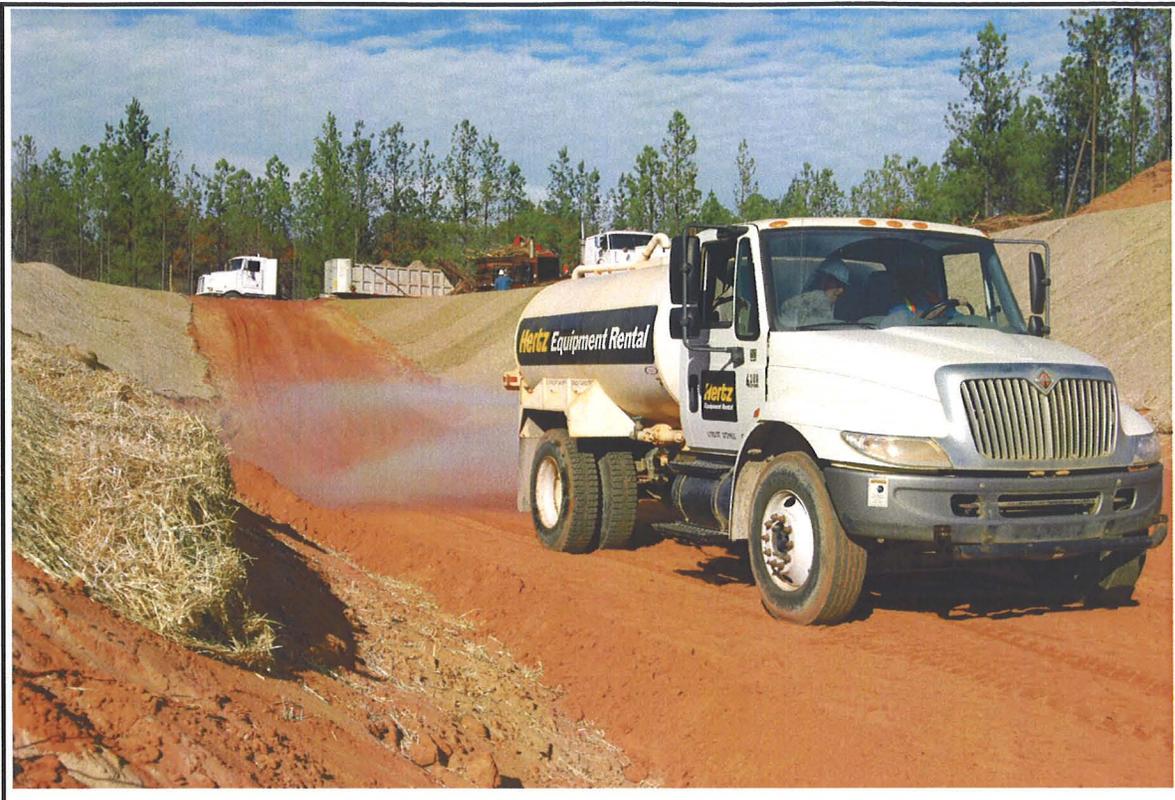
Photo 9. December 5, 2007- Moisture conditioning of fill layer.

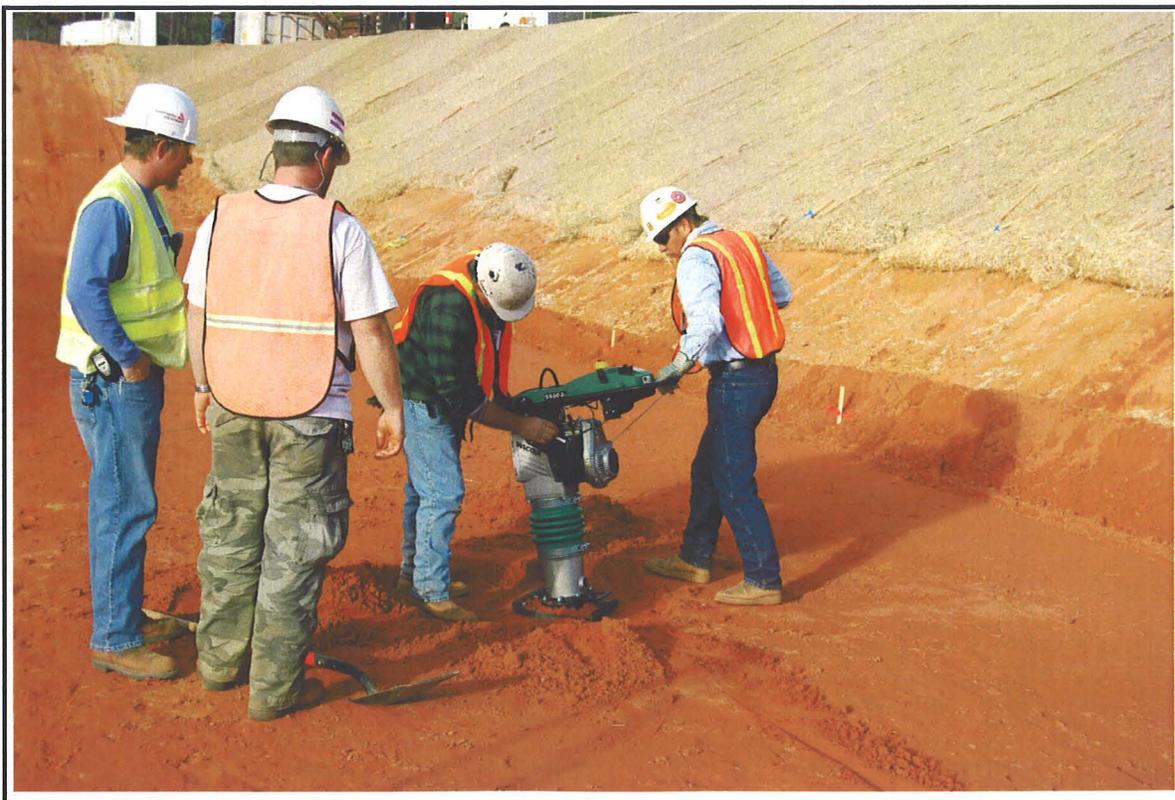
Photo 10. December 5, 2007 – A sand cone density test excavation is being repaired with a “Wacker Packer”.

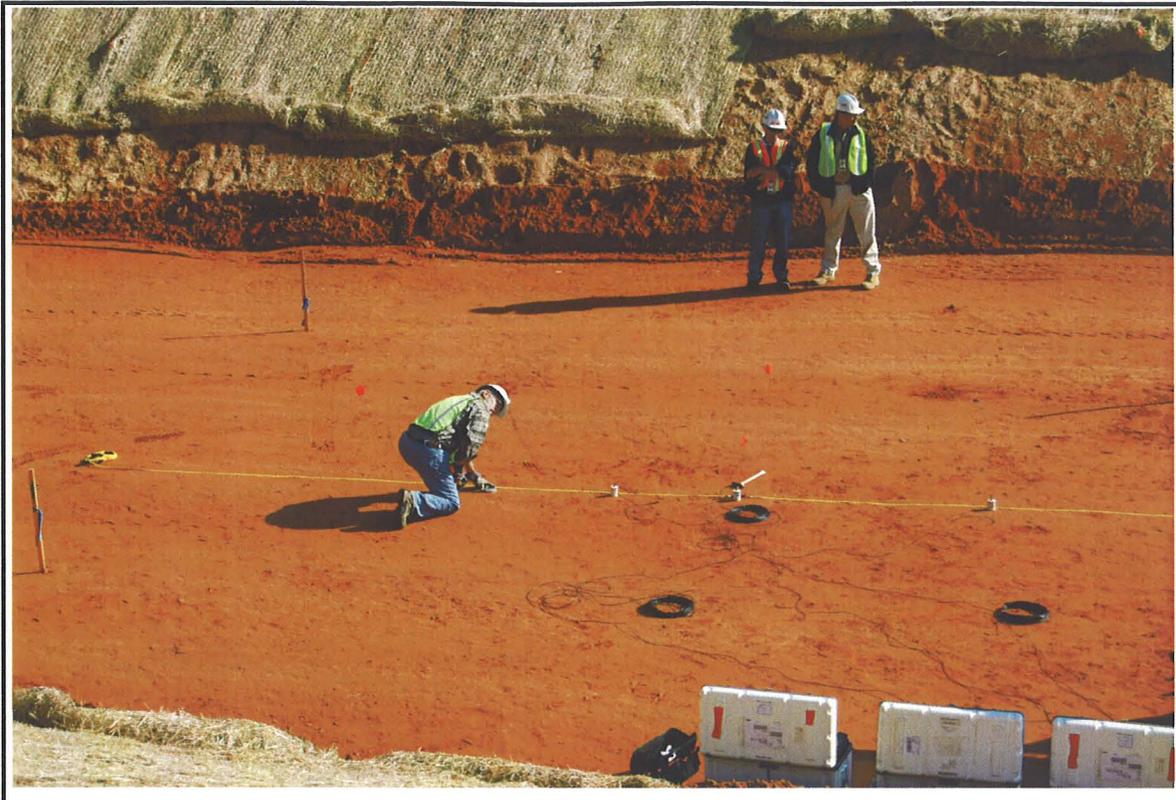
Photo 11. December 9, 2007- Dr. Stokoe generates vibrations for Spectral Analysis of Surface Wave (SASW) testing, at shallow depth.

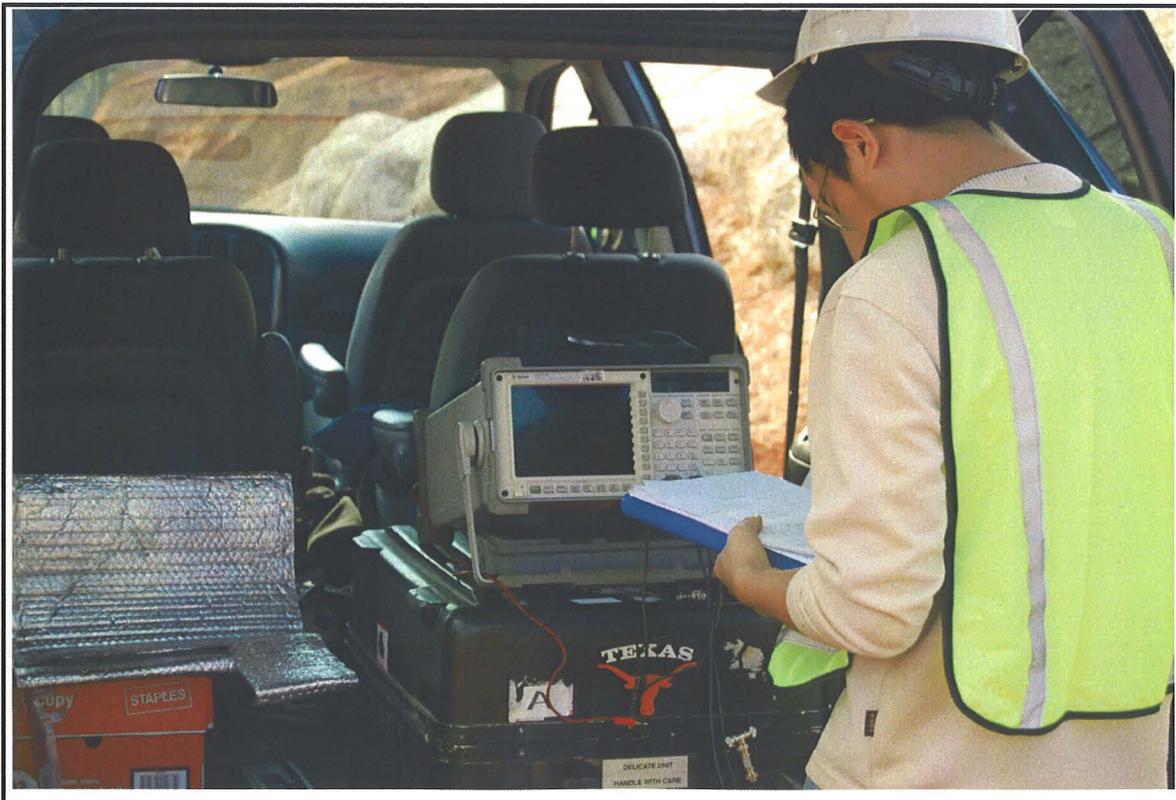
Photo 12. December 9, 2007- Jiabei Yuan Records SASW test data.
