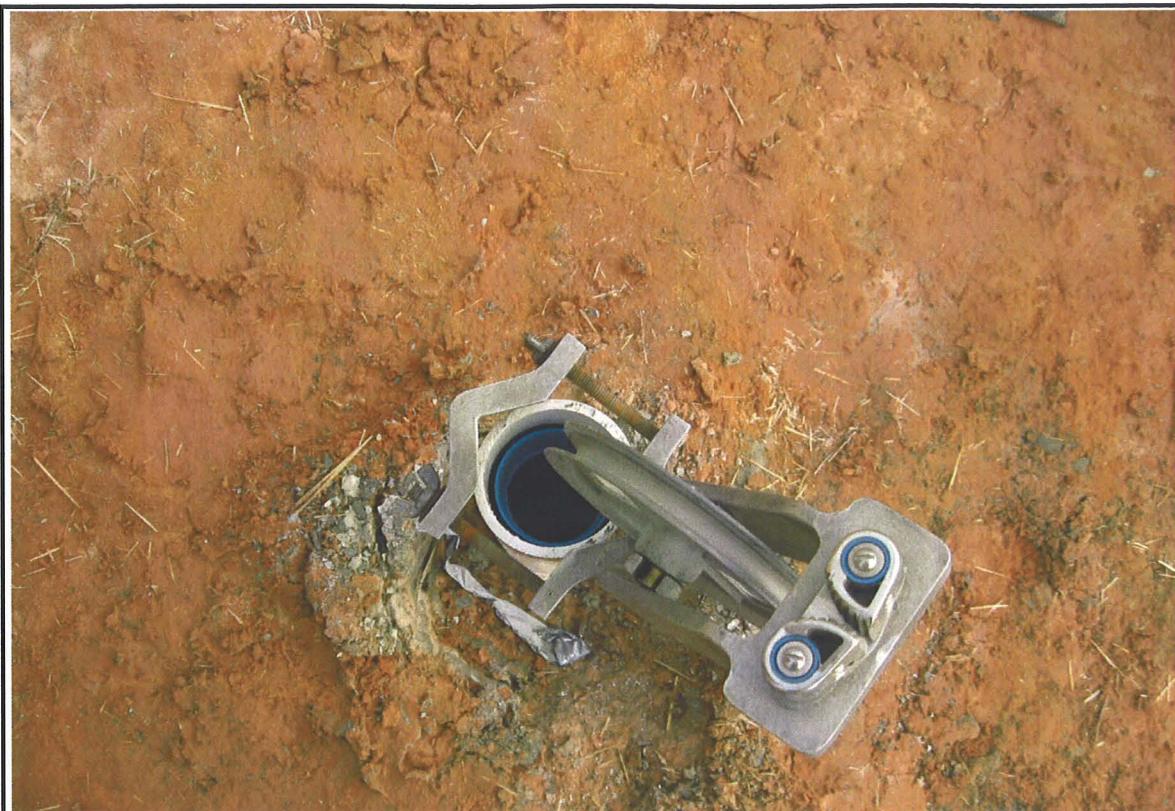
Photo 21. January 22, 2008 – Cross-Hole casing (3" ID, schedule 40, flush coupled PVC) with blue slope indicator casing inside ready to perform the borehole location deviation survey.

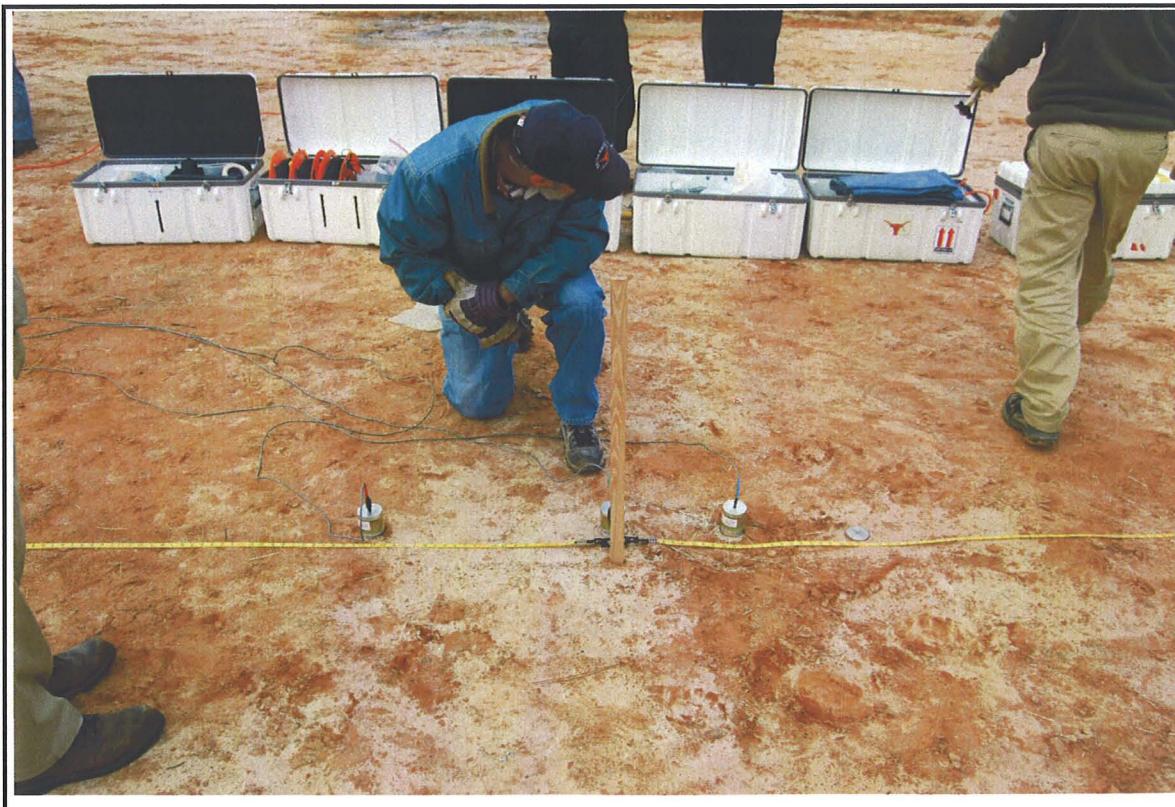
Photo 22. January 24, 2008 – SASW testing at depth begins with the placement of low frequency geophones.

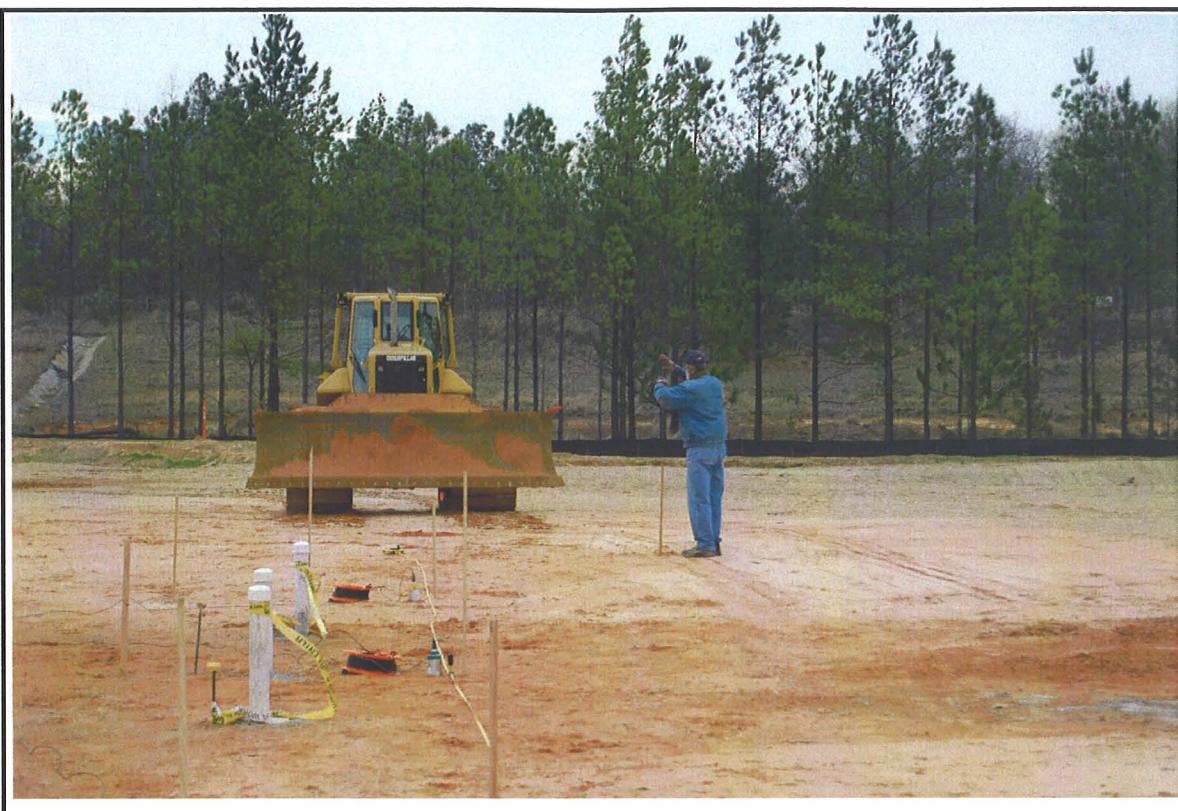
Photo 23. January 24, 2008 – SASW Testing continues with vibrations generated by a bulldozer.

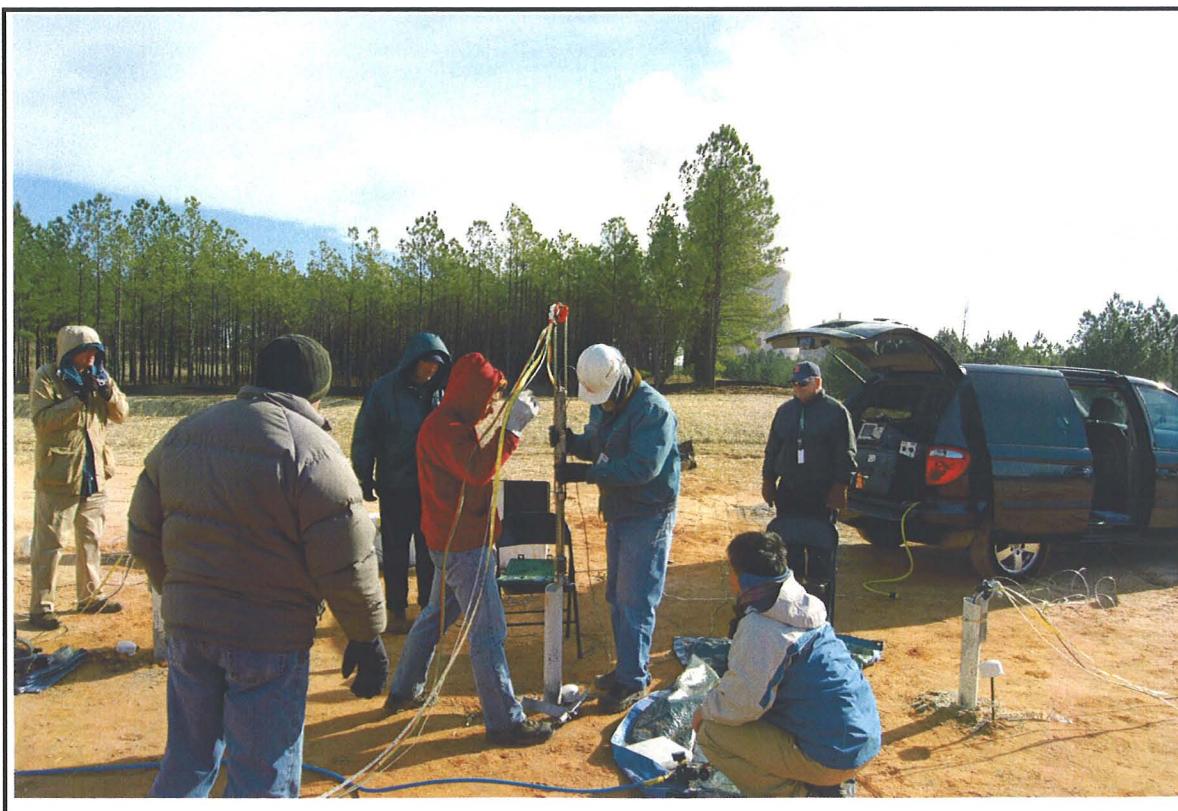
Photo 24. January 25, 2008 – Cross-Hole seismic test “trigger” being lowered into cased borehole by Dr. Stokoe assisted by Jiabei Yuan. Min Jae Jung controls pneumatic equipment that will lock the trigger in the borehole at the test depth.

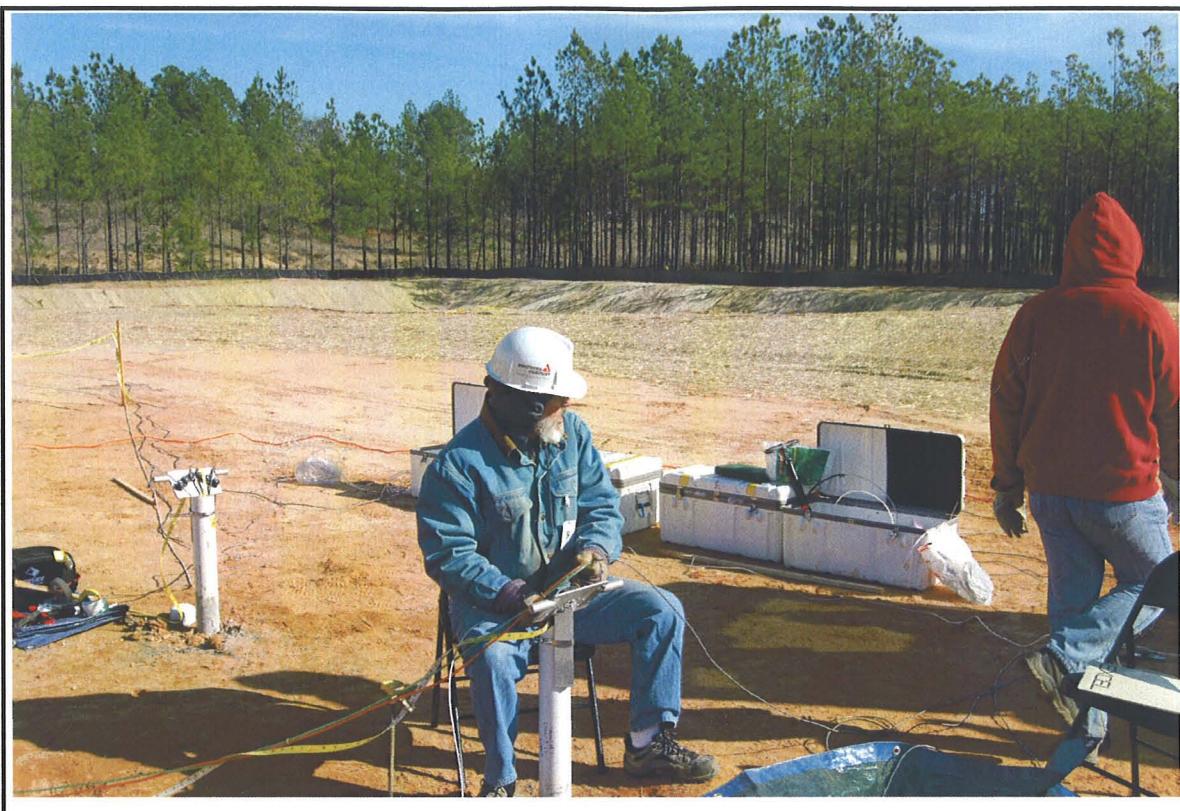
Photo 25. January 25, 2008 – Cross-Hole seismic triggering is being performed by Dr. Stokoe while others record the data.

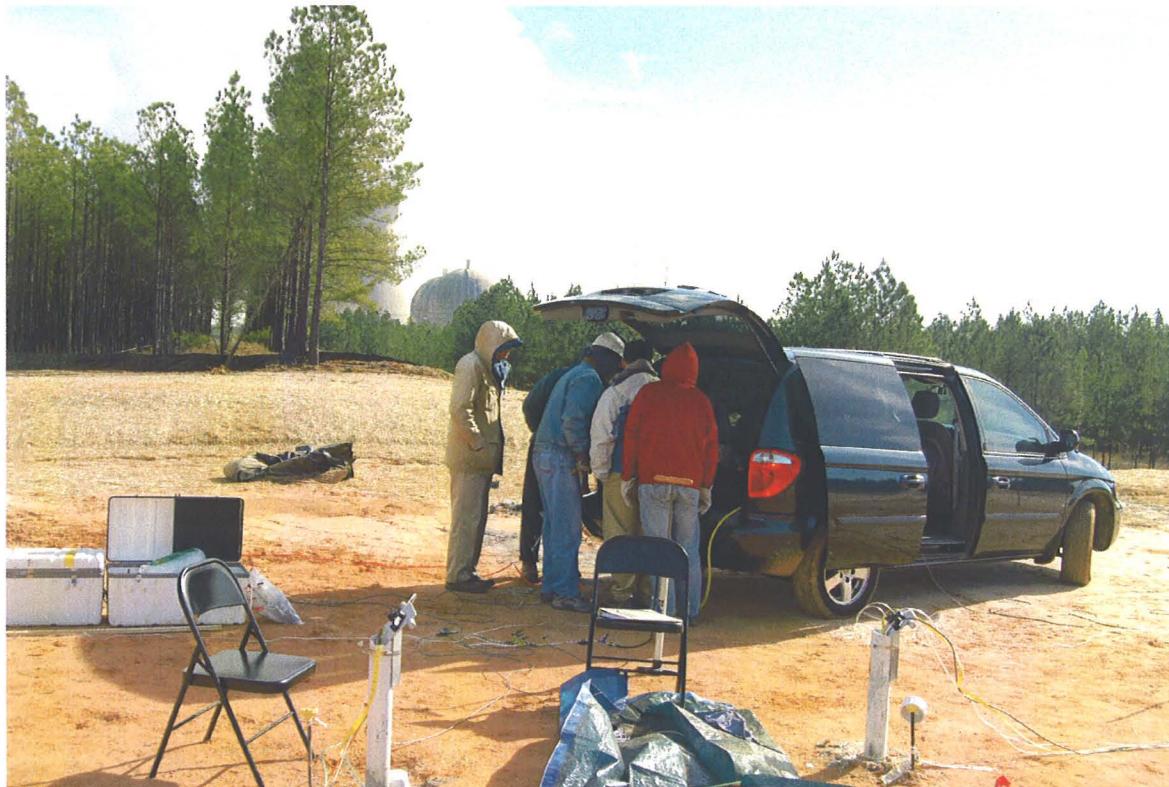
Photo 26. January 25, 2008 – Dr. Stokoe checks that the recorded data are acceptable.
