Comanche Peak Nuclear Power Plant, Units 3 & 4 COL Application Part 2, FSAR

Figure 2.5.1-227 Ground Based LiDAR Outcrop near CPNPP Dam

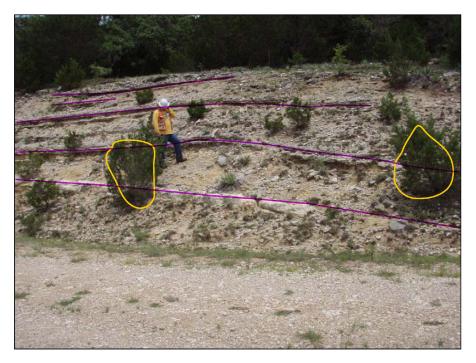
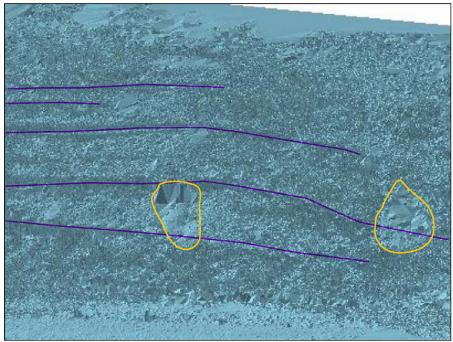
- (Purple lines) are overlain of exposed bedding to show the comparison between the LiDAR image (lower) and the photograph (above).
- (Yellow lines) show poor imaging areas due to vegetation.
