**SUBJECT: RADIUM DYE COMPANY—RESULTS AND CONCLUSIONS OF THE U.S.
NUCLEAR REGULATORY COMMISSION'S INITIAL SITE VISIT**

**OAK RIDGE INSTITUTE FOR SCIENCE AND EDUCATION:
SITE STATUS REPORT FOR THE RADIUM DYE COMPANY AT
318/314 WEST 10th STREET, KANSAS CITY, MISSOURI**

Property: Former Radium Dye Company
318/314 West 10th Street
Kansas City, Missouri 64105

Inspection Dates: February 23-24, 2017

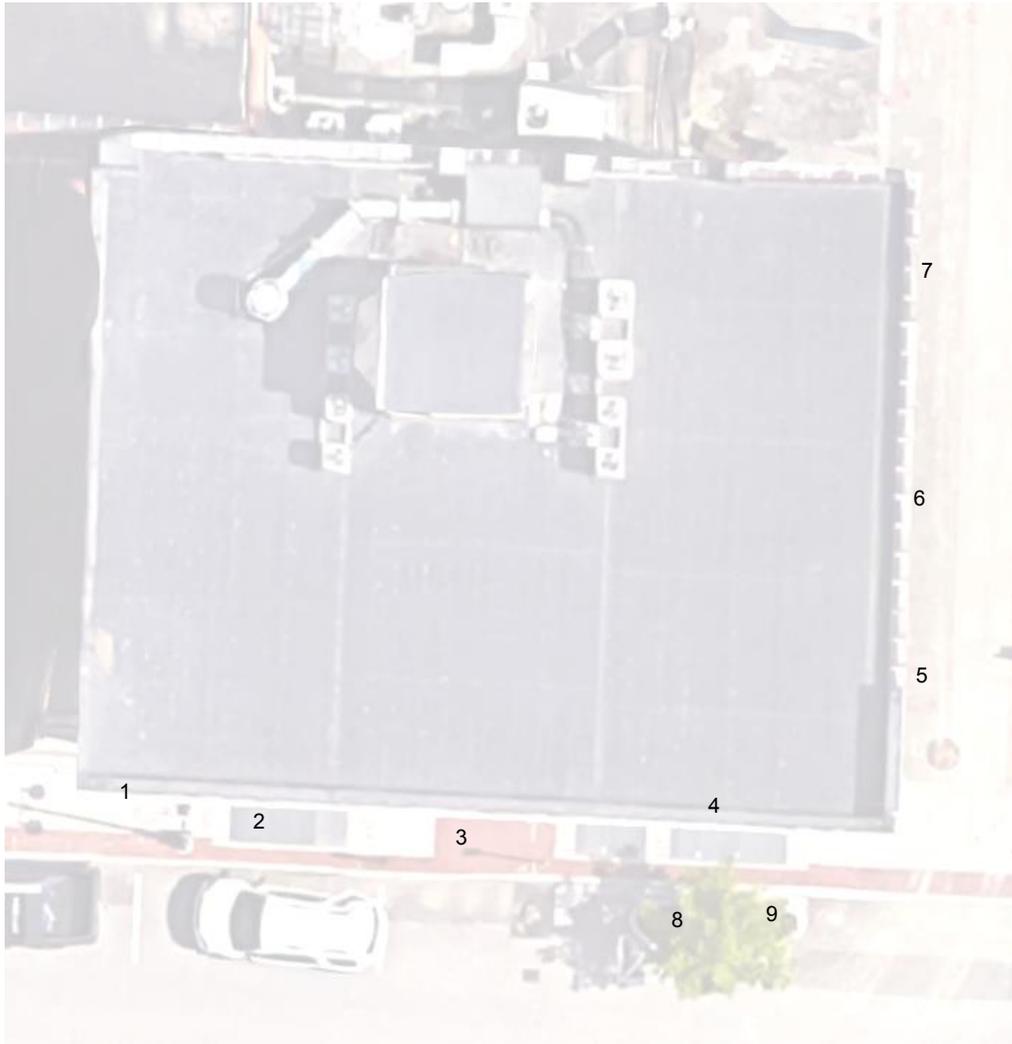
For the outside area, the 2×2 sodium iodide detector responses ranged from 10,000 to 14,000 cpm and included the south and west sides of the building exterior and a small grassy area to the west of the building. Exposure rates ranged from 9 to 10 $\mu\text{R}/\text{h}$ at 1 meter. The west side of the building is composed of a gray brick material that had higher gamma responses than the red brick ranging from 18,000 to 22,000 cpm and 18 to 20 $\mu\text{R}/\text{h}$. This was consistent for the entire west face of the building exterior. No discrete areas of elevated radiation were encountered outside the building.

| Site: Radium Dye Co. | Area: IAAO, Outside Area | Date(s): 02/24/2017 | Time: 1935/1948 |

| Radiation Type | Instrument | Detector | Background |
|---|---|---|---|
| Gamma | 2221: No.693 | 44-10: No.1151 | 10 - 22 kcpm ^a |
| Gamma | 192: No.1128 | NA | 9 - 20 μ R/h ^a |

^aBackground varied depending on naturally occurring radioactive material in the area (i.e., red or gray brick).

= measurement location number
See table for measurement

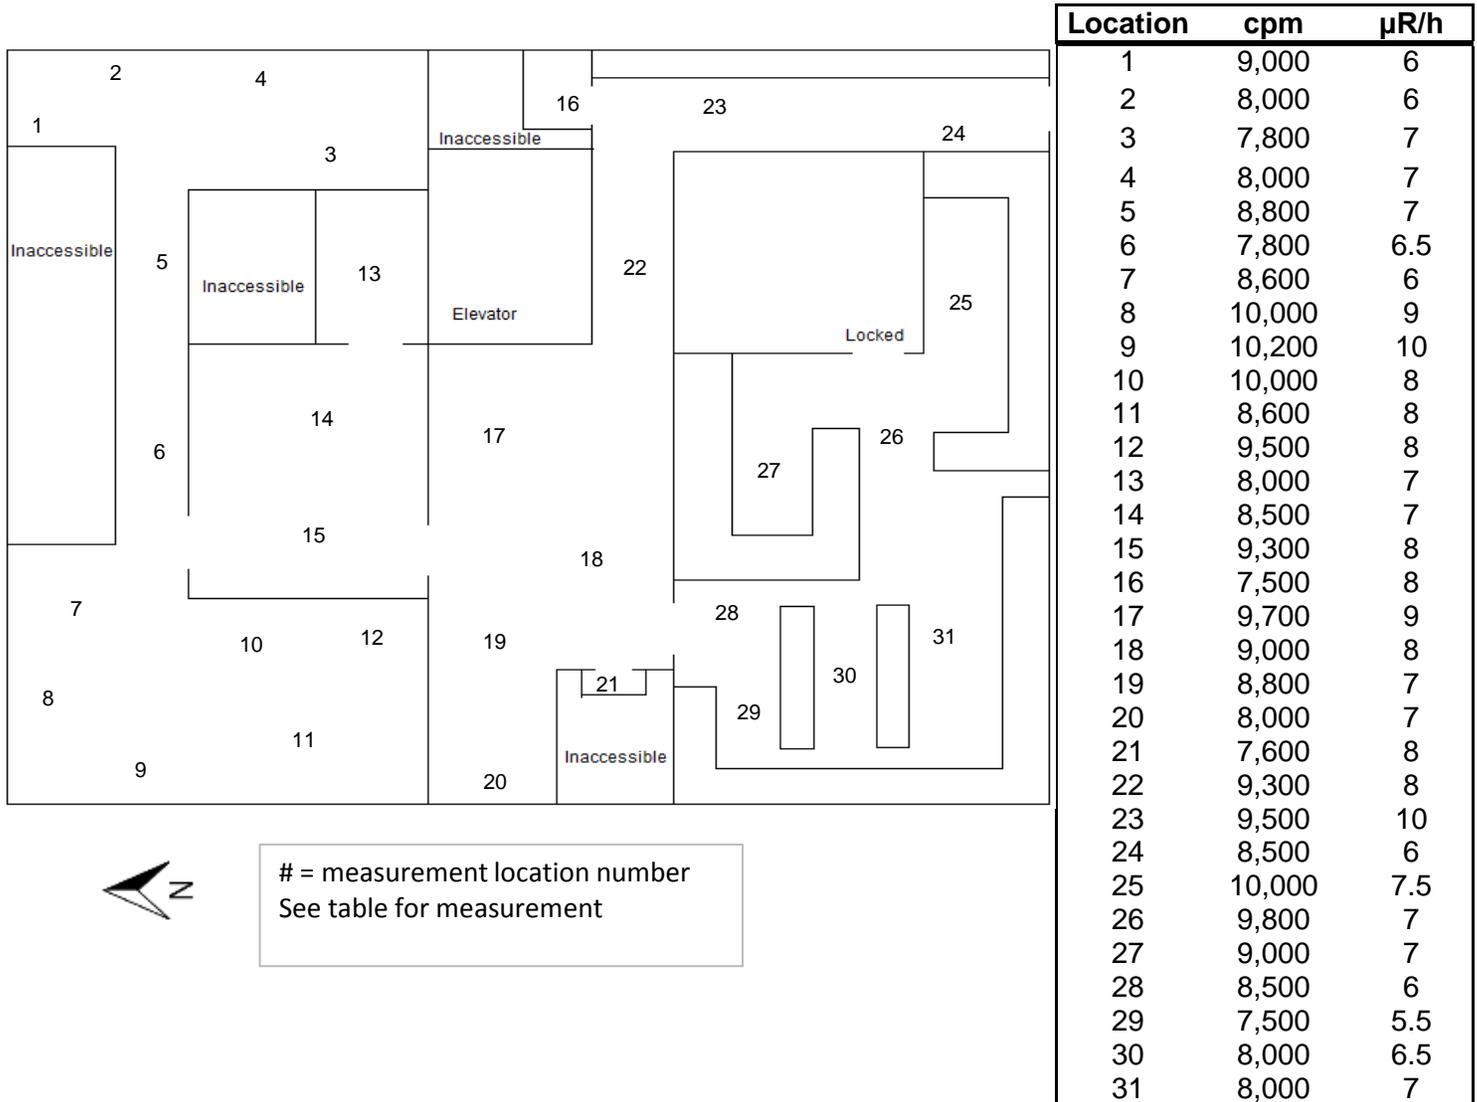
| Site: Radium Dye Co. | Area: IAAO, Basement | Date(s): 02/23/2017 | Time: 1900/1947 |

| Radiation Type | Instrument | Detector | Background |
|---|---|---|---|
| Gamma | 2221: No.693 | 44-10: No.1151 | 7 - 11 kcpm ^a |
| Gamma | 192: No.1128 | NA | 5 - 10 μ R/h ^a |

^aBackground varied depending on naturally occurring radioactive material in the area (i.e., red brick).

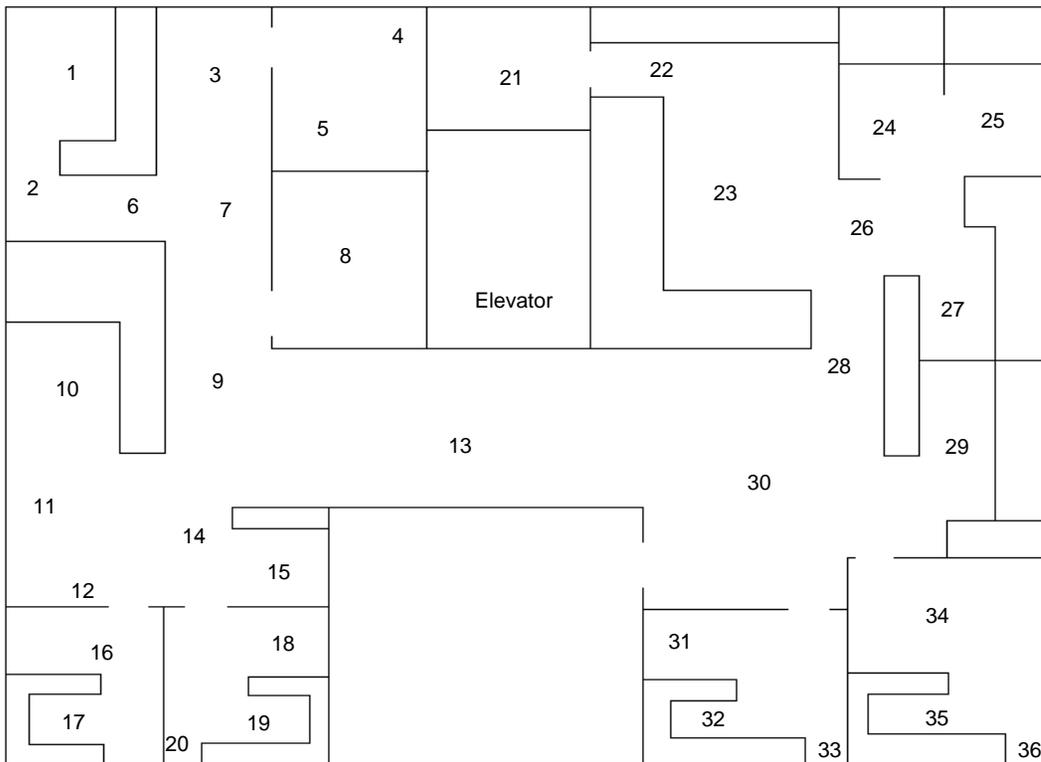
| Site: Radium Dye Co. | Area: IAAO, First Floor | Date(s): 02/23/2017 | Time: 1951/2035 |

| Radiation Type | Instrument | Detector | Background |
|---|---|---|---|
| Gamma | 2221: No.693 | 44-10: No.1151 | 6 - 15 kcpm ^a |
| Gamma | 192: No.1128 | NA | 5 - 14 μ R/h ^a |

^aBackground varied depending on naturally occurring radioactive material in the area (i.e., red brick).

= measurement location number
See table for measurement

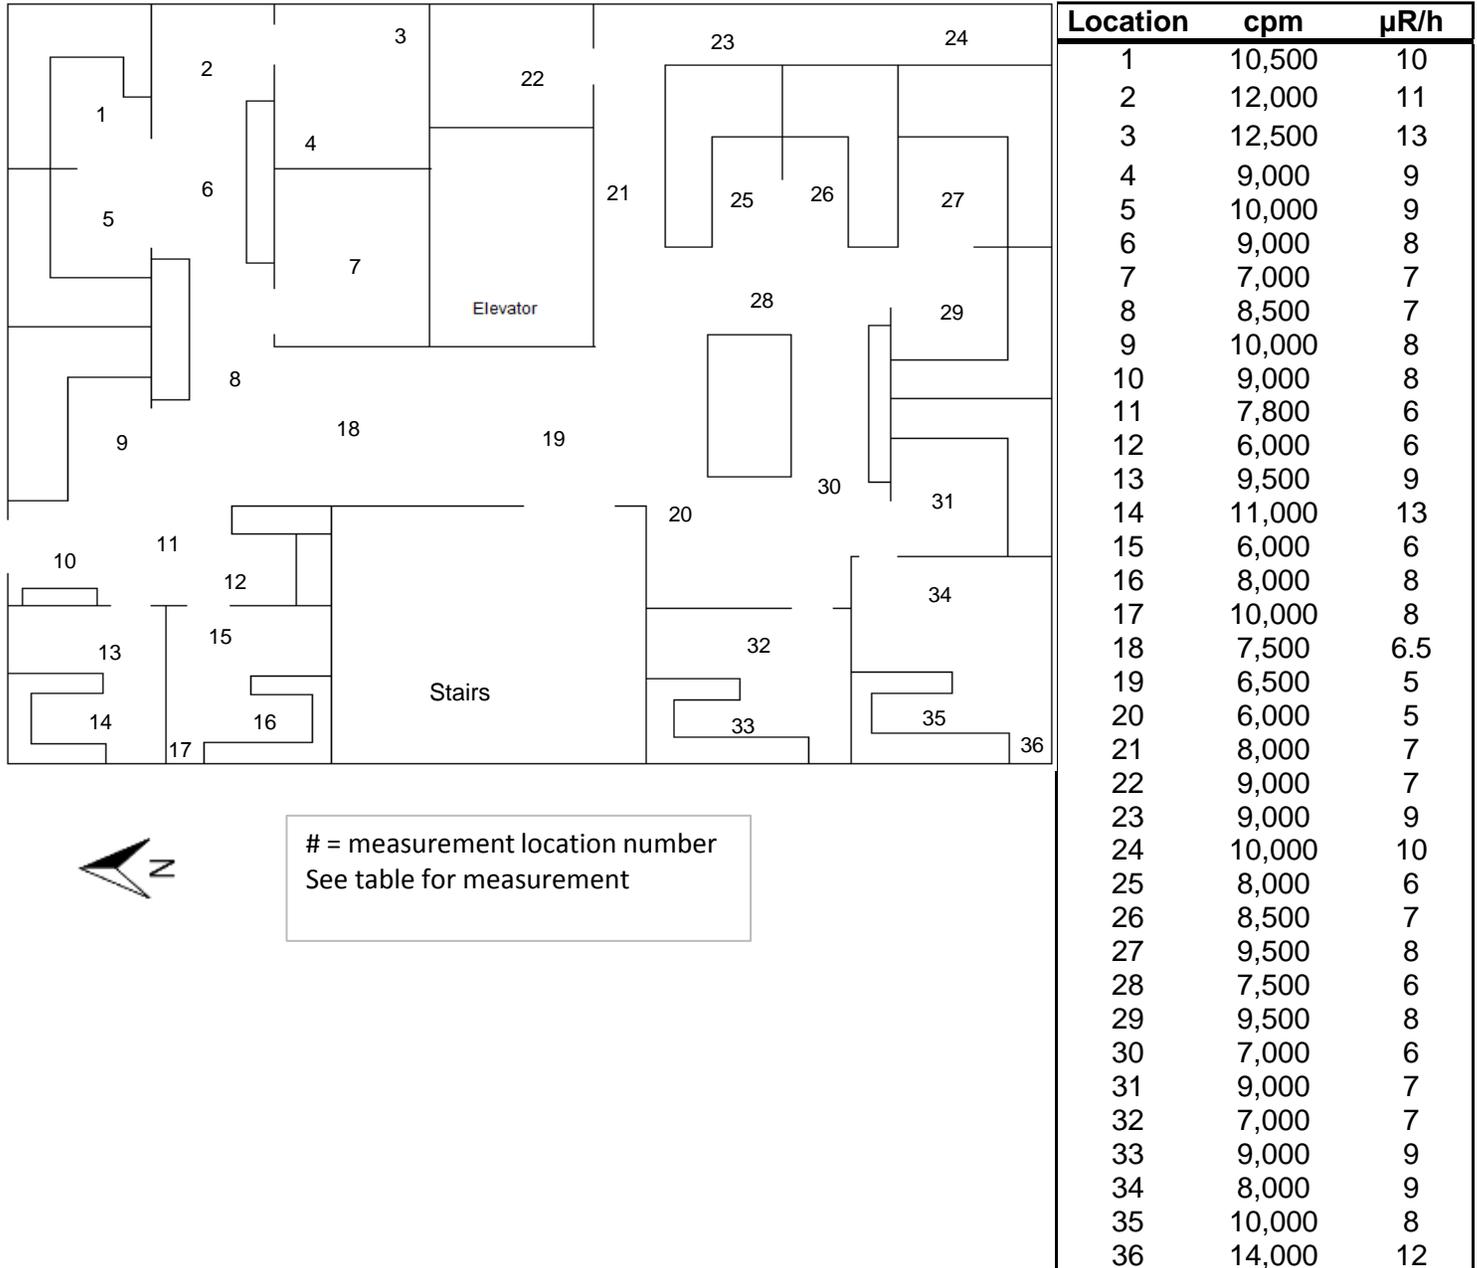
| Site: Radium Dye Co. | Area: IAAO, Second Floor | Date(s): 02/24/2017 | Time: 1745/1840 |

| Radiation Type | Instrument | Detector | Background |
|---|---|---|---|
| Gamma | 2221: No.693 | 44-10: No.1151 | 6 - 14 kcpm ^a |
| Gamma | 192: No.1128 | NA | 5 - 13 μ R/h ^a |

^aBackground varied depending on naturally occurring radioactive material in the area (i.e., red brick).
