# Module 9: Operating Experience

## **Presentation on Molten Salt Reactor Technology by: David Holcomb, Ph.D.**

**Presentation for:**  
US Nuclear Regulatory Commission Staff  
Washington, DC

**Date:**  
November 7–8, 2017

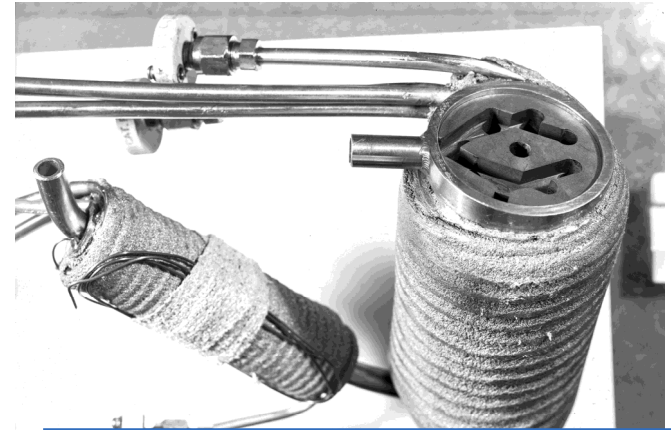
ORR In-Pile Fuel Salt Loop

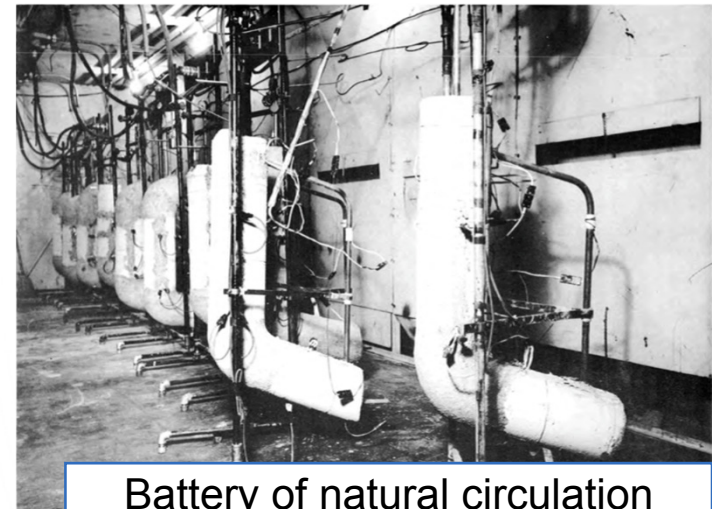
Battery of natural circulation loops as of 1957

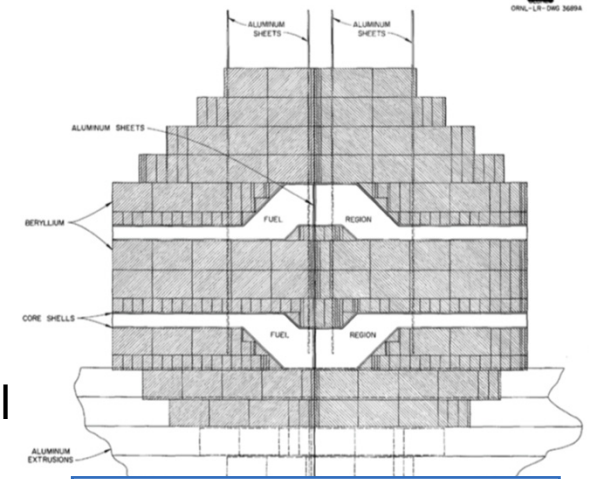
ART Room  
Temperature Critical  
Assembly

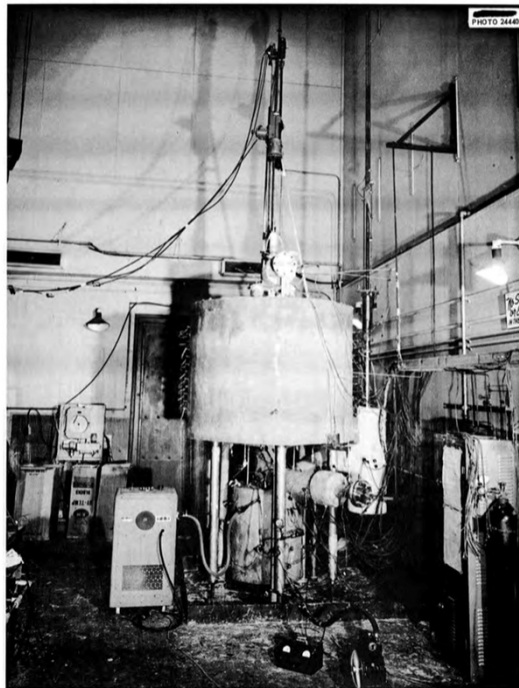
ART 650°C Critical Assembly

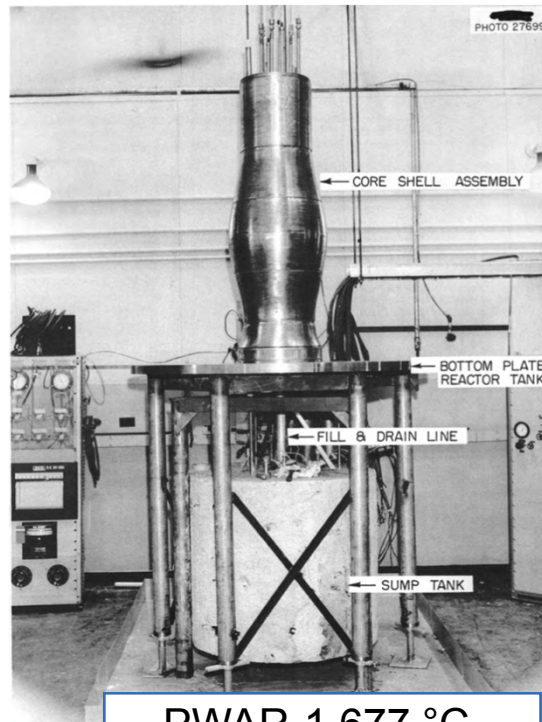
PWAR-1 677 °C  
Core Shell Assembly

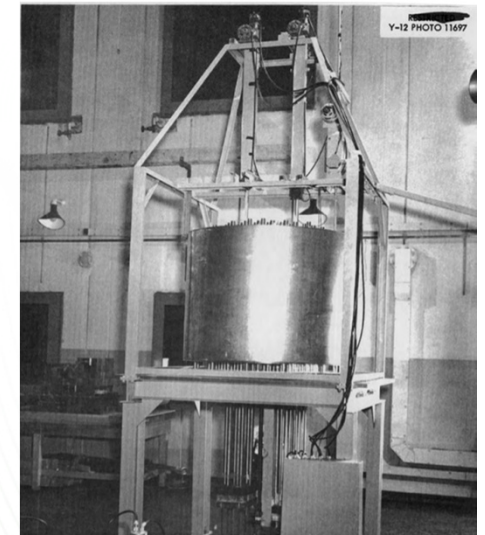
First ARE Critical Assembly  
Structure

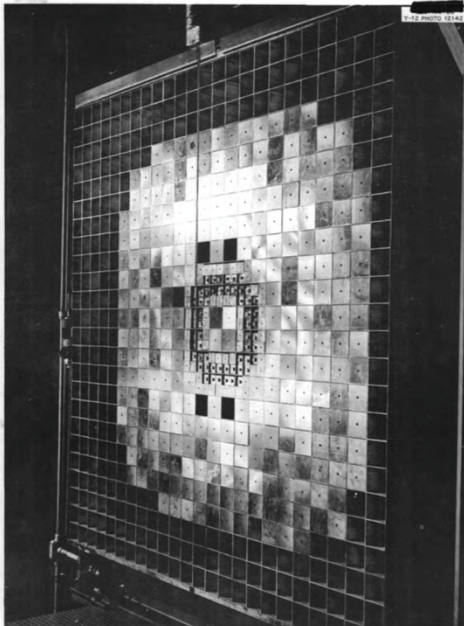
Second ARE critical experiment

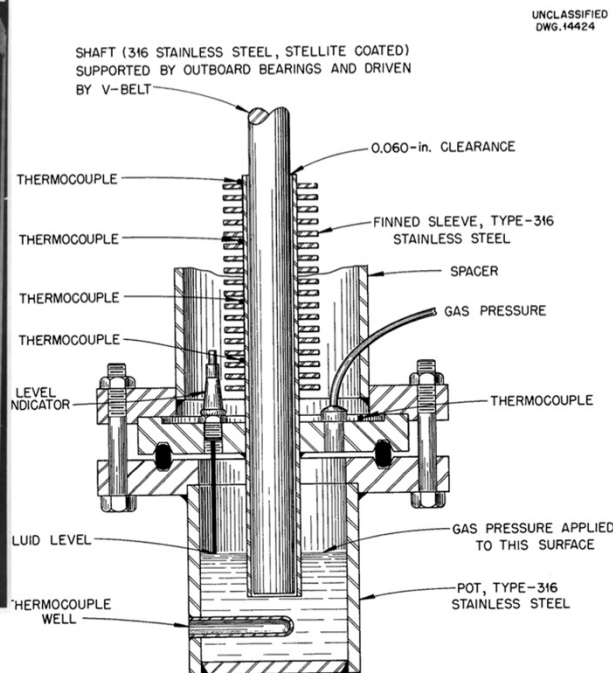
Freeze seal tester

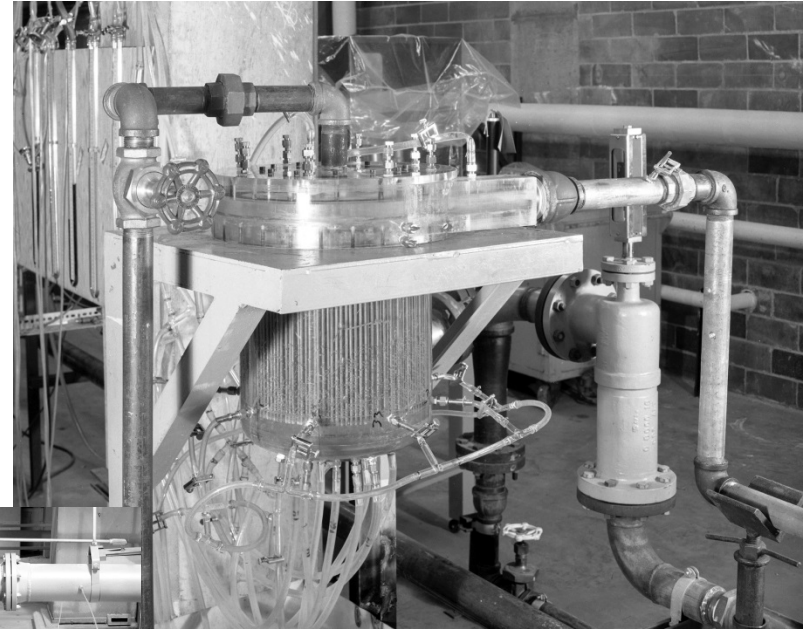
1/5 scale MSRE core model

- 1/5 scale core hydraulic model matched Reynolds number between water and fuel salt
- Full scale core model first run with water then with simulant fluid to match Reynolds numbers
- Specialized test rigs were developed for all components

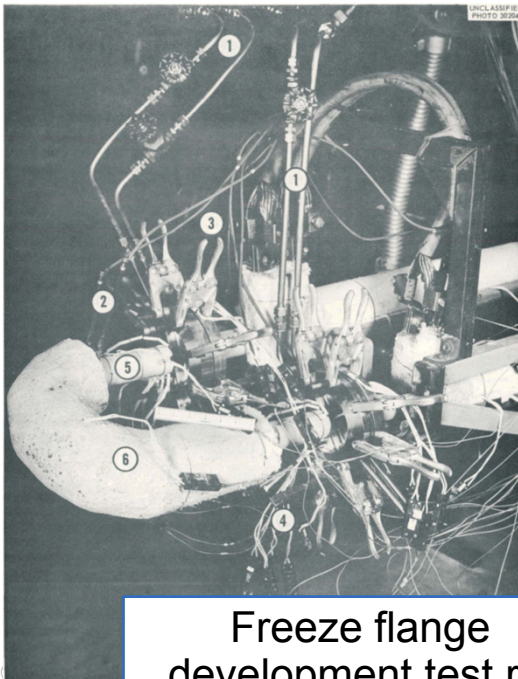
Freeze flange  
development test rig

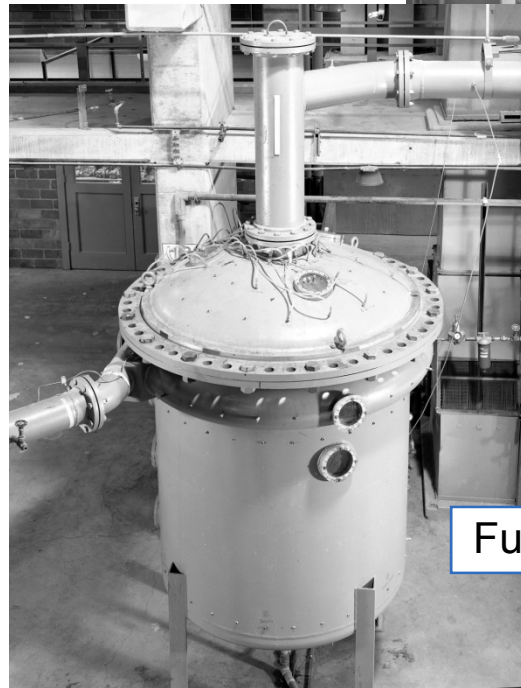
Full scale MSRE core model

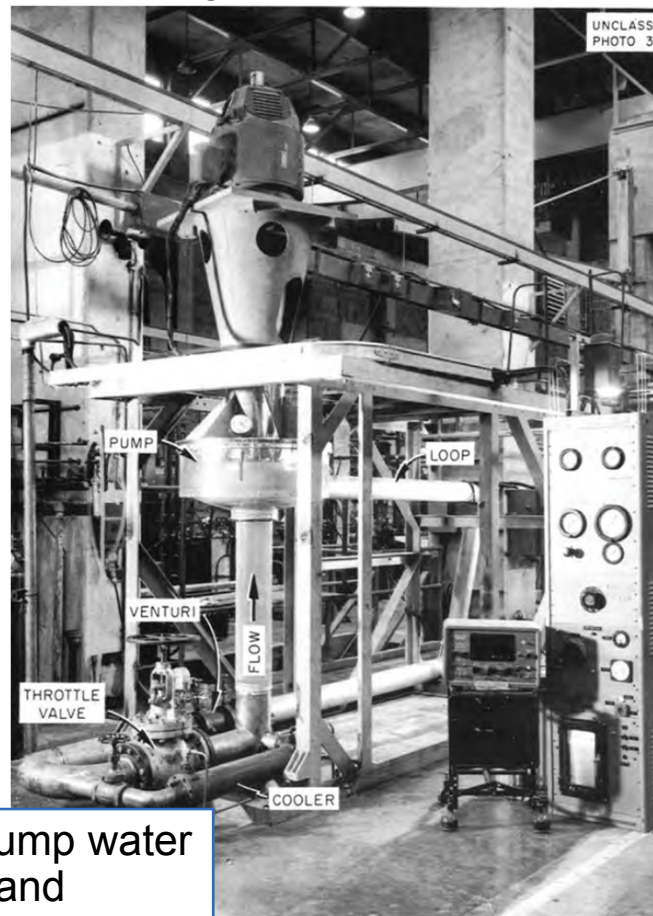
MSRE fuel pump water test stand

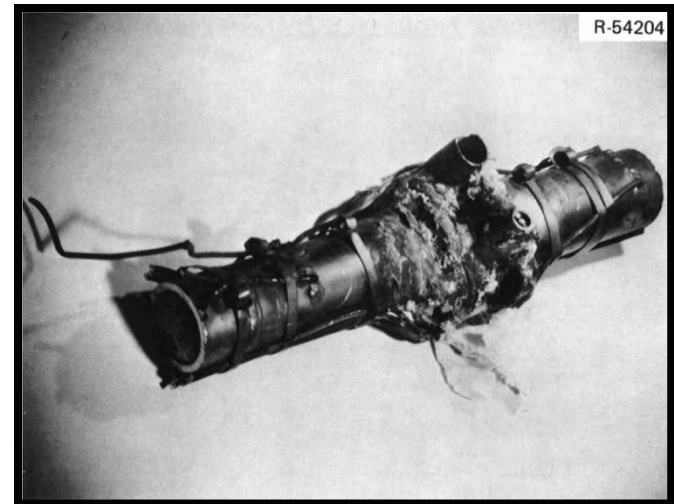
Bottom of cracked freeze valve

- Reactor vessel progressively embrittled due to neutron damage
- Drain tank isolation freeze valve cracked during its final cycle due to a field modification
  - Stiffening the air-cooling housing prevented pipe flexing
  - Xenon, iodine, krypton, and noble metals detected in reactor cell
- Small, continuous leak of lubricating oil into fuel pump causing foaming
  - Periodic plugging of offgas system
  - Fixed with larger filter
- Pump-entrained gas caused sporadic (about 10 times/h) increases in reactor power ( $\sim 5\text{--}10\%$ ) for a few seconds
- Control rod failed scram test due to snagging on thimble
  - Experimental 'rod-jogger' stuck control rod in out position during a *pseudo random binary sequence* test
  - Power level ramped up then decreased without intervention

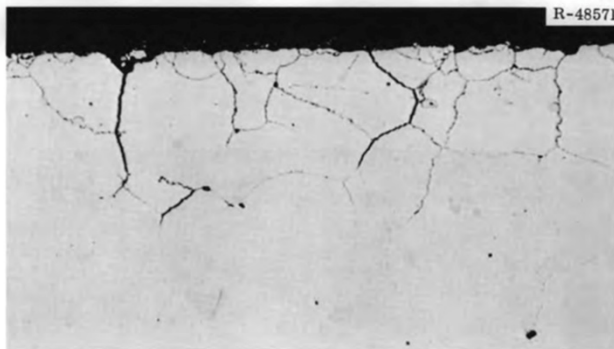
Typical microstructure of Alloy N after exposure to MSRE core for 22,533 h at 650°C – 500x

- Would be unacceptable for multi-decade lifetimes for thin-walled components
- Tensile testing of Alloy N surveillance specimens from the MSRE produced cracks in the grain boundaries connecting to the salt-exposed surfaces containing tellurium
- Intergranular embrittlement can be reduced by adding 1–2% niobium to Alloy N or by maintaining the salt in reducing conditions

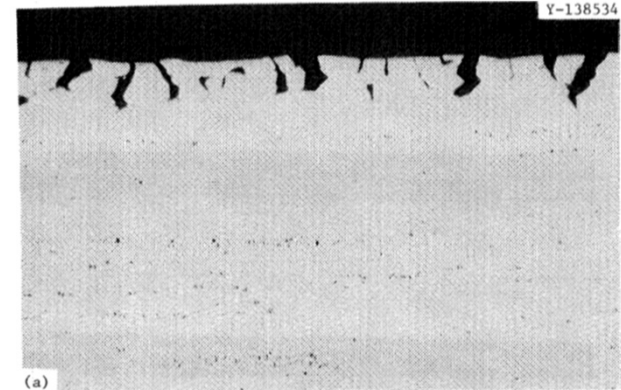
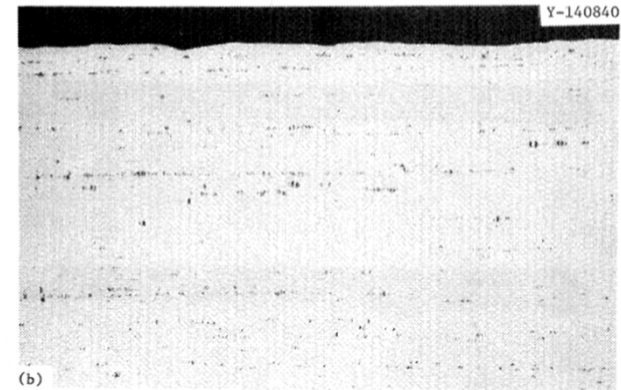
Alloy N exposed to MSRE fuel salt (500 h, 700°C) containing tellurium (a) oxidizing, (b) reducing – 100x

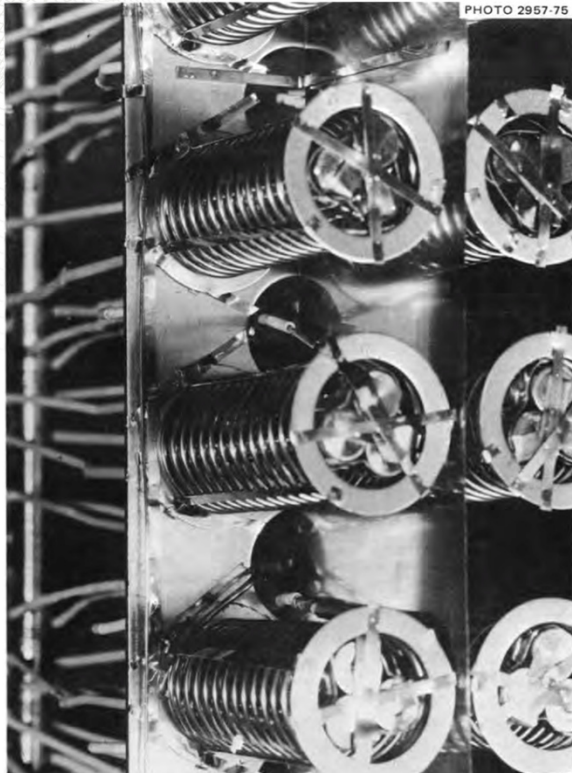
Cluster of modified Alloy N creep specimens prior to irradiation

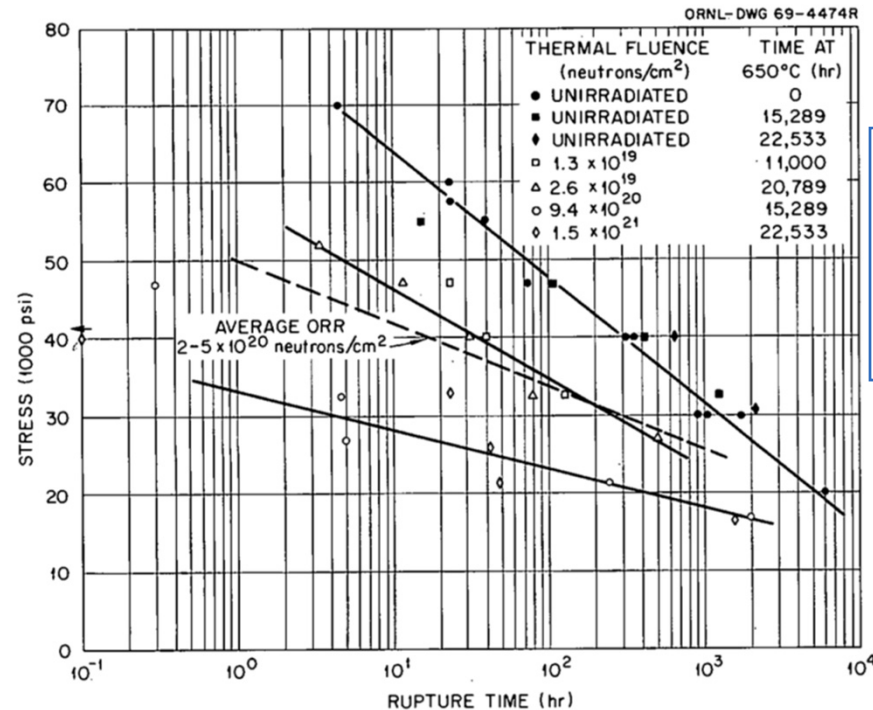
Stress rupture properties of MSRE surveillance specimens

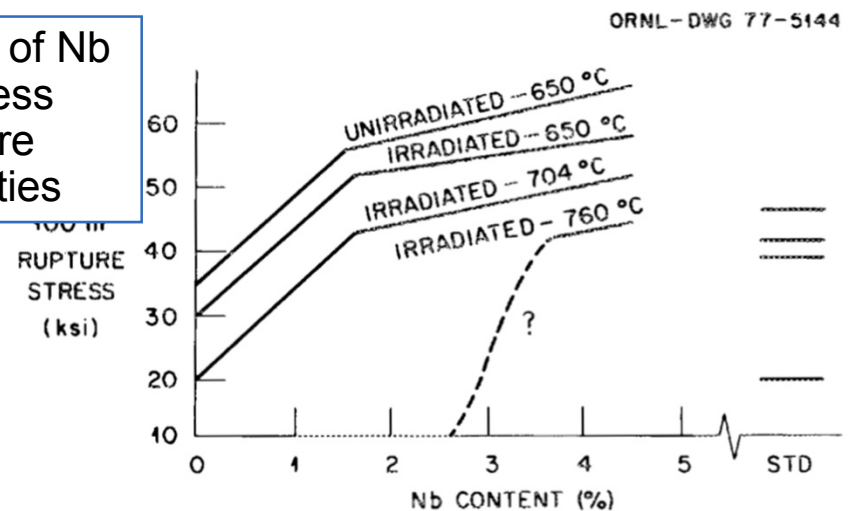
Influence of Nb on stress rupture properties

All niobium-modified Alloy N specimens irradiated at 650°C had rupture lives in excess of those of standard unirradiated Alloy N

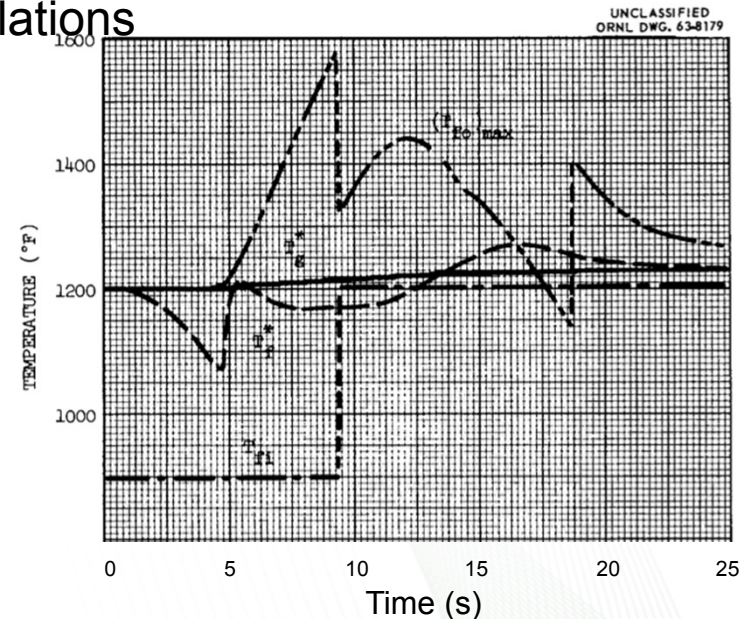
ZORCH temperature prediction for unprotected cold slug accident

- MURGATROYD code logic was developed and validated for Aqueous Homogeneous Reactor design
  - Extended to provide separate graphite heat capacity
  - Single point, single energy group, seven delayed neutron precursor groups
  - Employed for both design and safety calculations
  - Beta effective was used based upon the fraction of the time fuel is in the core
- ZORCH code developed that includes axial spatial dependence in fuel and graphite temperature to more accurately represent transient responses
  - Shows that no damage would be anticipated even for unrealistic transients
  - Maximum fuel temperature anticipated  $\sim 850^{\circ}\text{C}$  ( $< 5$  seconds) for unprotected cold slug addition

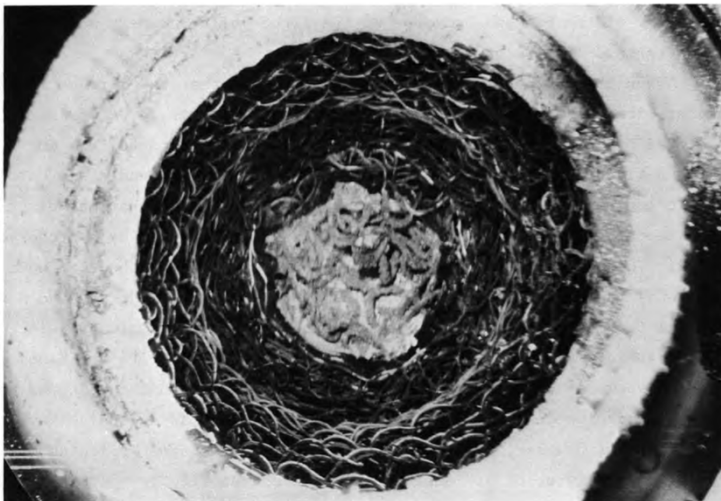
ORNL-DWG 67-4764

MSRE Mark 1 Offgas Particle Trap

- Lubricating oil leaking from pump seal caused issues with filters, check valves, and control valves
- Hydrocarbons tended to have gaseous fission products stick to them and in turn deposit on the particle filters thus clogging the system
- Problem was substantially reduced by employing a larger (15 versus 10 cm diameter), redesigned particle trap

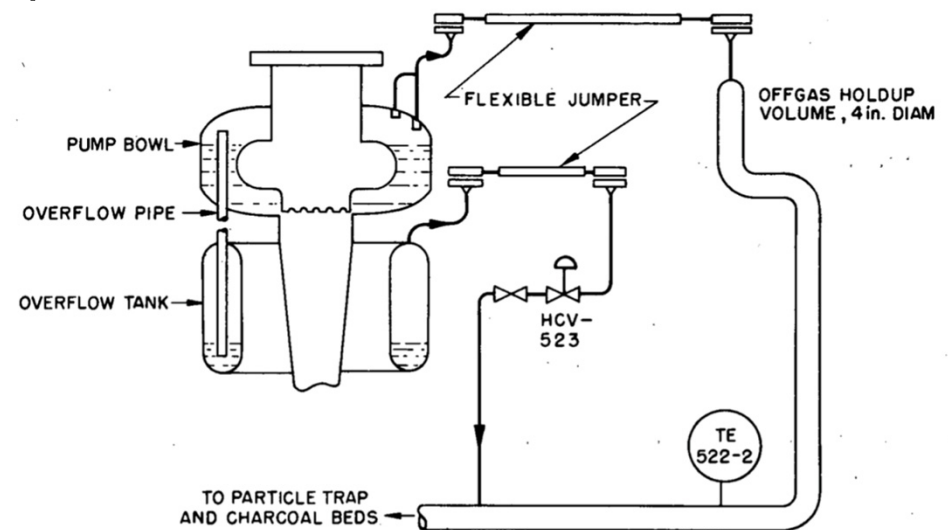
Offgas Piping Near Pump and Overflow Tank

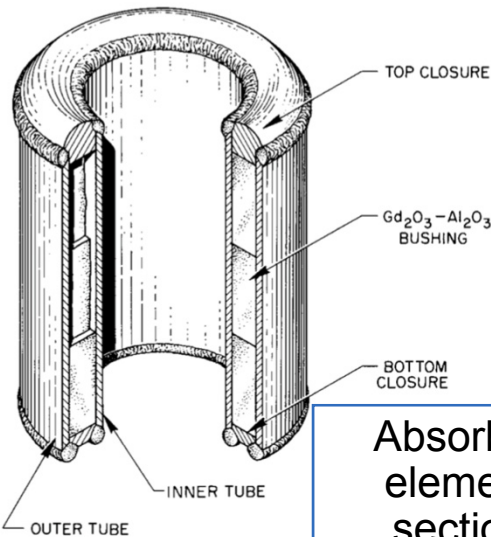
UNCLASSIFIED  
ORNL-DWG 64-1105R

Absorber element section

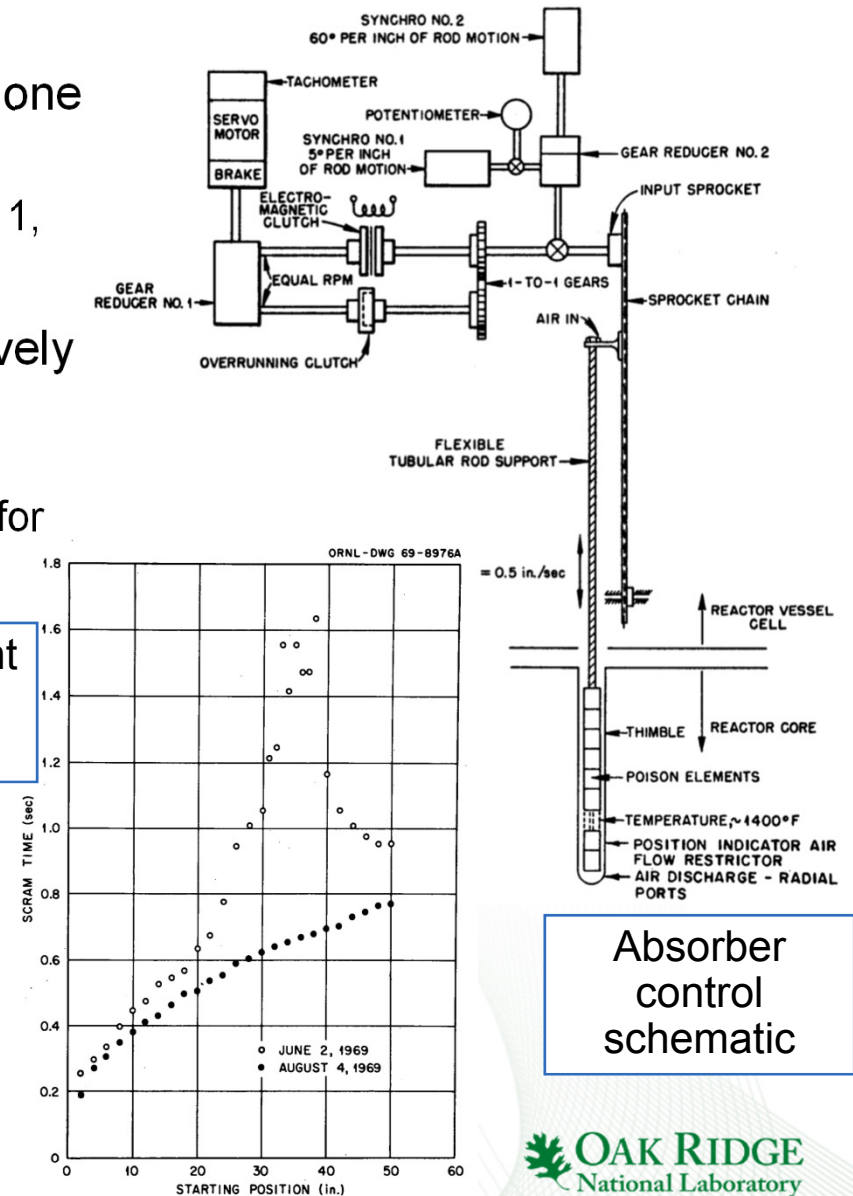
Absorber control schematic

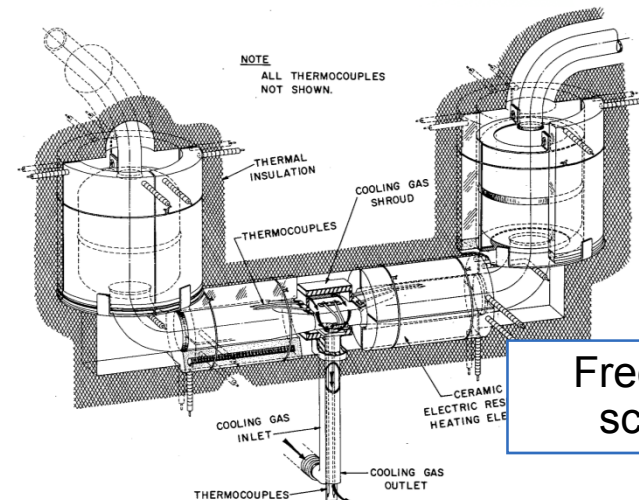
Freeze valve schematic

- 12 freeze valves located throughout the plant
- Freeze valves preferred since reliable mechanical closure valve unavailable
  - Development began in 1960
  - Operations not hampered by “slow” response and lack of “off-on” functionality
- Three operational modes
  - Deep frozen: heaters adjusted to maintain 400–500°F without cooling air
  - Thawed: heaters adjusted to maintain 1200°F without cooling air
  - Frozen: Heaters remained in thawed condition but cooling gas flow adjusted to hold just frozen to allow for rapid thaw
- Main fuel salt drain valve (FV-103) kept in frozen condition while operating and required to open in 15 minutes
  - One unscheduled drain caused by setpoint drift and untested operating procedure
- While initially some issues with incomplete freezing, extensive valve testing eventually resulted in improved operating procedure

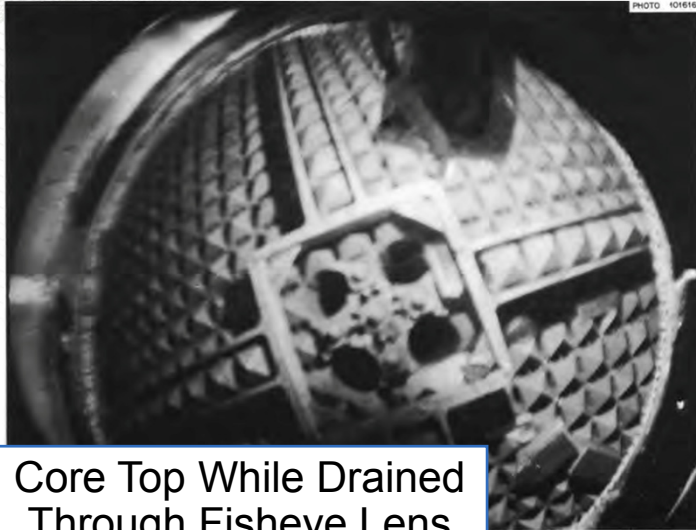
Core Top While Drained Through Fisheye Lens

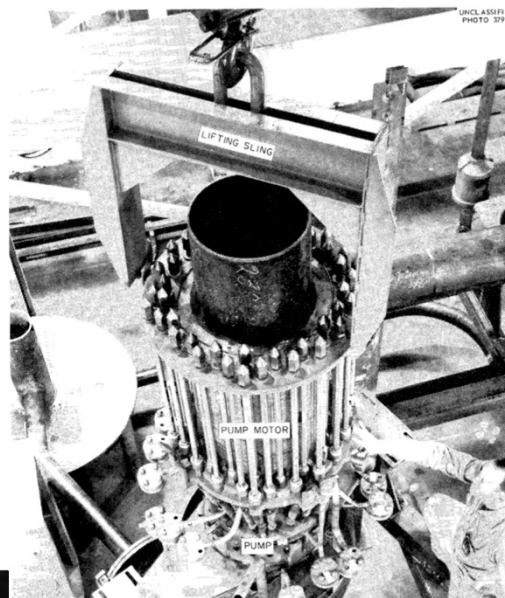
MSRE Pump Mockup Lift Sling

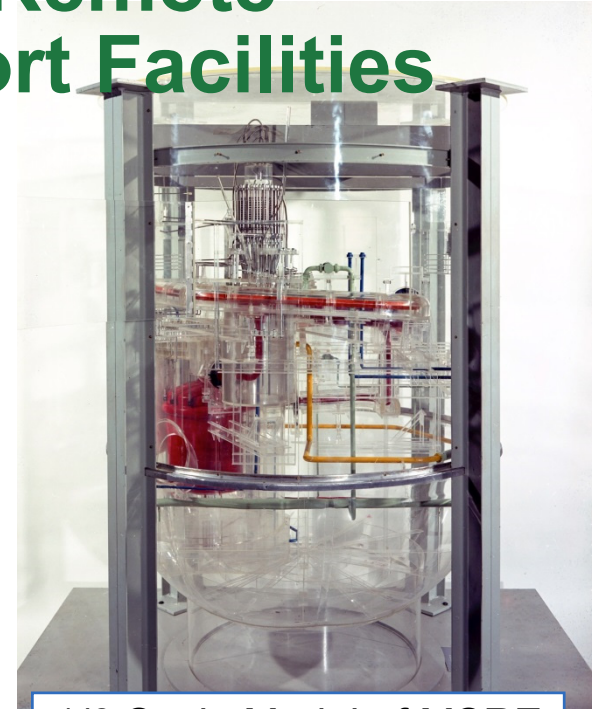
1/6 Scale Model of MSRE

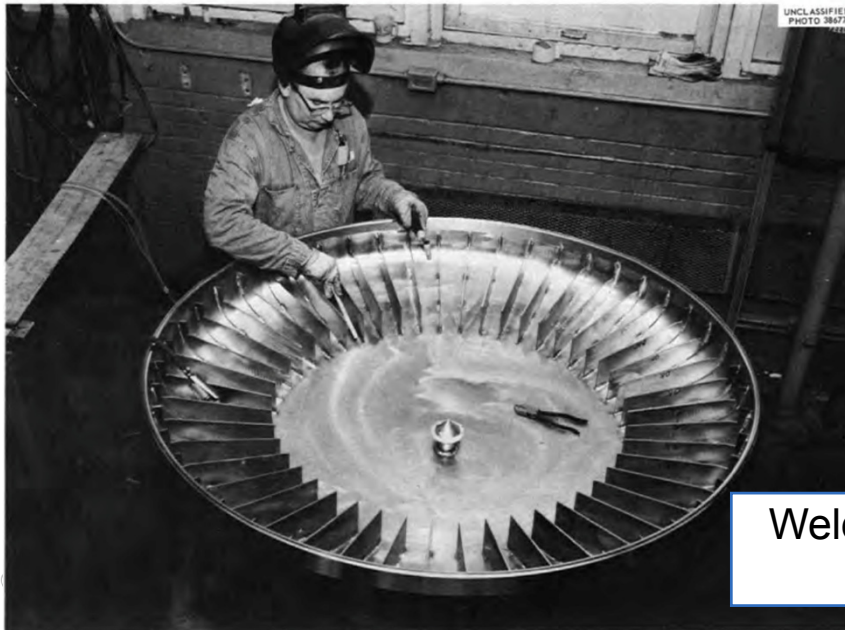
Welding flow straightening vanes on lower vessel head

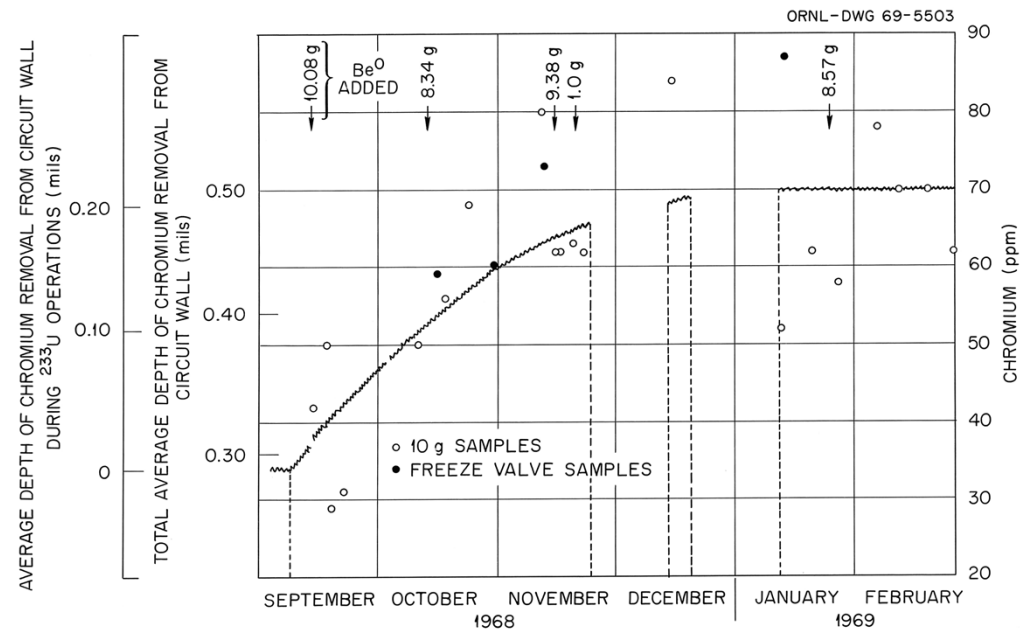
Corrosion in MSRE Fuel Circuit Following  $^{233}\text{U}$  Changeover

- Fissile material was changed from  $^{235,238}\text{UF}_4$  (33%  $^{235}\text{U}$ ) to  $^{233}\text{UF}_4$ 
  - Total amount of uranium in the  $^{235}\text{U}$  fuel exceeded that contained in the  $^{233}\text{U}$  fuel by sixfold
- Operation with  $^{233}\text{U}$  fuel showed pronounced changes in fission product and corrosion chemistry as variations of the concentration of  $\text{UF}_3$  in the fuel salt were made
  - Persisted until 28.80 g of  $\text{Be}^0$  were added
- After opening for maintenance the fuel salt became oxidizing with respect to the MSRE fuel salt containment for both  $^{235}\text{U}$  and  $^{233}\text{U}$  operation

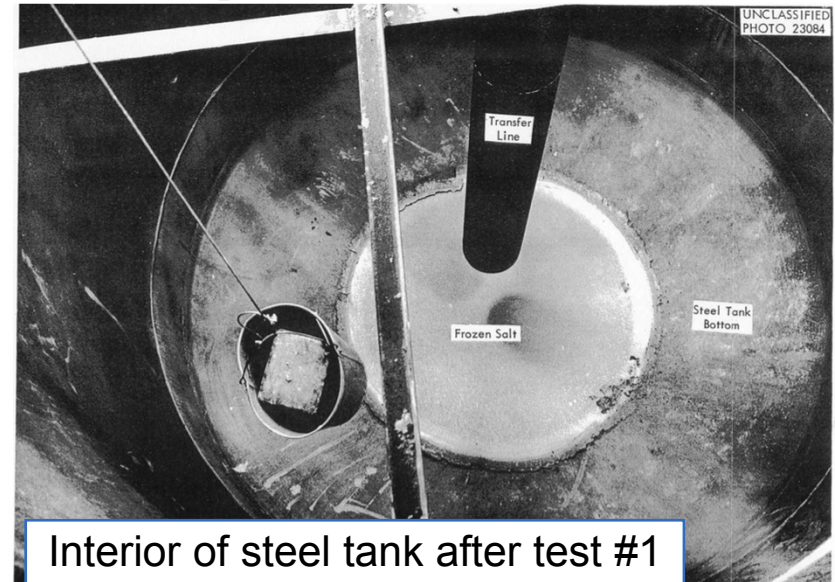
Interior of steel tank after test #1

- Water adjacent to center of tank boiled briskly, but not violently enough to shake tank

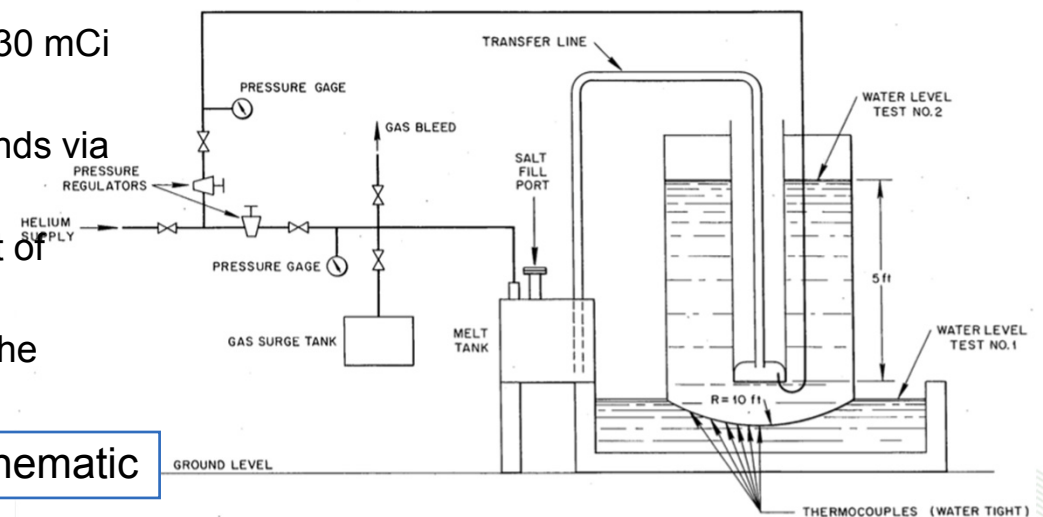
UNCLASSIFIED  
ORNL-LR-DWG 5331

Experiment schematic

- 229 kg of unirradiated fluoride (11.5 NaF-46.5%LiF-42KF mol%) salt (including 2 kg of  $UF_4$ ) heated to 816°C – water to 85°C
  - 99 grams irradiated  $Na_2UF_6$  added – 15–30 mCi (~6 days after irradiation)
  - Salt forced into water tank in 45–50 seconds via helium overpressure
  - Violent boiling in tank – negligible amount of steam reached surface
  - No radioactivity was detected outside of the water

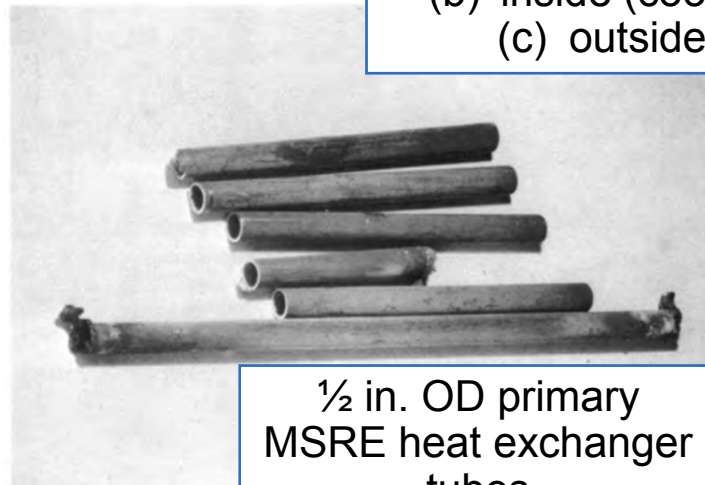
1/2 in. OD primary MSRE heat exchanger tubes

- Fuel salt side exhibits characteristic minor tellurium corrosion
- Coolant salt side remains in good condition

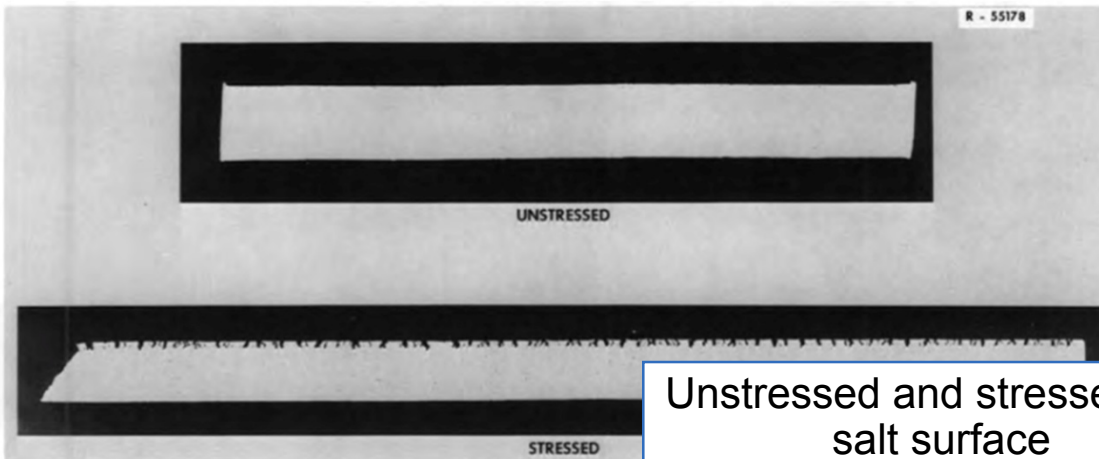
Unstressed and stressed fuel salt surface

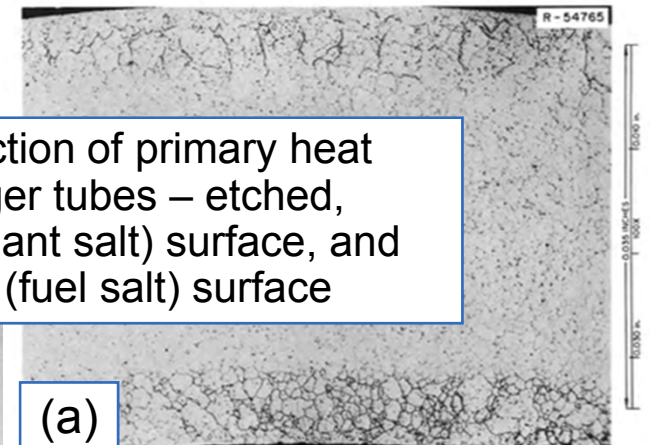
- (a) Cross-section of primary heat exchanger tubes – etched,  
(b) inside (coolant salt) surface, and  
(c) outside (fuel salt) surface

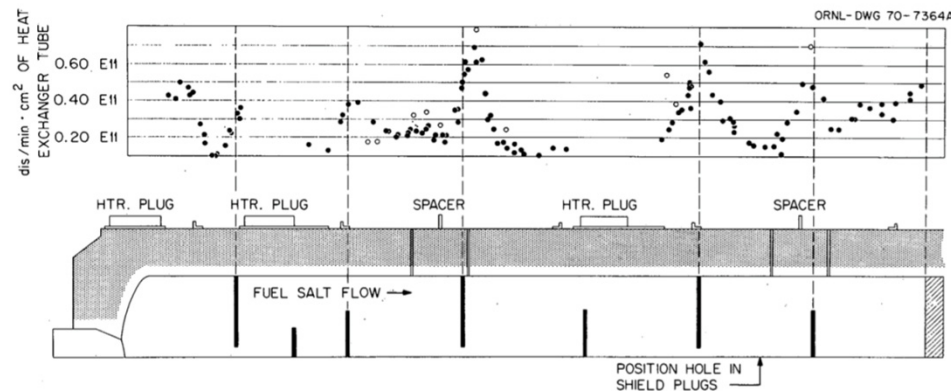
Fig. 7.23. Activity of  $^{103}\text{Ru}$  at reactor shutdown on November 2, 1969, in the MSRE heat exchanger.

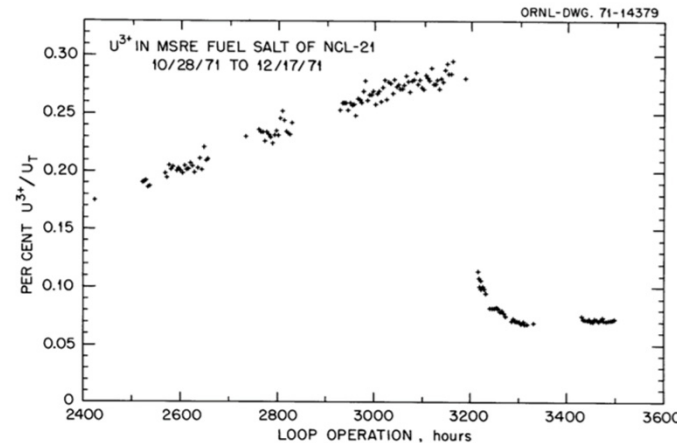
Electrochemical Measurement of  $U^{3+}$  in Flowing Fuel Salt Surrogate

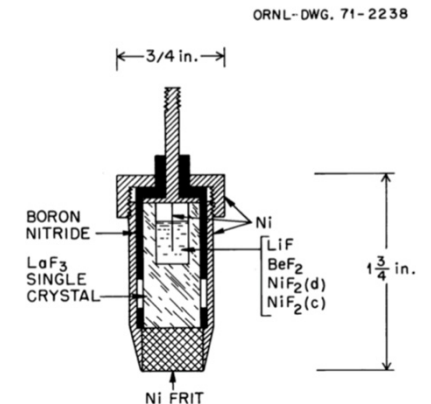
Reference Electrode

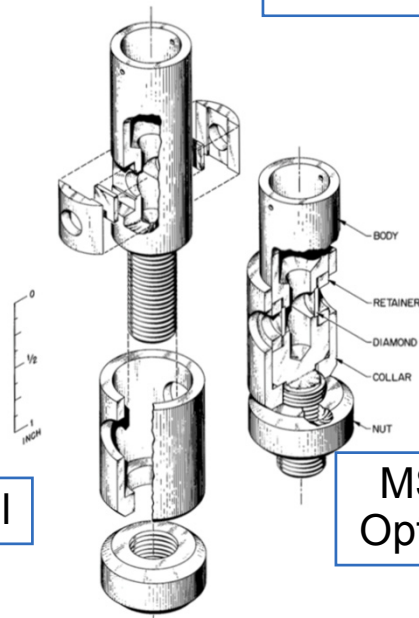
Diamond Window Cell

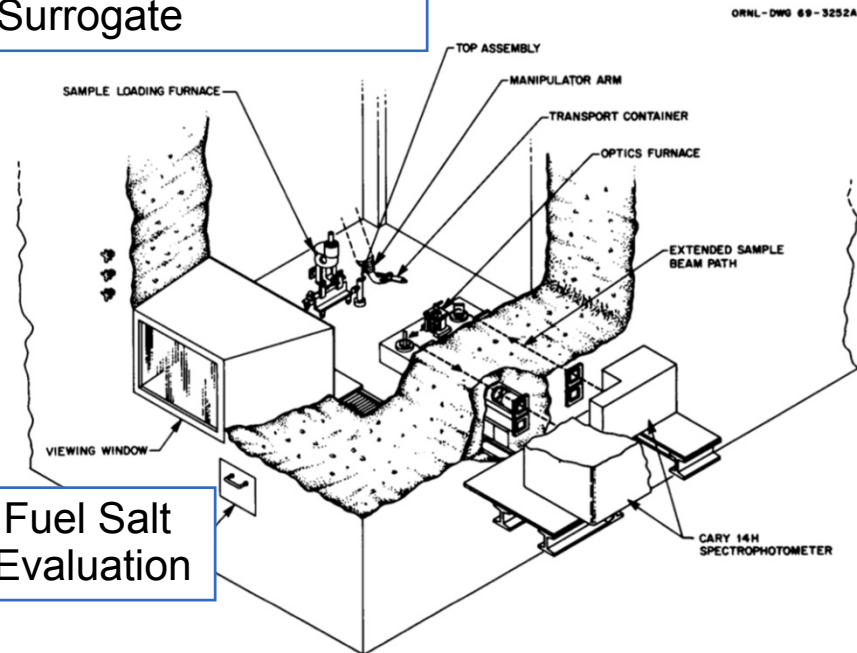
MSRE Fuel Salt Optical Evaluation

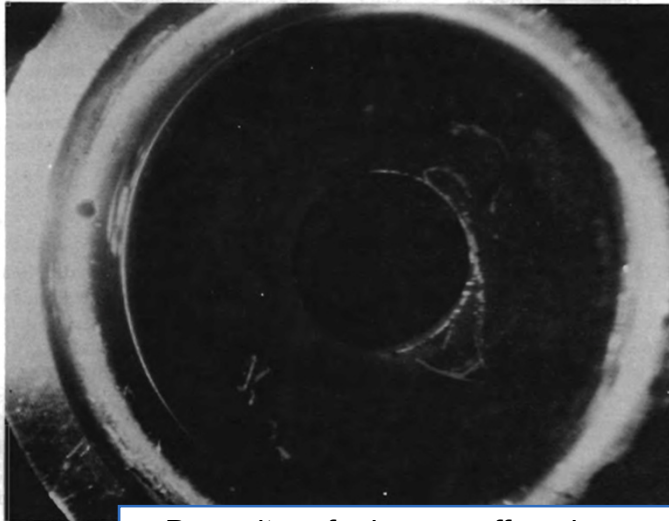
PHOTO 1856 - 74

Deposit on fuel pump offgas jumper line flange
