Long Mott Generating Station

Construction Permit Application Part VI Supplemental Information

Xe-100 Technical Report

Preliminary Plume Exposure Pathway Emergency Planning Zone Analysis

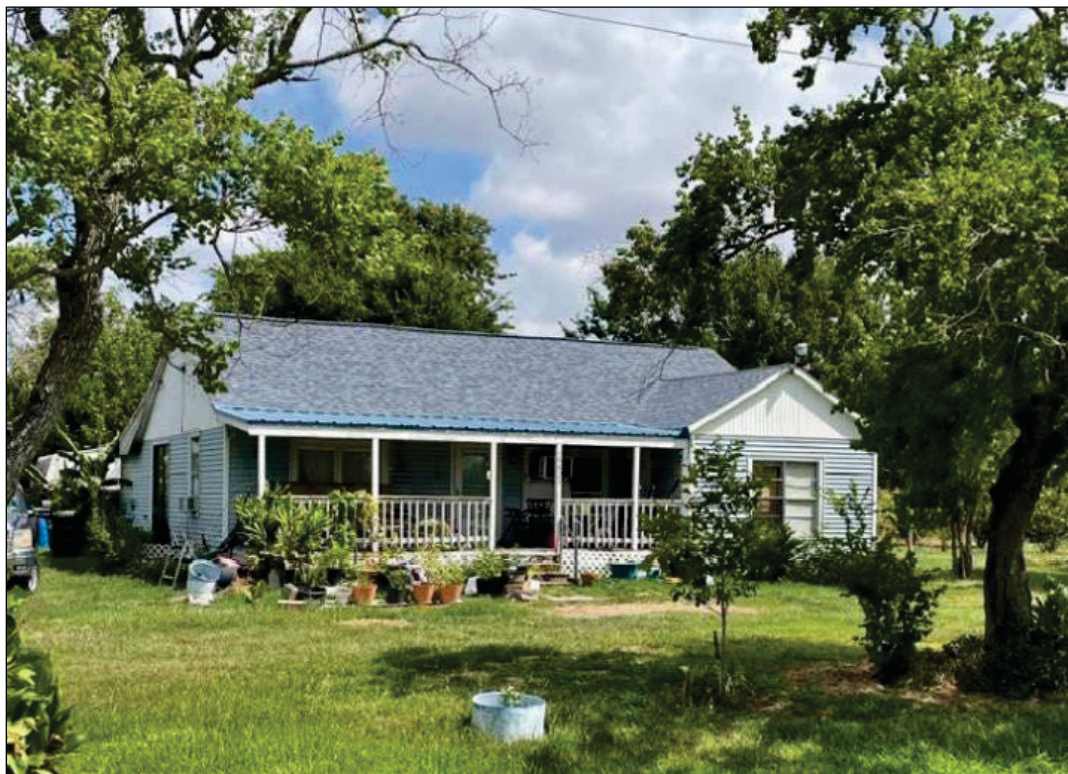
Figure 5.6. An Example of a Transitional Ranch House (AR 6) within the APE.

Modern architecture in the area is a combination of styles, with storm and flood prevention resulting in instances of brick or concrete-block construction lifted with pilings, piers, stilts, or concrete-masonry-unit blocks in low-land areas. Rural houses typically do not exhibit a clear style or historical form and often embody modest, one-story house forms lacking complexity and non-essential stylistic features (**Figure 5.5**). Minimal Traditional houses reflect the mid-20th century FHA principles of austere construction are common in Calhoun County. However, because of their simplicity and frequency in the landscape, individual Minimal Traditional-style residences are typically found ineligible for individual NRHP designation. Ranch style houses are also ubiquitous in Calhoun County. The Ranch style residence, promoted as modern on the inside and traditional on the outside, became the most common style across the nation in the 1950s and 1960s. Ranch-style houses date from about 1935 to 1975 and the ubiquity of these houses means that they are typically found ineligible for listing in the NRHP as individual resources. Variations of the Ranch include the Minimal Ranch or Transitional Ranch, which is exemplified by AR 6 (**Figure 5.6**). These buildings are small in scale; lack overhanging roof eaves and other elaborations; may have

a broader profile than Minimal Traditional residences; and may be devoid of character defining details including a picture window, horizontal-sash double-hung windows, eaves, brick skirting, or an attached garage (McAlester 2015, 602). Transitional Ranch houses rarely possess sufficient architectural distinction and are consequently found individually ineligible for listing in the NRHP in most cases.

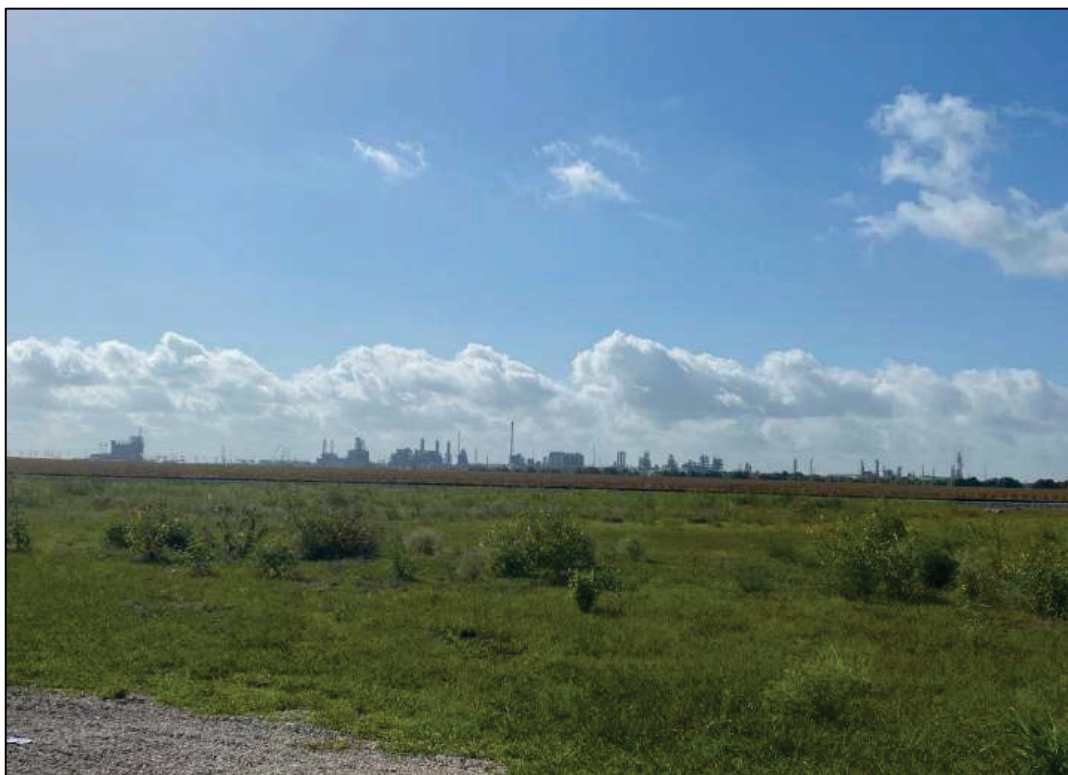
Figure 7.3. Overview of AR 1a, facing Southeast.

AR 1a is a southwest facing, 20th century industrial facility. Located in the vicinities of Seadrift and Port Lavaca, the plant is comprised of a combination of modern and historic age structures which retain varying levels of integrity (**Figures 7.3-7.5**). The historic age buildings that comprise AR 1a are generally utilitarian in appearance with few or no stylistic elements. The buildings have generally continued to serve their functions, aside from Buildings 13 and 14, which are former administrative buildings currently slated for demolition through a separate project (**Table 7.2**). Though the plant technology and many of the supporting structures have changed over time, the general function and feeling of the Seadrift facility has remained consistent as a site of petrochemical processing and manufacturing. Observation was conducted from outside of the facility fence line to comply with Dow/ UCC safety protocols.

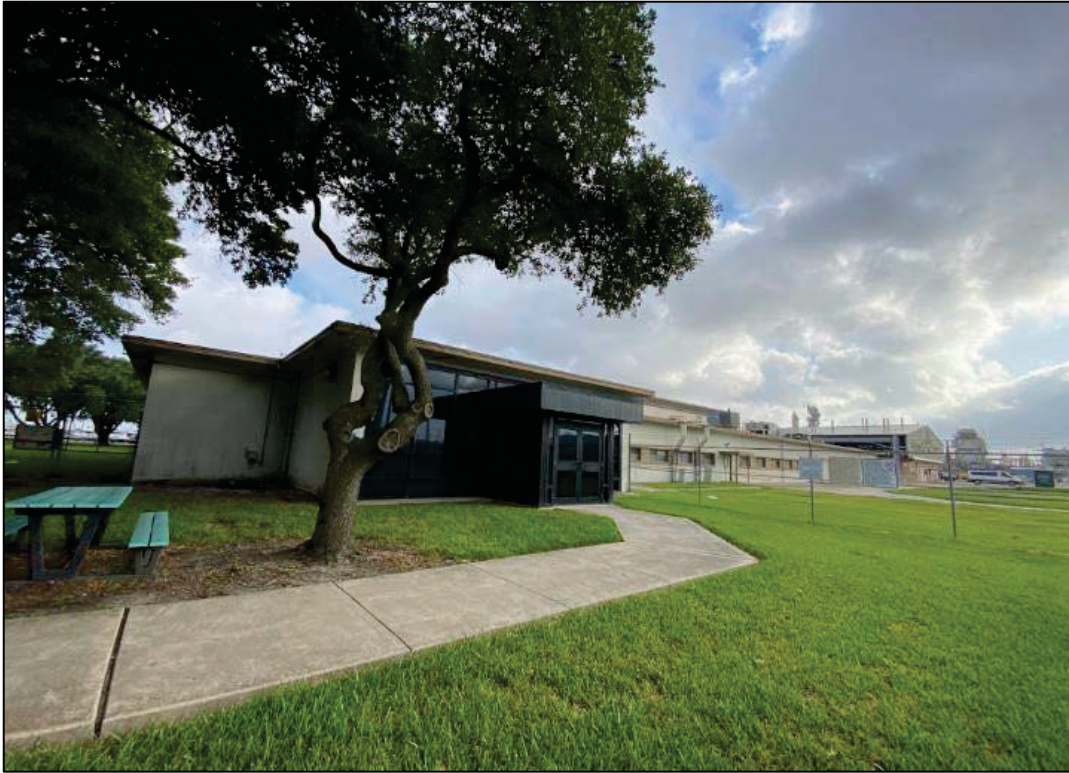
Figure 7.6. AR 1a, View of Southeast Elevation of Building 1, facing North.

Building 1 is the most ornamented of the historic-age structures that comprise AR 1a and displays contemporary stylistic elements but is nonetheless consistent with the rest of the facility in its overall utilitarian design. The building is one-story, covered by a flat metal roof with wide eave overhangs, and has an L-shaped floor plan with a wing extending northwest from the main block. The southeast (main) elevation, from west to east, features the main entrance; a secondary entrance covered by a flat entryway roof; a row of four pairs of four-light, fixed, aluminum windows; a third entrance similar to the second, featuring a flat roof supported by two cylindrical metal supports and accessed via a low-pitch concrete ramp embedded with a metal handrail; a row of five pairs of four-light, fixed, aluminum windows; a fourth entryway of consistent character; and a fifth entryway featuring a set of double doors, each inset with a single light, which features a concrete ramp and metal handrail, but no entryway roof or supports. The main entrance is comprised of a set of metal double doors inset with two large panes which access a vestibule enclosed on the northeast and southwest sides by six fixed windows and covered by a flat, metal roof extending from the elevation below the principal roofline. The eaves of the roof overhang the enclosed vestibule which features a wide metal fascia (**Figure 7.6**). The southwest elevation features a row of sixteen wall openings—pairs of four-light, fixed, aluminum windows—followed by three wall openings of the same configuration to the north (**Figure 7.7**). The northwest elevation of the wing features one wall opening: a set of two abutted rectangular vents inset within an aluminum frame (**Figure 7.8**). The northwest and northeast elevations of the main portion of Building 1 were not visible from the facility fence line.

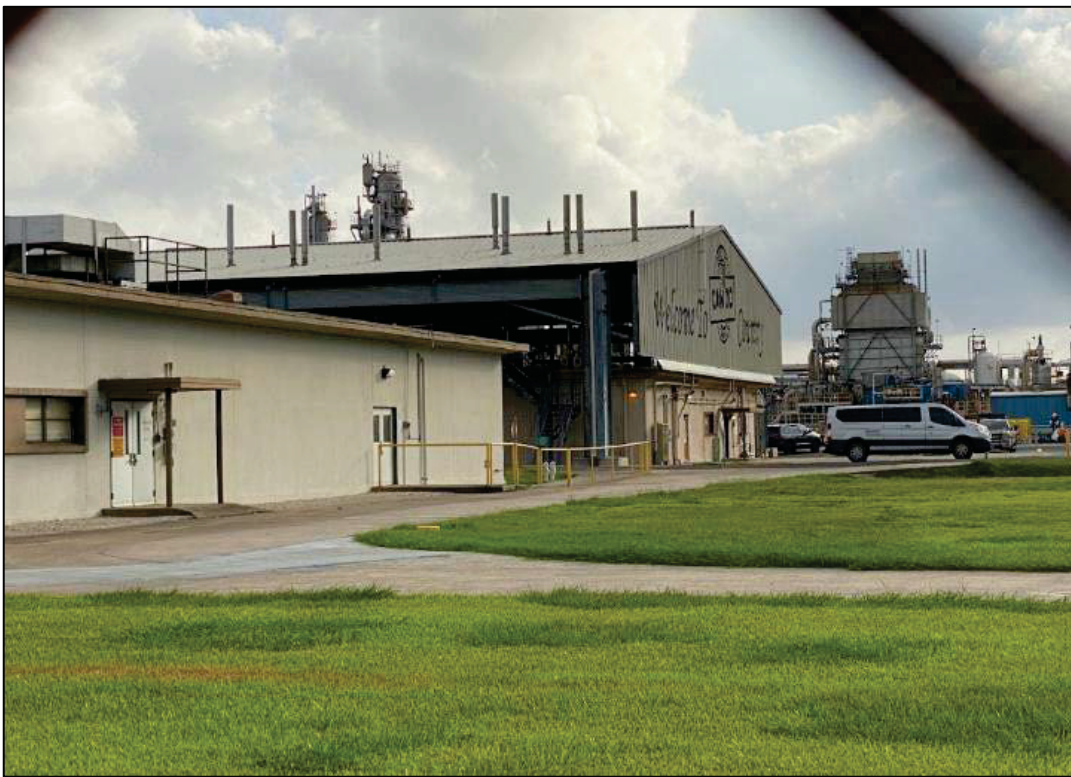
Figure 7.9. AR 1a, View of Southeast Elevation of Building 2, facing Northeast.

Building 2 is largely obscured from view by a non-historic, front-gable secondary roof structure. A partial view of the southeast (main) elevation reveals wide overhanging eaves; corrugated metal siding; a flat porch roof over the main entrance; and at least two additional wall openings to the west: a second entrance and a window of unknown sash operation. A partial view of the southwest elevation suggests there are additional entrances (**Figures 7.9-7.10**).

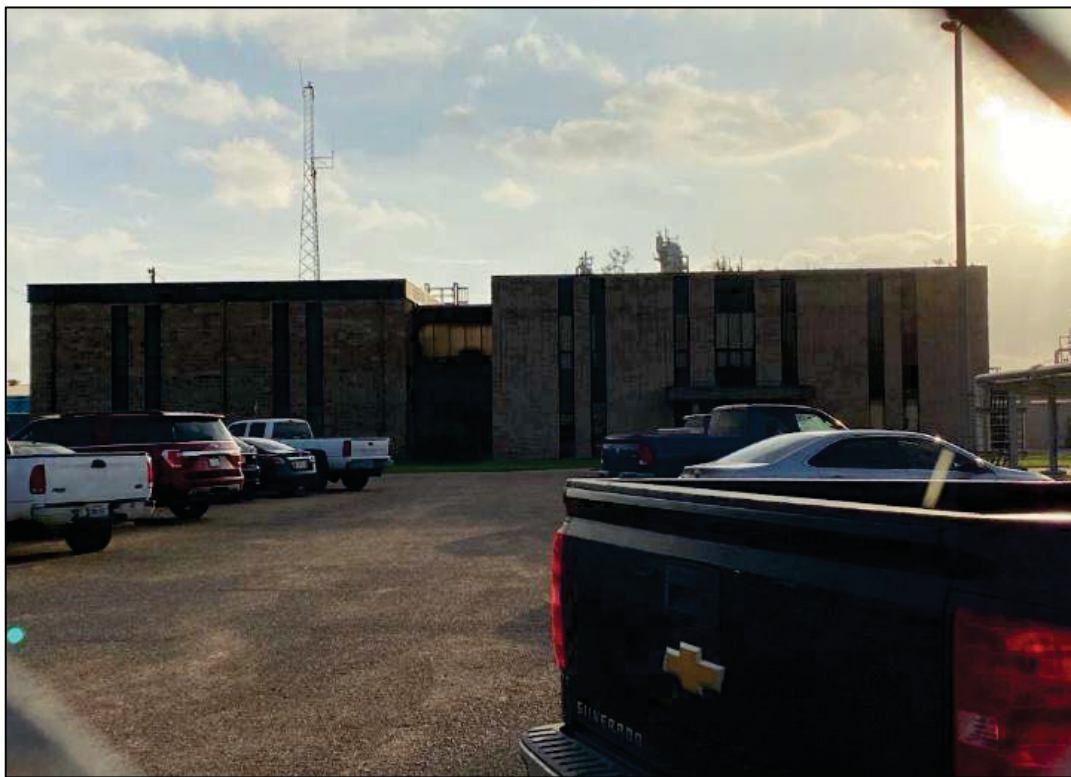
Figure 7.11. AR 1a, View of Southwest Elevation of Buildings 13 & 14, facing East.

Buildings 13 and 14 are two-story, southwest-facing industrial buildings connected along their northwest (Building No. 13) and southeast (Building No. 14) sides via a two-story, enclosed walkway (**Figure 7.11-7.13**). The southwest elevations of both buildings feature linear wall openings extending from the roofline to grade. Building 13 features two columns of six fixed, aluminum windows on either side of a central window configuration: two columns of six fixed, aluminum windows on either side of a 12-light rectangular, fixed, aluminum window. Below the most central wall opening, a flat roof extends over the main entryway of the building. The entrance is comprised of a set of metal framed double doors inset with large lights. Building 14 features two columns of six fixed windows along the same elevation. A partial view of an addition along the northwest elevation of Building 14 reveals an unornamented entrance and a vent.

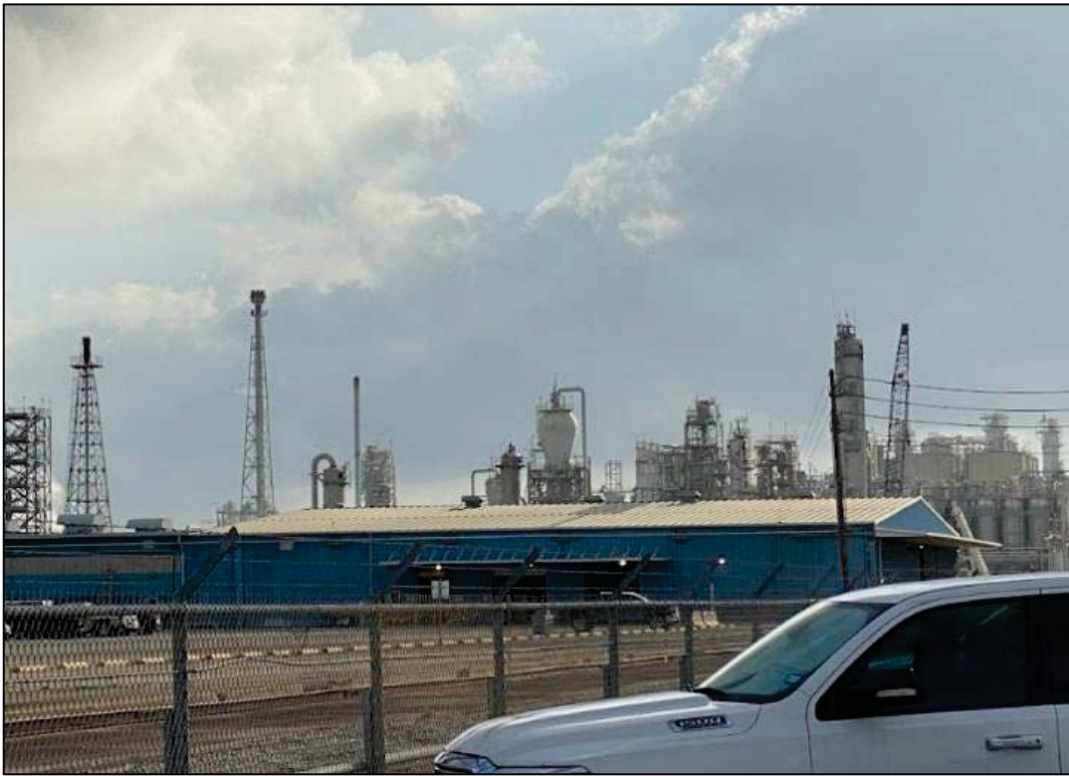
Figure 7.14. AR 1a, Partial View of Southwest and Southeast Elevations of Building 140, facing Southeast.

was destroyed during an on-site explosion in 1991 and consequently is not historic. However, the portion below the metal, gable roof was constructed as part of the original UCC facility. Along the southeast elevation, the historic portion of the building features two overhead garage doors. Along the southwest elevation, two additional overhead garages and a possible entrance are located beneath a flat, metal roof which extends from below the principal roofline and is supported by suspension cables (**Figure 7.14**).

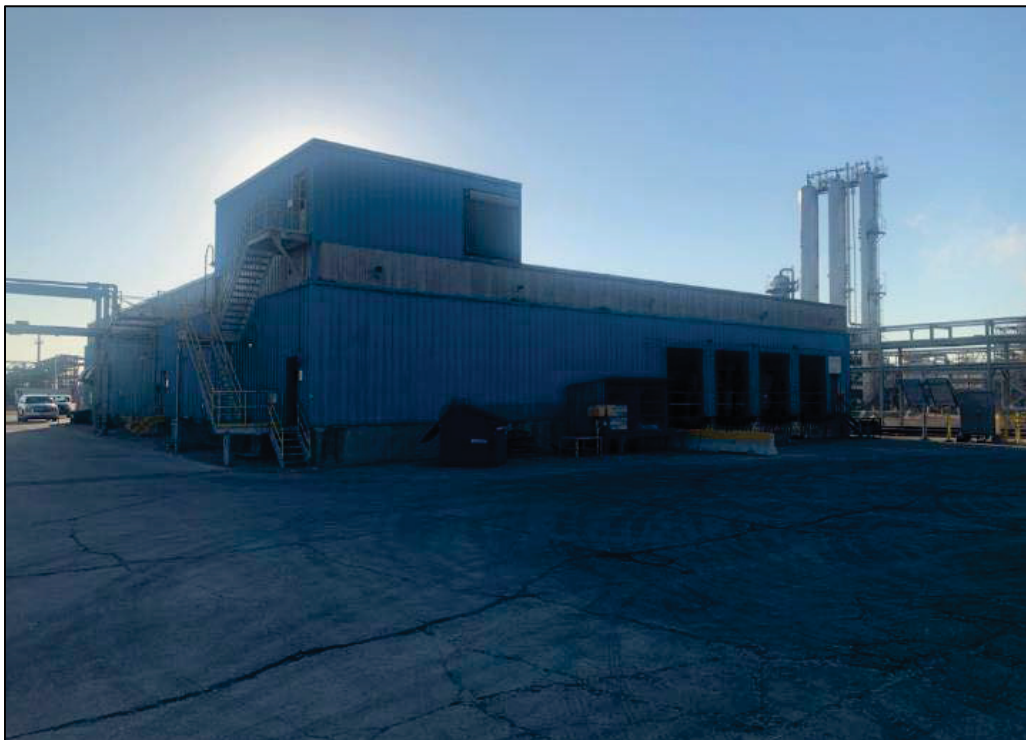
Figure 7.15. AR 1a, View of Northwest and Southwest Elevations of Building 380, facing East.

Building 380 is a 1.5-story, northwest-facing industrial warehouse clad in non-historic corrugated metal siding covered by a flat roof and rests on a concrete foundation. The building measures approximately 12,860 square feet, and a second story of approximately 912 sq. ft. rises from the northwest corner of the roof. Along the northwest elevation of the first story, the building displays two entrances, accessed by metal staircases affixed with metal handrails, and two vents extending from the exterior wall, approximately halfway between the roofline and grade. Along the northeast elevation, no wall openings are visible, but modern aeriels suggest an outbuilding covered by a low-pitched, gable roof is located parallel to this elevation. The southeast elevation features four slatted, square vents. The southwest elevation features three overhead garages and an entrance accessed via metal stairs affixed with metal handrails. The second story features one entrance, accessed via a metal staircase along the northwest elevation and a rolling metal garage door along the southwest elevation (**Figures 7.15-7.16**). Archival research indicates that building 380 was constructed as part of the facility expansions in the early 1960s. Documentation of this building was provided by Dow personnel, as it is not visible from the fence line along any elevation of the facility.

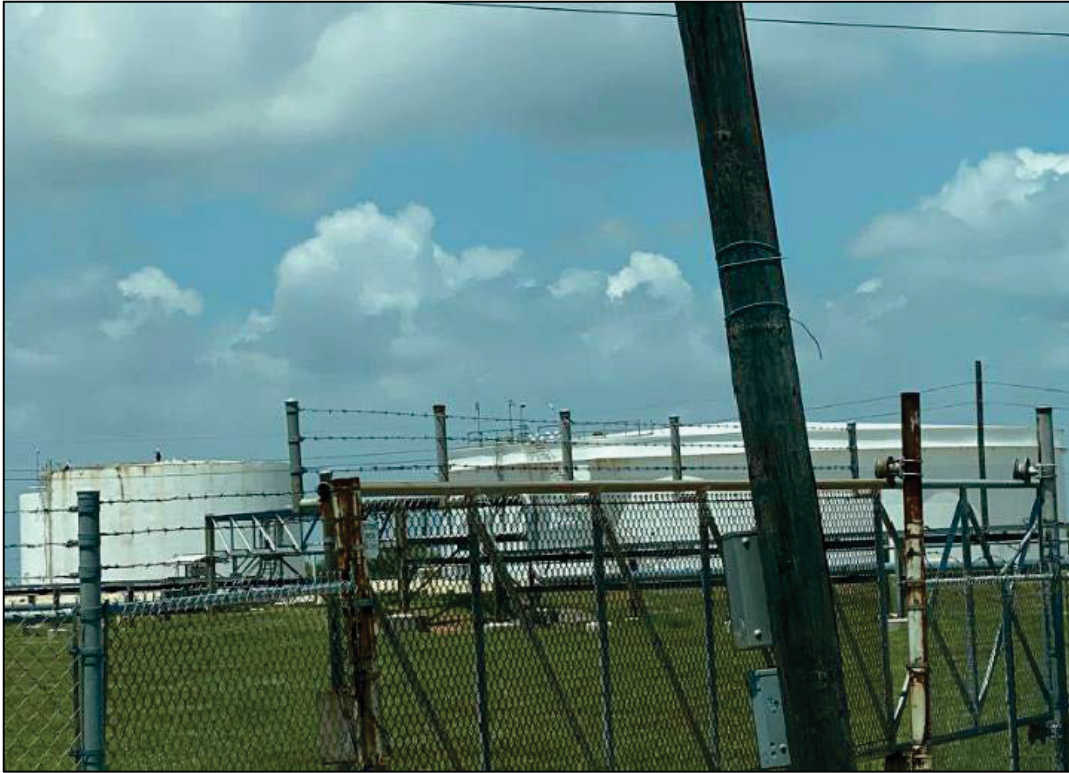
Figure 7.22. View of Rusting and Mixed Condition of AR 1b Elements, facing Northwest.

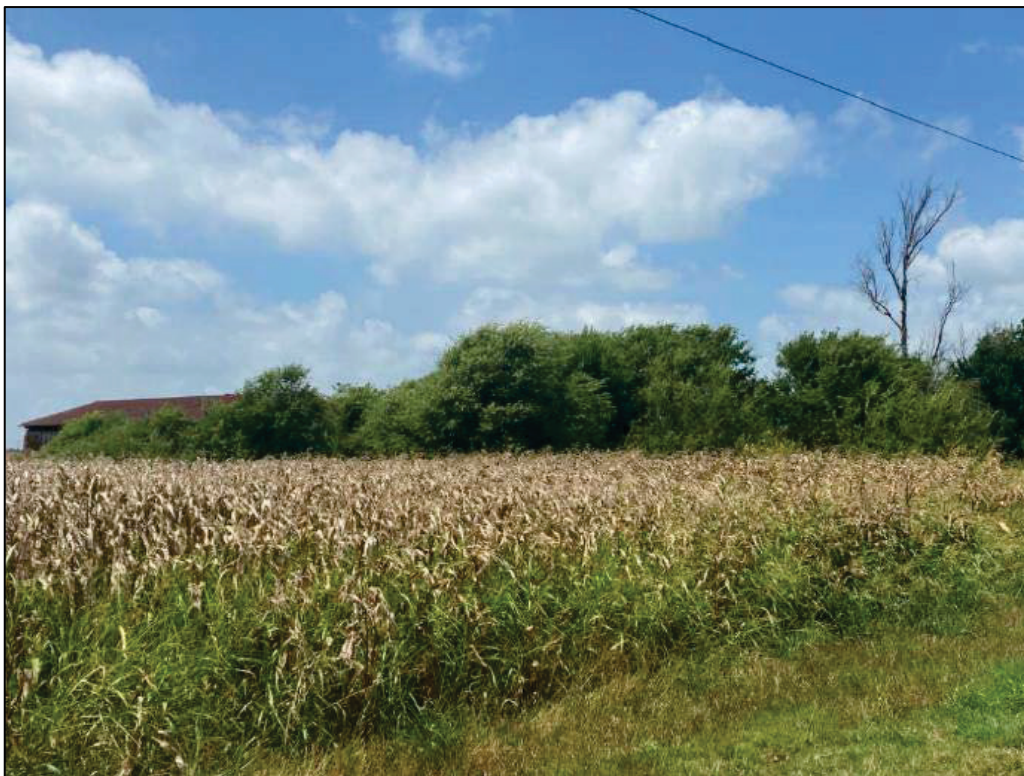
Figure 11.3. View of AR 5 and Outbuilding, facing South; Note Vegetation Overgrowth.

entrance is located along the central block of the house and is covered by a deteriorated shed roof supported by painted wood posts. There is one outbuilding associated with AR 5, a wood barn that sits at the southwest corner of the property (see **Figure 11.3**). Many partial or full elevations were not accessible from the public right-of-way, and historic images of the property varied in quality and completeness, limiting the assessment of wall openings and stylistic elements.

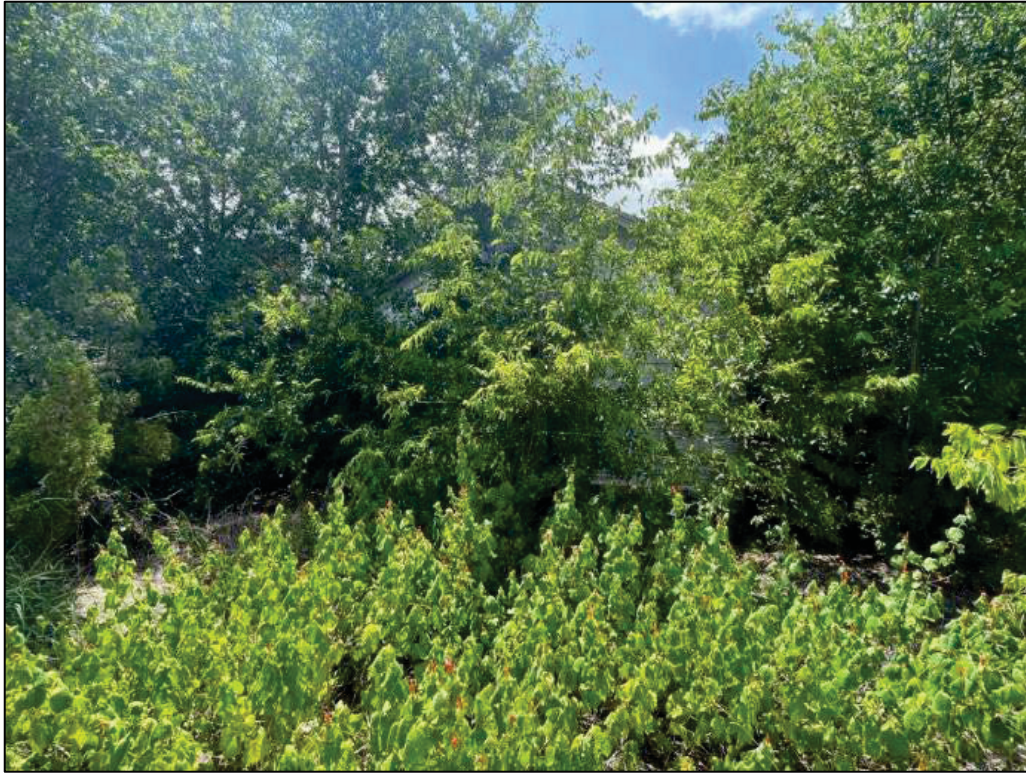
Figure 11.4. View of the Northwest (Main) Elevation of AR 5, facing South; Note the Significant Overgrowth of Vegetation.

AR 5 is a northwest facing, one-story, single-family, Ranch which is covered by a cross-gable, asphalt shingle roof and displays extreme signs of neglect and deterioration. AR 5 appears to be abandoned (**Figure 11.4**). Along the northwest elevation, the roofline features two cross-gable roofs alongside a central shed roof, presumably covering a porch which is obscured from view by vegetation. The house is clad in a combination of painted brick, stone veneer, and brick veneer. AR 5 features aluminum, sliding and double-hung windows. The main entrance of the house is not visible from the public right-of-way. An interior brick chimney is located centrally along the northwest slope of the side-gable (principal) roof. A second and potential third entrance are located along the southeast (rear) elevation but are partially obscured from view. The secondary

AR 5 is in poor condition and appears abandoned. The visible stylistic elements of the resource appear to be original to the house; however, extensive structural damage and neglect has resulted in diminished integrity.

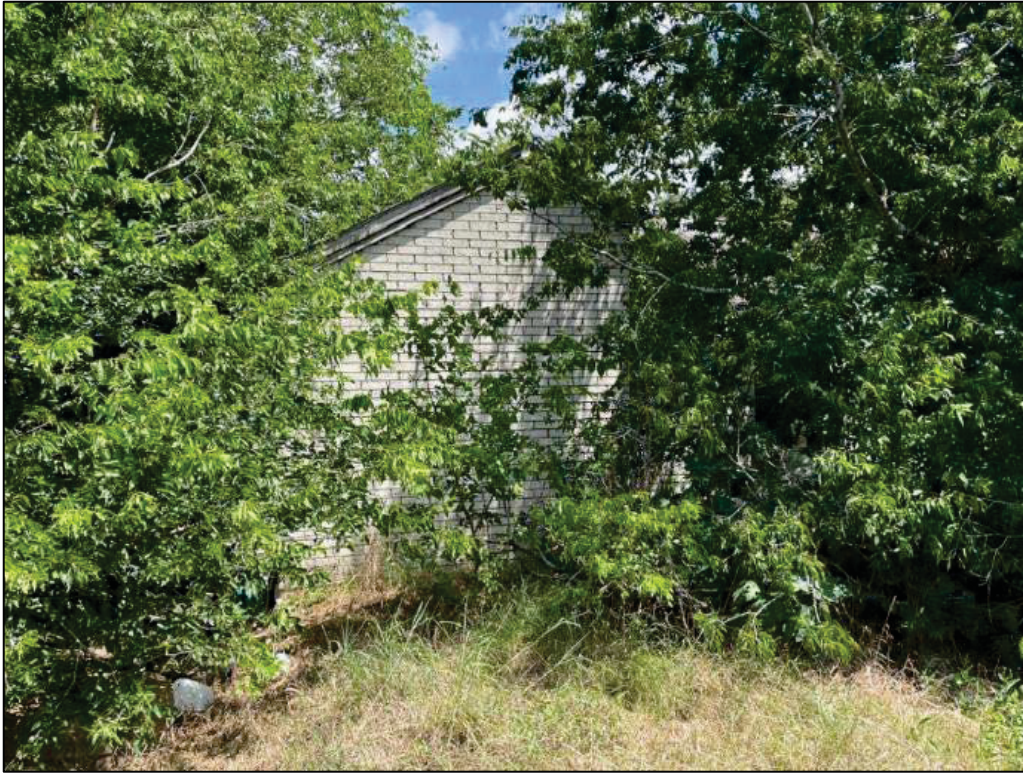
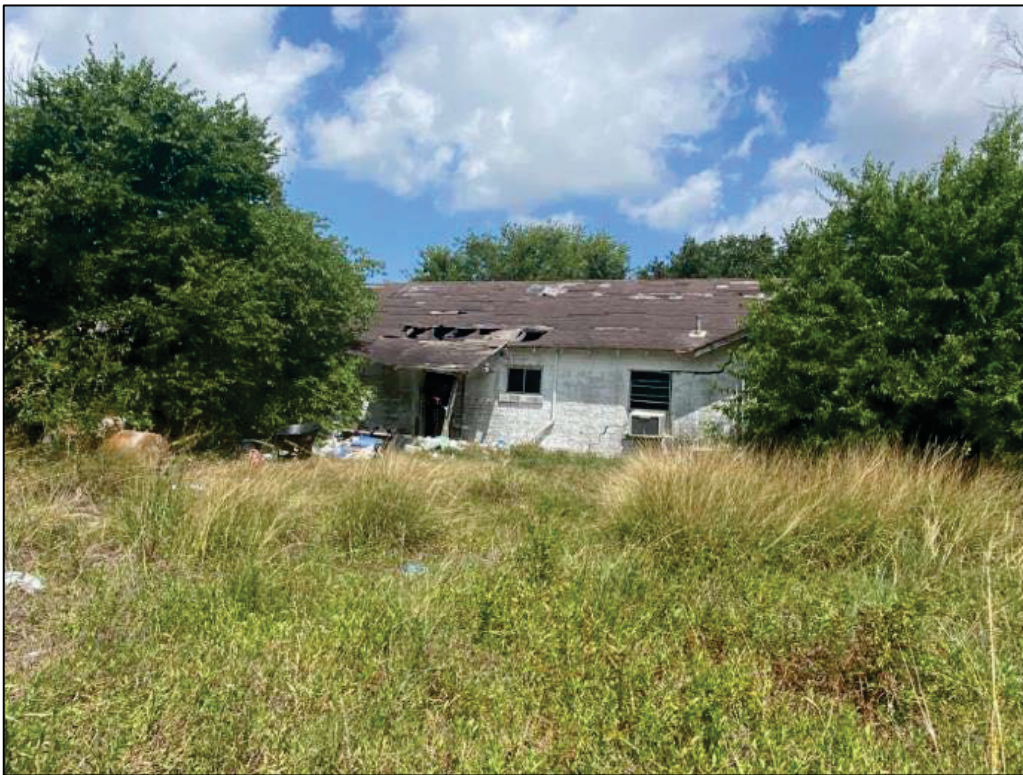
Figure 11.6. View of Southeast (Rear) Elevation of Cross-gable Section, facing North.

The southeast (rear) elevation was only partially visible, due to vegetation overgrowth, and the southwest half of the house could not be assessed from any angle along this elevation. Along the visible portion, a secondary entrance was located beneath a badly degraded porch featuring a shed roof extending from the principal roof line and supported by two wood posts. The entryway features a metal frame storm door inset with four lights and an additional exterior door which could not be assessed from outside of the property. To the west of the secondary entrance is a small sliding, aluminum window and an aluminum, double-hung window, and a garage door partially obscured from view (**Figure 11.6-11.7**).

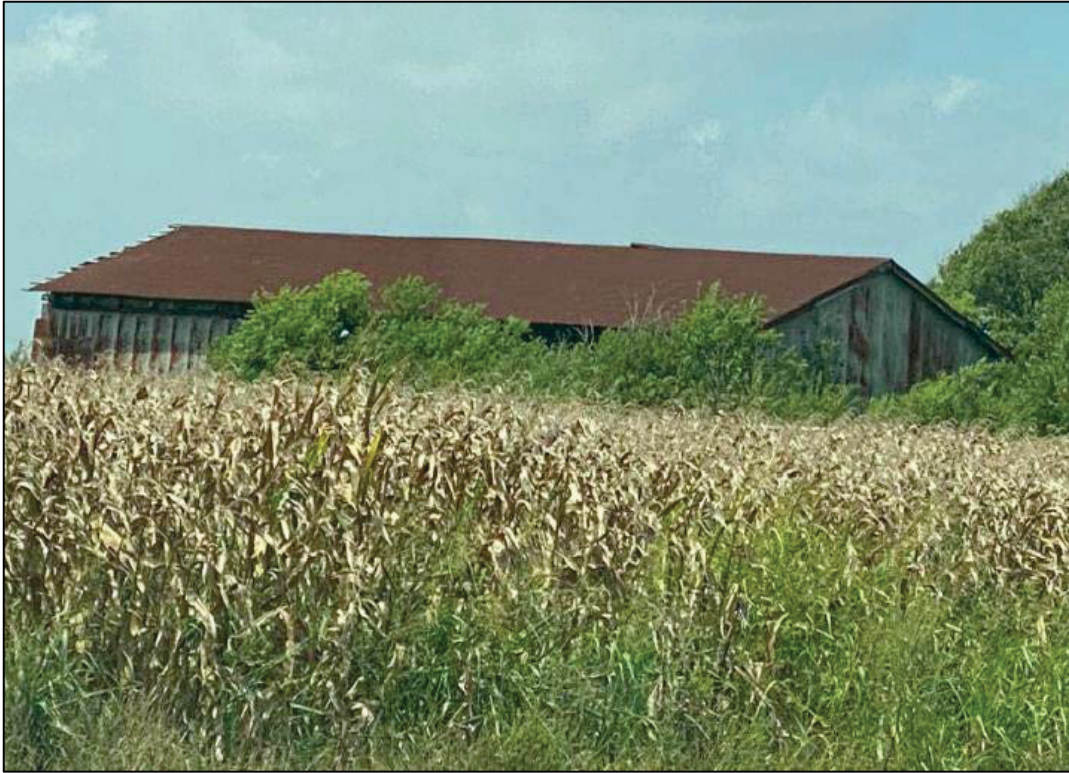
Figure 11.8. View of Northwest and Northeast Elevations of Outbuilding, facing South.

AR 5 has one associated building: an agricultural storage building covered by a side-gable, asphalt shingle roof. The building is clad in wood board siding that displays peeling red paint and is accessed via openings along the northeast and southwest elevations. The roof shows signs of damage along the southeast elevation and vegetation overgrowth obscures most of the structure from the public right-of-way (**Figure 11.8**).

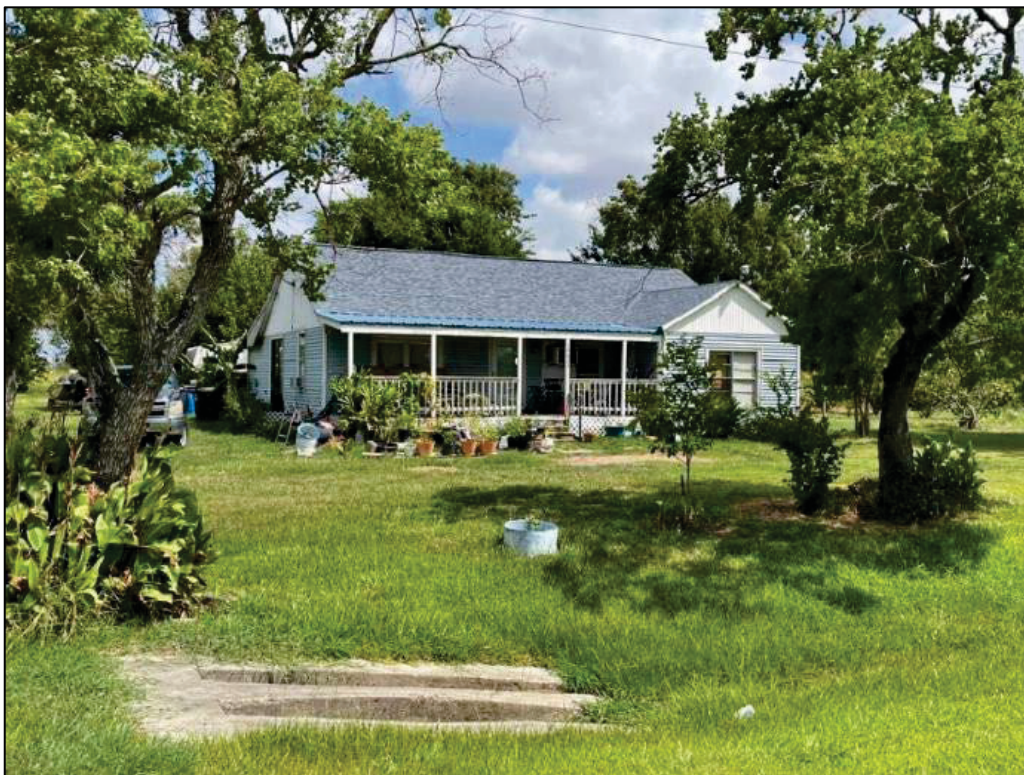
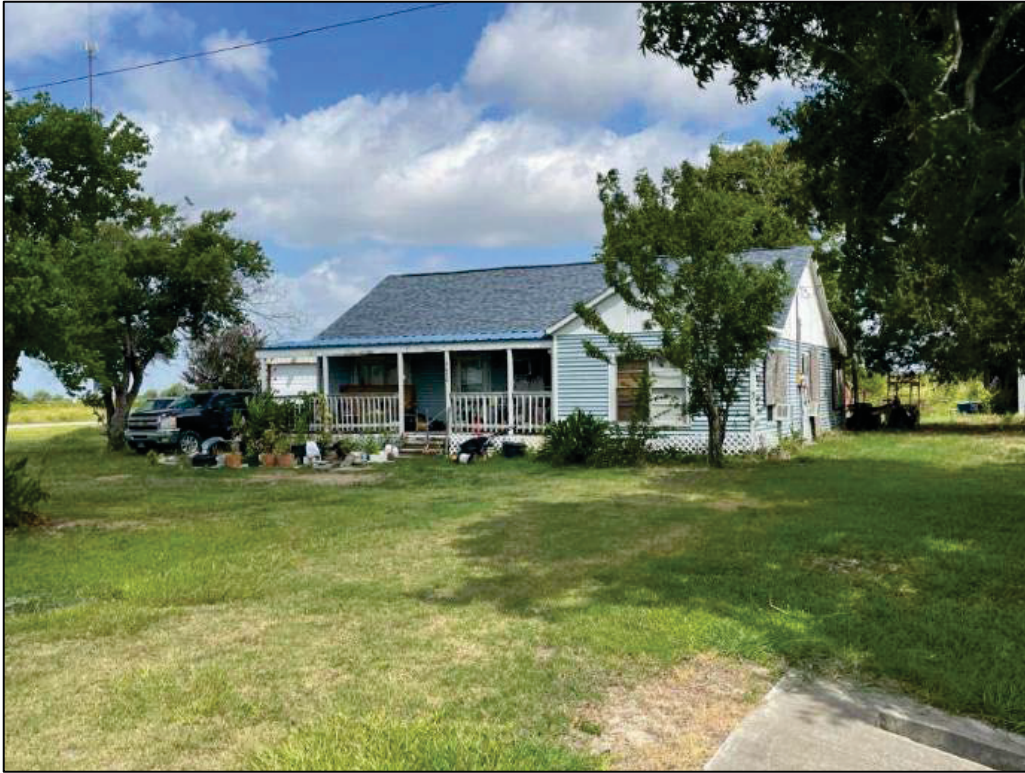
Figure 12.3. View of the Southeast (Main) Elevation of AR 6, facing Northwest.

The southeast (main) elevation features four wall openings. Underneath the shed roof porch, there are two pairs of double-hung vinyl windows, one of which contains a window air conditioning unit. The main entryway is situated underneath the porch roof and consists of a paneled wood door covered by a metal storm door with an inset lite. On the front gable wing of the southeast elevation, there is a pair of double-hung, two-over-two vinyl windows (**Figure 12.3-12.4**).

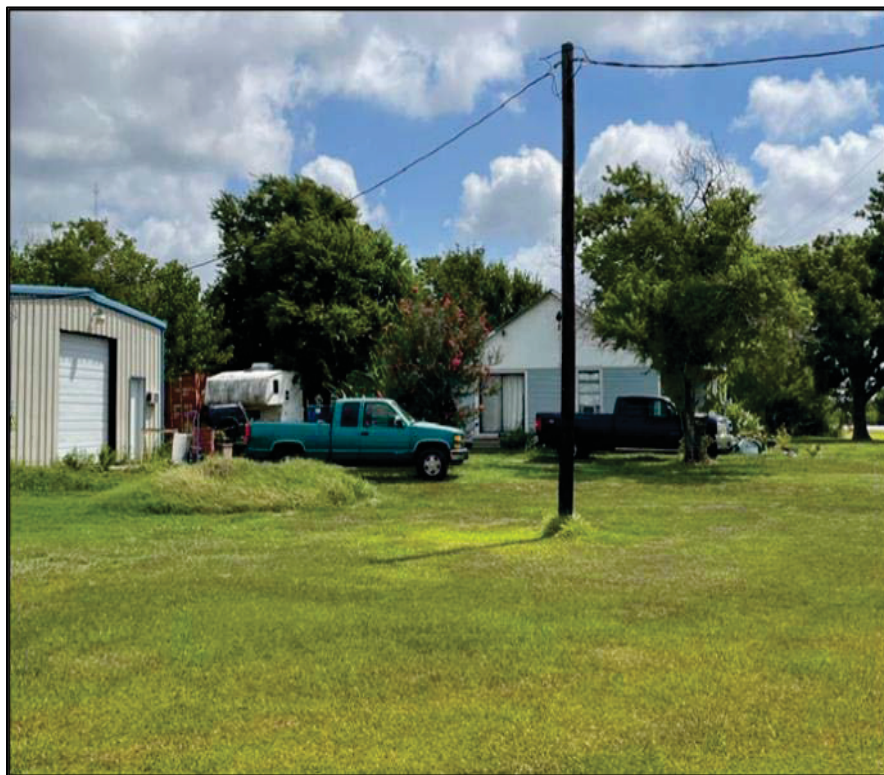
Figure 12.5. View of the Southwest Elevation of AR 6, facing Southwest.

The southwest elevation features two wall openings: a sliding glass side door and a double-hung window containing a window air conditioning unit (**Figure 12.5**).

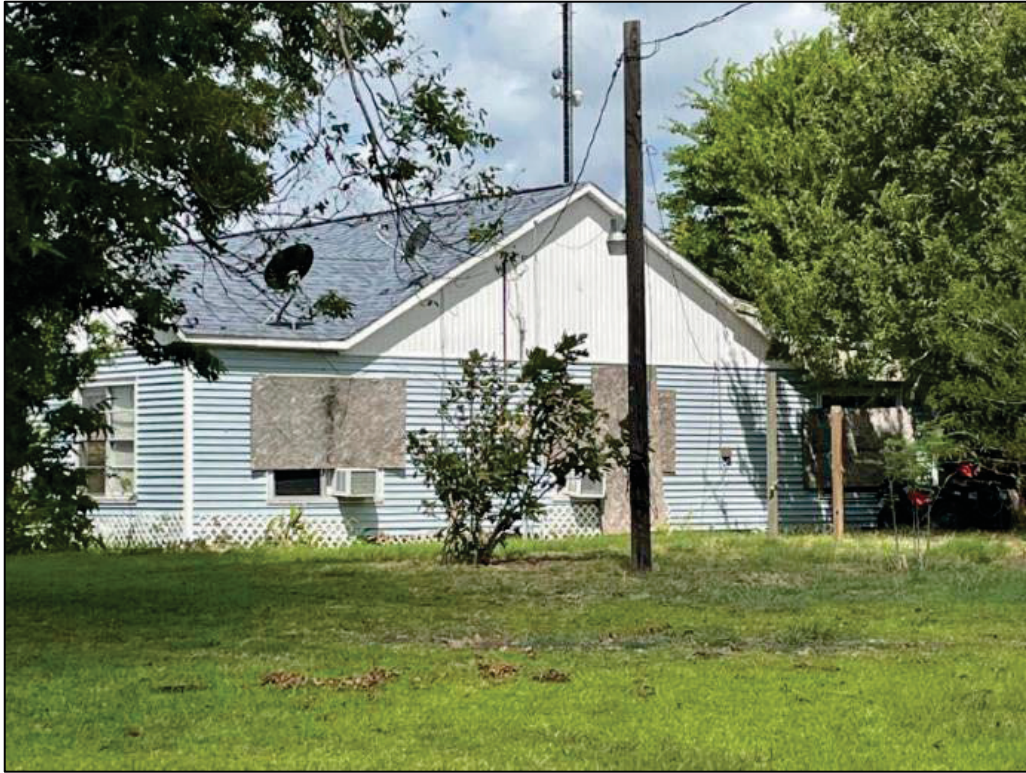
Figure 12.6. View of the Northeast Elevation of AR 6, facing Northeast.

The northeast elevation features three window openings that are partially covered by particle board, two of which contain window air conditioning units (**Figure 12.6**).

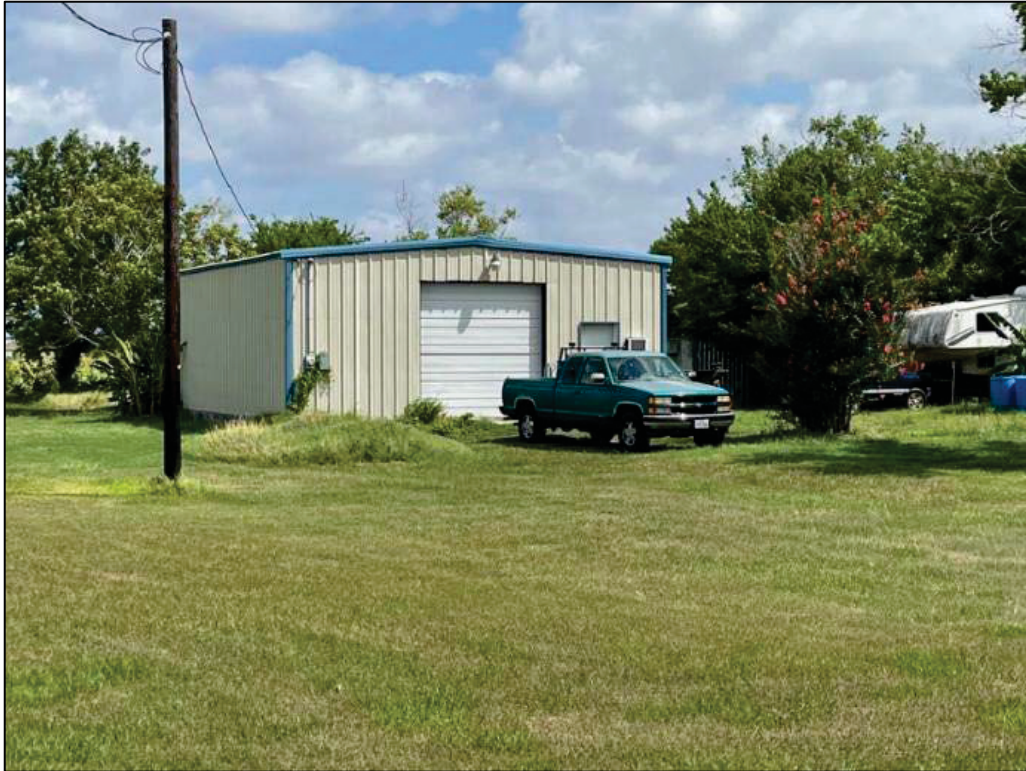
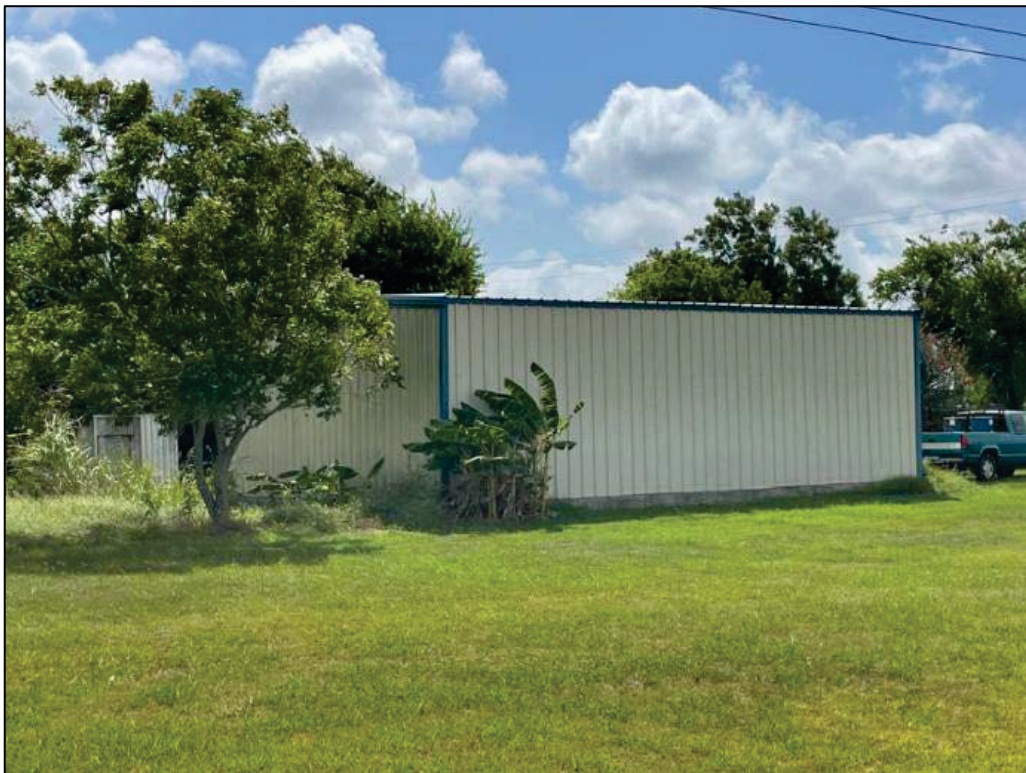
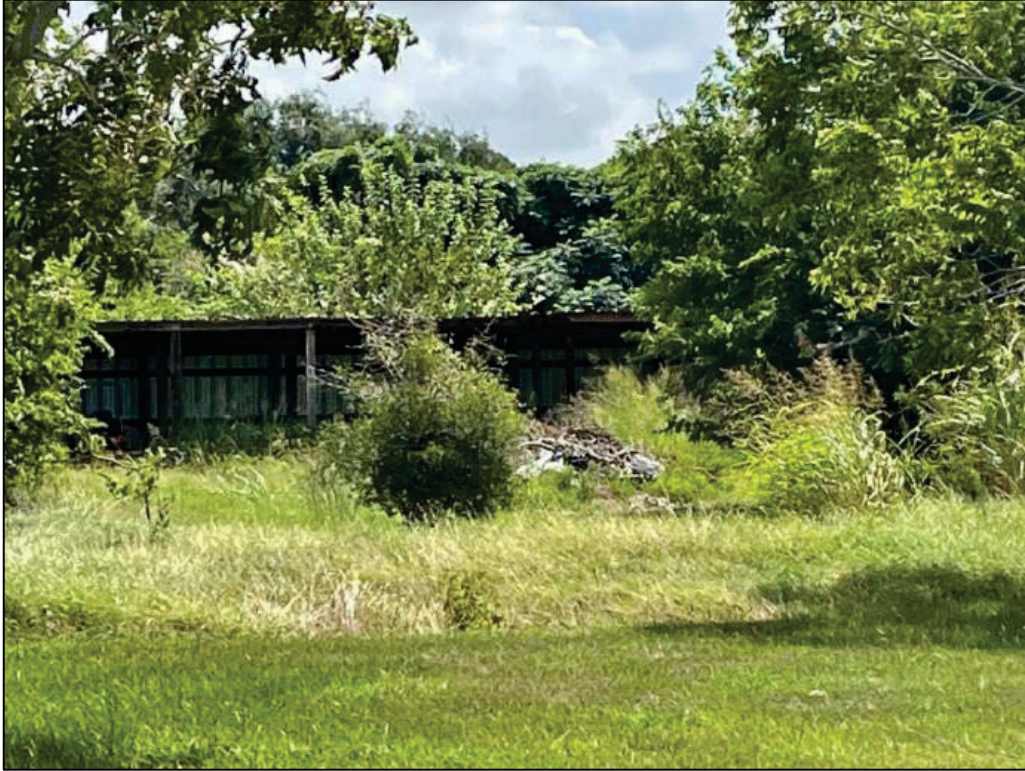
AR 6 is associated with two non-historic outbuildings: a metal storage building, and a vehicle shed. The storage building is on a concrete slab foundation with a low-pitch front gable standing seam metal roof and is clad in vertical standing seam metal siding (**Figure 12.7-12.9**). The southeast (main) elevation of the storage building contains a metal overhead garage door and a solid metal door. The vehicle shed is topped with a corrugated metal shed roof supported by a wood frame (**Figure 12.10**). The vehicle shed is open to the exterior aside from corrugated metal siding on the northwest (rear) elevation.

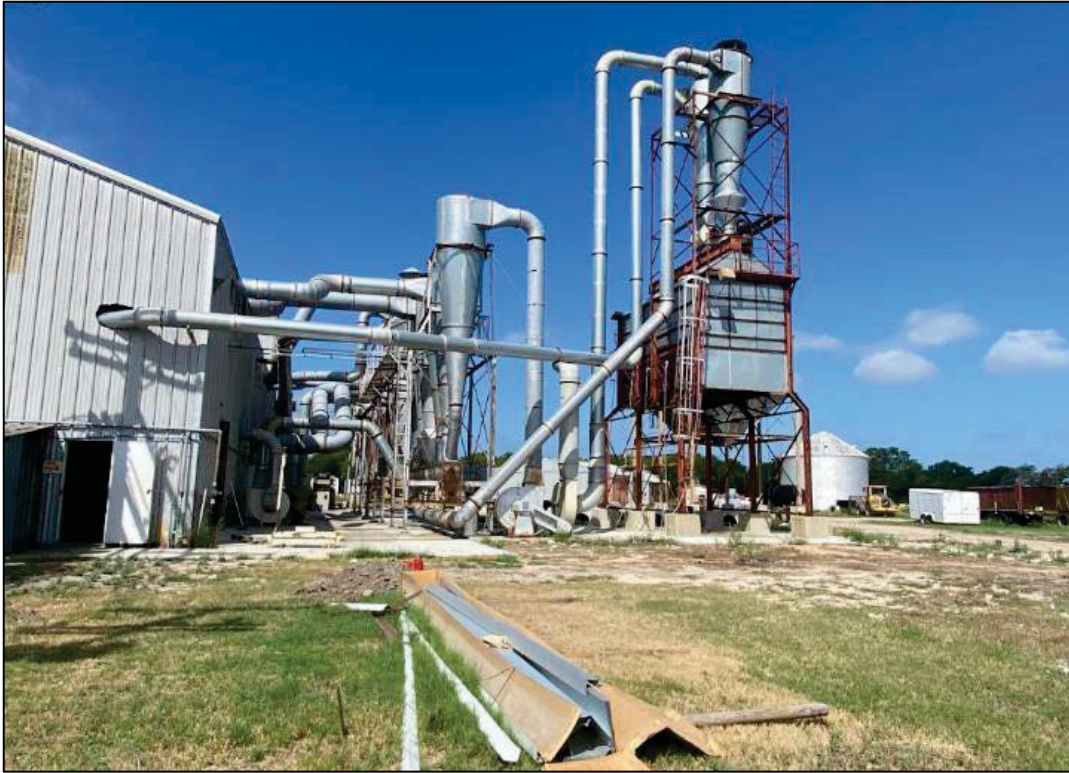
Figure 16.12. View of Processing Machinery, facing West; Note the Cotton Littered around the Ground Outside of the Ginning Building.
