Long Mott Generating Station

Construction Permit Application Part VI Supplemental Information

Xe-100 Technical Report

Preliminary Plume Exposure Pathway Emergency Planning Zone Analysis

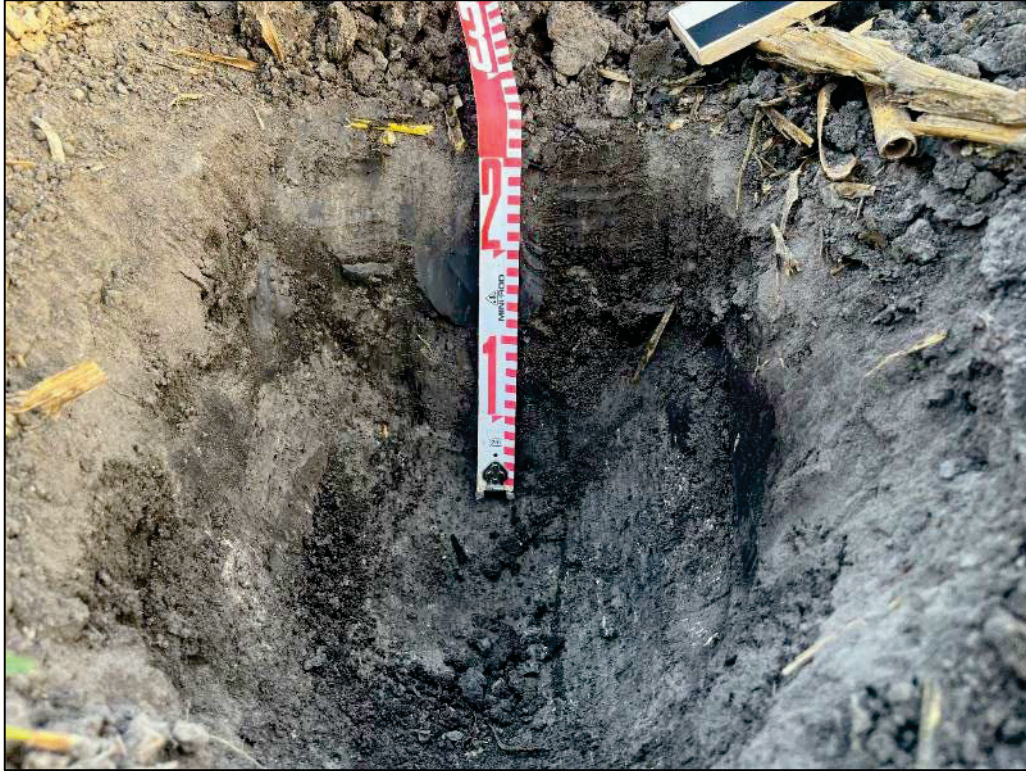
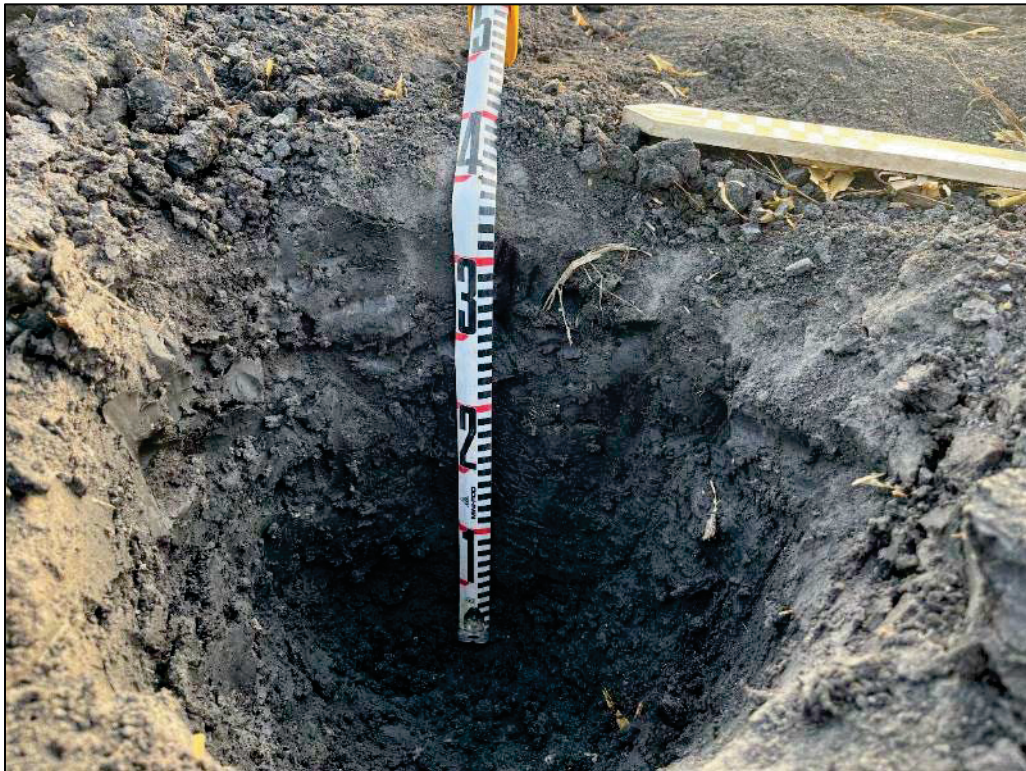
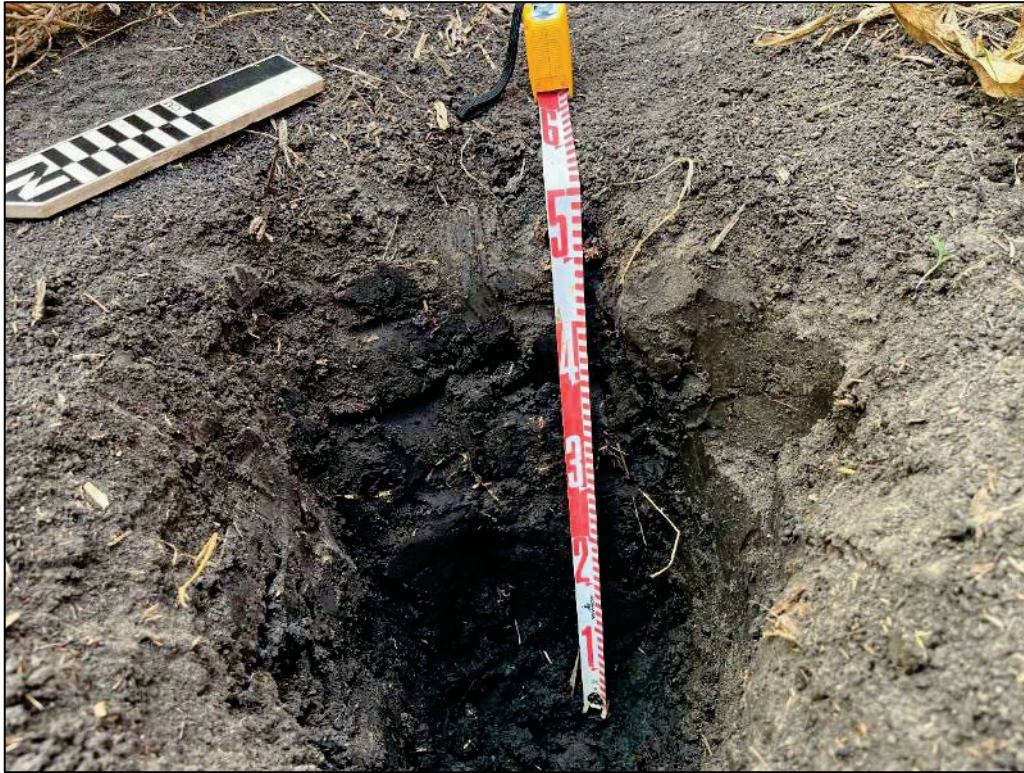
A total of 176 shovel tests were excavated within the APE (see **Appendix A**), all of which were void of cultural material (**Figure 5.8**). All observed soils within the APE were similar and consisted of very compact 10YR 3/1 silt clay loam Zone I, from the ground surface down to approximately 10 – 25 cmbs, underlain by a 10YR 4/1 clay Zone II, from 10/25 – 50 cmbs (**Figures 5.9 – 5.11**).

Figure 5.9. Observed Soil Profile.

Figure 5.10. Observed Soil Profile.

Figure 5.11. Observed Soil Profile.
