November 21, 2002

L-2002-233
10 CFR 50.4
10 CFR 50.54 (f)

RE: St. Lucie Units 1 and 2
Docket Nos. 50-335 and 50-389
Reactor Pressure Vessel Head (RPVH) Inspection
NRC Bulletin 2002-02 Supplemental Response

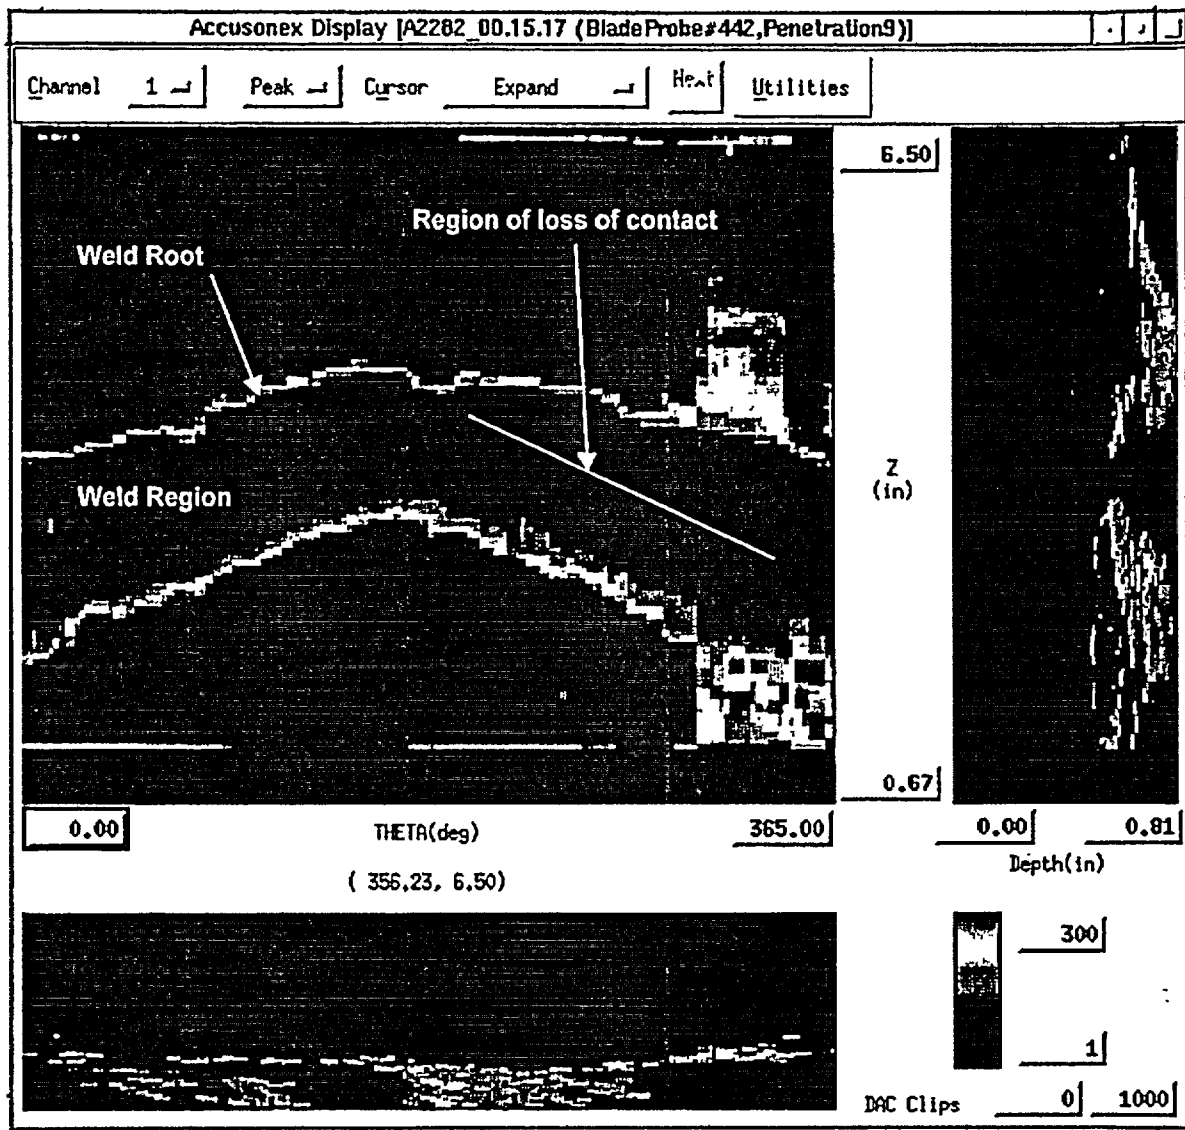
Most penetrations have identified areas of limited coverage due to issues related to maintaining surface contact between the UT probe and the penetration surface. The regions of limited coverage have been localized primarily to the weld region and/or the nozzle material below the weld and are generally located on the downhill side of the nozzle penetration. Refer to Figure 1 for an illustration of the coverage obtained for a typical nozzle examination. Contact between the

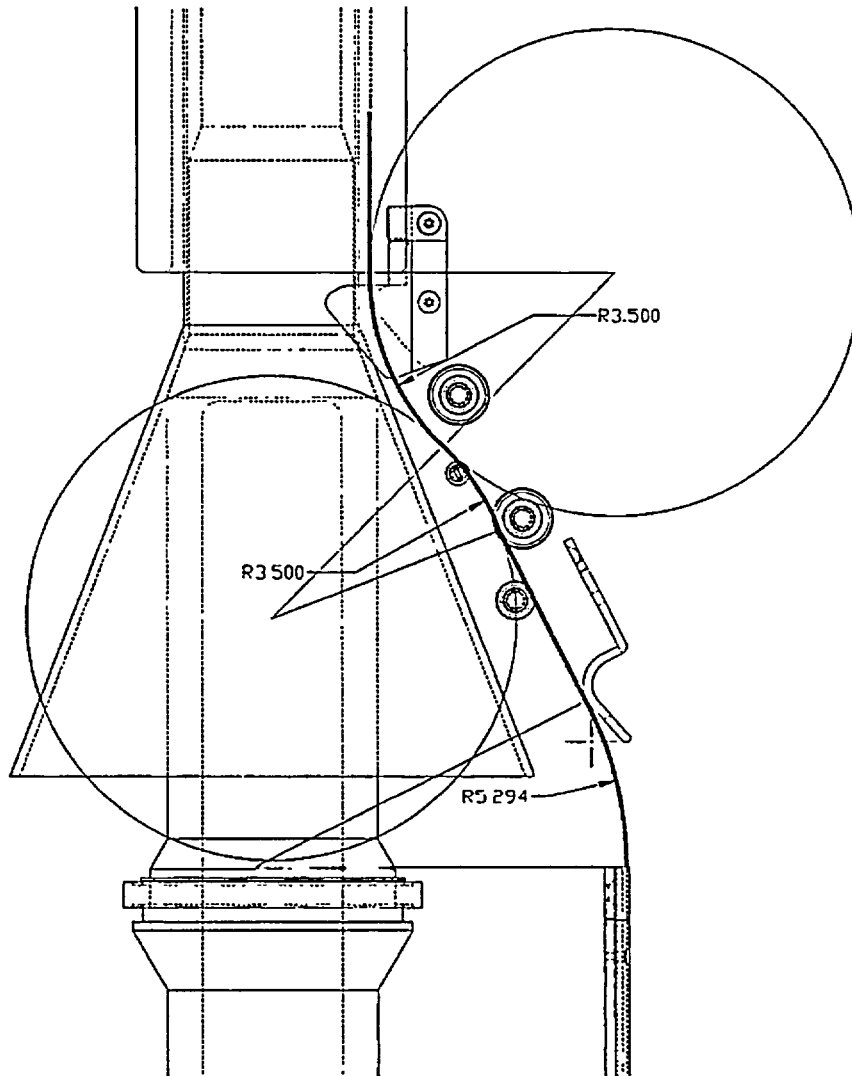
probe and examination surface is affected by the gap between the guide sleeve and the nozzle penetration ID surface, and by the delivery method of the blade UT probe into the gap. The UT probe is delivered into the gap between the guide sleeve and the nozzle penetration by flexing the probe around the guide funnel that is in close proximity to the CEDM penetration. See Figure 2 below for an illustration of the insertion of the blade probe. The blade probe is designed to fit a nominal gap size and has compliance built in for slight variations in the sleeve centering. This compliance allows for the probe to be inserted into a range of gap sizes to compensate for guide sleeve positioning. However, if the guide sleeve is offset to one side of the nozzle that provides a gap that exceeds the tolerance of the probe compliance, contact with the examination surface will not be maintained. Shrinkage of the nozzle ID surface in the weld region due to welding adds to the surface contact issue. The nozzle penetrations examined at St. Lucie Unit 1 have exhibited evidence of shrinkage at the nozzle ID surface in the weld region; refer to Figure 3 for an example of the effects of the shrinkage for maintaining contact.
