# **Integrated Chemical Effects Test Project: Test #2 Data Report**

**Los Alamos National Laboratory**

**U.S. Nuclear Regulatory Commission  
Office of Nuclear Regulatory Research  
Washington, DC 20555-0001**

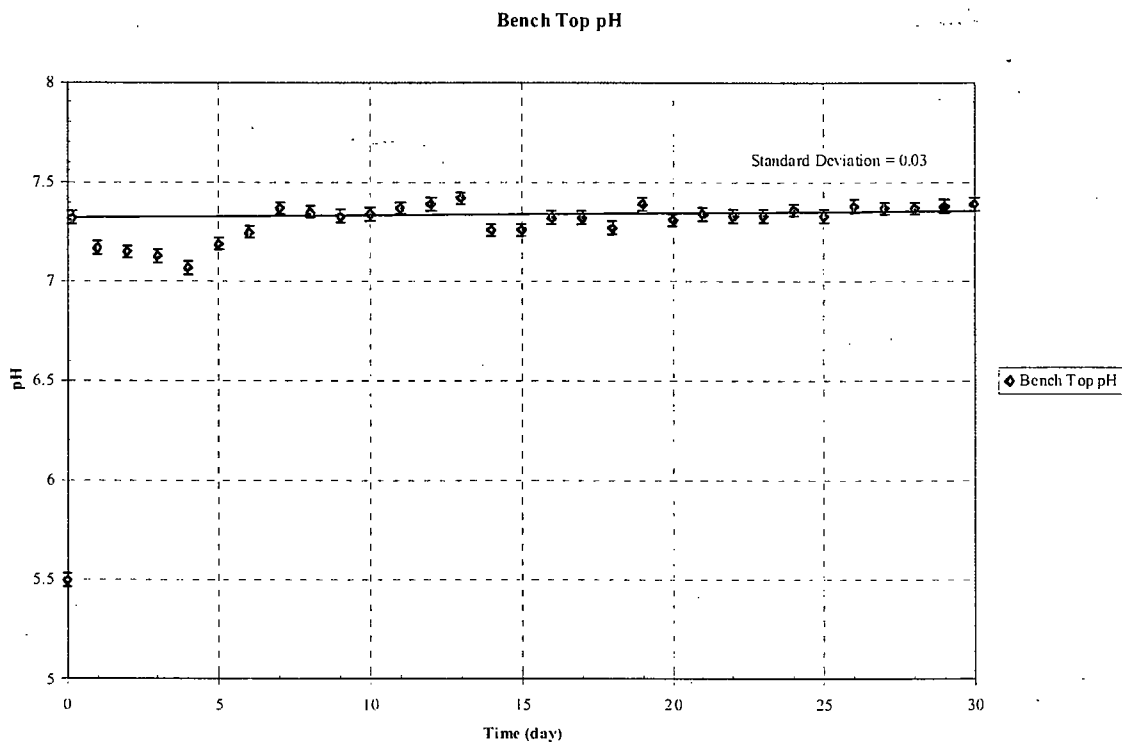
Figure 4-1. Bench-top pH meter results.

**pH:** Before test initiation, 14.54 kg of boric acid and 0.66 g of LiOH were dissolved in the ICET tank solution. The measured in-line probe pH was 4.3, which was the expected value obtained from analytical predictions. At test initiation, the in-line probe reading was an unexpectedly high value of 5.61. The bench-top pH meter (which is calibrated before each measurement) provided a similar reading of 5.5, which validated the sudden increase. The addition of latent debris and concrete dust caused the change in pH. TSP Batch 1 and Batch 2 were then metered as described in Subsection 4.1.1. When these prepared batches were added, the in-line probe showed a rise in pH until it reached the value of 7.3, which corresponded to the bench-top reading. After the spray, the in-line pH probe drifted to unreasonably high values that deviated from the bench-top readings. Thus, the bench-top pH values are the only values truly reflective of the solution pH beyond that point. The malfunctioning pH probe was replaced after this test.

Over the first week of Test # 2, the average pH, after the first 4 hours of the test, was 7.2, with a minimum value of pH 7.07 and a maximum value of pH 7.32. During the second week, the average pH rose to 7.3, with a minimum pH of 7.37 and a maximum value of pH 7.42. The average pH remained constant at 7.3 throughout the final 2 weeks of testing. Figure 4-1 shows the pH, as measured by the bench-top pH meter.

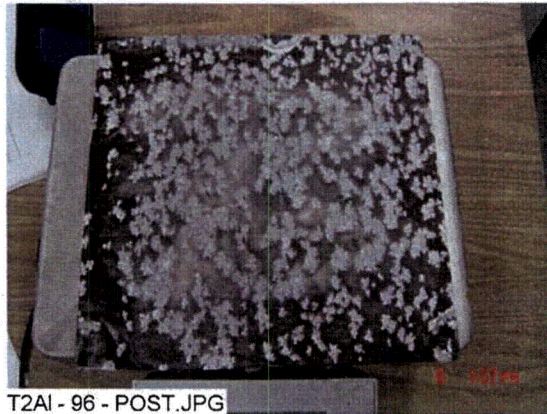
**Figure 4-3. AI-96 submerged, post-test.**

Figure 4-2 through Figure 4-7 display the pre-test and post-test pictures of the three submerged aluminum coupons. Each post-test aluminum coupon exhibits a similar pattern of white particle deposits. Also, each post-test coupon has a reddish-brown color, which is most attributable to the submerged copper coupons. The relative spatial location of these coupons, given in order from the west side of the tank to the east side of the tank, is as follows: Al-98, Al-97, and Al-96. It is evident that the concentration of white particles increases slightly from the westernmost coupon to the easternmost coupon.

According to SEM/EDS results, the dominant corrosion products on the submerged aluminum coupons are likely aluminum hydroxide with other substances containing silicon, calcium, sodium, magnesium, phosphorus, carbon, and oxygen. In addition, evidence was found that some copper deposited on the submerged aluminum coupon surfaces. Comparing the redox potential ( $E^0$ ) of  $\text{Al}^{3+}$  and  $\text{Cu}^{2+}$ , which is  $-1.662$  and  $0.3419$  V (Ref. 6), respectively,  $\text{Cu}^{2+}$  in the solution may oxidize aluminum metal. As a result, aluminum metal may be oxidized into  $\text{Al}^{3+}$  and released to the solution. Correspondingly  $\text{Cu}^{2+}$  is reduced into metallic copper and subsequently deposits at the aluminum coupon surface.

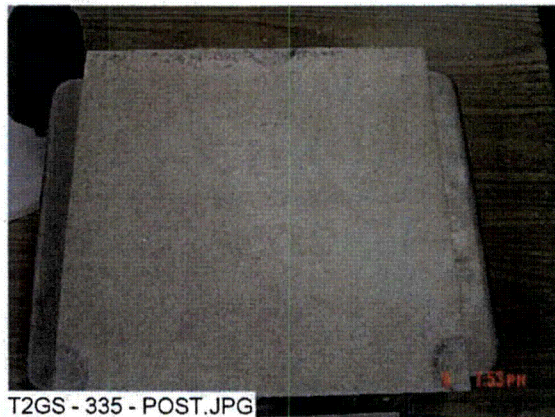
Figure 4-9. GS-335 submerged, post-test.

Figure 4-8 through Figure 4-13 present the pre-test and post-test pictures of three submerged GS coupons. Each post-test GS coupon exhibits nearly identical patterns of dense gray particle deposits. The relative spatial location of these coupons, given in order from the west side of the tank to the east side of the tank, is as follows: GS-337, GS-338, and GS-335. There is no discernable relationship between the spatial location of the coupons and particle deposition patterns or density. For the submerged GS coupons, the possible corrosion products are phosphoric and carbonate compounds of zinc and calcium.

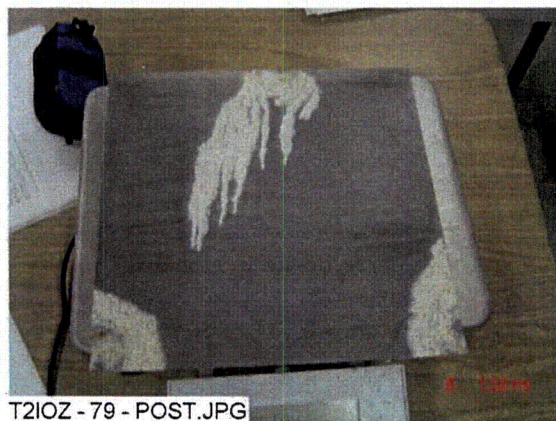
**Figure 4-15. IOZ-79 submerged, post-test.**

Figure 4-14 through Figure 4-17 present pre-test and post-test pictures of two submerged IOZ CS coupons. Each post-test CS coupon exhibits similar patterns of white particle deposits. The IOZ-81 coupon is located on the west side of the tank in relation to the

IOZ-79 coupon. For each coupon, particle deposition appears to preferentially occur near the coupon rack contact points. With respect to the IOZ-81 coupon, the IOZ-79 coupon has more deposits near the top of the coupon and fewer deposits in the bottom corners of the coupon.

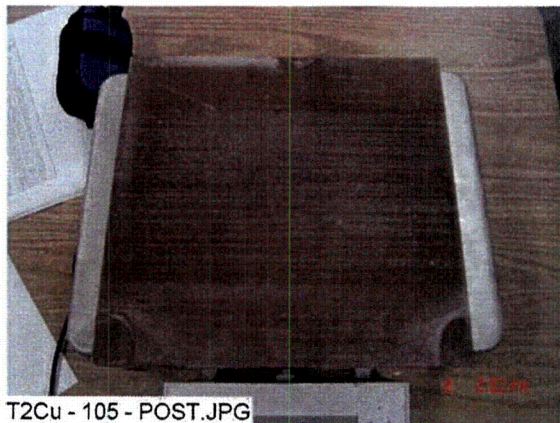
**Figure 4-19. Cu-105 submerged, post-test.**

Figure 4-18 through Figure 4-21 present the pre-test and post-test pictures of two submerged copper coupons. Each post-test copper coupon exhibits similar patterns of white, streak-like deposits. The deposition streaks are almost perfectly horizontal and are more highly concentrated for coupon Cu-123. Different corrosion effects are visible at the contact points. The Cu-123 coupon is located on the west side of the tank in relation to the Cu-105 coupon. The Cu-105 coupon appears to have a greater distribution of these white, streak deposits. For submerged copper coupons, the possible corrosion products include  $\text{CuO}$ ,  $\text{Cu}_2(\text{CO}_3)(\text{OH})_2$ ,  $\text{Mg}_3(\text{PO}_4)_2$ , and substances containing magnesium, copper, sodium, aluminum, calcium, carbon, and oxygen.

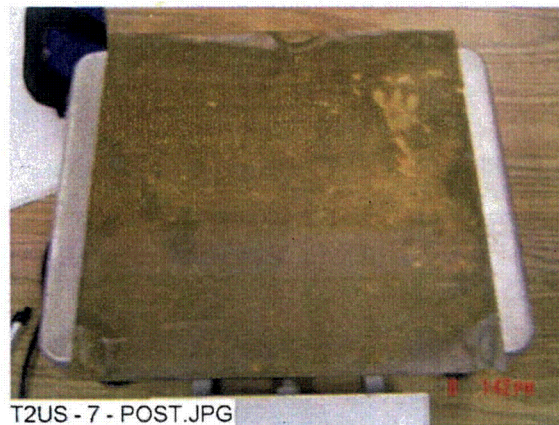
**Figure 4-23. US-7 submerged, post-test.**

Figure 4-22 and Figure 4-23 present the pre-test and post-test pictures of the submerged carbon steel coupon. The post-test carbon steel coupon exhibits a reddish-brown color

and significant corrosion around the edges. Different corrosion effects are visible at the contact points. This carbon steel coupon was adjacent to a copper coupon. For the submerged steel coupon, the possible corrosion products include phosphoric and carbonate compounds of iron and calcium and compounds composed by iron, aluminum, silicon, sodium, calcium, magnesium, phosphorus, and oxygen.

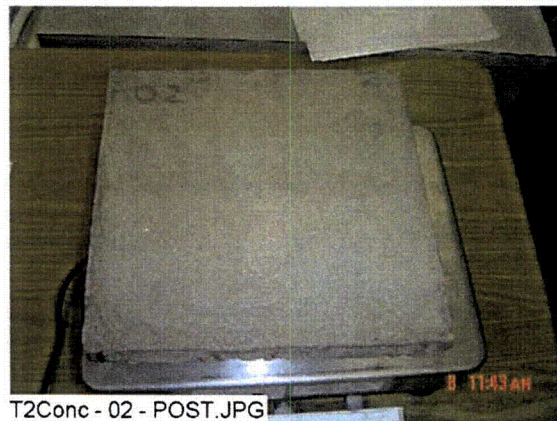
**Figure 4-25. Conc-02 submerged, post-test.**

Figure 4-24 and Figure 4-25 present the pre-test and post-test pictures of the submerged concrete coupon. The post-test concrete coupon exhibits an enhanced gray color as compared with the pre-test coupon.

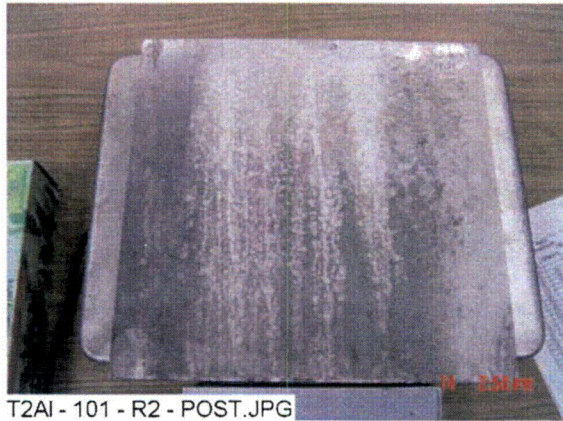
**Figure 4-27. AI-101 unsubmerged, post-test.**

The physical and chemical changes that the unsubmerged coupons experienced during Test #2 are less significant than the submerged coupons. Figure 4-26 through Figure 4-29 demonstrate the pre-test and post-test pictures of two unsubmerged aluminum coupons. Each post-test aluminum coupon exhibits similar deposits. Also, the texture of each coupon is coarser and the surface is less lustrous than its pre-test appearance. The reddish-brown color that was observed on the submerged coupons is absent on the unsubmerged coupons. The Al-101 coupon was loaded into Rack 2, which was located in the southern position on the tank's middle tier (see Figure 3-2). The Al-132 coupon was loaded into Rack 5, which was located in the southern position of the tank's top tier. The Al-101 specimen exhibits a greater concentration of these deposits.

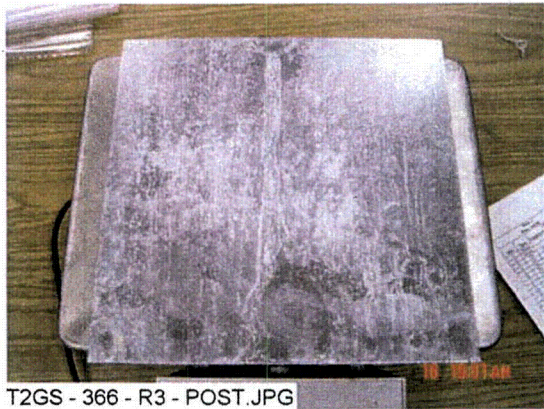
**Figure 4-31. GS-366 unsubmerged, post-test.**

Figure 4-30 through Figure 4-33 show the pre-test and post-test pictures of two unsubmerged GS coupons. Each post-test GS coupon exhibits similar types of deposits. This deposition is visibly different and much less concentrated than that of the submerged coupons. The GS-366 coupon was loaded in Rack 3, which was located in the center position of the tank's middle tier. The GS-416 coupon was loaded in Rack 5, which was located in the southern position of the tank's top tier. The GS-366 coupon exhibits more of these deposits.

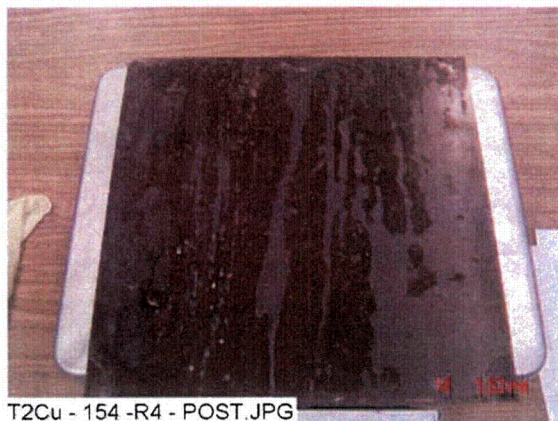
**Figure 4-35. Cu-154 unsubmerged, post-test.**

Figure 4-34 through Figure 4-37 present the pre-test and post-test pictures of two unsubmerged copper coupons. Each post-test copper coupon exhibits similar types of

deposits. Unlike on the submerged coupons, the deposition patterns are vertical and less uniform. The Cu-154 coupon was loaded in Rack 4, which was located in the northern position of the tank's middle tier. The Cu-196 coupon was loaded in Rack 7, which was located in the northern position of the tank's top tier. The Cu-196 coupon exhibits a greater density of these white deposits.

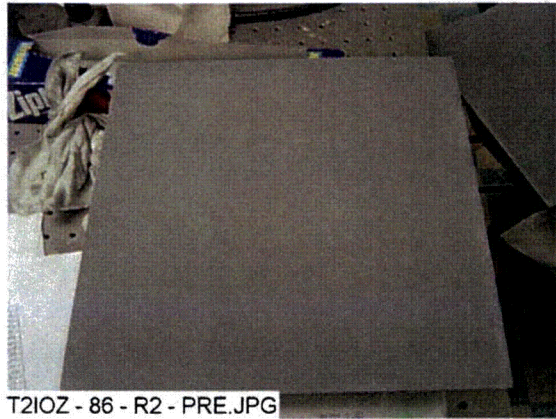
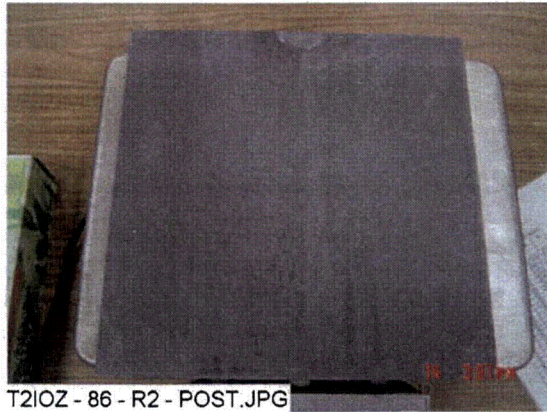
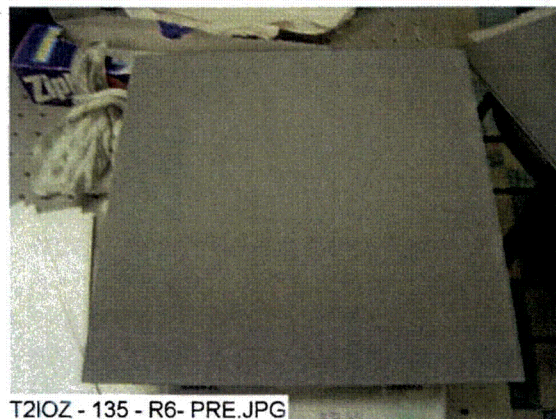
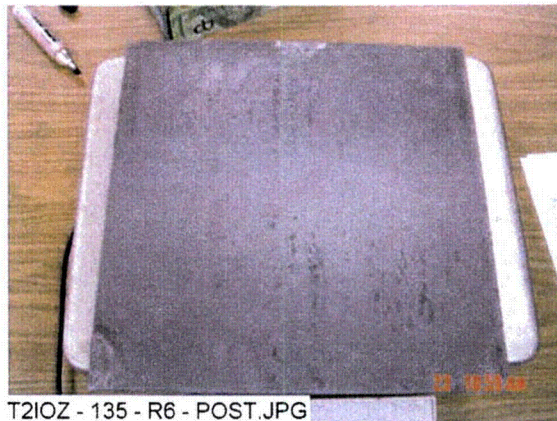
Figure 4-38 through Figure 4-41 present the pre-test and post-test pictures of two unsubmerged IOZ CS coupons. Each post-test CS coupon exhibits similar types of deposits. These deposits are much less concentrated than the deposits on the submerged coupons. The IOZ-86 coupon was loaded in Rack 2, which was located in the southern position of the tank's middle tier. The IOZ-135 coupon was loaded in Rack 6, which was located in the center position of the tank's top tier. There are no apparent differences in the IOZ coupons as a function of coupon location.

**Figure 4-38. IOZ-86 unsubmerged, pre-test.**

**Figure 4-39. IOZ-86 unsubmerged, post-test.**

**Figure 4-40. IOZ-135 unsubmerged, pre-test.**

**Figure 4-41. IOZ-135 unsubmerged, post-test.**

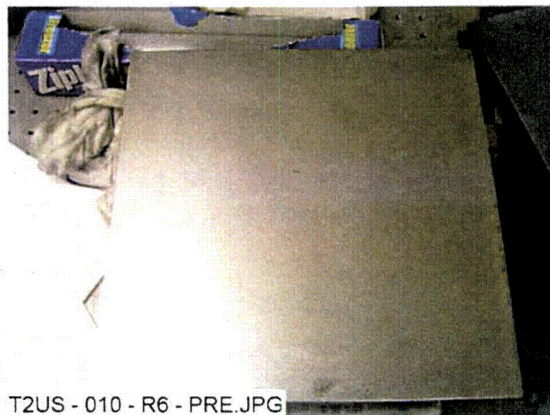
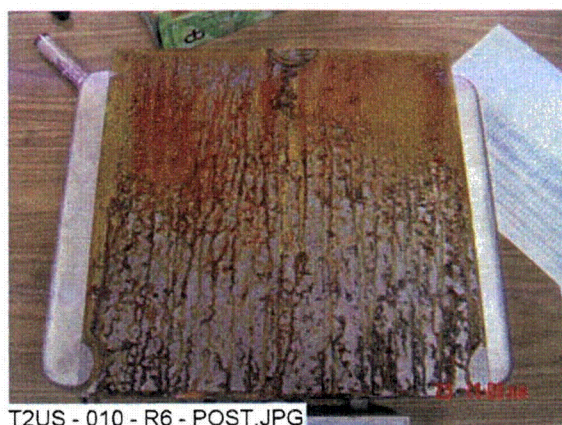
Figure 4-42 and Figure 4-43 present the pre-test and post-test pictures of one unsubmerged carbon steel coupon. The post-test carbon steel coupon exhibits a reddish-brown color and significant corrosion around the edges. The color is similar to that of the submerged carbon steel coupon, although the corrosion does not appear to be as severe as on the submerged coupon. The US-10 coupon was loaded in Rack 6, which was in the center position of the tank's top tier.

**Figure 4-42. US-10 unsubmerged, pre-test.**

**Figure 4-43. US-10 unsubmerged, post-test.**

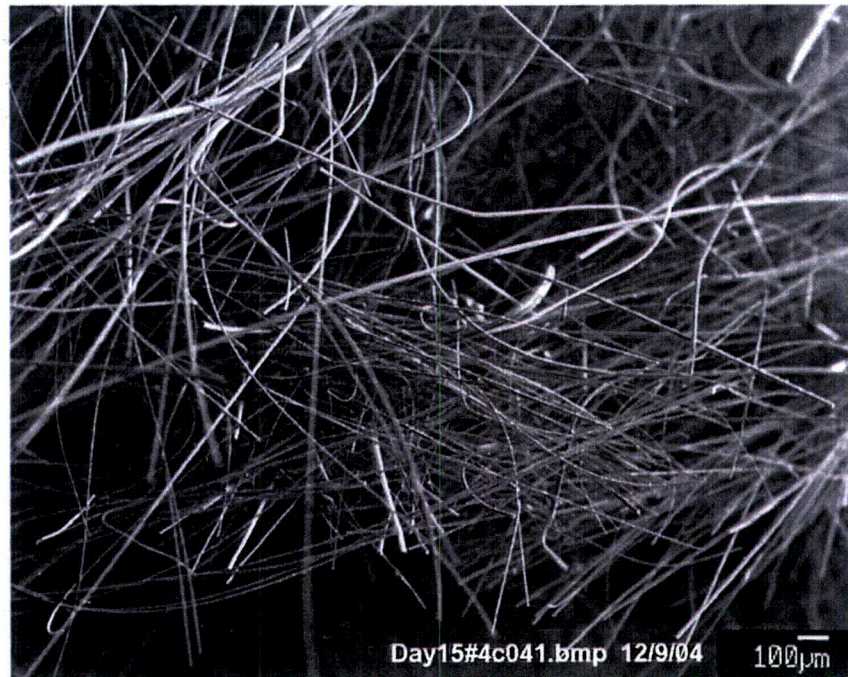
Figure 4-44 illustrates the clean fiberglass as it appears before the test. This visual baseline is used to compare with images from samples taken after the test began. As can be seen, there are no deposits on the clean fiberglass.

Figure 4-44. Clean fiberglass before exposure to test chemicals.

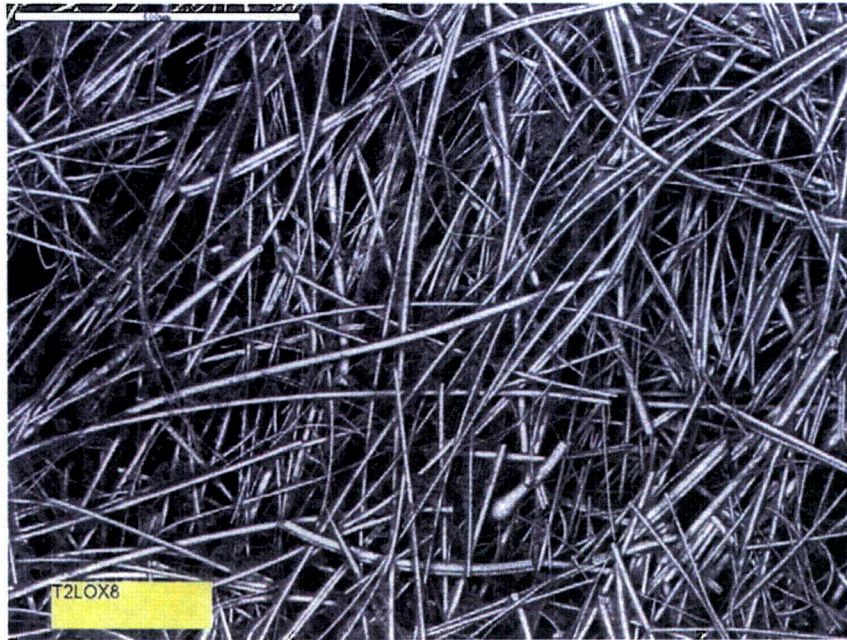
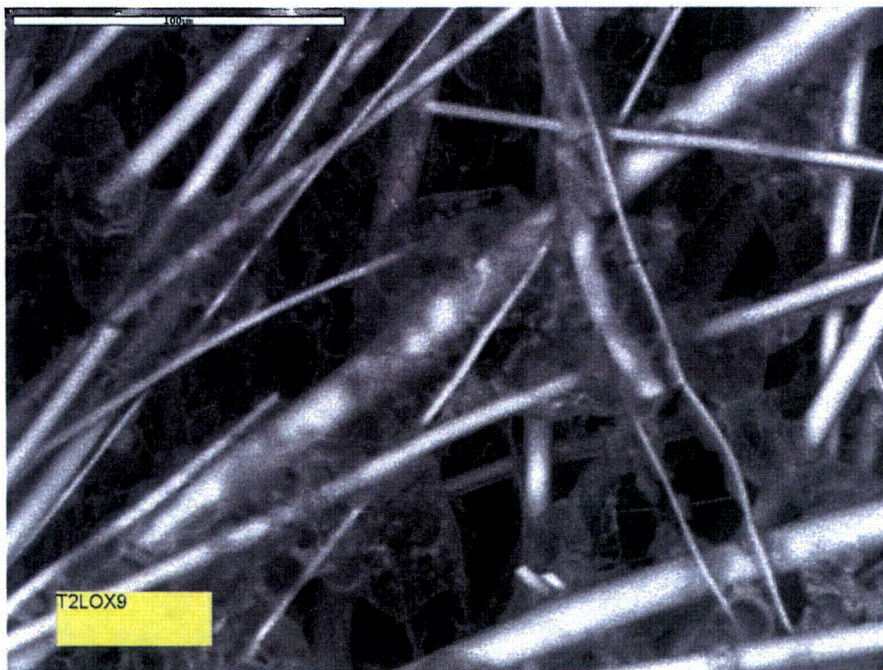
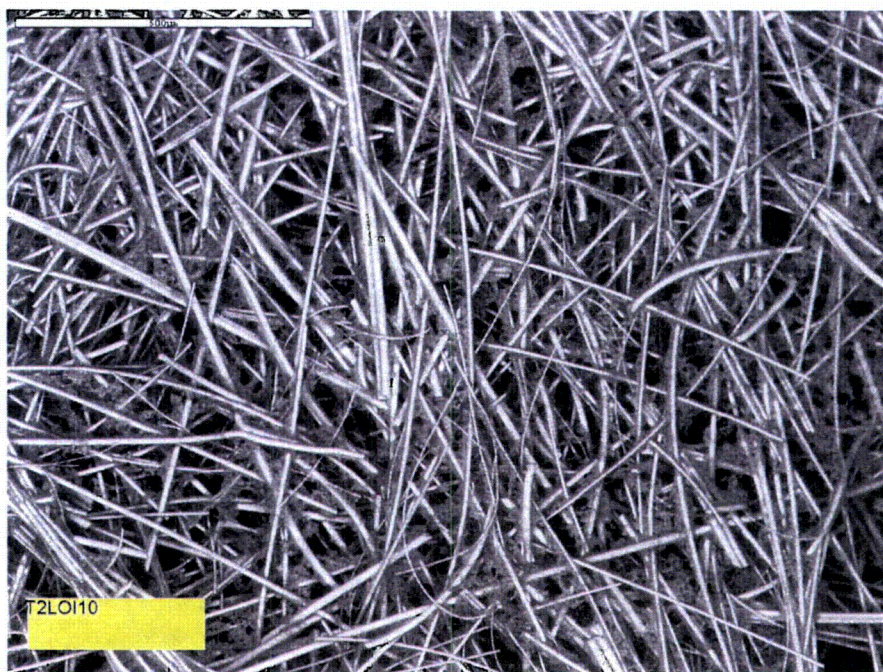
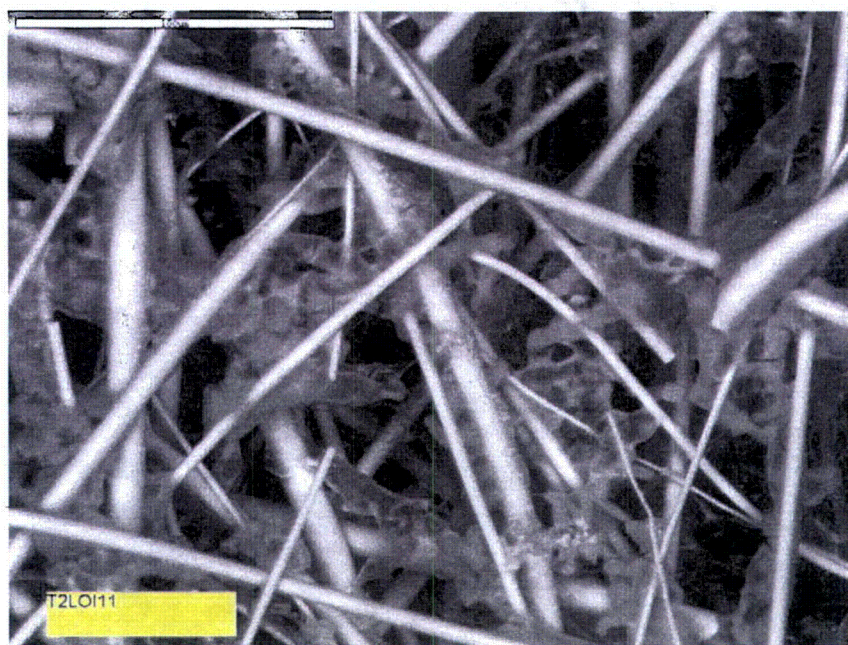
Based on the SEM results, deposits were found after 16 days of the test on both the interior and the exterior of the low-flow fiberglass samples. There was no significant difference in the amounts of deposits on the interior and exterior samples.

Figure 4-45. ESEM image overview for the Test #2, Day-16 exterior low-flow fiberglass sample.

Figure 4-46. Higher-magnification ESEM image of a Test #2, Day-16 exterior low-flow fiberglass sample.

Figure 4-47. ESEM image overview of a Test #2, Day-16 interior low-flow fiberglass sample.

Figure 4-48. Higher-magnification ESEM image of a Test #2, Day-16 interior low-flow fiberglass sample.

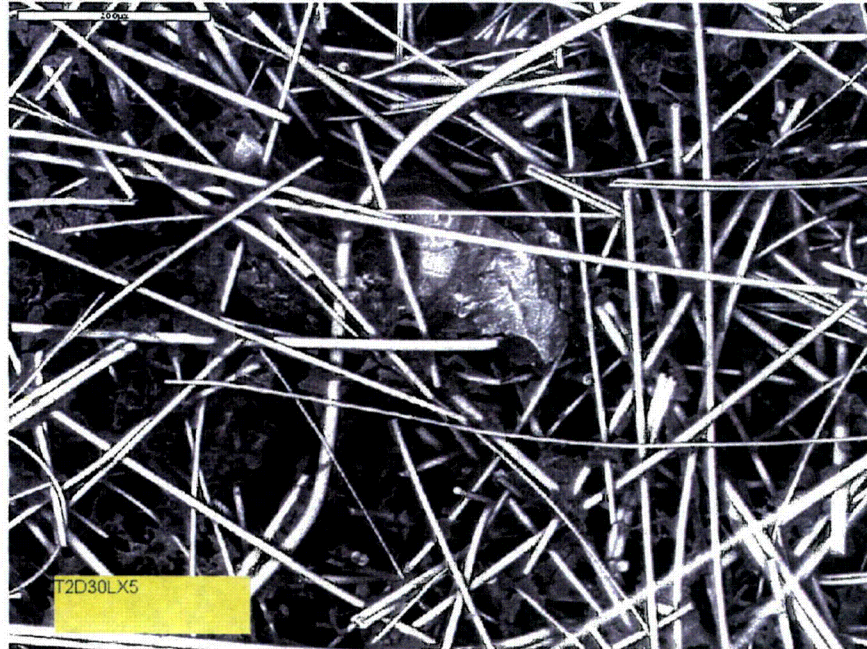
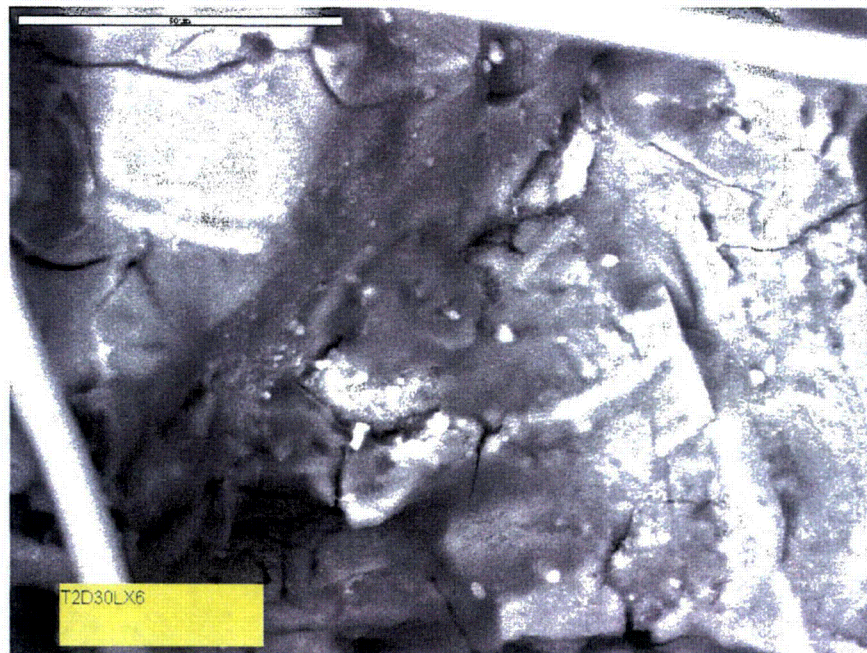
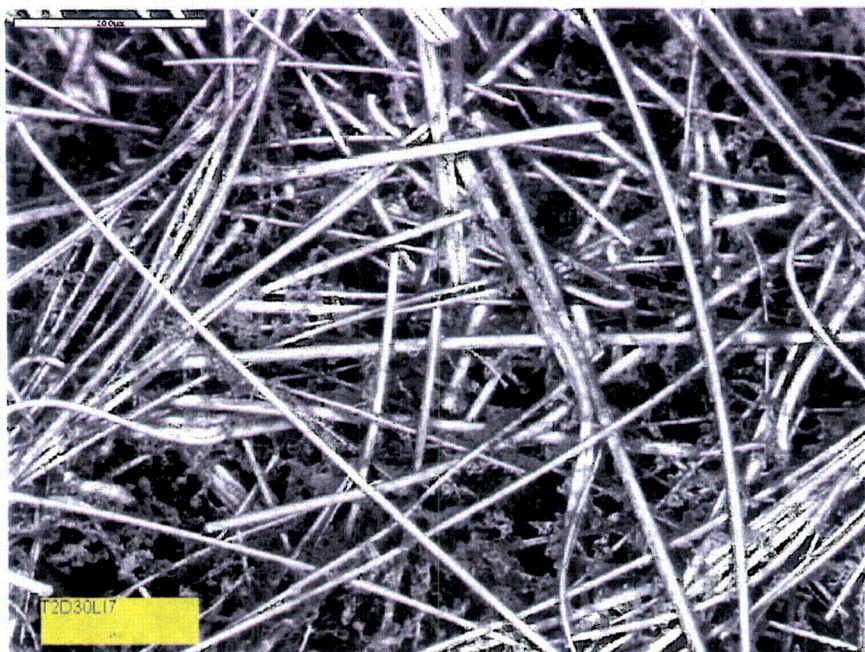
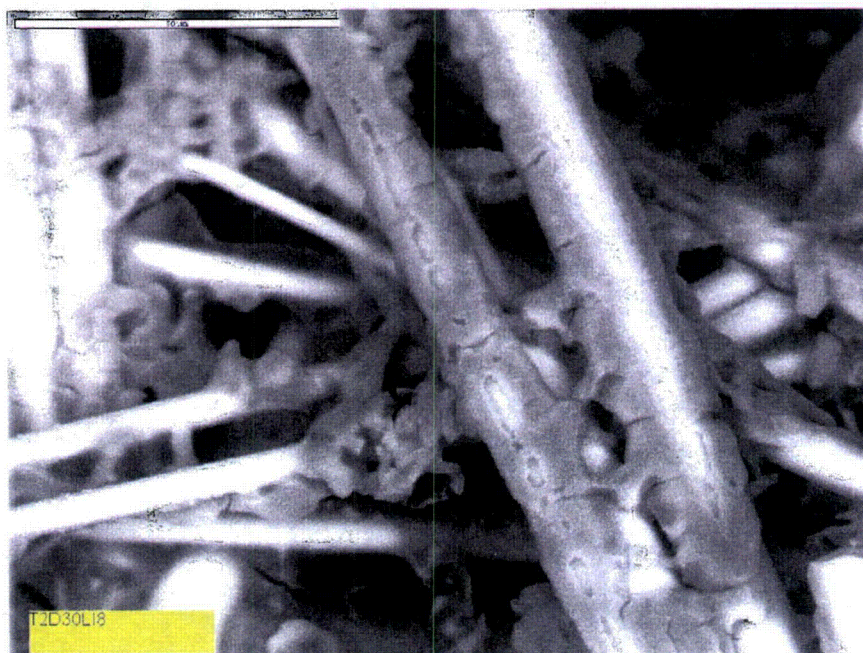
On Day 30, more particulate deposits were found on the exterior of low-flow fiberglass samples than were found on Day 16. As the test proceeded from Day 16 to Day 30, particulate deposits had a greater chance of being retained or attached to fiberglass.

Comparing the two samples revealed slightly more deposits on the Day-30 interior low-flow fiberglass sample than on the Day-16 sample. Comparing the exterior and the interior of Day-30 low-flow fiberglass samples revealed more particulate deposits on the exterior sample.

Figure 4-49. ESEM image for a Test #2, Day-30 low-flow exterior fiberglass sample.

Figure 4-50. Higher-magnification ESEM image of a Test #2, Day-30 low-flow exterior fiberglass sample.

Figure 4-51. ESEM image of a Test #2, Day-30 low-flow interior fiberglass sample.

Figure 4-52. Higher-magnification ESEM image of a Test #2, Day-30 low-flow interior fiberglass sample.

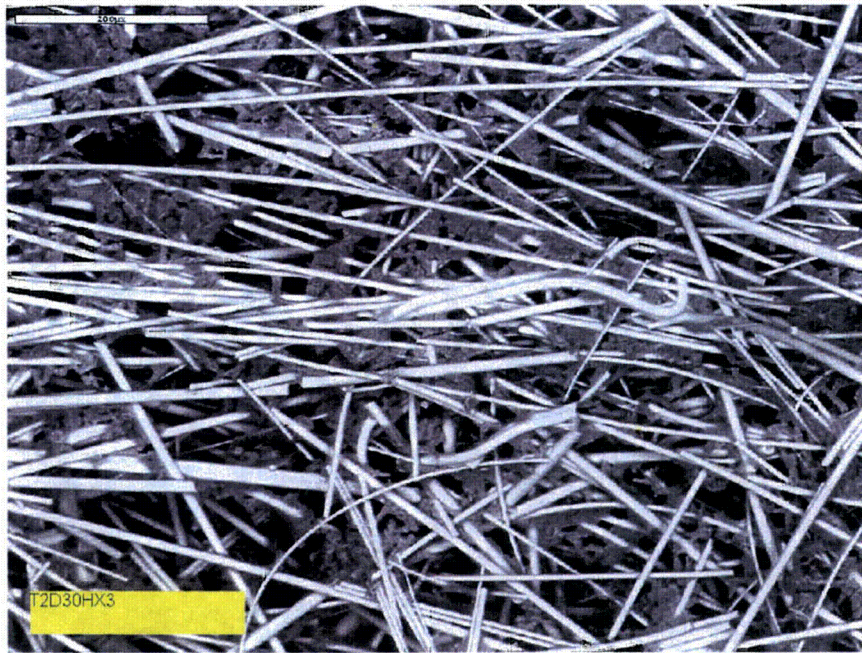
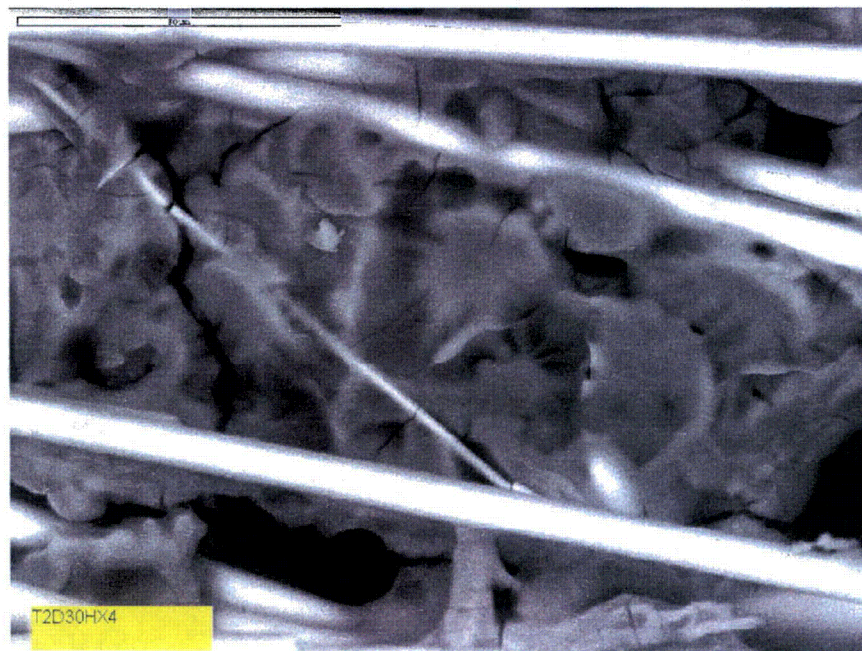
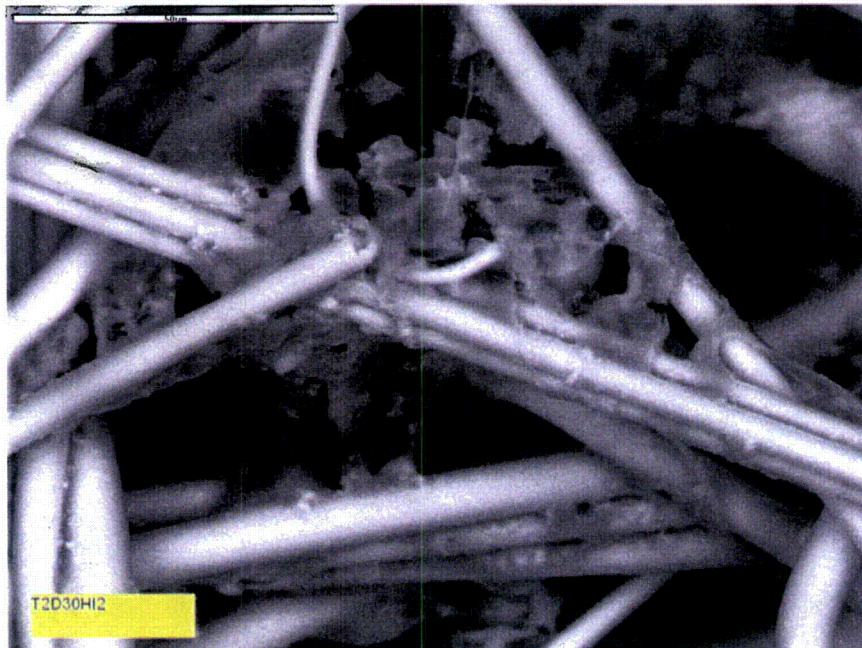
In the Day-30 high-flow fiberglass samples, significantly fewer particulate deposits were found on the interior samples than on the exterior samples. However, there is no apparent

difference between Day-30 high- and low-flow fiberglass samples. The possible reason is that the total suspended solid (TSS) concentration was generally low in Test #2 (~10 mg/L).

Figure 4-53. ESEM image for a Test #2, Day-30 high-flow exterior fiberglass sample.

Figure 4-54. Higher-magnification ESEM image of a Test #2, Day-30 high-flow exterior fiberglass sample.

Figure 4-56. Higher-magnification ESEM image of a Test #2, Day-30 high-flow interior fiberglass sample.

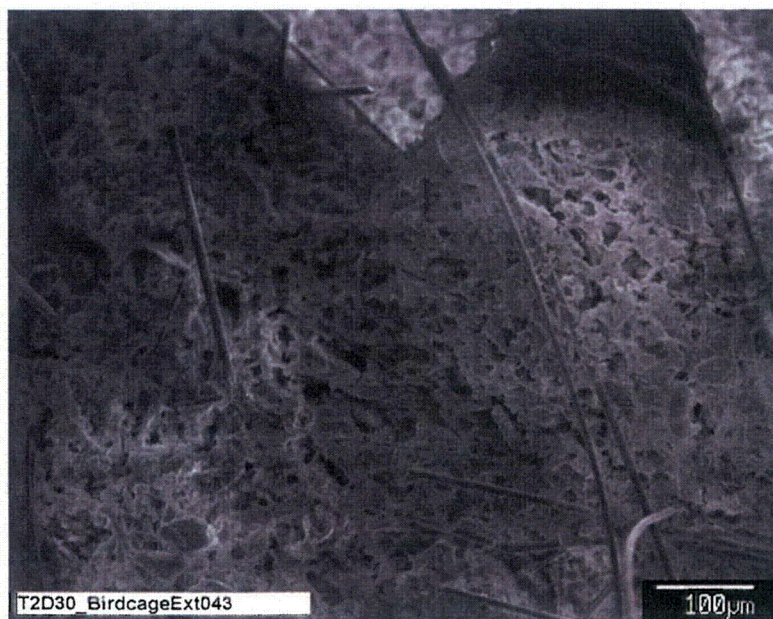
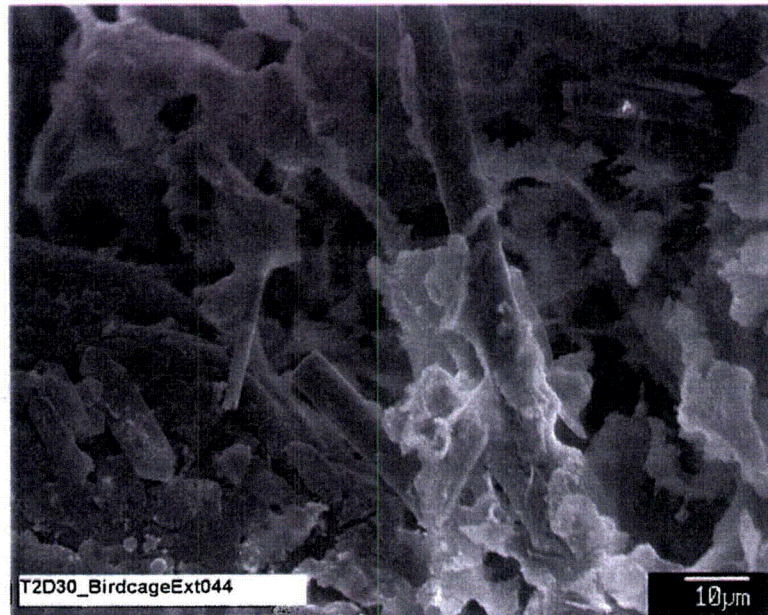
For the Day-30 fiberglass sample within the birdcage, Figure 4-57 indicates a coating over the exterior of the fiberglass. It shows the development of a continuous coating, which includes particles that were likely physically deposited or attached. In addition, Figure 4-58 shows the presence of lathlike crystals in the exterior of the fiberglass sample. The crystals may have been physically deposited or originated from chemical precipitation. The EDS result (Figure 4-59) shows that the crystal is composed of carbon, oxygen, sodium, magnesium, phosphorus, and calcium.

**Figure 4-57.** SEM image of a Test #2, Day-30 exterior fiberglass sample within the birdcage.

**Figure 4-58.** Higher-magnification SEM image of a Day-30 exterior fiberglass sample within the birdcage.

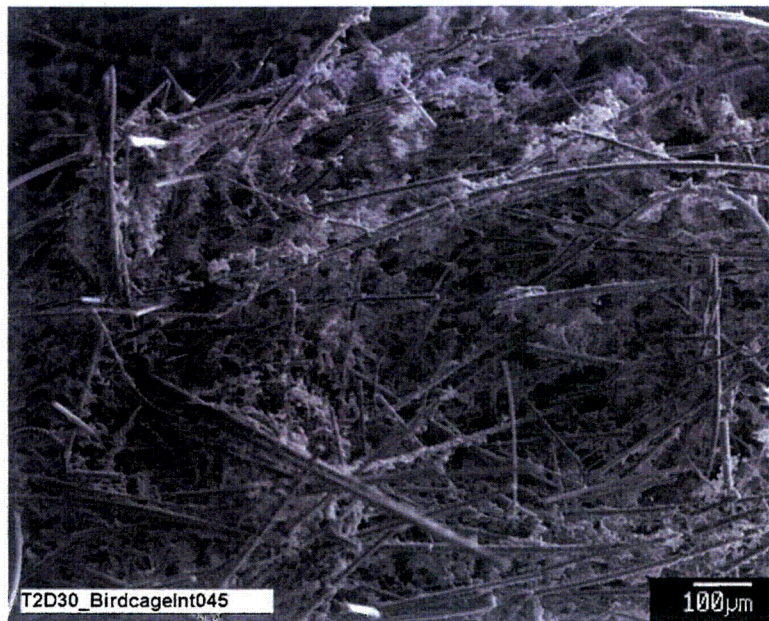
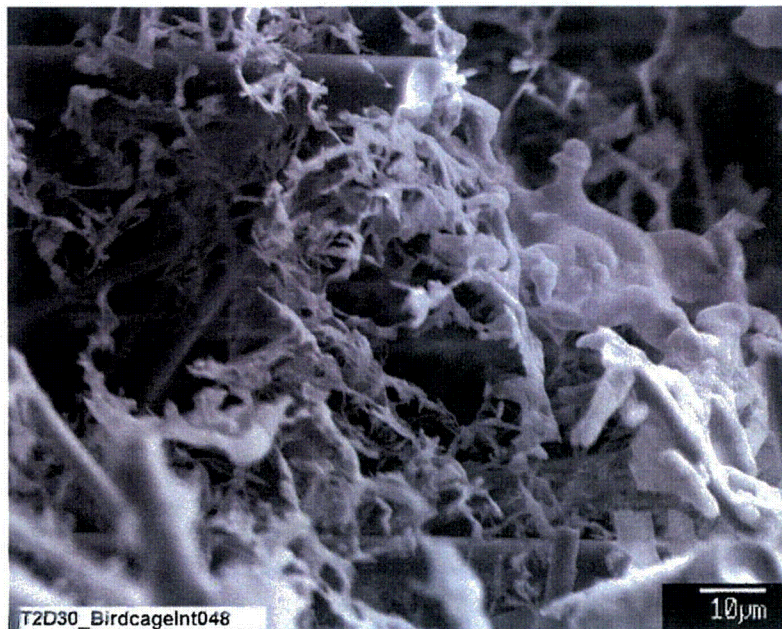
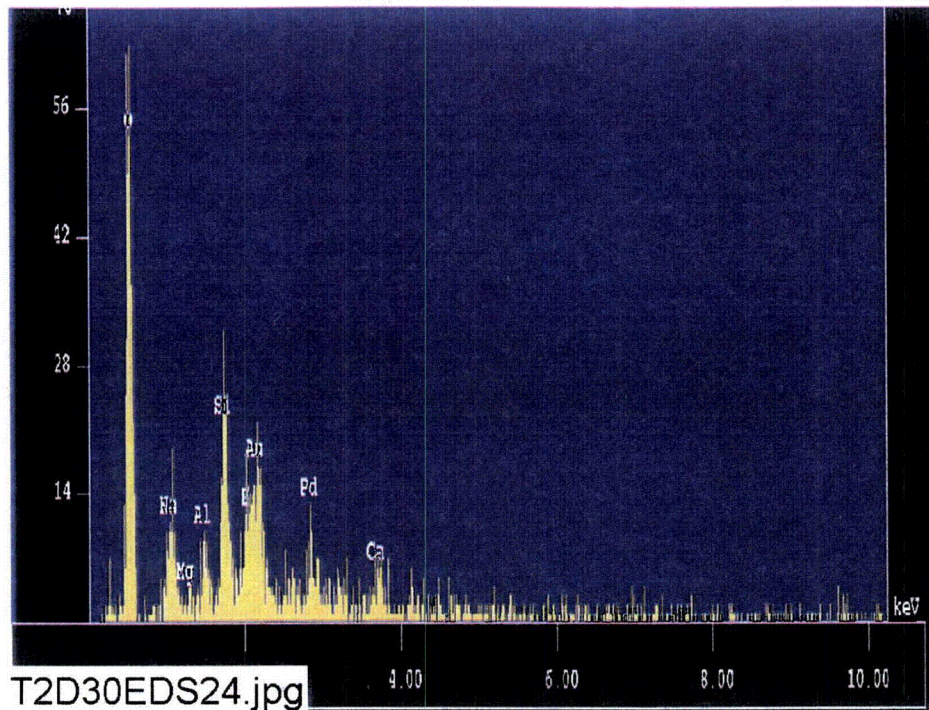
Different from the exterior, the birdcage interior fiberglass sample had no significant particulate deposits or crystal material attached (see Figures 4-60 and 4-61). Instead, flocculent deposits were dominant. Because there was no direct water flow through the fiber, the migration of particles into the fiberglass interior is less likely. Therefore, the flocculent deposits found in the interior samples were likely formed by chemical precipitation. EDS results (Figure 4-62) indicate that the flocculence is composed of oxygen, sodium, magnesium, silicon, aluminum, phosphorus, and calcium.

Figure 4-60. SEM image of a Test #2, Day-30 interior fiberglass sample within the birdcage.

Figure 4-61. Higher-magnification SEM image of a Test #2, Day-30 interior fiberglass sample within the birdcage.

**Figure 4-62.** EDS counting spectrum for the flocculence on the fiberglass, as shown in Figure 4-61. From left to right, the element peaks are oxygen, sodium, magnesium, aluminum, silicon, phosphorus, gold, palladium, and calcium. (Gold and palladium are coating substances for SEM analyses.)

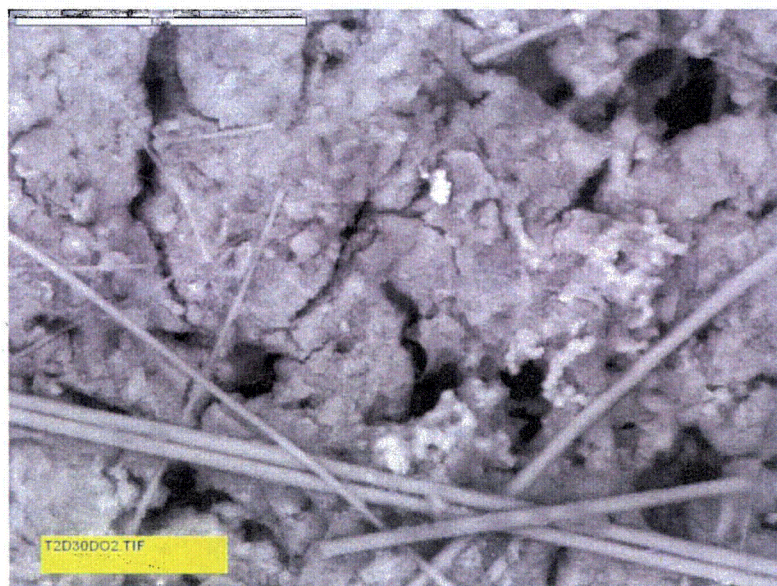
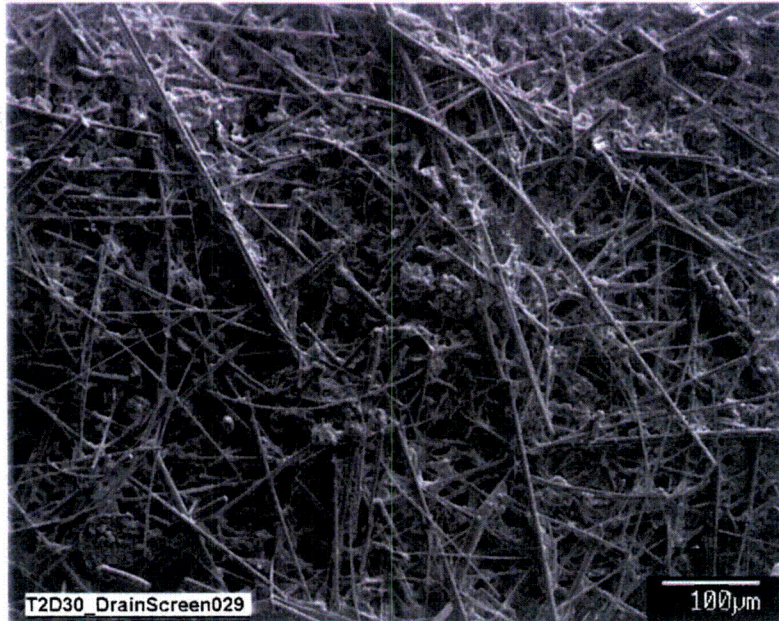
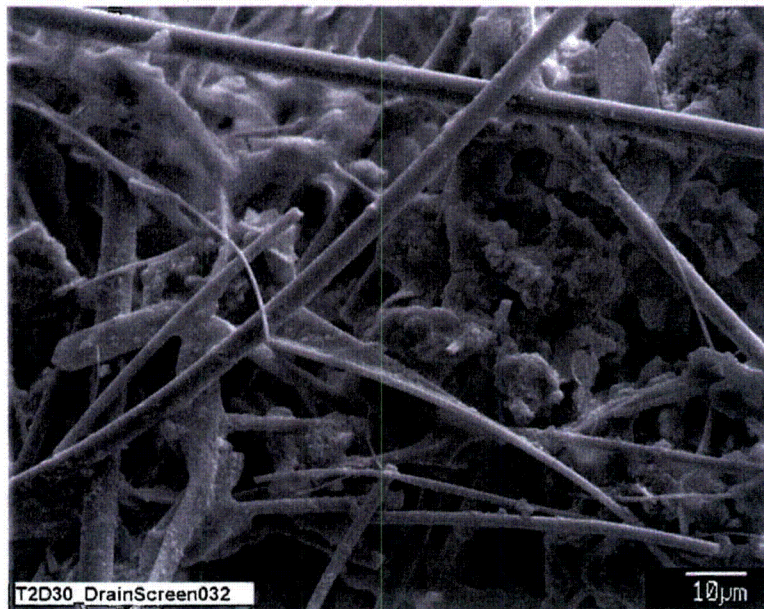
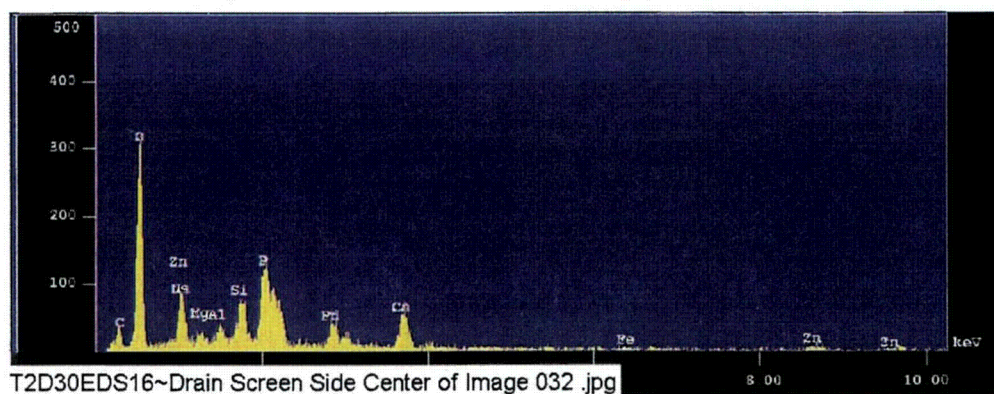
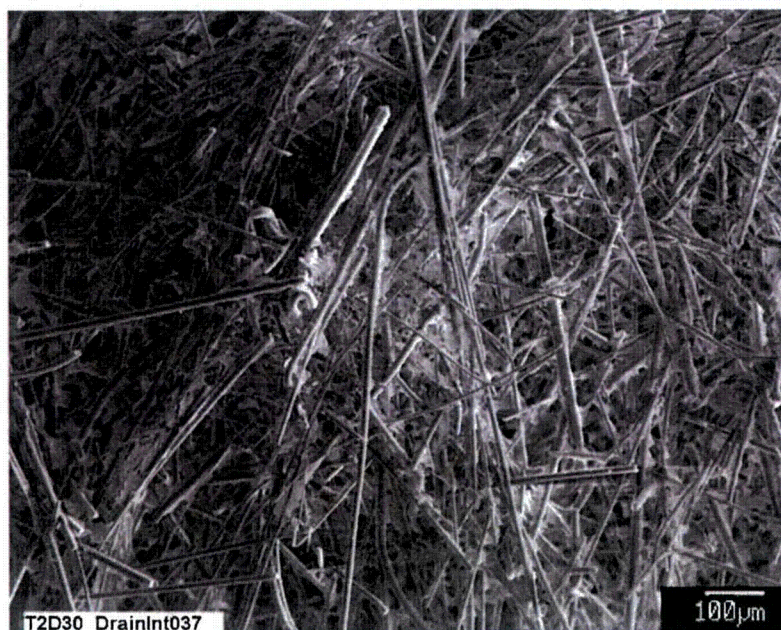
More particulate deposits were observed on the exterior of the Day-30 drain collar fiberglass sample than on the interior. The amount of the deposits on the sample farthest from the drain screen was greater than the amount on the sample next to the drain screen, which was greater than the amount in the drain collar interior. Consistent with the birdcage fiberglass samples, the flocculent deposits were dominant in the interior drain collar samples. EDS results show that the particulate deposits on the drain collar exterior were composed of carbon, oxygen, sodium, magnesium, aluminum, silicon, phosphorus, and calcium. Figures 4-63 through 4-69 illustrate these findings.

**Figure 4-64.** Higher-magnification ESEM image of a Test #2, Day-30 exterior fiberglass sample on the drain collar (away from the drain screen). The image shows particulate deposits on the fiberglass.

Figure 4-65. SEM image of a Test #2, Day-30 fiberglass sample on the drain collar, next to the drain screen.

Figure 4-66. Higher-magnification SEM image of a Test #2, Day-30 fiberglass sample on the drain collar, next to the drain screen.

Figure 4-67. EDS counting spectrum for the center of the image shown in Figure 4-66. The deposits are composed of carbon, oxygen, sodium, magnesium, aluminum, silicon, phosphorus, and calcium.

Figure 4-68. SEM image of a Test #2, Day-30 interior fiberglass sample on the drain collar. The image shows flocculence on the fiberglass.

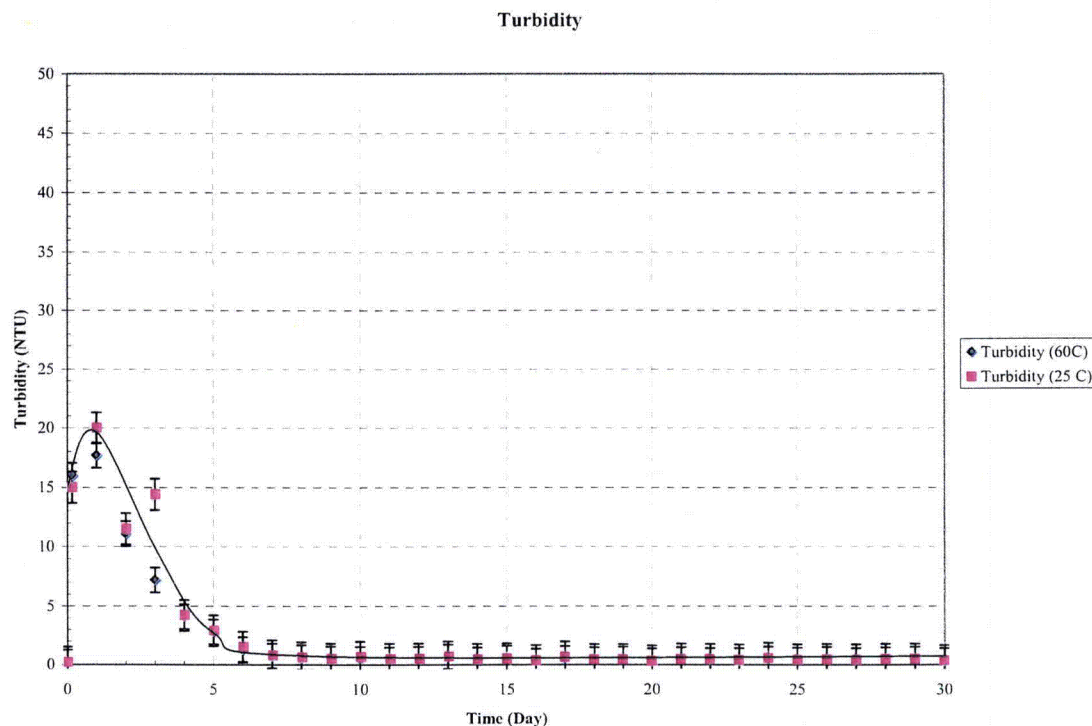
**Turbidity:** Figure 4-70 depicts the evolution of turbidity at 23°C and 60°C throughout the duration of the test. The first data point in the graph was taken after the latent debris and crushed concrete were added to the tank. Thus the turbidity values at this point serve as a baseline for the remainder of the test. A sharp rise in turbidity to approximately 15 NTU after 4 hours is noted. It was caused by the complete introduction of TSP chemicals at that point. The turbidity at each temperature reaches a maximum at the Day-1 test point of 20 NTU and 17.7 NTU for the 23°C and 60°C water samples, respectively.

Thereafter, the turbidity values at both temperatures gradually declined to the baseline measurements. The lone exception to this overall trend occurred on the Day-3 23°C turbidity measurement. On that day, a local turbidity maximum of 14.4 NTU was measured. This was attributable to the fact that the 23°C turbidity sample on that day was immersed in the cold-water bath for a longer time than normal. Steps were taken to rigorously track the immersion time of all subsequent turbidity samples.

Figure 4-70. Turbidity results.

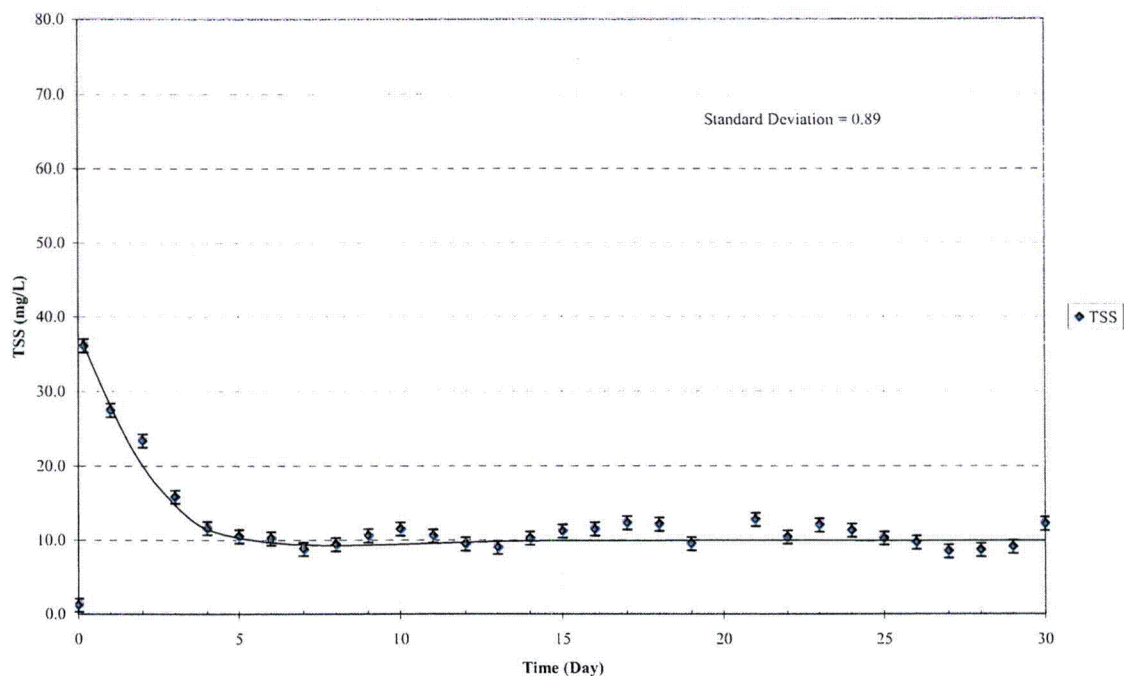
**Total Suspended Solids:** Total suspended solids (TSS) are measured by filtering a volume of approximately 500 mL through an in-line filter directly at the sample tap. The selected equipment ensures that TSS measurements are not affected by temperature-dependent or time-dependent precipitation reactions that may occur once the process solution is removed from the tank. The TSS concentration was 36.2 mg/L at the end of the 4-hour spray cycle. After the first 24 hours of the test, the TSS concentration dropped to 27.5 mg/L and continued to drop uniformly to approximately 10 mg/L by Day 4 of the test. The concentration remained approximately constant through the last day of testing. The TSS concentrations are shown in Figure 4-71.

Figure 4-71. TSS results.
