# **Integrated Chemical Effects Test Project: Test #2 Data Report**

**Los Alamos National Laboratory**

**U.S. Nuclear Regulatory Commission  
Office of Nuclear Regulatory Research  
Washington, DC 20555-0001**

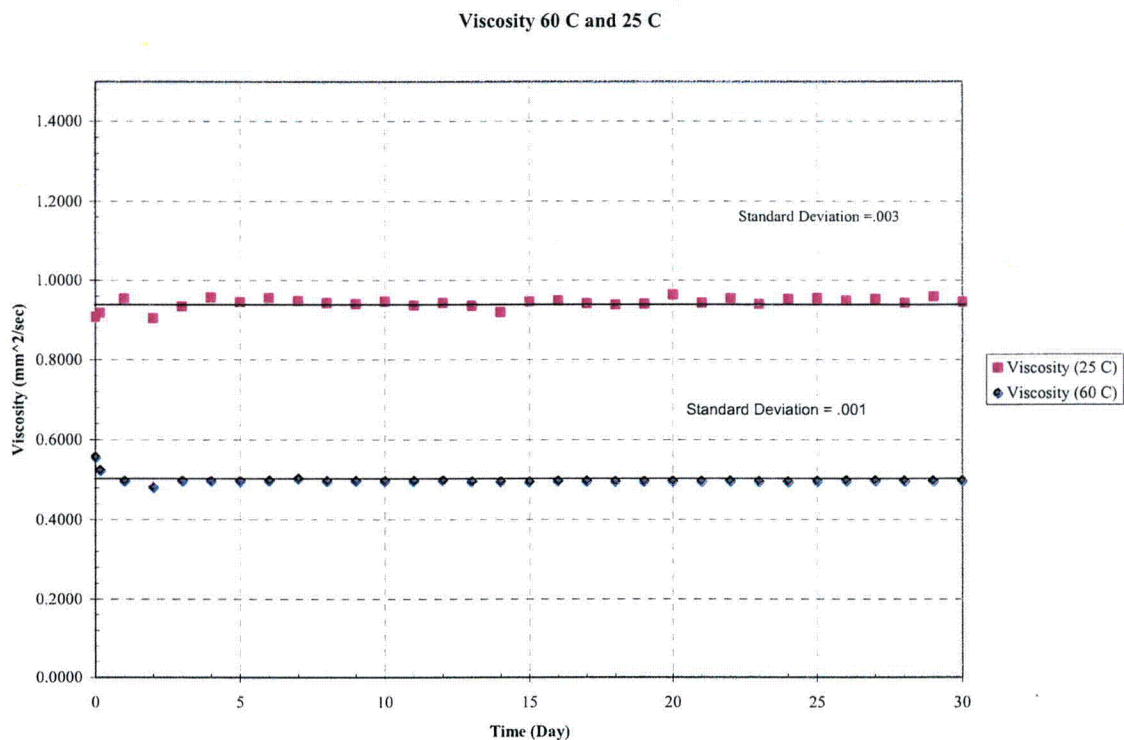
**Kinematic Viscosity:** Kinematic viscosity was measured with a Cannon-Fenske capillary viscometer. Viscosity was measured on unfiltered samples, each at a temperature of  $60^{\circ}\text{C} \pm 1.0^{\circ}\text{C}$  [ $140^{\circ}\text{F} (\pm 1.8^{\circ}\text{F})$ ] and again at  $23^{\circ}\text{C} (\pm 2.0^{\circ}\text{C})$  [ $73.4^{\circ}\text{F} (\pm 3.6^{\circ}\text{F})$ ]. Viscosity of water is highly sensitive to temperature, and the allowed temperature range results in a variation of viscosity of 2.9% between  $59^{\circ}\text{C}$  ( $138.2^{\circ}\text{F}$ ) and  $61^{\circ}\text{C}$  ( $141.8^{\circ}\text{F}$ ), and a 9.3% variation between  $21^{\circ}\text{C}$  ( $69.8^{\circ}\text{F}$ ) and  $25^{\circ}\text{C}$  ( $77.0^{\circ}\text{F}$ ). For this reason, temperature was measured to  $0.1^{\circ}\text{C}$  accuracy with a National Institute of Standards and Technology (NIST)-traceable thermometer for all viscosity measurements. Also, the measured viscosity values were corrected to a common temperature to facilitate comparisons. The corrected temperatures were  $60.0^{\circ}\text{C}$  ( $140^{\circ}\text{F}$ ) and  $23.0^{\circ}\text{C}$  ( $73.4^{\circ}\text{F}$ ). Viscosity results for Test #2 are presented in Figure 4-72. The viscosities at  $60^{\circ}\text{C}$  ( $140^{\circ}\text{F}$ ) and  $25^{\circ}\text{C}$  ( $77.0^{\circ}\text{F}$ ) remained constant throughout the test.

Figure 4-72. Viscosity at 60°C and 25°C.

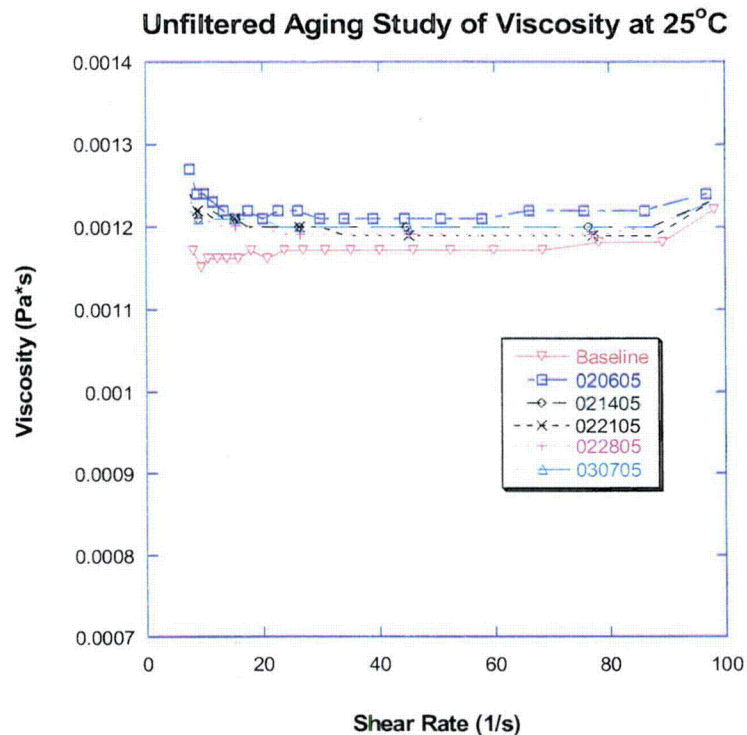
**Strain-Rate Viscosity:** At Day 1 and weekly thereafter, samples were taken off site for strain-rate viscosity measurements. All of the strain-rate viscosity measurements were performed on water samples at 60°C and 25°C. Figure 4-73 shows the results from each sample at 25°C. The legend shows the dates of the samples. For example, “020605” refers to the sample from February 6, 2005. The horizontal lines of each sample indicate that the solution remained Newtonian with no significant changes throughout the 30-day test.

Figure 4-73. Aging study of viscosity at 25°C.

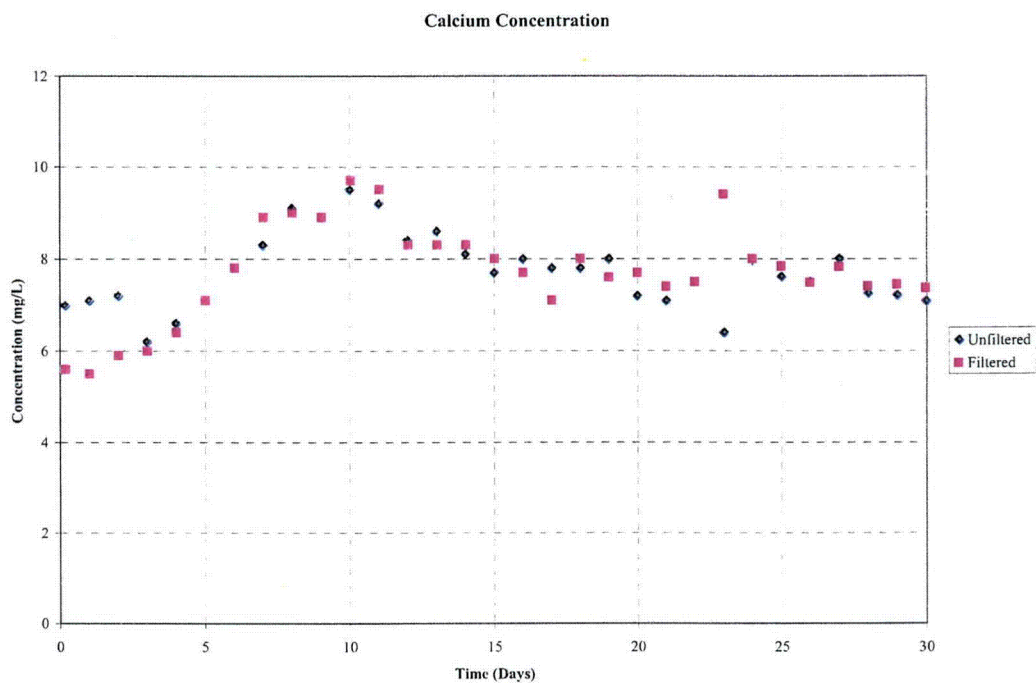
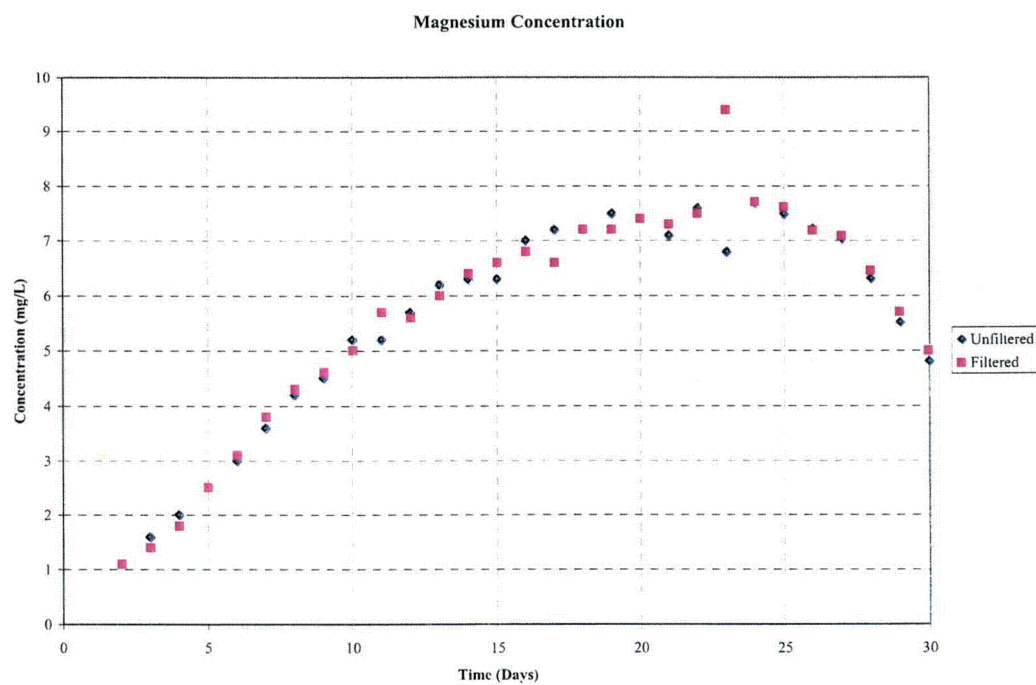
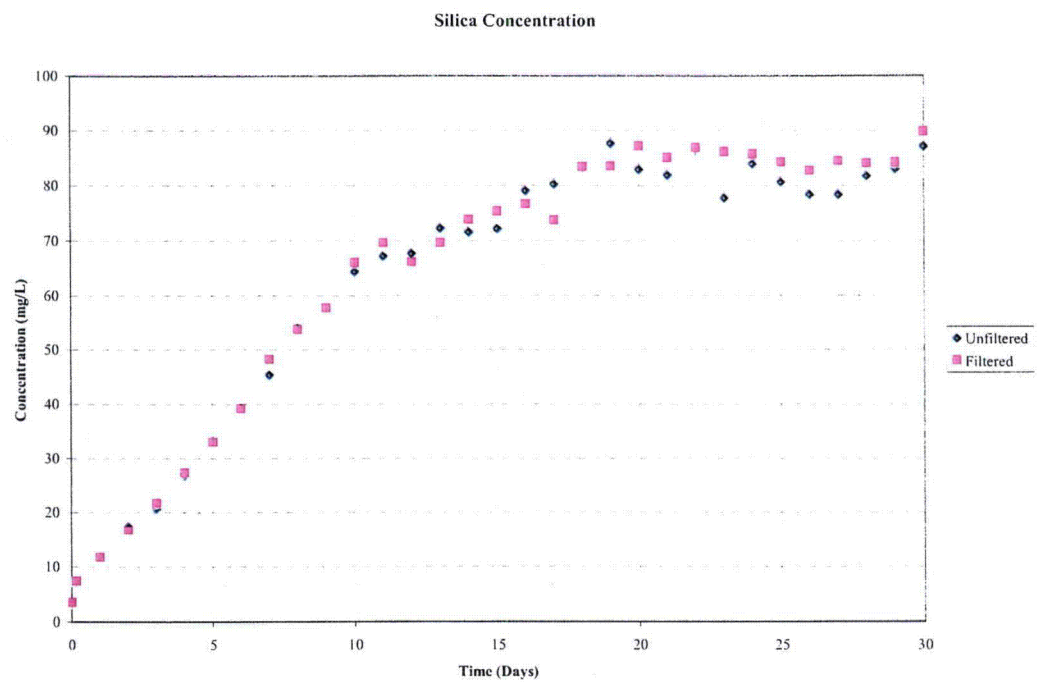
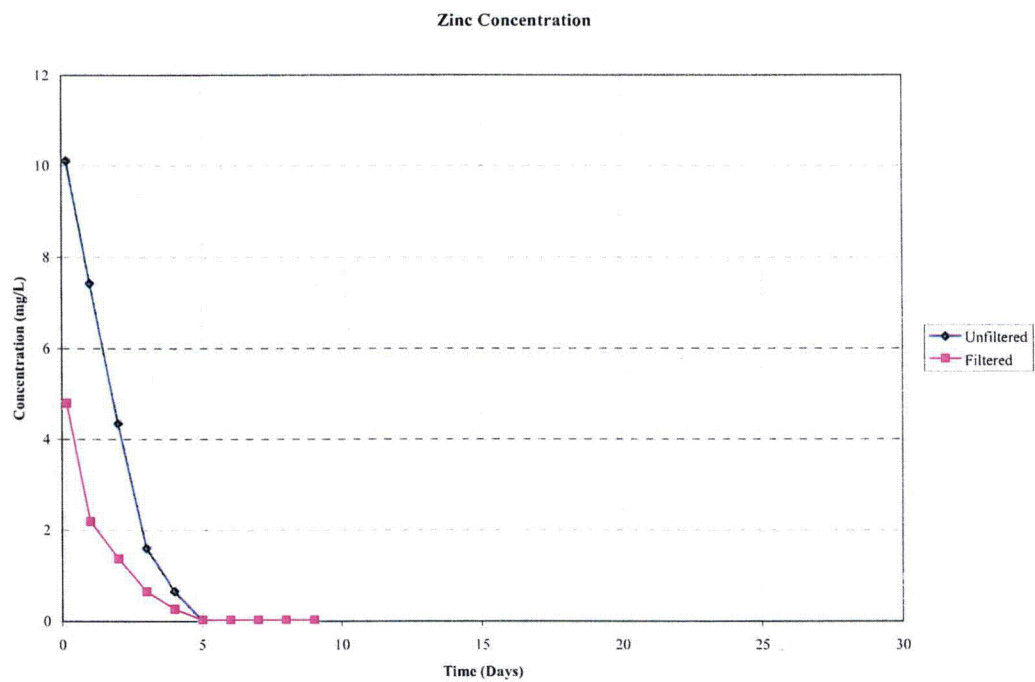
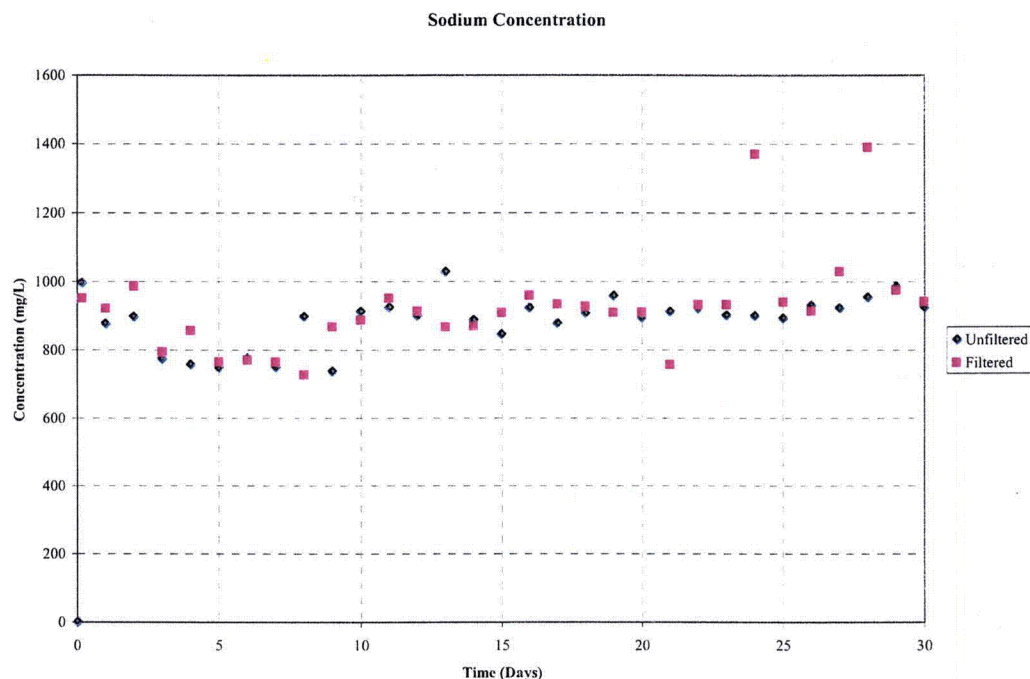
ICP-AES results for Test #2 are contained in this section. Aluminum, copper, iron, and nickel were below detection limits and therefore are not represented graphically. The evolution of the calcium, magnesium, silica, zinc, and sodium concentrations present in the tank solution are represented in Figures 4-74 through 4-78. As shown in the figures, calcium (average around 8 mg/L) and sodium (average around 900 mg/L) are relatively steady throughout the test. The zinc concentration goes to zero by Day 5. Magnesium and silica show similar patterns, starting near zero and increasing to their maximum values by Day 20. The maximum value of magnesium is close to 8 mg/L, and that of silica is 90 mg/L. Measurement uncertainties are for calcium, -14% and +19%; for sodium,  $\pm 20\%$ ; for magnesium, -13% and +20%; and for silica, -9% and +12%.

**Figure 4-74. Test #2 calcium concentration.**

**Figure 4-75. Test #2 magnesium concentration.**

**Figure 4-76. Test #2 silica concentration.**

**Figure 4-77. Test #2 zinc concentration.**

Figure 4-78. Test #2 sodium concentration.

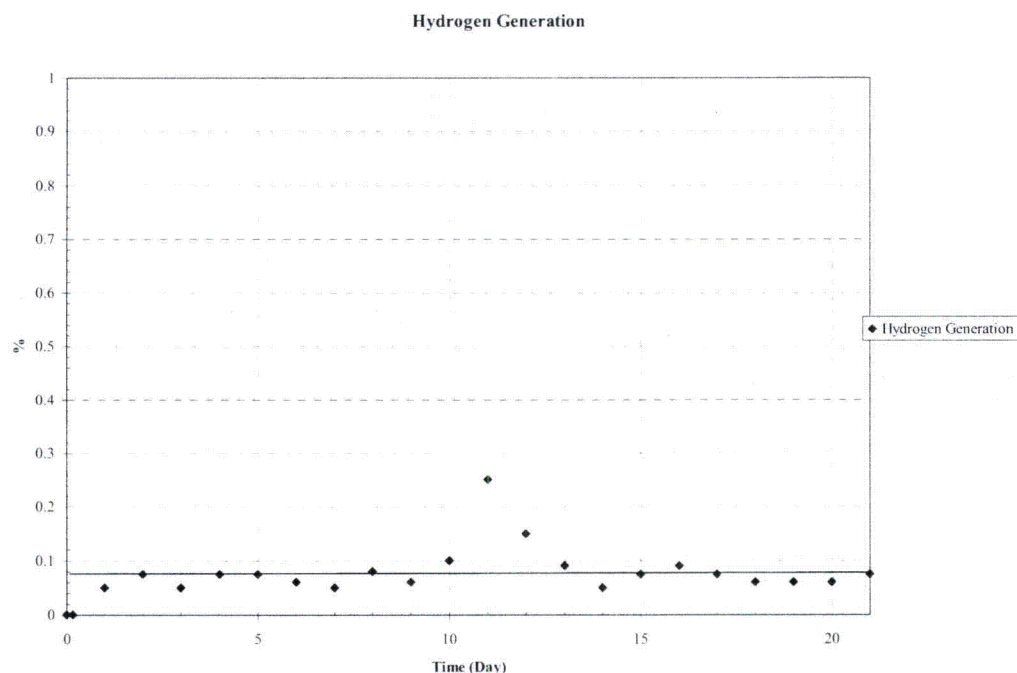
Hydrogen remained below 0.1% during the first 10 days of testing. Figure 4-79 displays the evolution of hydrogen generation. The spike at Day 11 represents a change in the operational procedure. From the beginning of the test through Day 10, the vent valves on the tank lid were left open at all times. On Day 11 and Day 12, the vent valves were closed to determine actual hydrogen buildup without venting the tank. Through the first 10 days, the hydrogen content varied between 0.05% and 0.1%. After Day 10, the hydrogen concentration increased to 0.25% on Day 11 and then dropped to 0.15% on Day 12. This drop was probably due to the brief time when the tank vent lid was opened to return the recycled solution contents to the tank. From Day 13 on, one of the vent valves was purposely left open, which is why the hydrogen content again dropped below 0.1%.

Figure 4-79. Test #2 hydrogen concentration.

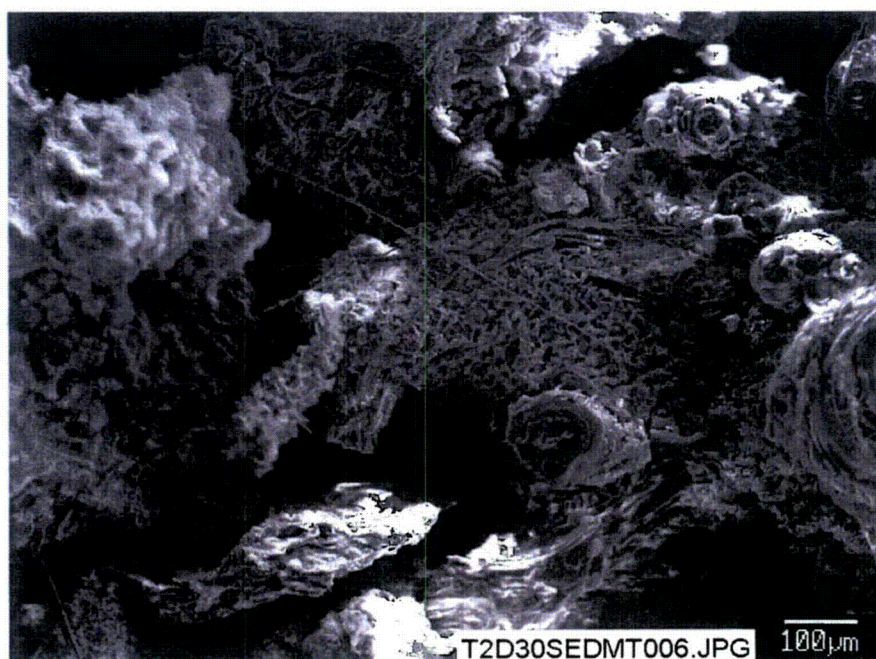
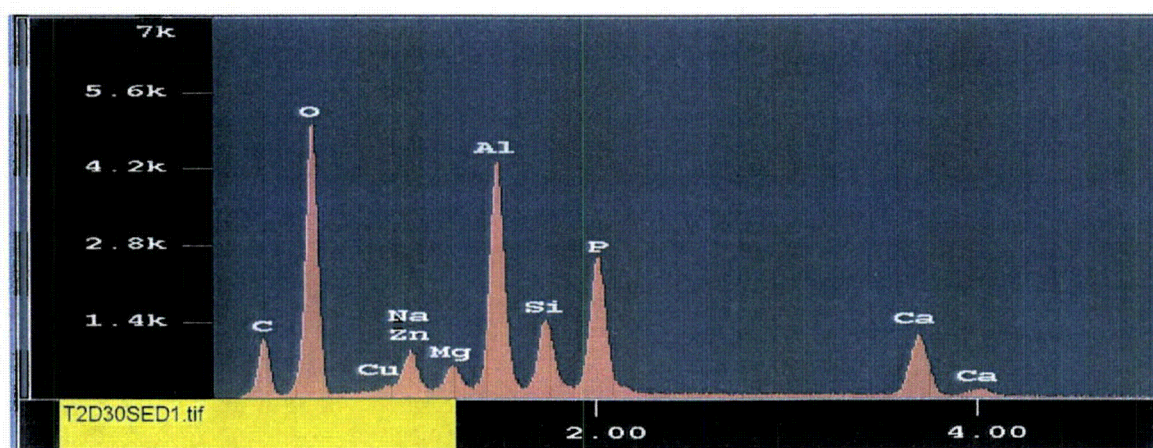
Before ICET Test #2 initiation, latent debris and crushed concrete were added to the tank solution. For Test #2, this material was observed to settle completely on the bottom of the tank over the course of several days. This particulate, in combination with fugitive fiberglass strands, form the basic substrate of the sediment layer recovered from the tank at the end of Test #2. In addition, this bed may serve as a repository for chemical products that are either formed in the bed or deposited on top via settling over the course of the tests. Among all the sample types collected during ICET, tank sediment is the most heterogeneous in terms of both physical configuration and elemental composition. After draining the tank and manually recovering the sediment, 302 g was collected following Test #2. This is total mass as measured when thoroughly drained of free water by gravity but still moist. Figures 4-80 and 4-81 show an SEM image and EDS counting spectrum, respectively, of the Test #2 sediment.

Based on SEM images, the sediment sample contains particulate deposits and fiberglass debris. Due to the heterogeneous nature of the sediment, it is likely composed of corrosion products, concrete debris, dirt, and fiberglass. EDS results show that the composition of the sediment in several locations is similar to the fine powder deposited on both a vertical and a horizontal piece of the submerged rack (see Appendix B).

Figure 4-80. SEM image of a Test #2, Day-30 sediment sample.

Figure 4-81. EDS counting spectrum for the circularly layered material near the right edge of Figure 4-80.
