Subject: St. Lucie Unit 1 Retired PZR Safety "A" Nozzle DM Weld Destructive
Examination Report

MRP Materials Reliability Program _____ MRP 2008-053
(via email)

SUMMARY

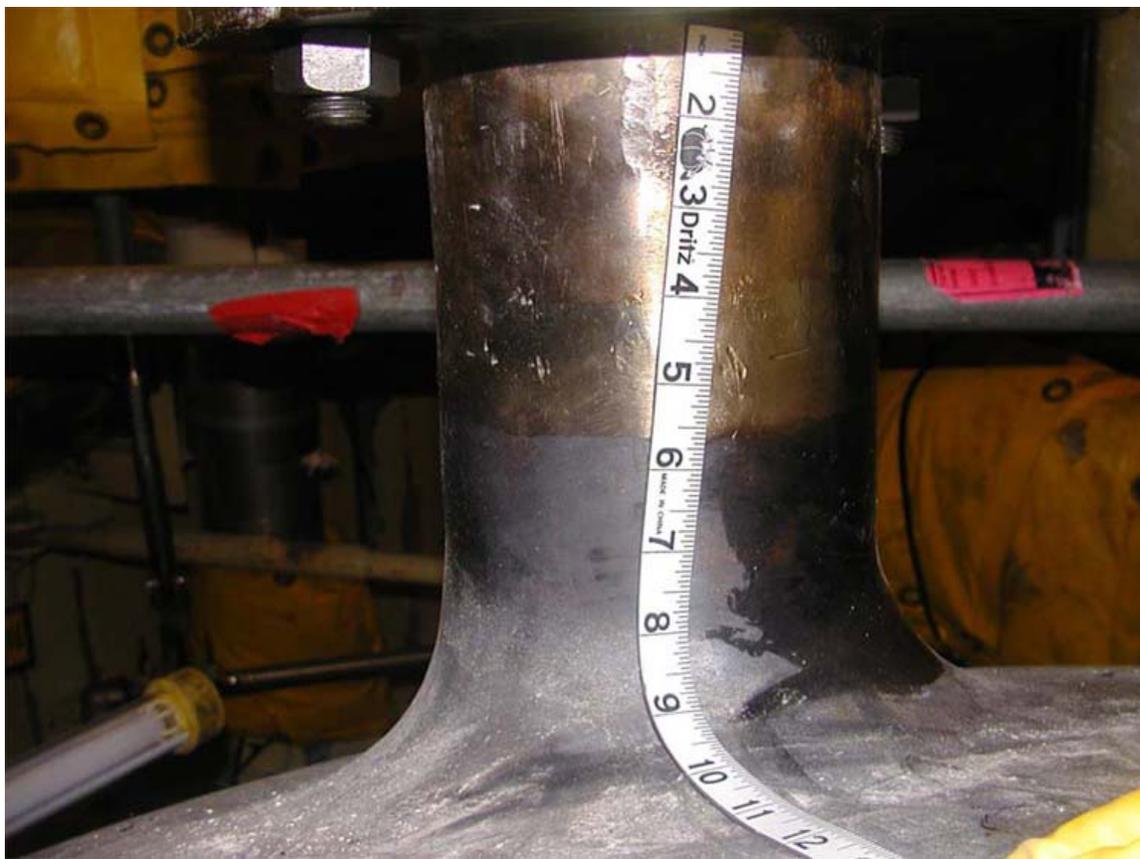
Figure 1: Photograph showing in-service position of safety nozzle "A".

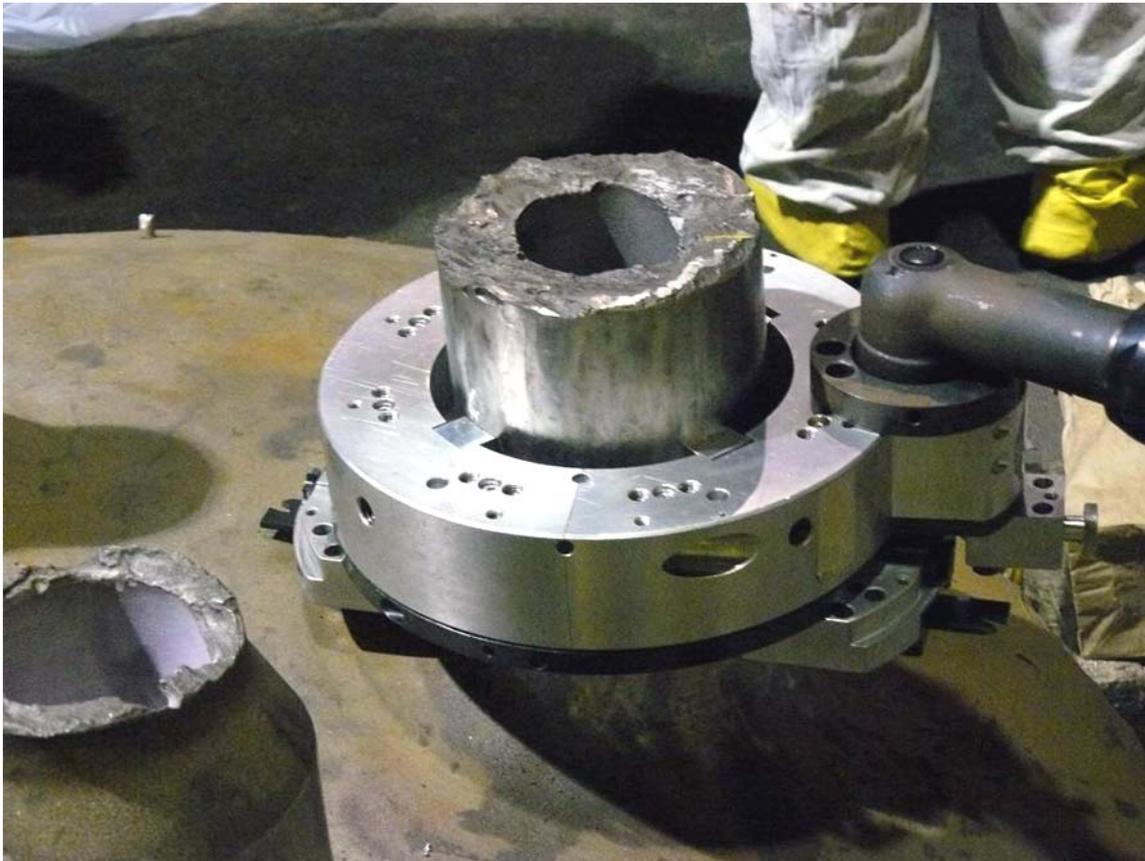
Figure 2: Photograph taken at the RACE facility showing removal of the safety nozzle with a split-lathe machine operated by AREVA.

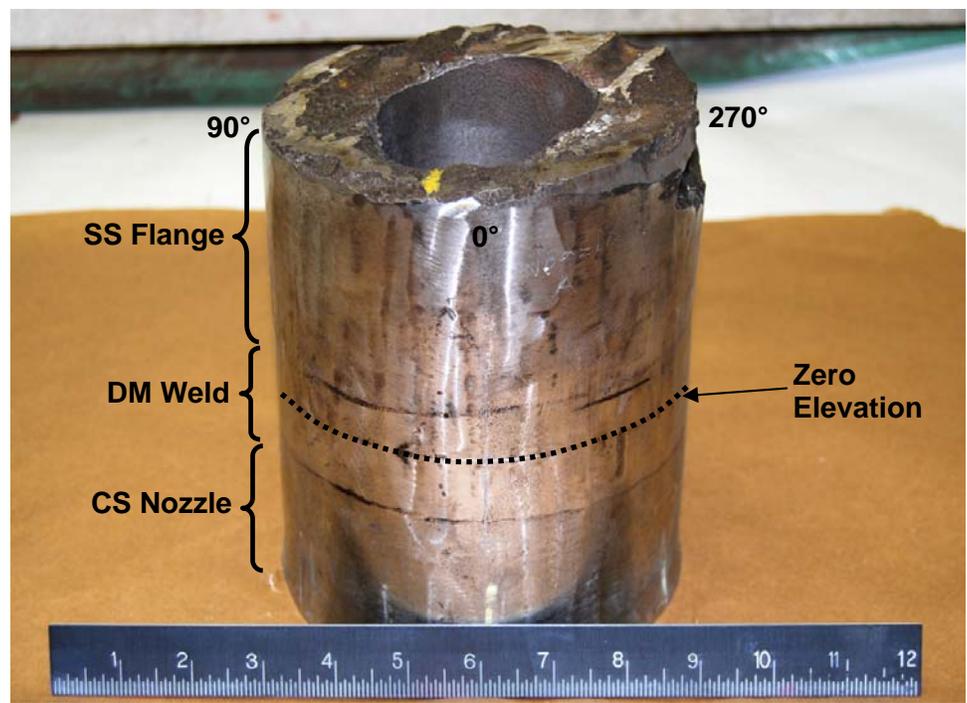
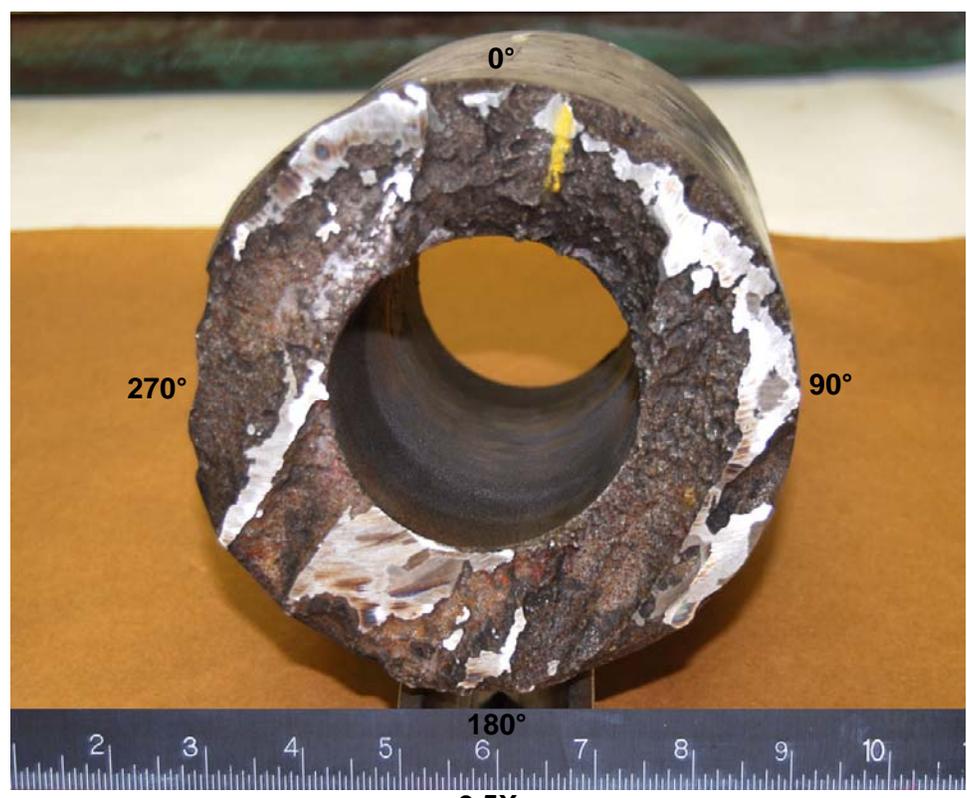
Figure 6: Photographs of the as-received piece showing typical OD appearance (top) and flame cut surface (bottom).

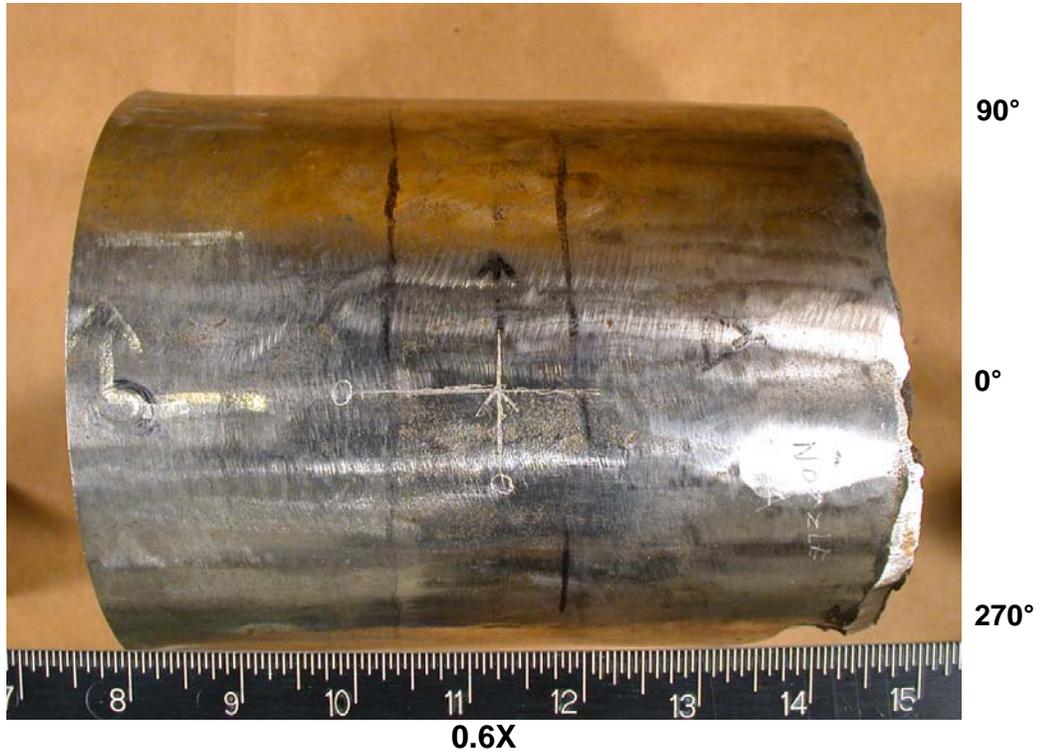
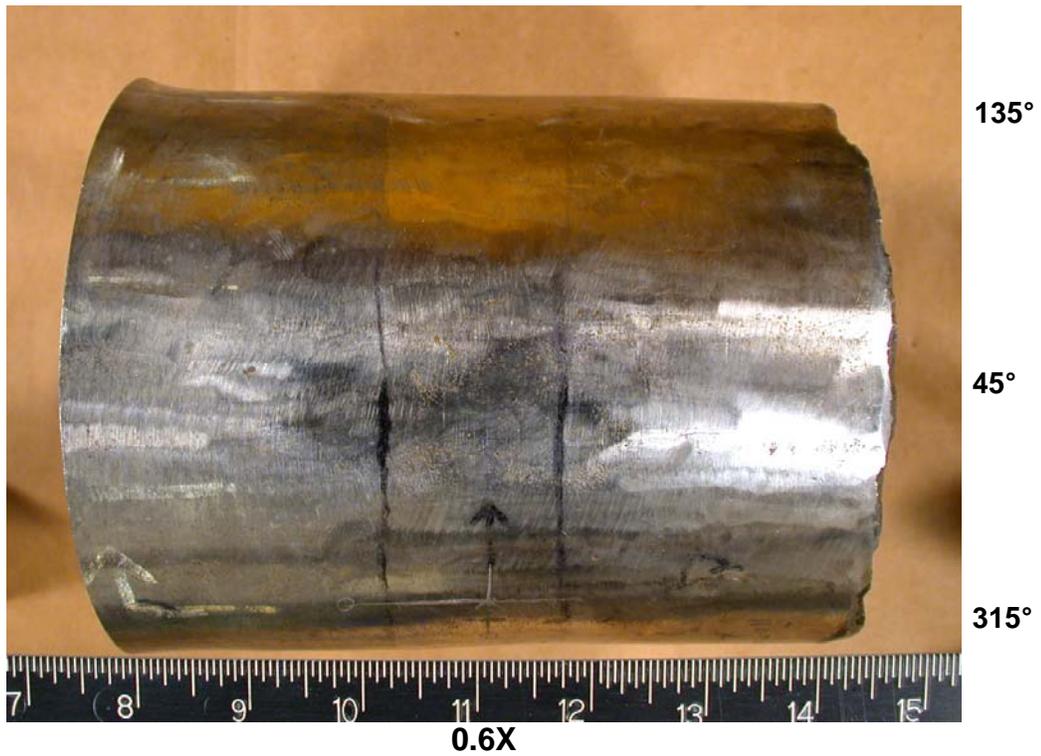
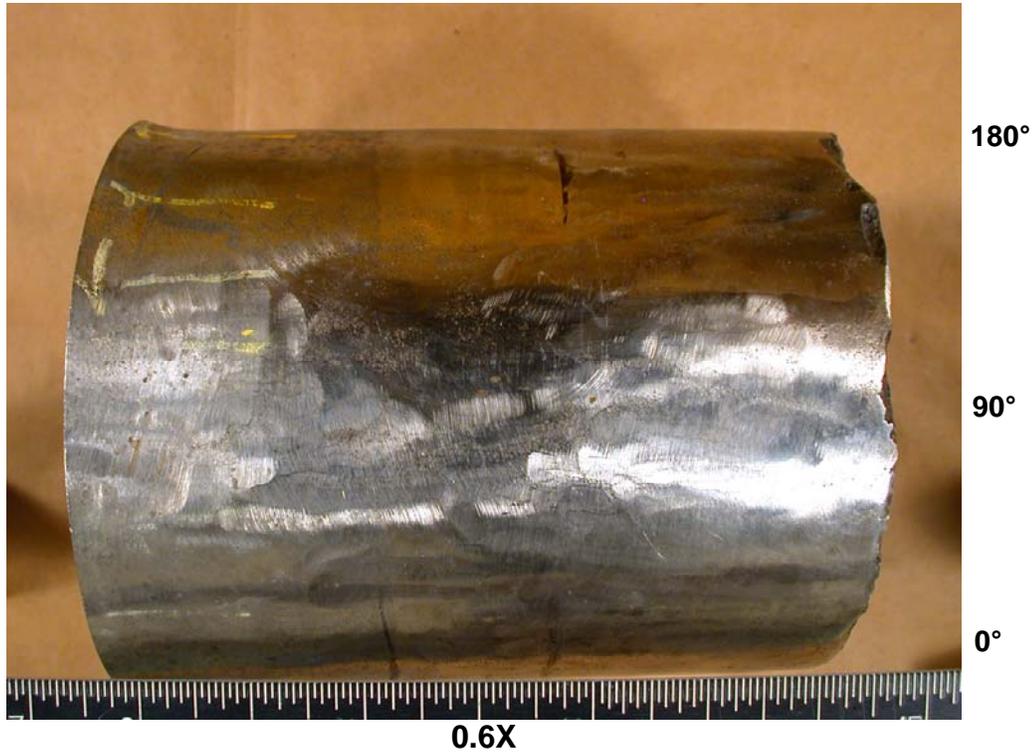
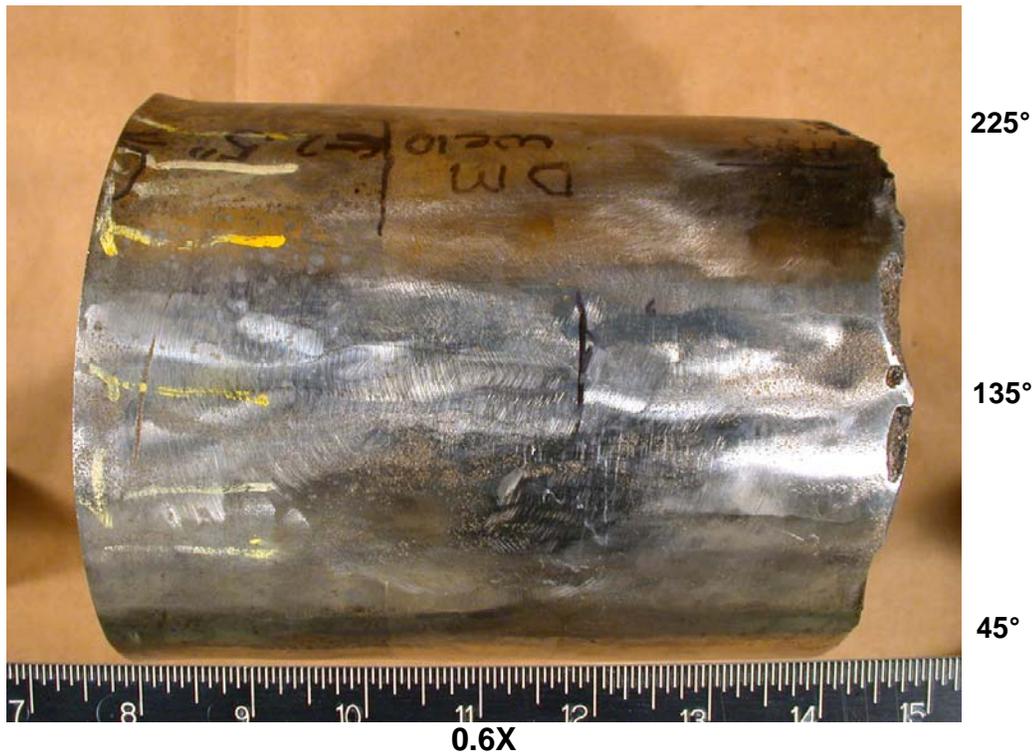
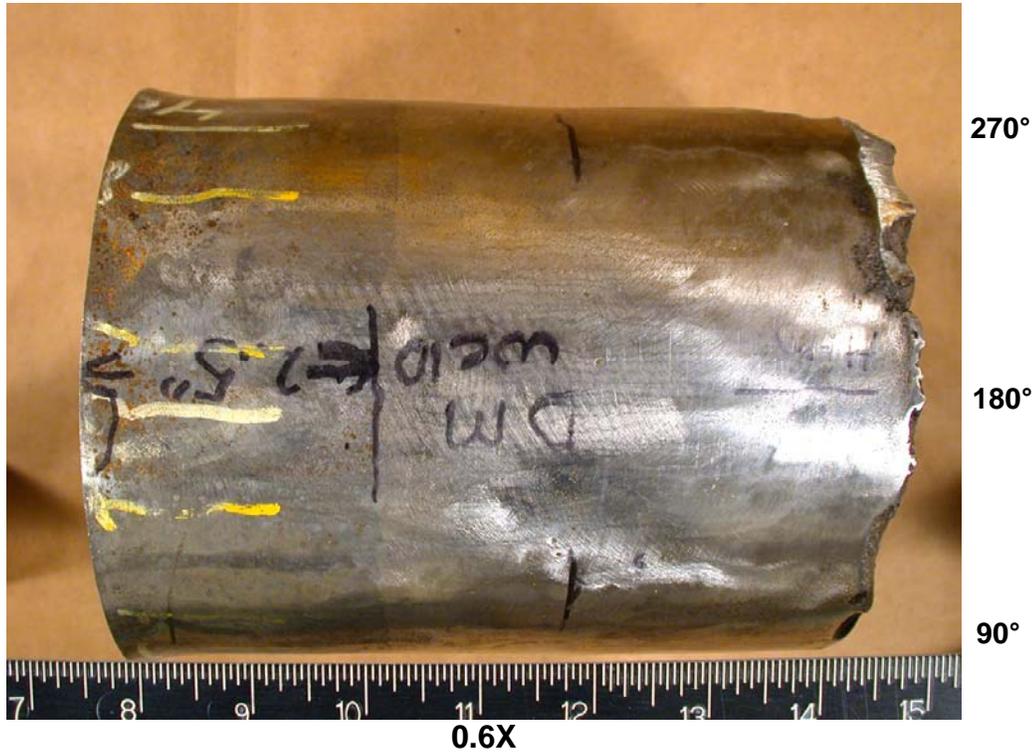
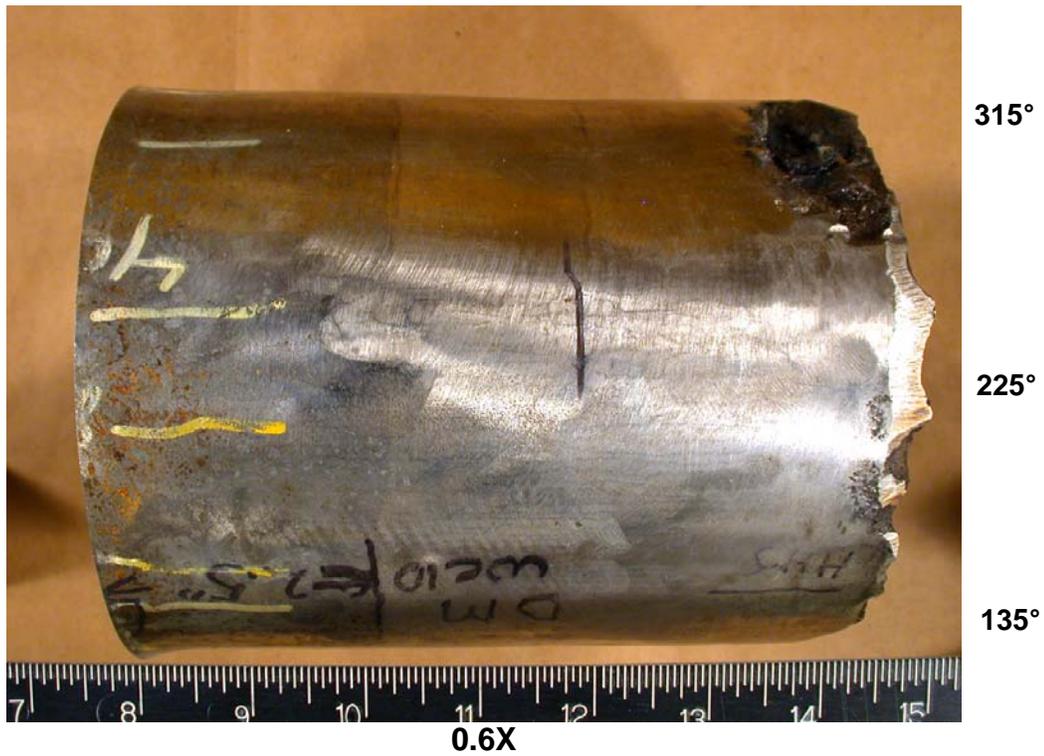
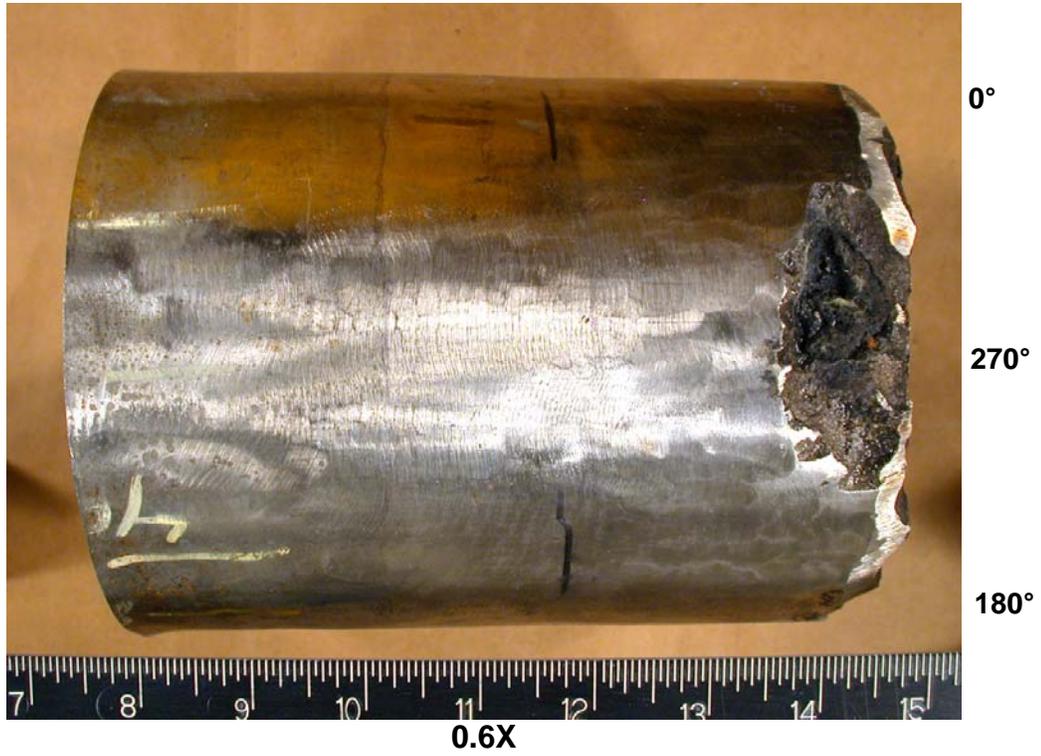
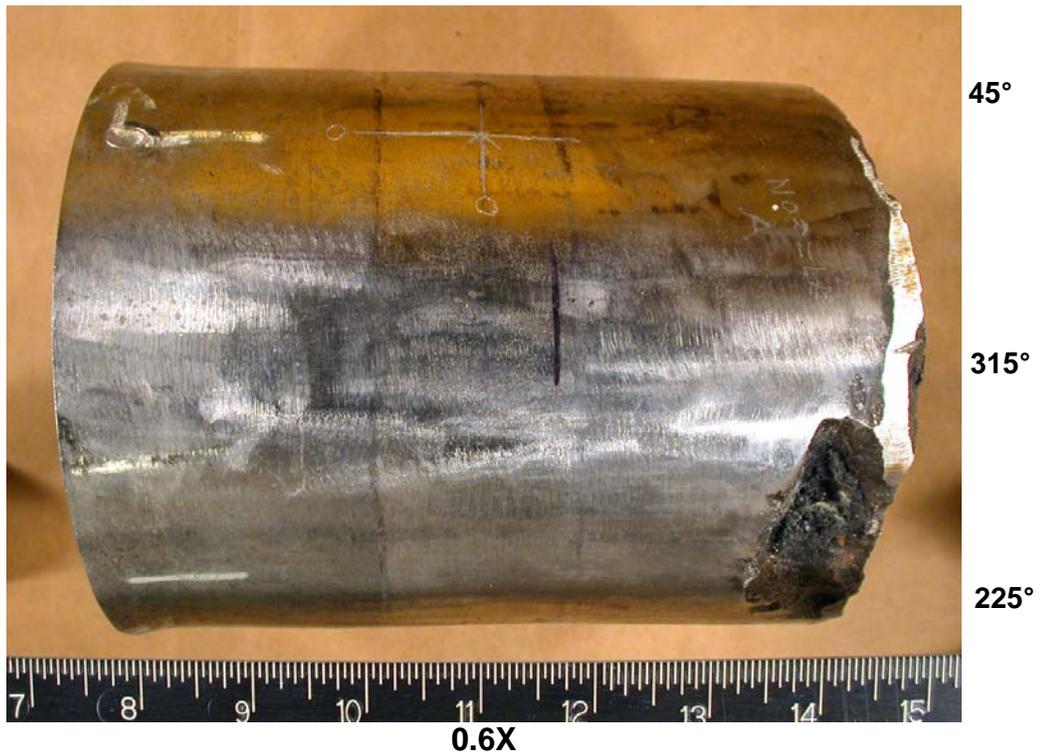
Figure 7: As-received photographs of safety nozzle OD surface.

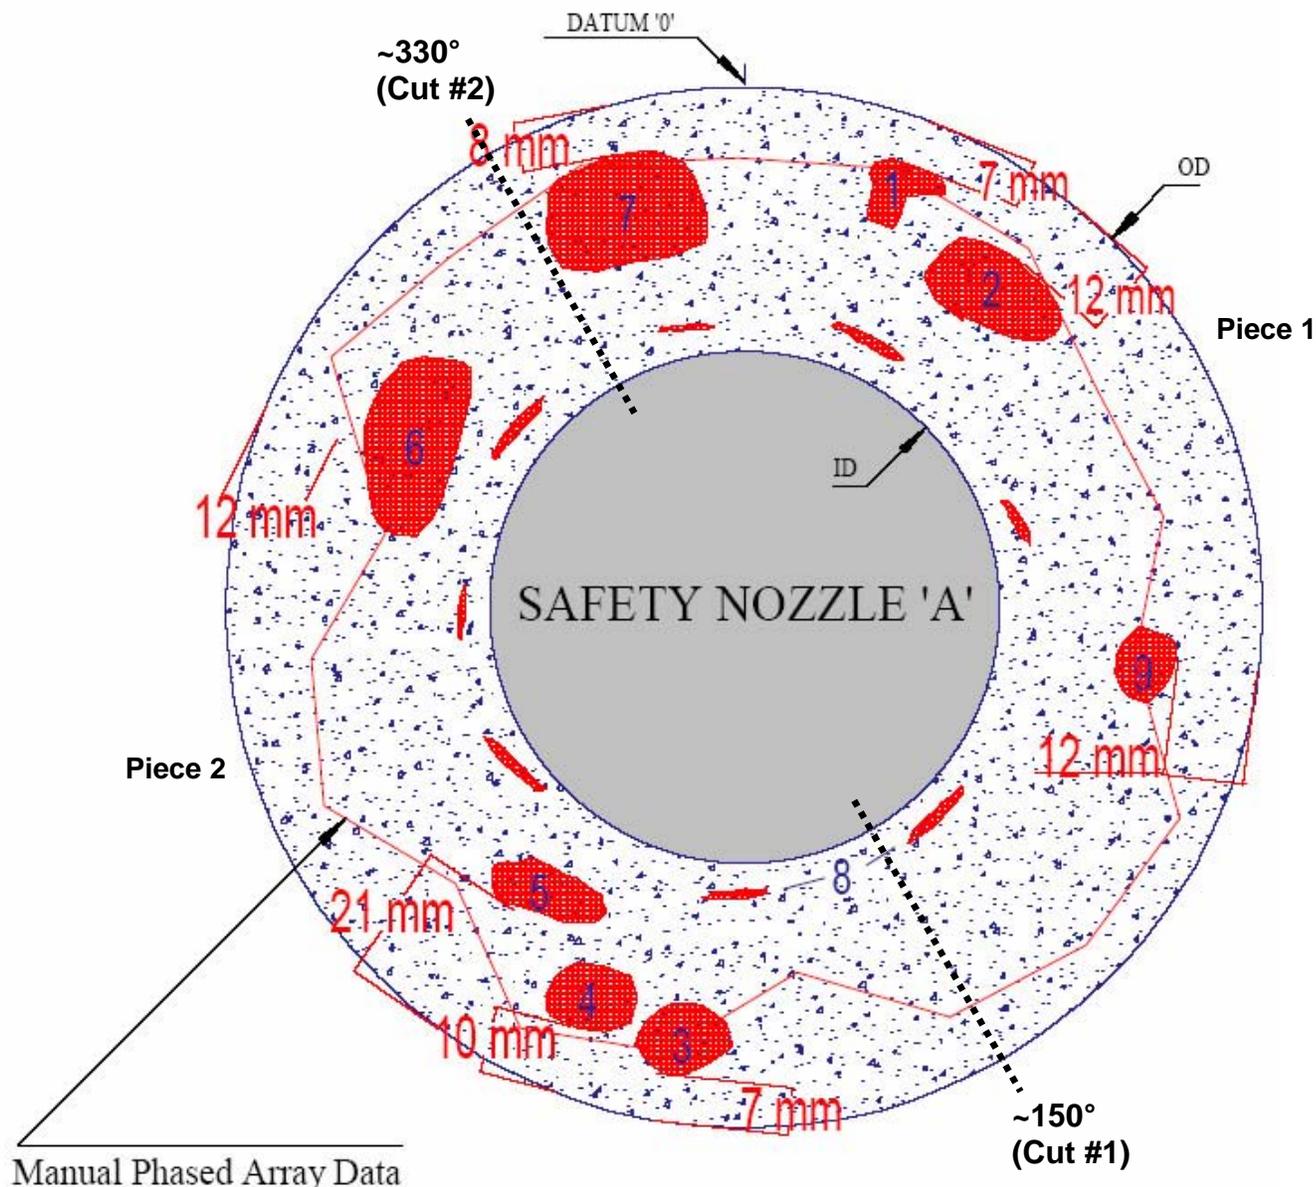
Figure 8: UT map previously shown in Figure 4 showing the first two longitudinal sections made in the laboratory. The first cut was made through the ~150° orientation. The OD was measured after making this cut and then the piece was split open clamshell-style through the ~330° orientation, creating piece 1 (330° to 150° clockwise) and piece 2 (150° to 330° clockwise).

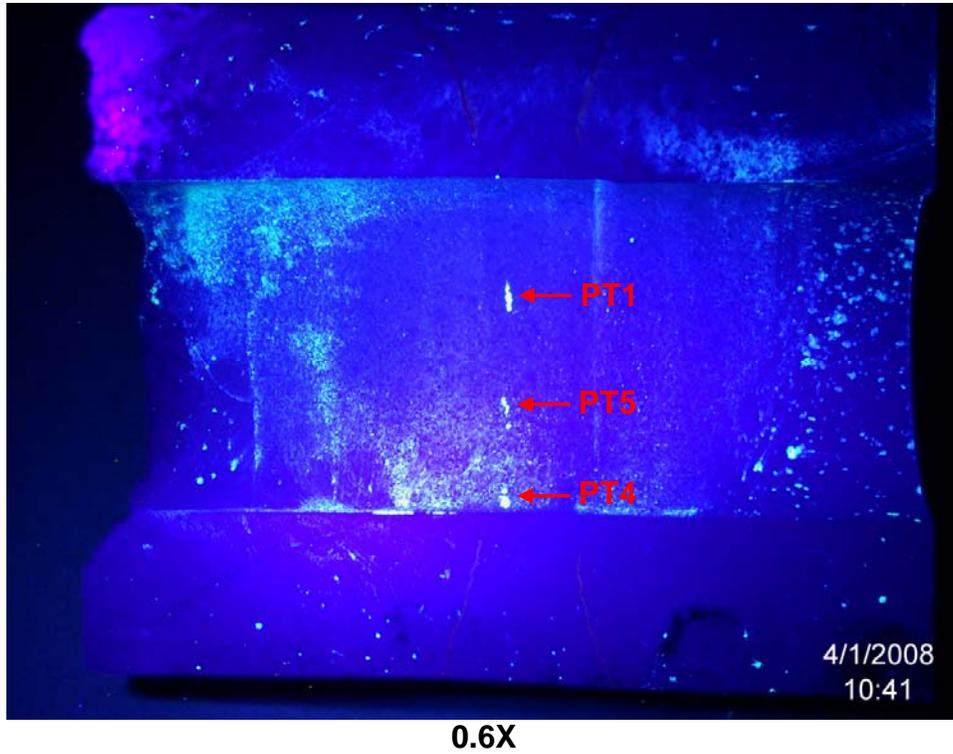
Figure 9: PT photographs of Piece 1 showing three aligned linear indications. These indications corresponded to PT1, PT4, and PT5 shown in Figure 5.

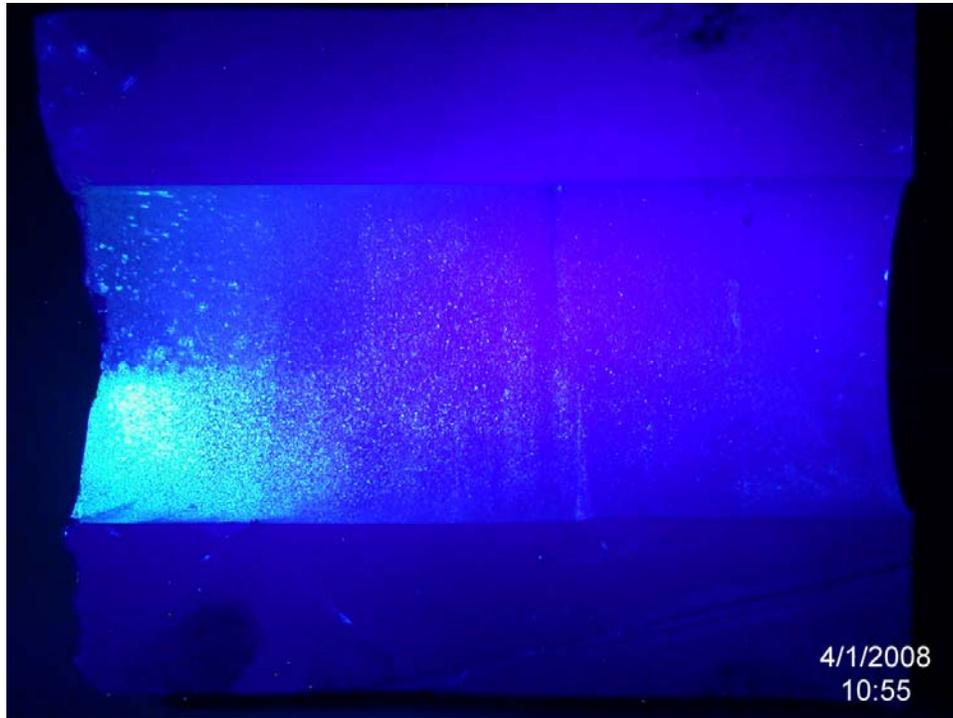
No surface connected ID indications corresponding to PT2 and PT3 were found on piece 2 (Figure 10).

Figure 10: PT photographs of piece 2. No ID-connected indications were detected, even though earlier PT results indicated two surface connected indications (PT2 and PT3 in Figure 5).

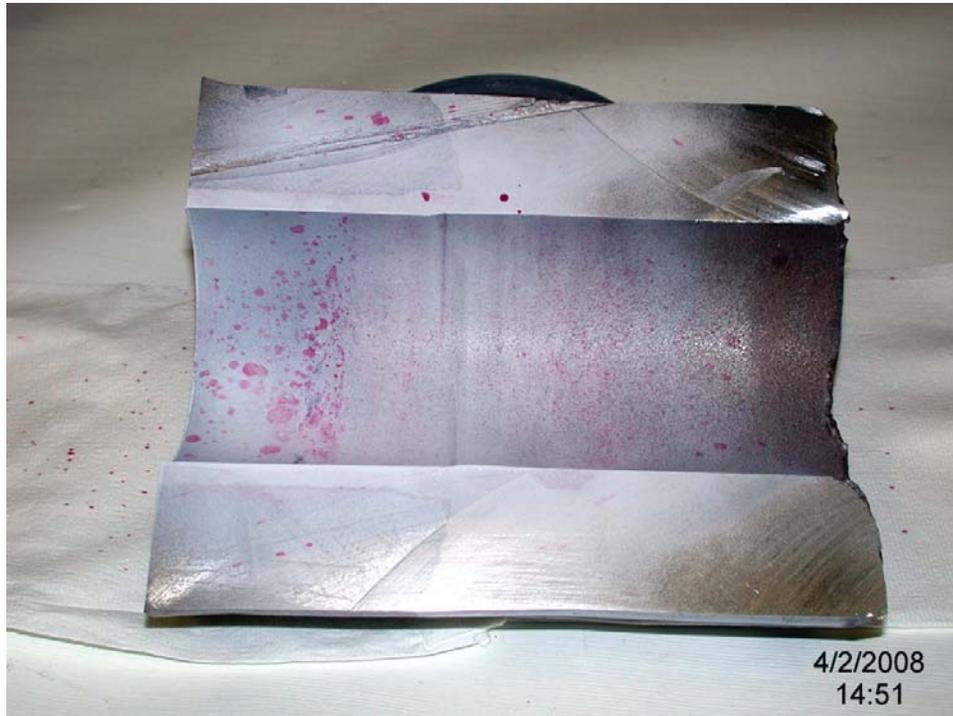
Figure 11: Visible dye PT photographs of piece 2. Four small indications were detected on the 150° cut face; no ID-connected indications were found. No further work was performed on piece 2.

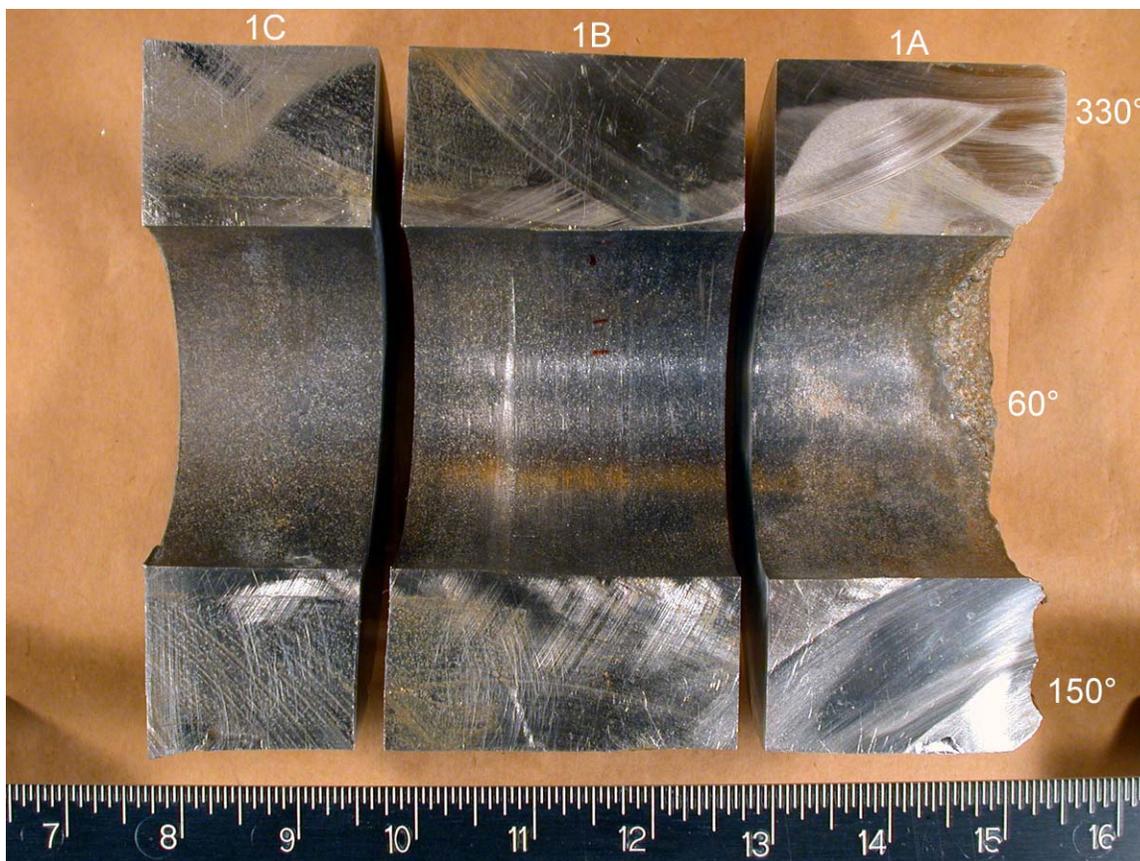
Figure 12: Piece 1 section photograph. Transverse sections were made approximately 0.75" from each weld toe to reduce the sample size and facilitate metallographic specimen preparation. The section photograph for piece 1B is shown in Figure 13.

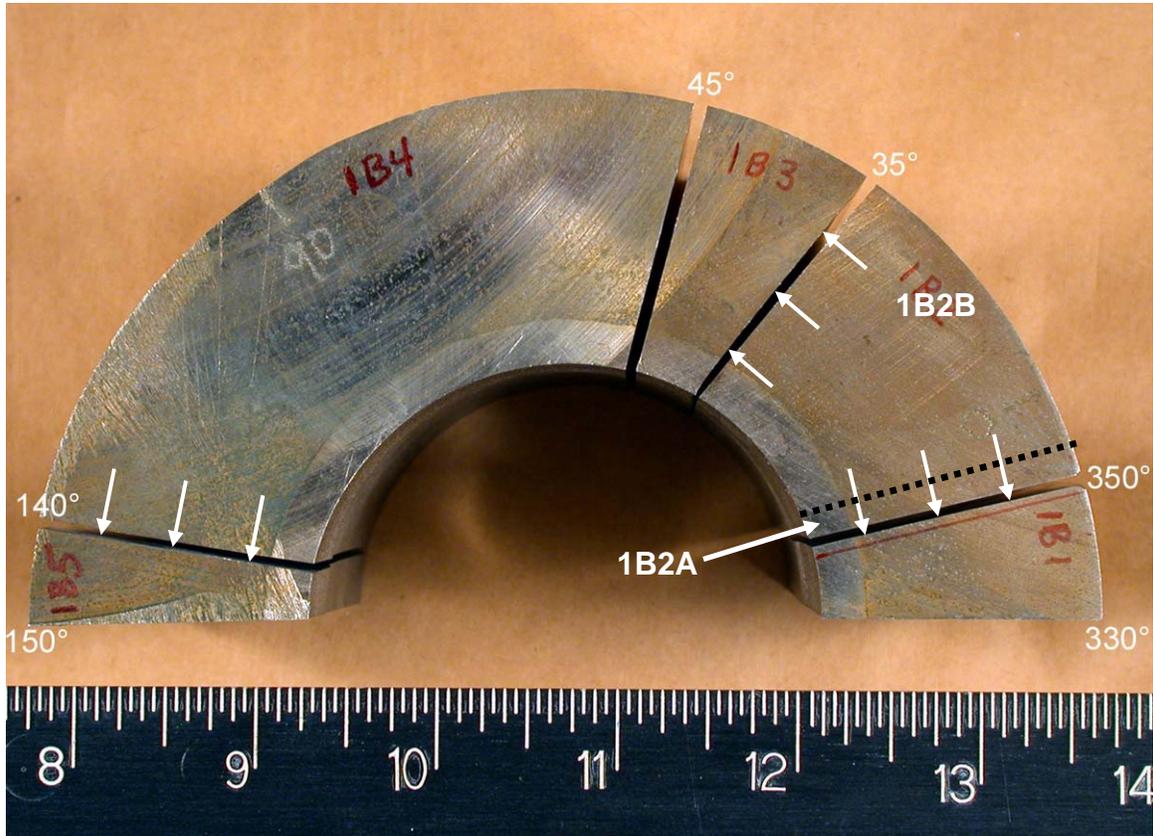
Figure 13: Piece 1B section photograph. Arrows indicate surfaces polished for SEM and metallographic examinations. Piece 1B2A was sectioned further to create an open crack specimen (see Figure 16).

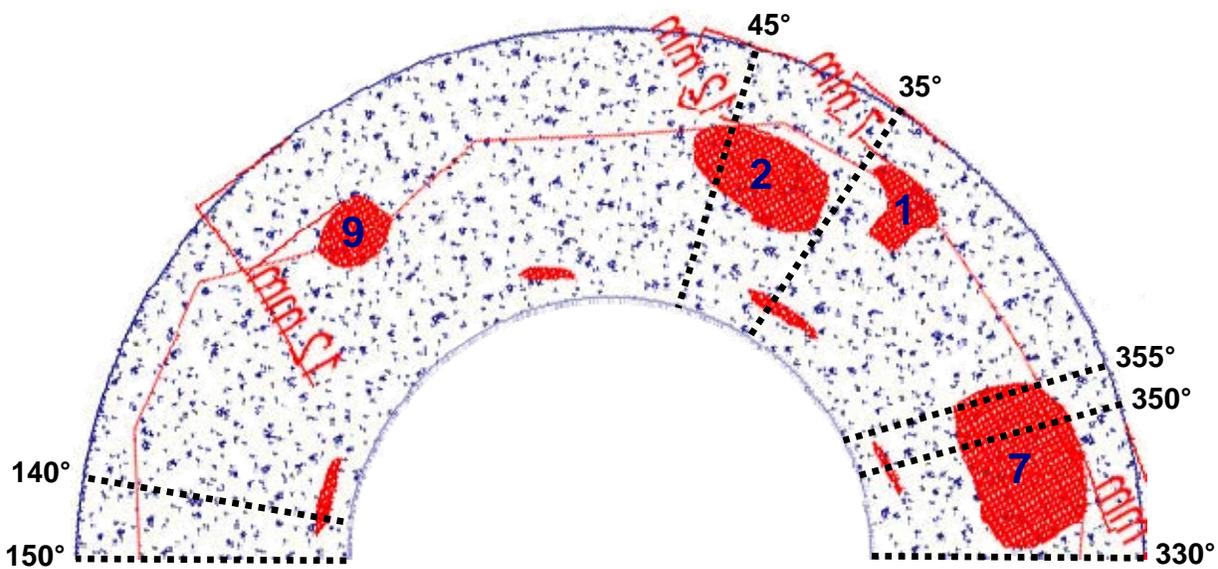
Figure 14: Piece 1B cut locations added schematically to the UT map shown previously in Figure 8. (NOTE: The map mirror image is shown to match the orientation of the photograph on the previous page.)

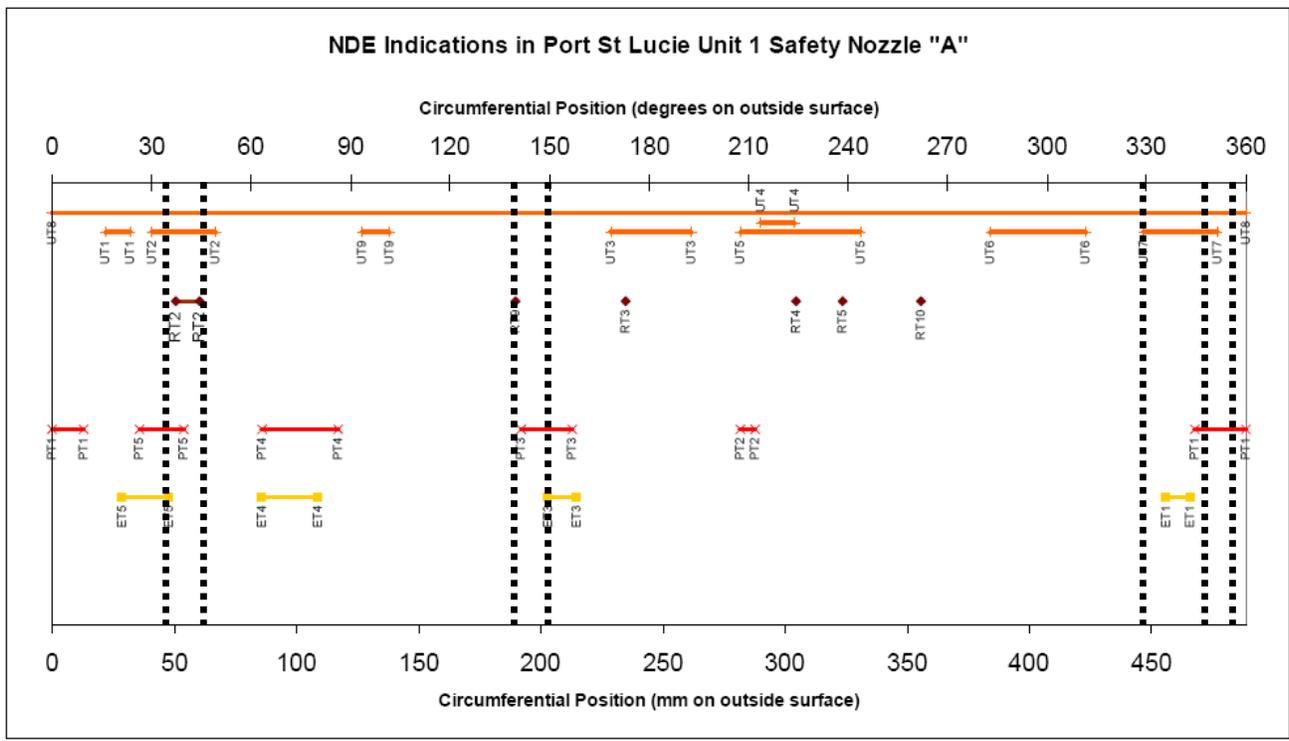
Figure 15: Piece 1 cut locations added schematically to the NDE shown previously in Figure 5.

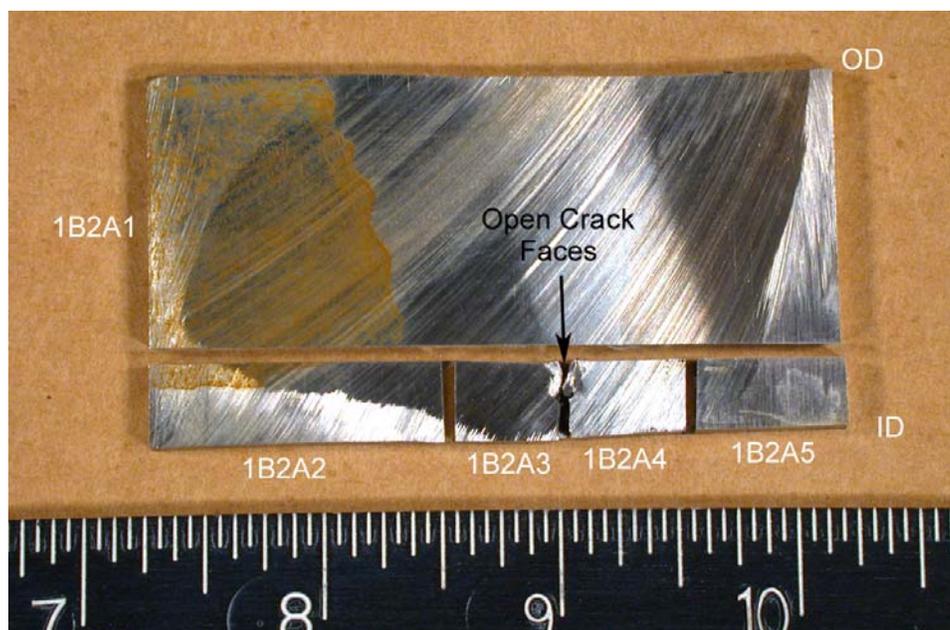
Figure 16: Piece 1B2A section photograph. The piece 1B2A4 open crack face was examined by SEM/EDS.

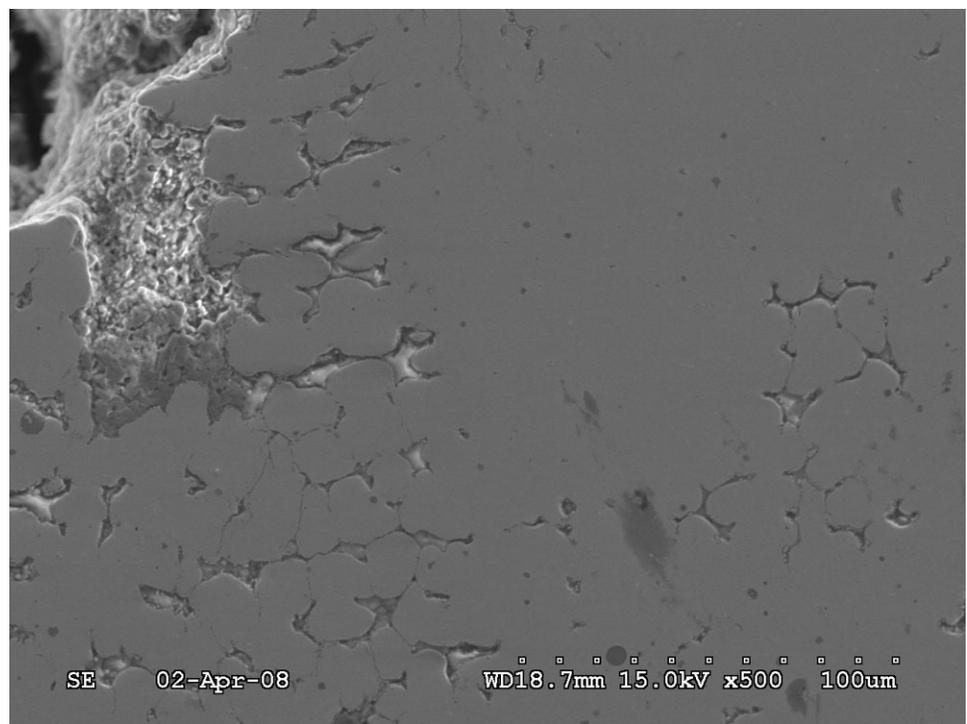
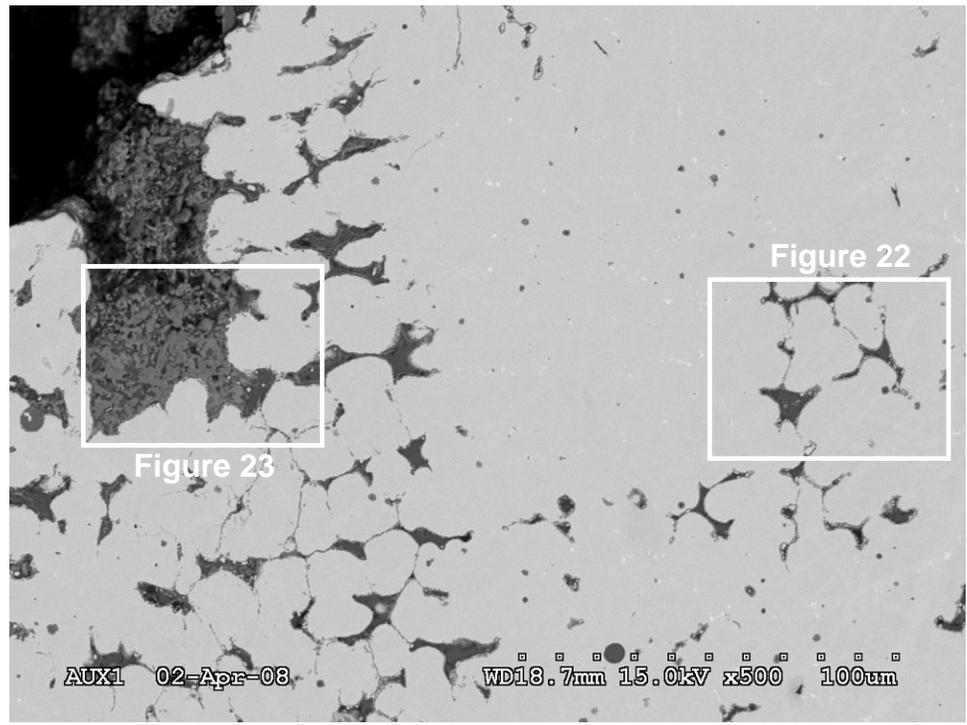
Figure 21: Higher magnification micrographs taken of the affected weld structure adjacent to the weld void.

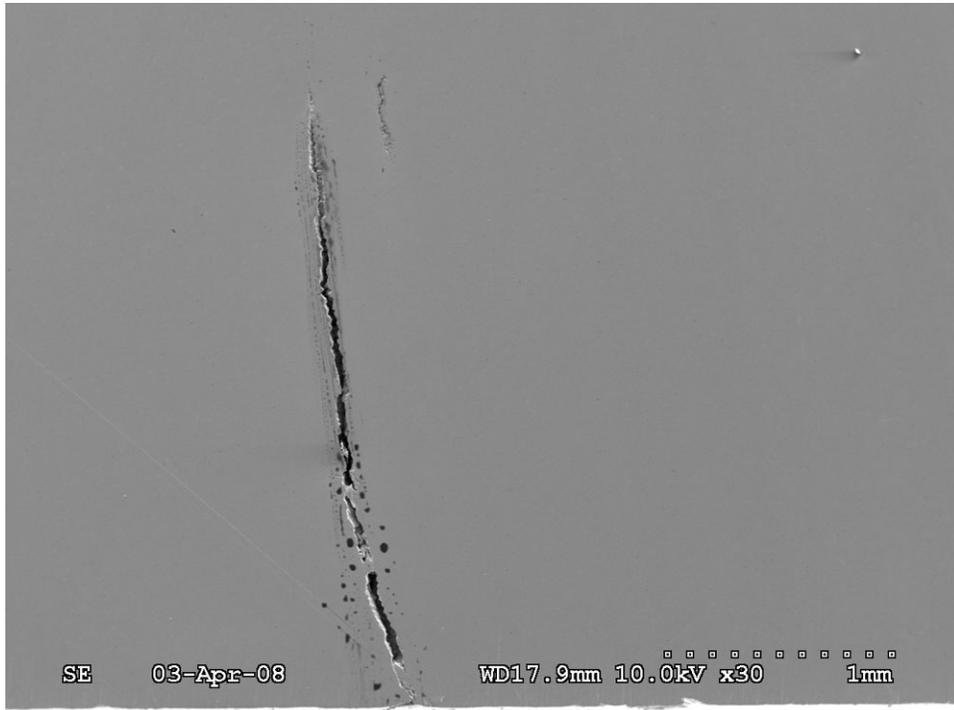
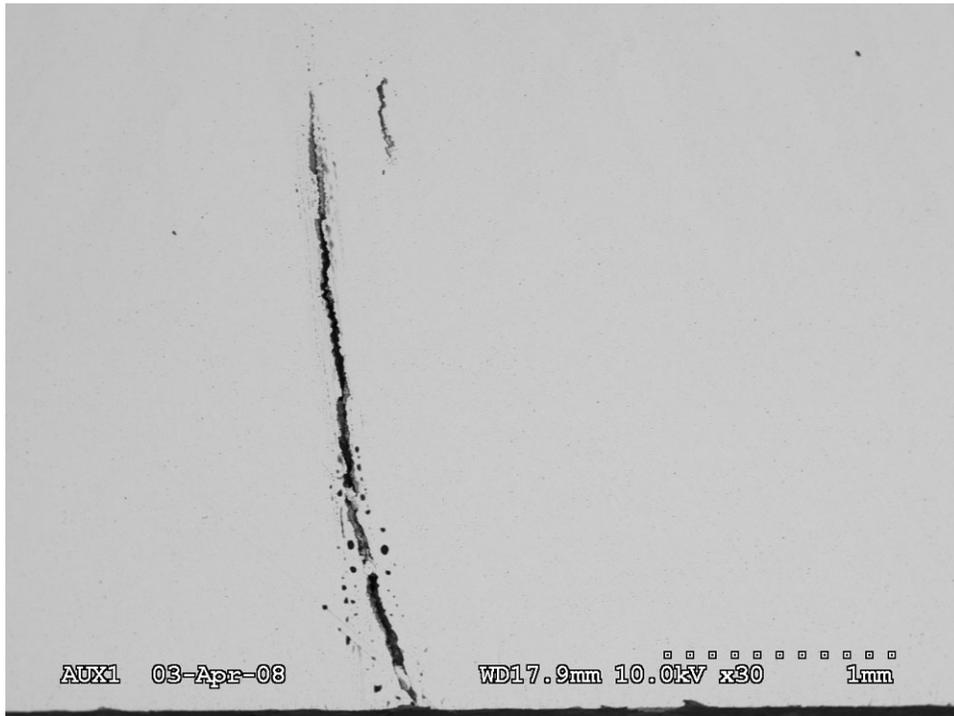
Figure 27: Low magnification micrographs of crack present in cross section prepared through 35°. Circular features toward the ID surface were caused by penetrant bleed-out from the defect. Note that the defect is tighter at the ID surface.

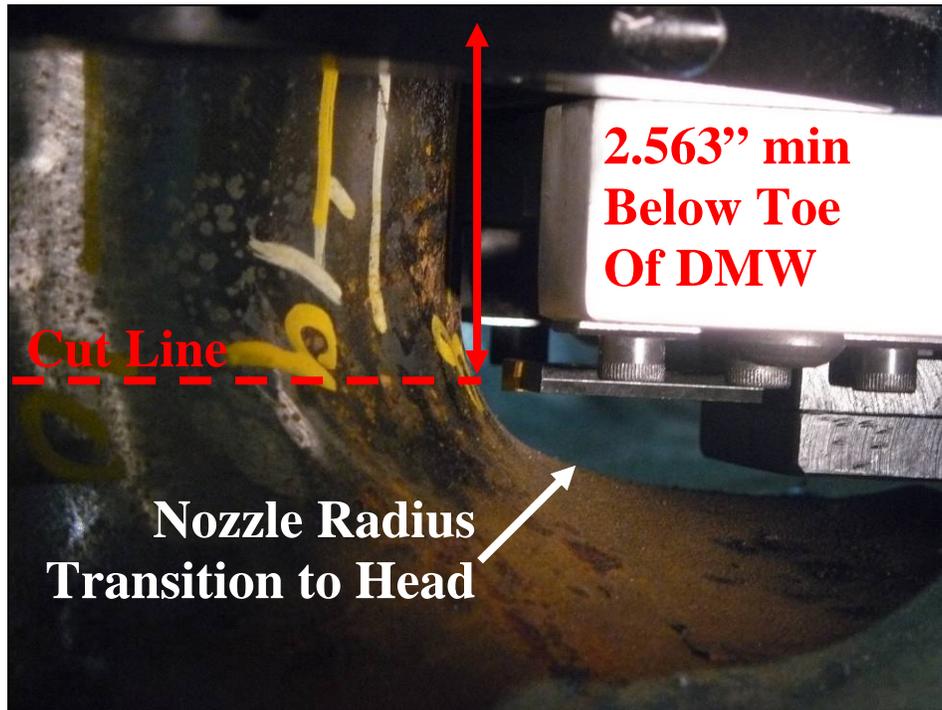
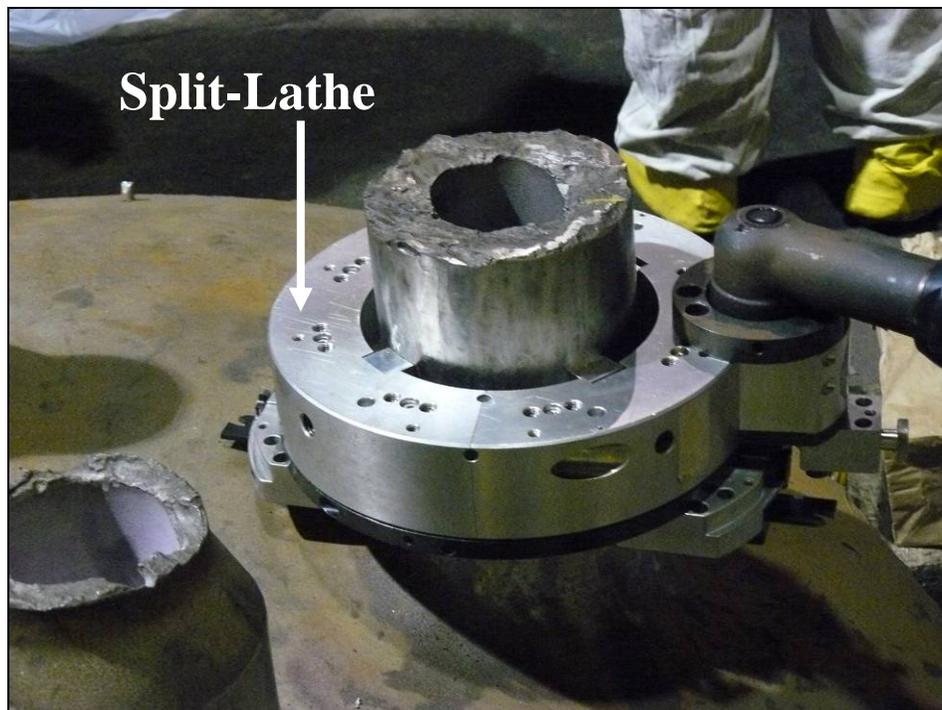
The DMW was removed by machining with a transverse nozzle cut as close to the head as feasible (See Figure 1) on March 14th, 2008. The minimum reported distance from the toe of the DMW to the cut line is 2.563”. This approach allowed for shipping part of the nozzle, the entire weld, and the remaining attached pipe section to a lab where conditions and procedures can be more carefully controlled.

Figure 1: DMW Removal of Safety Nozzle "A"
