Subject: St. Lucie Unit 1 Retired PZR Safety "A" Nozzle DM Weld Destructive
Examination Report

MRP Materials Reliability Program _____ MRP 2008-053
(via email)

SUMMARY

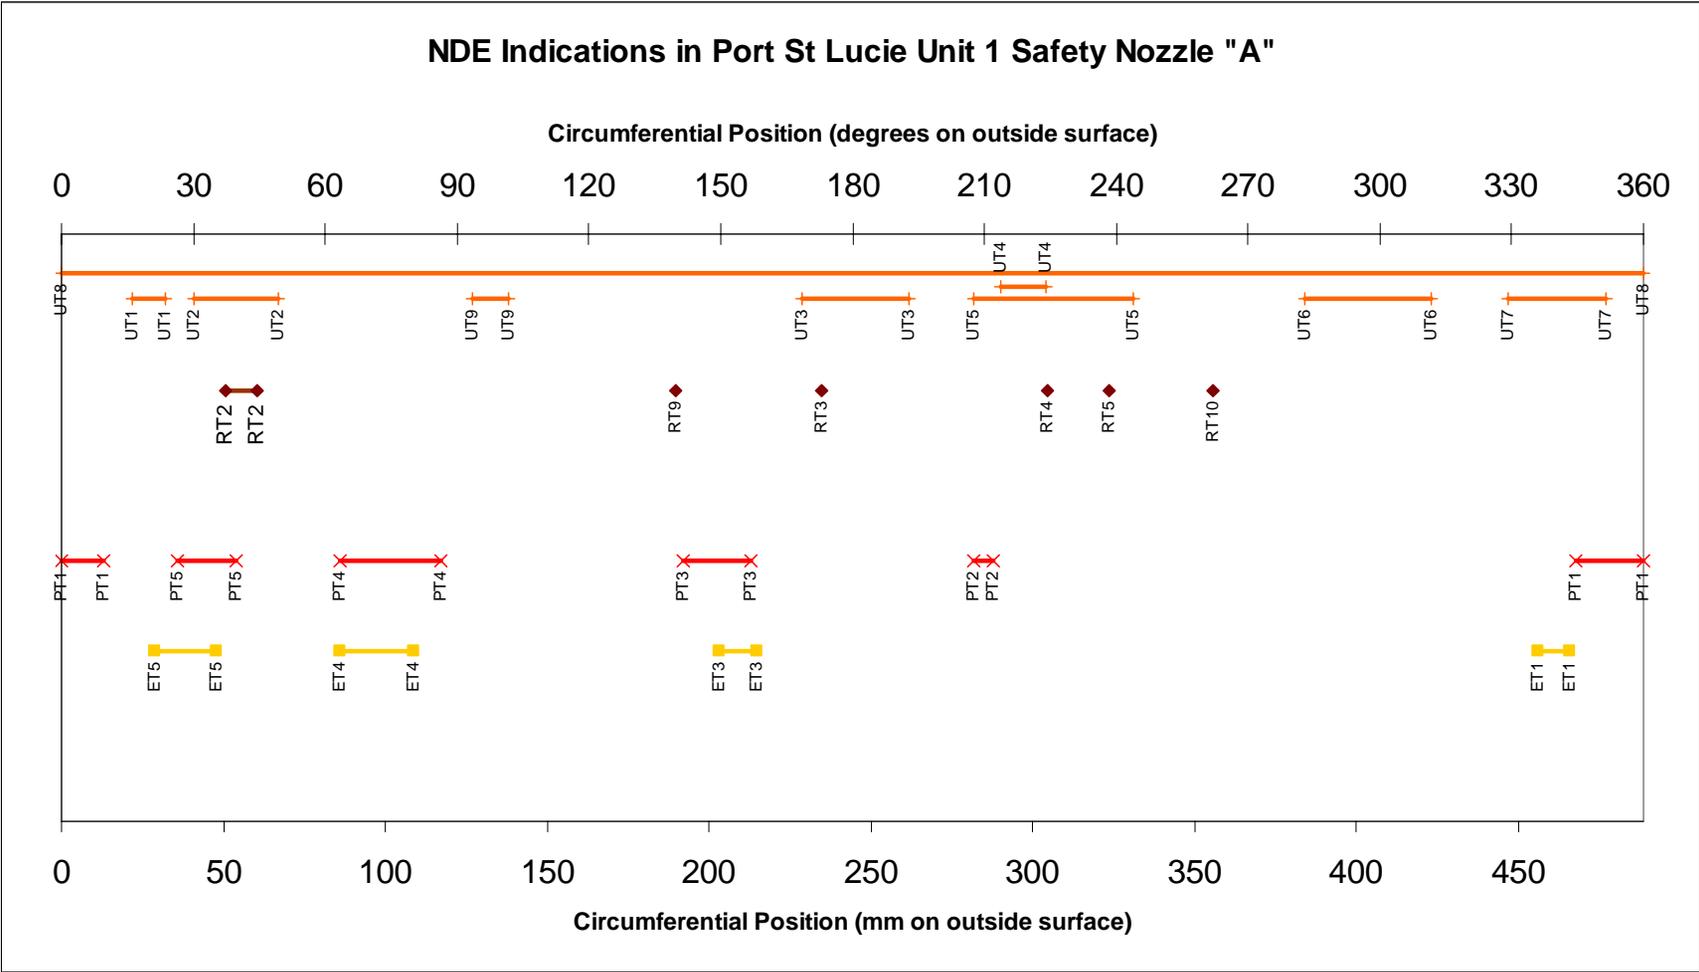
Figure 3 – Azimuthal Location Correlation of Indications by NDE Method

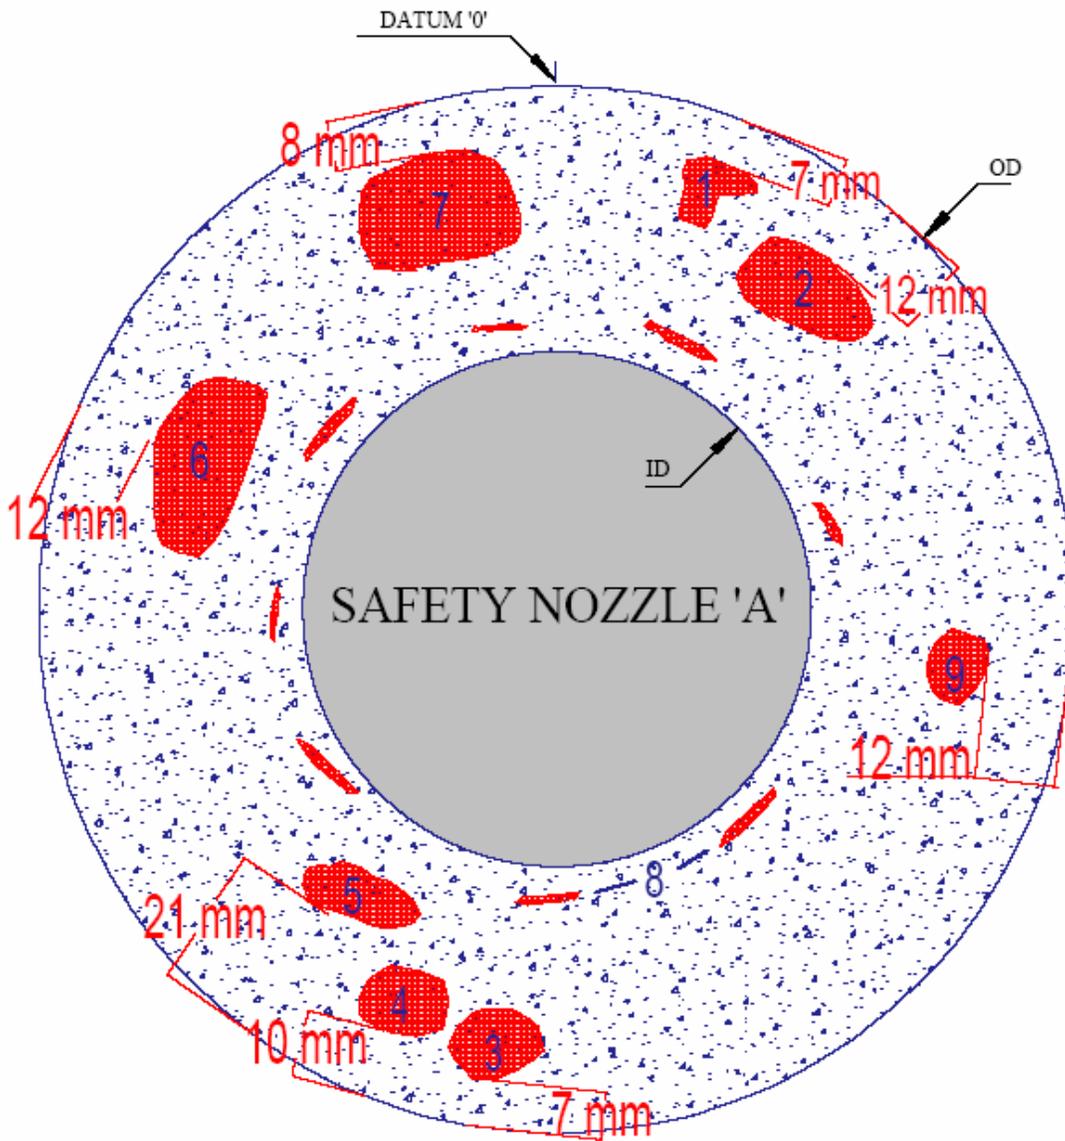
**Figure 4 – Automated UT Reflectors Mapped onto Weld Cross-Section
(Positive angular progression is clockwise)**

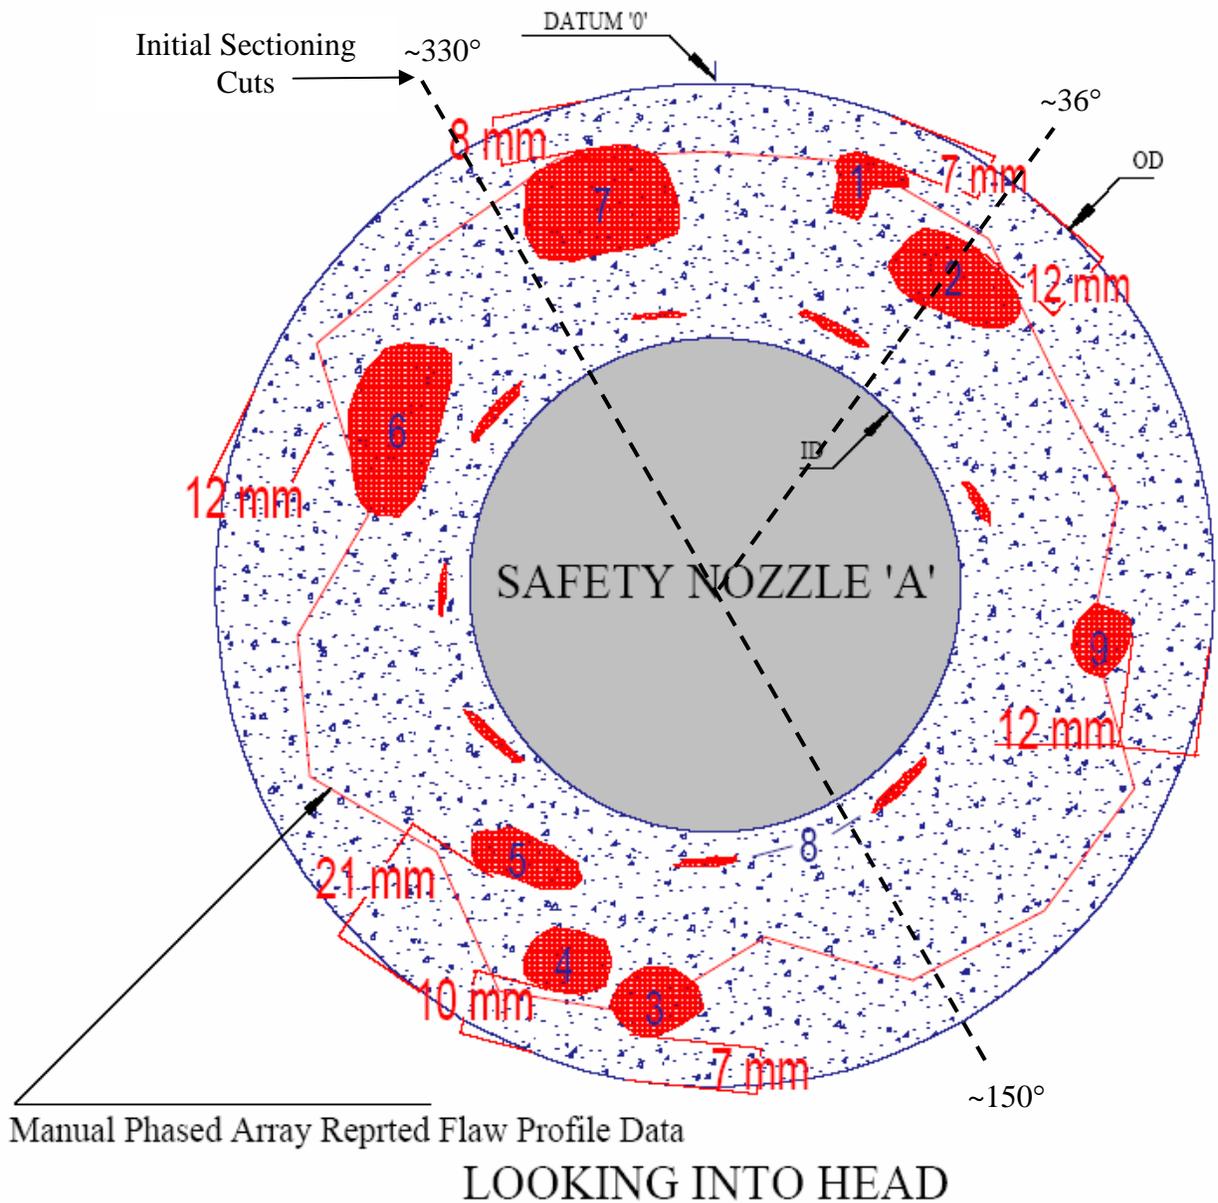
Figure 5 – Automated UT Reflectors Mapped onto Weld Cross-Section w/ Manual UT-Derived Profile Superimposed
