# **Farley Breakers: Lessons Learned**

EPRI JUTG Meeting  
August 26-28, 2008

Victor Hall, NRR/DE/EQVB

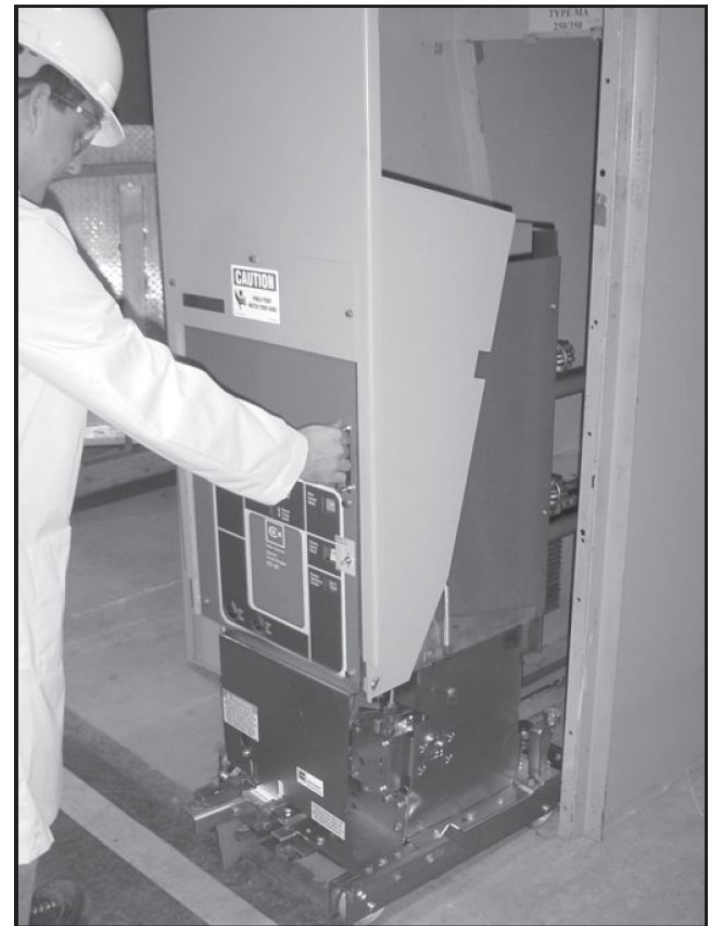
Figure 4-4 Insertion of MA-VR

- Many fit up and quality issues identified
- Minimal Vendor-Licensee Engineering interface
- Farley had “unofficial” assurance that the breakers would fit
- Purchase requirement to test-fit first breaker removed from POs.

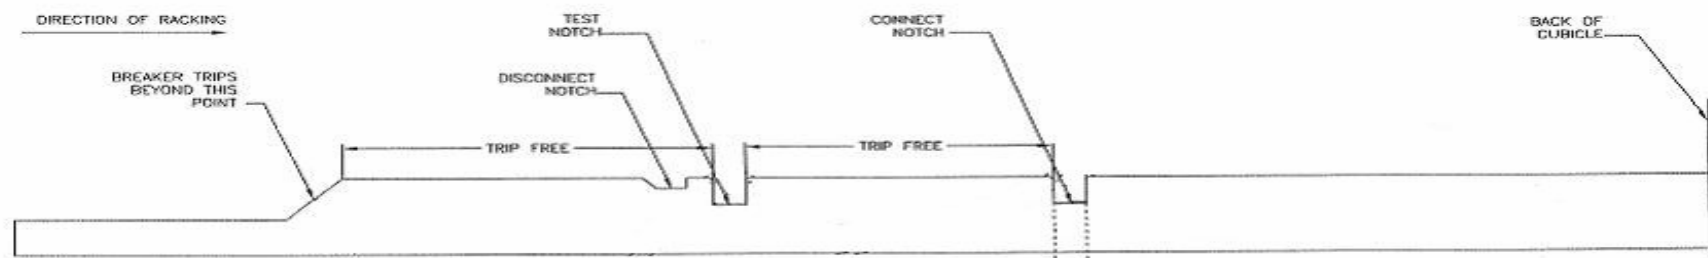
Figure 2 (below)

- Improper manipulation of foot pedal rendered breaker inoperable
