6 Destructive Testing and Results

6.5 Metallographic Examination of Cracking in Nozzle 31 Section 2

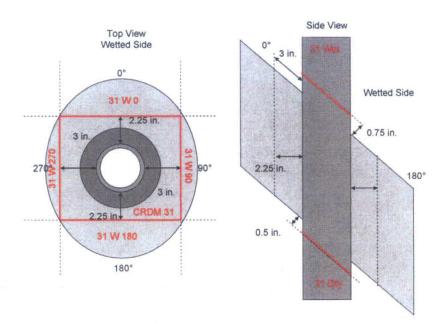
Figure 6.1 Initial Weight-Reduction Cuts Made on Nozzle 31

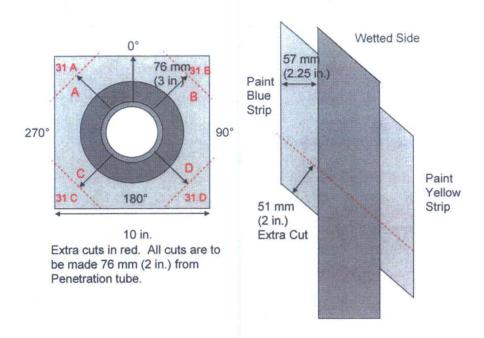
Figure 6.2 Additional Reduction Cuts Made on Nozzle 31

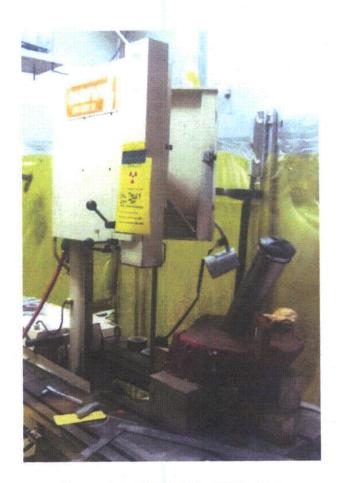
Figure 6.6 Initial Cut on Nozzle 31

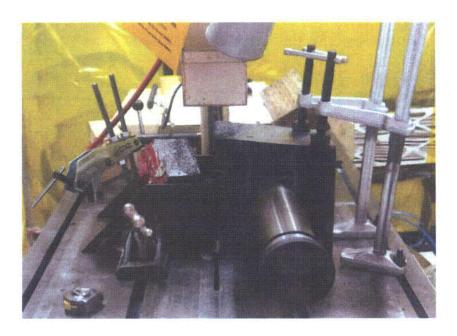
Figure 6.7 Nozzle 31 After Carbon Steel Was Cut into Square

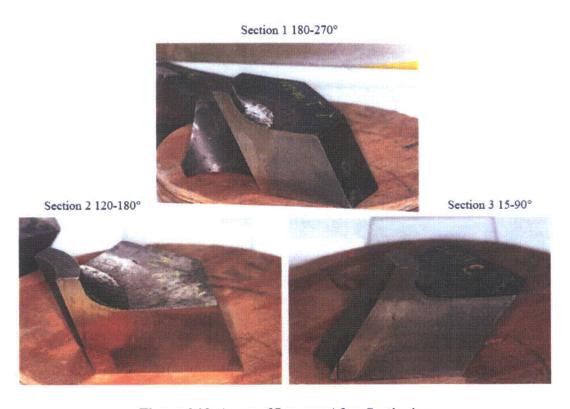
The three regions identified in the cut plan were cut from Nozzle 31 using the large band saw. These regions were cut from the nozzle after removal of the excess carbon steel. After the sections were cut from the nozzle, the position and extent of the weld, buttering, and triple point were obvious. The pieces were cut just above the triple point to release the penetration tube and allow direct inspection of the buttering above the triple point to determine which of the NDE responses was associated with the through-weld crack. Figure 6.10 shows the three sections after removal from the nozzle, and Figure 6.11 shows Section 2 after further cutting to allow inspection of the buttering.

Figure 6.10 Areas of Interest After Sectioning

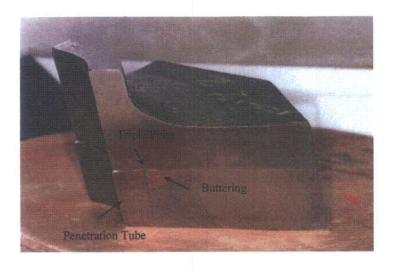
Figure 6.11 Section 2 After Cutting Above Triple Point To Remove Penetration Tube

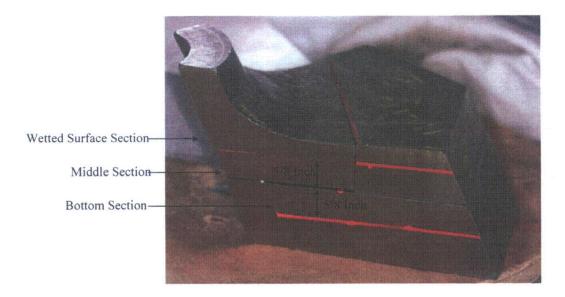
Figure 6.13 Section 2 After Cutting to Find Cracks

After the cutting, it was clear, based on the position and spacing of the cracks, which cracks were associated with which ET indications. Figure 6.14 shows the three cracks on the cut face 8 mm below the wetted surface. One interesting aspect of the cracks and the ET indications is how much longer the cracks are 8 mm into the weld than they were at the wetted surface. ET indication 9 is 8 mm long on the surface, and the visible crack length is 21-mm long at the cut surface. ET indication 10 is 6 mm long at the surface and is 25 mm long at the cut surface. Indication 11, which is 10 mm long at the wetted surface, is 15 m long at the cut surface. The crack spacing is preserved; cracks 10 and 11 are 5 mm apart on both surfaces, and cracks 9 and 10 are 11 mm apart on the wetted surface and 10 mm apart on the cut surface. By contrast, ET indication 8 is 16 mm apart from ET indication 9. It is worth noting that ET indications 8 and 12 do not represent cracks that penetrated 8 mm into the weld.

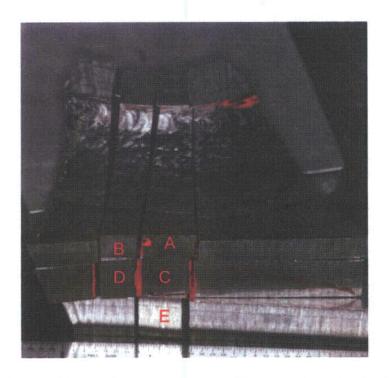
As final preparation for the destructive evaluation, the cracked sections were cut out in small pieces for easier fine cutting and polishing. The cracked specimens were cut out in five pieces labeled A through E. The cut nozzle Section 2 is shown in Figure 6.15. The through-weld crack associated with ET indication 10 and the nearby crack associated with ET indication 11 are contained in pieces A, C, and E. The nearby crack associated with ET indication 9 is contained in pieces B and D.

Figure 6.15 Cracked Metal Coupons Removed from Section 2

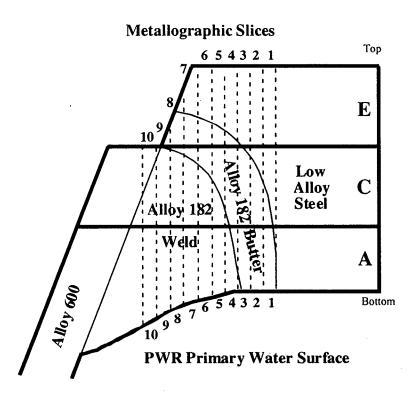
The sectioning diagram is illustrated in Figure 6.19 on the same schematic for Section 2 of the Nozzle 31 weldment presented in Figure 6.16. The zero cut was made in the low-alloy steel where no cracking was present, and the remaining cuts were produced parallel to this section. Individual metallographic cross-section samples were identified as A1–A10, C1–C10, and E1–E8. Piece E was shorter than pieces A and C because it was above the J-groove weld and the adjoining Alloy 600 tube detached during initial cutting.

Figure 6.19 Approximate Locations (dashed lines) of Metallographic Sections Through Pieces A, C, and E

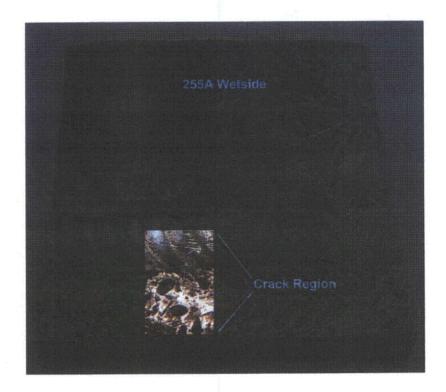
Figure 6.39 Wetted Surface Location of Crack at 255 Degrees

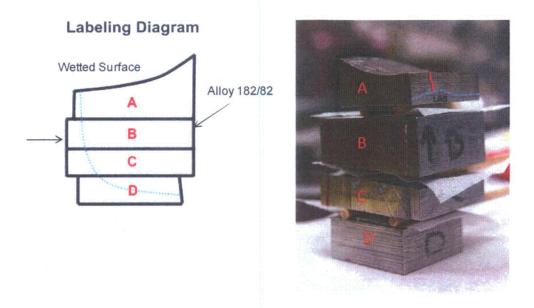
Figure 6.41 Sectioning Diagram for the Region Around 255 Degrees

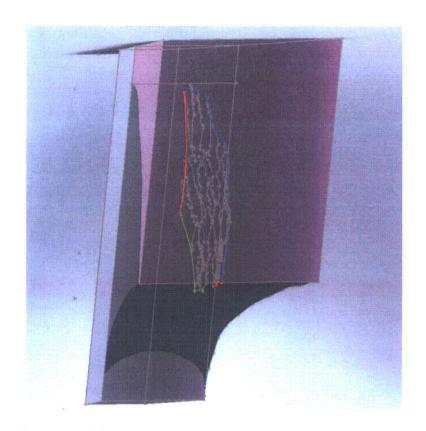
Now that the basic framework has been created, much more detail can be built into this rendering to better elucidate the crack morphology through the weldment. Even at this stage, rotating the constructed image allows insights into the through-thickness crack path. For example, a nearly edge-on view of the crack is shown in Figure 6.44. Here it can be seen that the crack meanders during propagation through the weld material, possibly following the residual stress pattern. However, the path is relatively straight overall compared to component dimensions. In a more tilted orientation as shown in Figure 6.45, the small amount of propagation of the crack into the Alloy 600 pipe is more evident.

Figure 6.44 Crack Viewed from a Nearly Edge-On Orientation

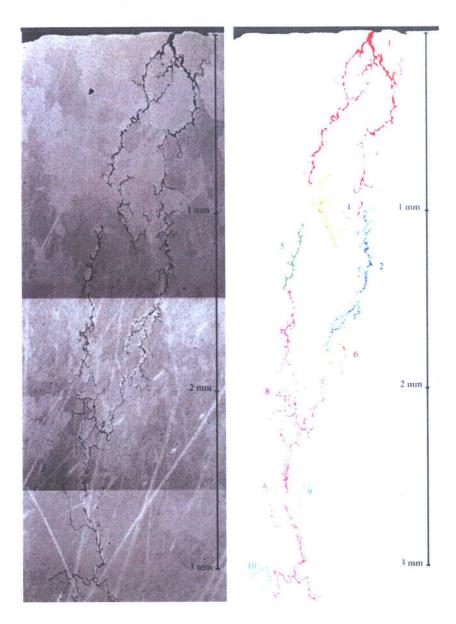
As described in Section 6, the crack segments were polished and examined using SEM. The crack has a branching and discontinuous morphology in the through-weld orientation. Images of the crack and a color-coded image showing the various crack segments are shown in Figure 8.3. The first 3 mm show nine separate segments with ligaments between them. All the segments are part of the same crack, but they connect with each other outside the plane shown in the slice.

Figure 8.3 Crack Segments. SEM image (left) and color-coded image (right).

Location	COD (µm)
1	10
2	29
3	6
4	2
5	6
6	6
7	2
8	Closed
9	Closed
10	4
11	2
12	9
13	7
14	3
15	2

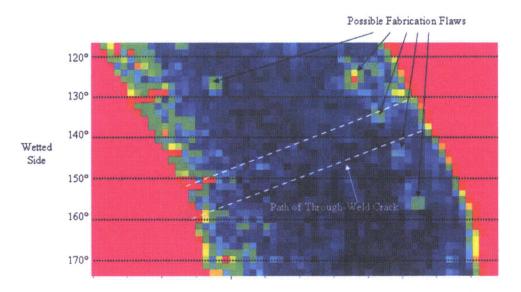
The ultrasonic inspection of the J-groove weld yielded no discernable signal from the through-weld crack. The UT data for the region around 135–155 degrees does show some likely fabrication flaws similar to the fabrication flaws found in the DE, such as in slice C10 (Figure 6.33). This lack of signal from the crack is interesting, as the crack is directly against the penetration tube for most of its length. The UT calibrations and the imaging of fabrication flaws in Nozzles 31 and 59 show that the UT can image small defects at the same depth into the weld metal. Even knowing exactly where to look, using the most sensitive frequency at the correct depth (5 MHz) and using high gain, it is not possible to find any significant crack signal. Figure 8.5 shows the 5-MHz results in the cracked area of the J-groove weld. The crack is in an unfavorable orientation, essentially presenting a knife's edge to the beam, which likely accounts for the lack of signal. It was known that the UT inspections would be less sensitive to an axially oriented flaw, and this has been confirmed by these inspections. Performing a UT inspection through the J-groove weld would need to use different angles to be sensitive to the axial cracks present in the weld.

Figure 8.5 5-MHz Ultrasonic Testing Data for the Cracked Region of the Nozzle 31 J-Groove Weld Metal

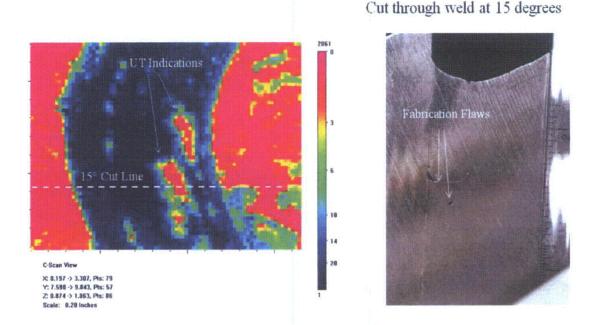
The zero-degree ultrasound was effective at detecting fabrication flaws. Some of the UT indications were intersected by the saw cuts. The cut faces showed the presence of welding flaws. One such exposed welding flaw at 15 degrees is shown in Figure 8.6.

Figure 8.6 PNNL UT Results Showing the Cut Line at 15 Degrees and the Cut J-Groove Weld Surface

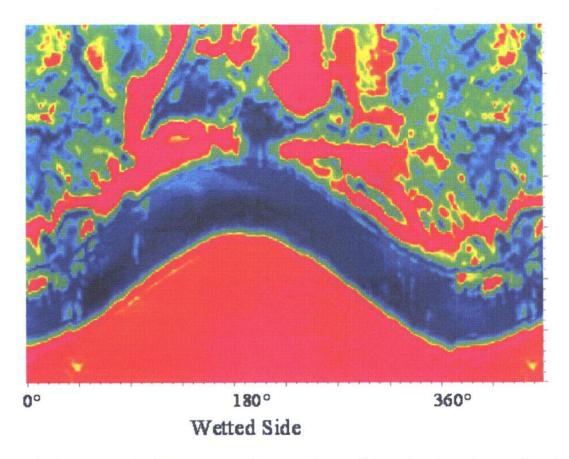
The ultrasonic data of the annulus and interference fit were obtained by PNNL while examining the J-groove weld. The data obtained by PNNL and industry (Figure 5.21) were very similar and showed the same pattern, including the river delta and apparent exit path. The industry-acquired data on the interference fit are shown in Figure 5.21. The data acquired by PNNL, with the region of interest focused on the annulus region, are shown in Figure 8.13. The ultrasonic data taken at PNNL were optimized for the J-groove weld, and the signal in the interference fit is often saturated, making it less quantitative.

Figure 8.13 PNNL-Acquired Data on the J-Groove Weld and Part of the Interference Fit of Nozzle 31 After the Nozzle Had Been Removed from the Head

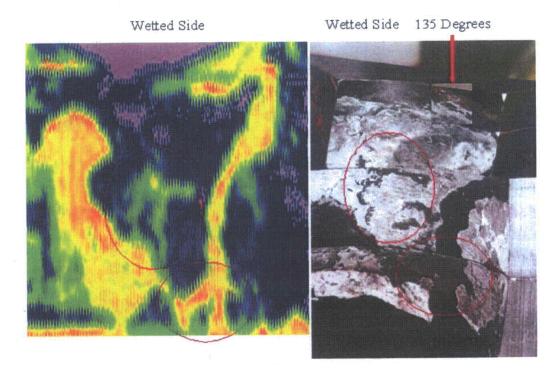
Despite the different techniques and goals, there are many similarities between the PNNL and industry data. Both data sets find the same pattern and the same signal that was called as a leakage path. When the ultrasonic data and the photographs of the annulus are compared, it is clear that the pattern of the boric acid deposits matches the ultrasonic data patterns. The called leakage path corresponds directly with the clean band in the annulus that starts near 90 degrees. Some of the other features in the boric acid deposit patterns are replicated in the UT data as well. Some correlations between the UT data and the boric acid pattern are shown in Figure 8.14.

Figure 8.14 Comparison of Boric Acid Patterns on the Carbon Steel Annulus and UT Patterns on the Left

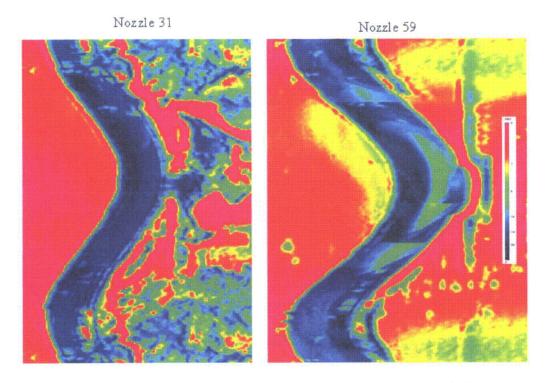
It is also useful to compare the results of a confirmed leaking nozzle such as Nozzle 31 with a likely non-leaking nozzle. PNNL performed similar UT examinations on Nozzle 59, which did not appear to have any through-weld leaks. The UT pattern in the annulus was very different than in Nozzle 31. In Nozzle 31, the UT revealed a complex pattern where the UT signal is transmitted and reflected, while in Nozzle 59, the annulus appeared to be a good reflector of ultrasound almost everywhere in the annulus. The difference in UT patterns is shown in Figure 8.16.

Figure 8.16 Comparison of the UT Patterns Found for the Interference Fit in Nozzles 31 and 59
