# TENNESSEE VALLEY AUTHORITY WATTS BAR NUCLEAR PLANT UNIT 2

**Refurbishment Program**

**August 6, 2009**

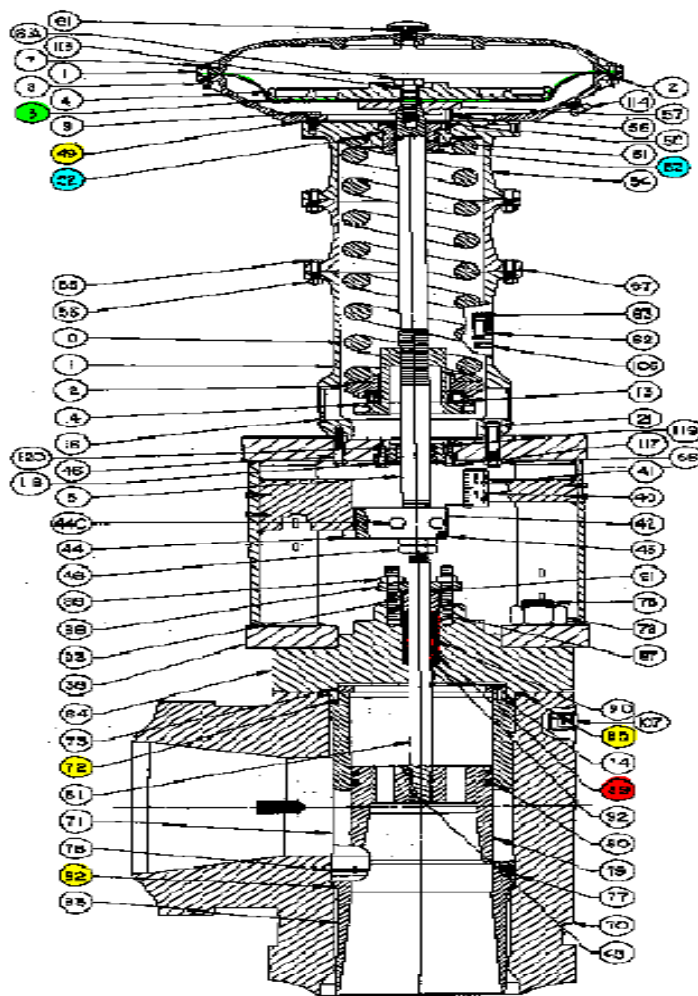
This valve is a 1 1/2", Hammel-Dahl, Globe valve with an A-40 Pneumatic Diaphragm type actuator. The items subject to refurbishment are the actuator diaphragm and valve packing
