### Seismic Walkdown Checklist (SWC)

Project: Byron 2 SWEL

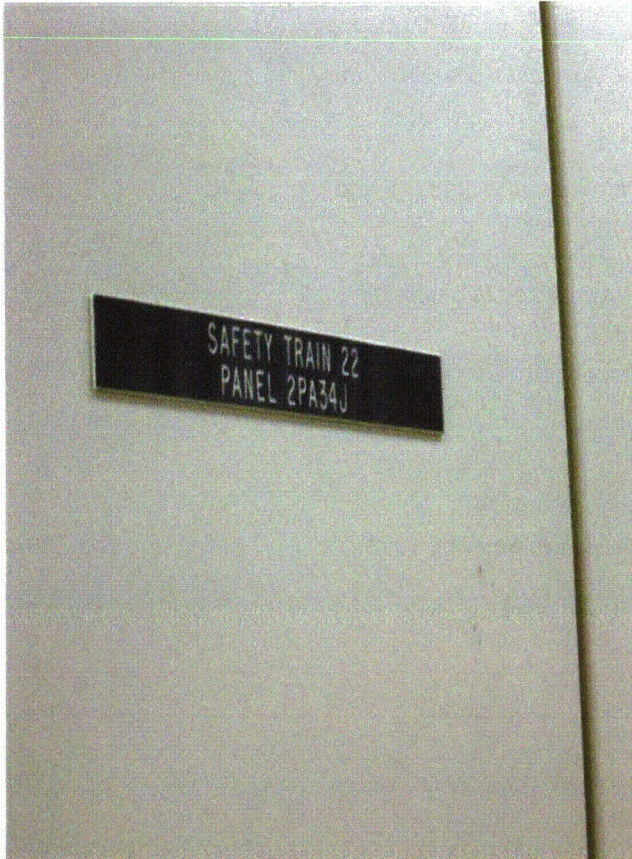
2PA34J Byron 1 & 2 082

6. Based on the above anchorage evaluations, is the anchorage free of potentially adverse seismic conditions? Yes  
*One side of exterior weld is visible due to loose cove molding. Interior weld also seen. (Cabinet opened) See discussion in Section 5 of report to address cove molding at anchorage detail. Anchorage is judged to be acceptable.

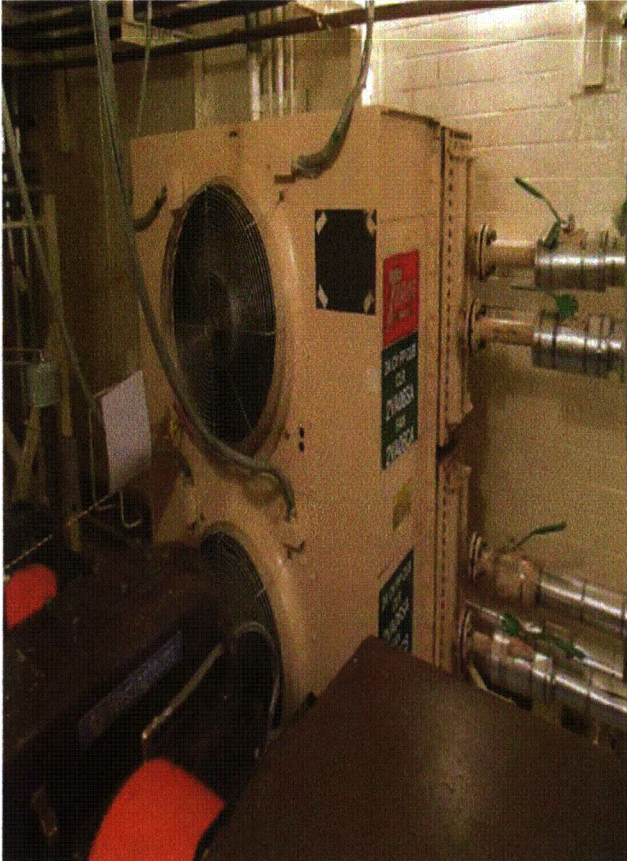
2VA06SA Byron 1 & 2 8-20-12 075

7. Are soft targets free from impact by nearby equipment or structures? Yes
8. Are overhead equipment, distribution systems, ceiling tiles and lighting, and masonry block walls not likely to collapse onto the equipment? Yes  
*Masonry walls are seismic and would not collapse on equipment*
9. Do attached lines have adequate flexibility to avoid damage? Yes
10. Based on the above seismic interaction evaluations, is equipment free of potentially adverse seismic interaction effects? Yes

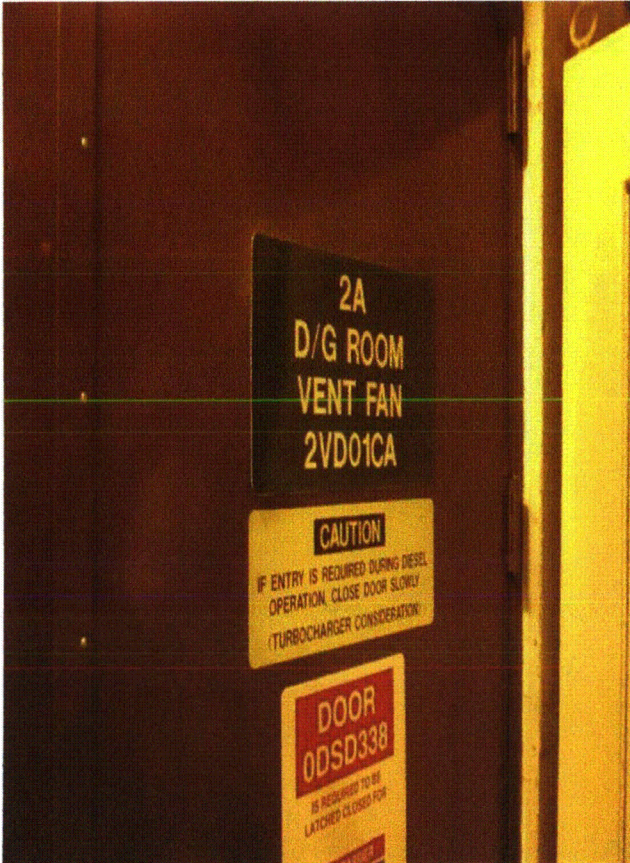
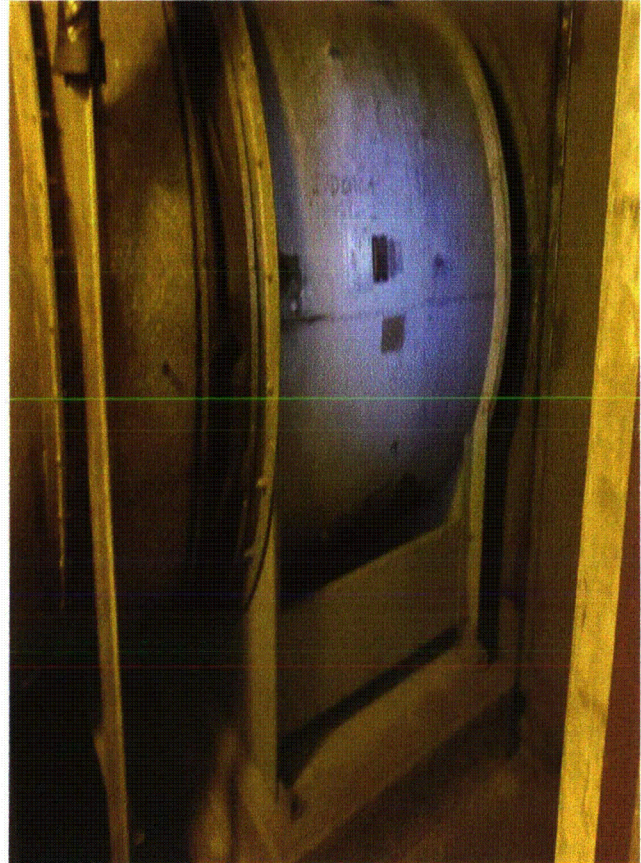
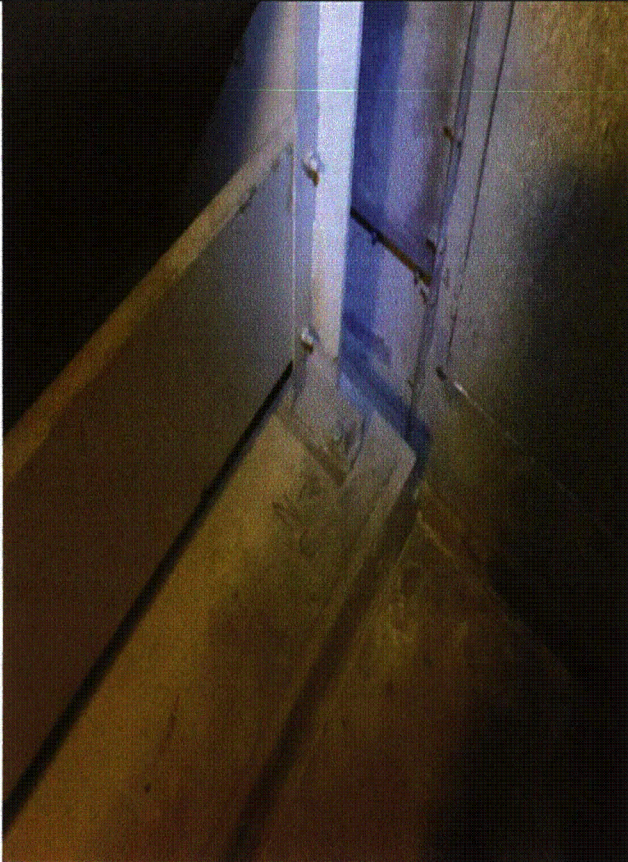
2VD01CA Byron 1 & 2 224

7. Are soft targets free from impact by nearby equipment or structures? Yes
8. Are overhead equipment, distribution systems, ceiling tiles and lighting, and masonry block walls not likely to collapse onto the equipment? Yes  
*Roof drain piping has Victaulic couplings but pipe is supported at each wall and at branch lines limiting displacement. Not a structural/seismic issue.*
9. Do attached lines have adequate flexibility to avoid damage? Yes
10. Based on the above seismic interaction evaluations, is equipment free of potentially adverse seismic interaction effects? Yes
