Subject: Advanced Copy of Exponent Report Summary

2. Principal Conclusions and Opinions

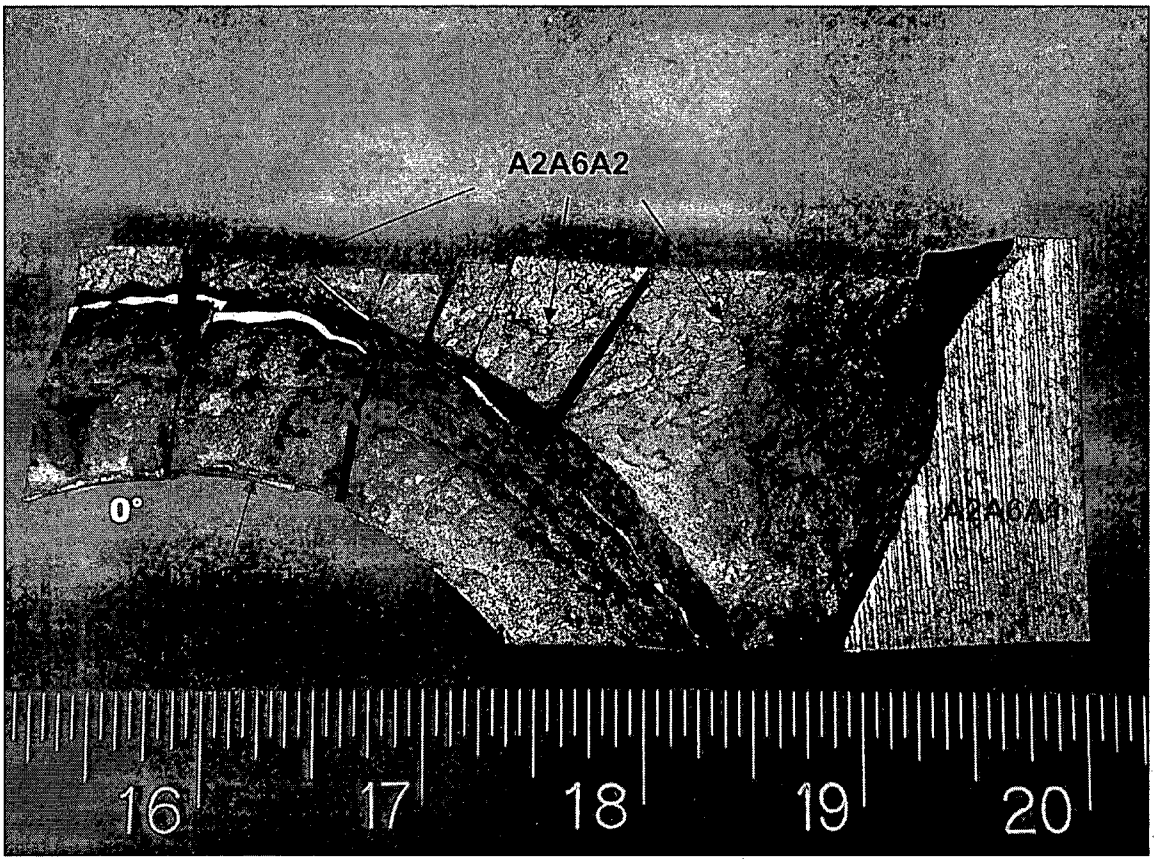
Figure 10.12 Piece A2A6 was first sectioned into Pieces A2A6A and A2A6B. Piece A2A6A was further sectioned into Pieces A2A6A1 and A2A6A2. Both cuts were made on the same plane, parallel to the paper. The first cut line is partially visible; Piece A2A6B is the upper portion of the weld. The second cut line between Pieces A2A6A1 and A2A6A2 is obscured by Piece A2A6A1

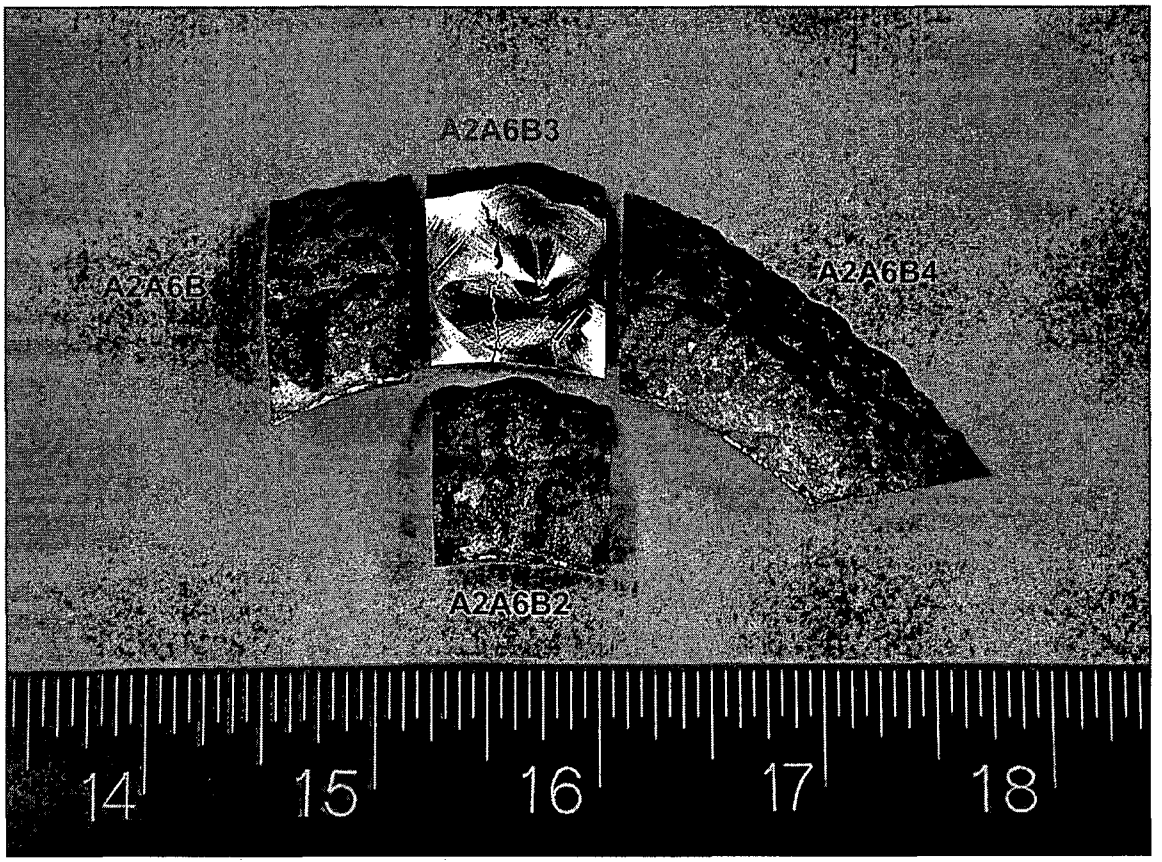
Figure 10.13 Piece A2A6B after sectioning. The bottom surface of A2A6B2 was mounted. The axial crack in A2A6B3 was opened up for SEM.

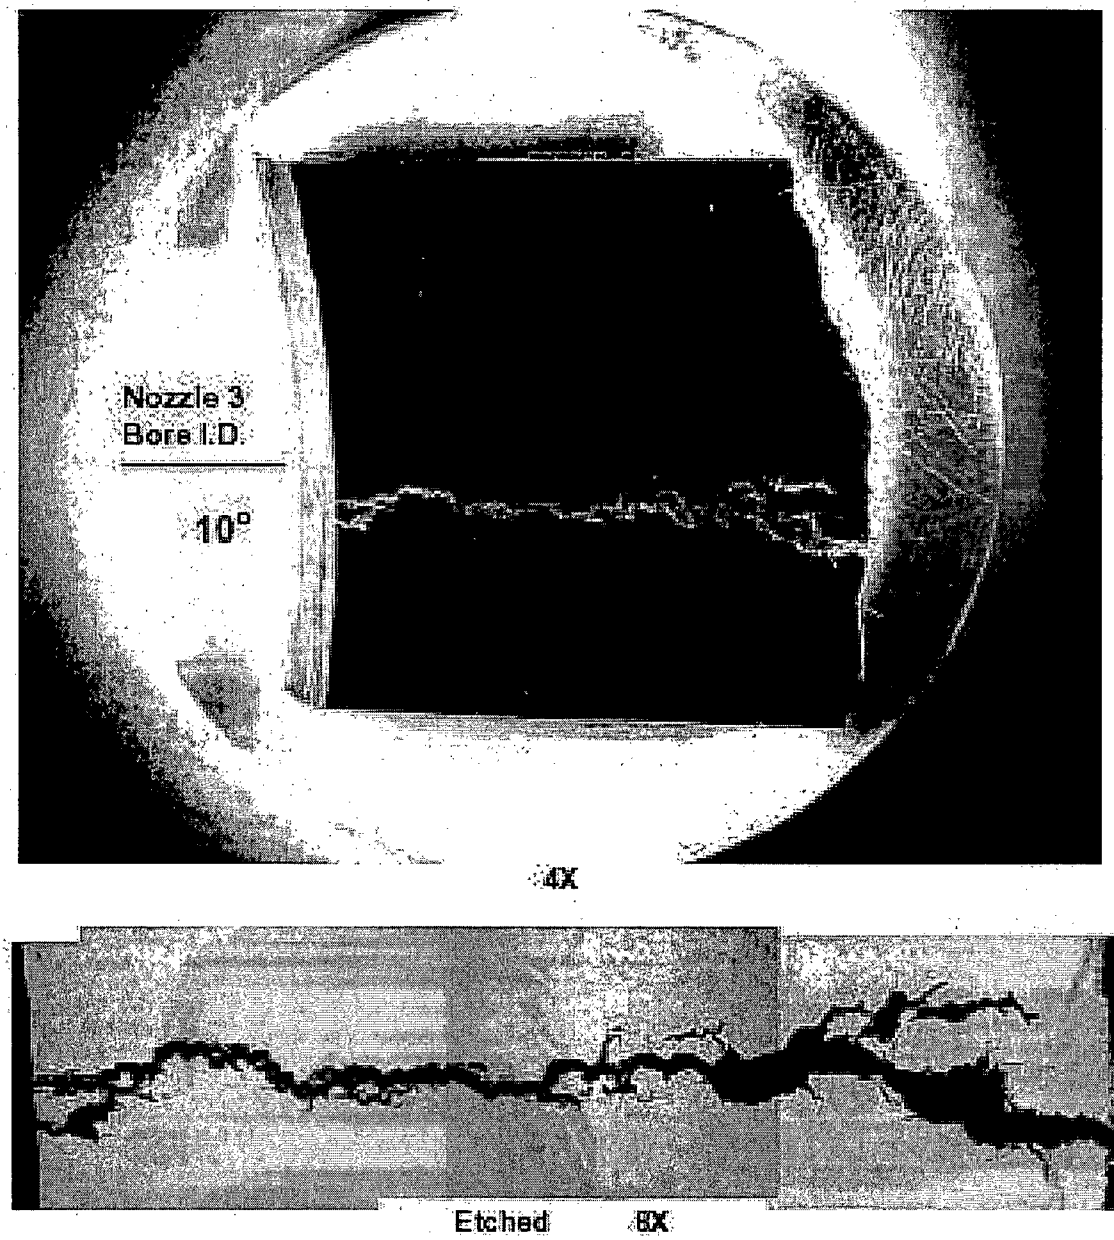
Figure 10.14 Macro photograph of metallographic mount sample A2A6B2 (see Figures 5.4 and 5.5 for the sample orientation). The axial cracking at ~10° is through the J-groove weld, in contrast to the cracking near 180°, which was partially through the weld. A slightly higher magnification micrograph is also provided
