Progress Energy Carolinas  
**Shearon Harris Nuclear Power Plant  
 Units 2 and 3  
 Part 2, Final Safety Analysis Report**  
 New Hill, North Carolina

Geologic Map and Structural Data for the  
 North and South Borrow Pits

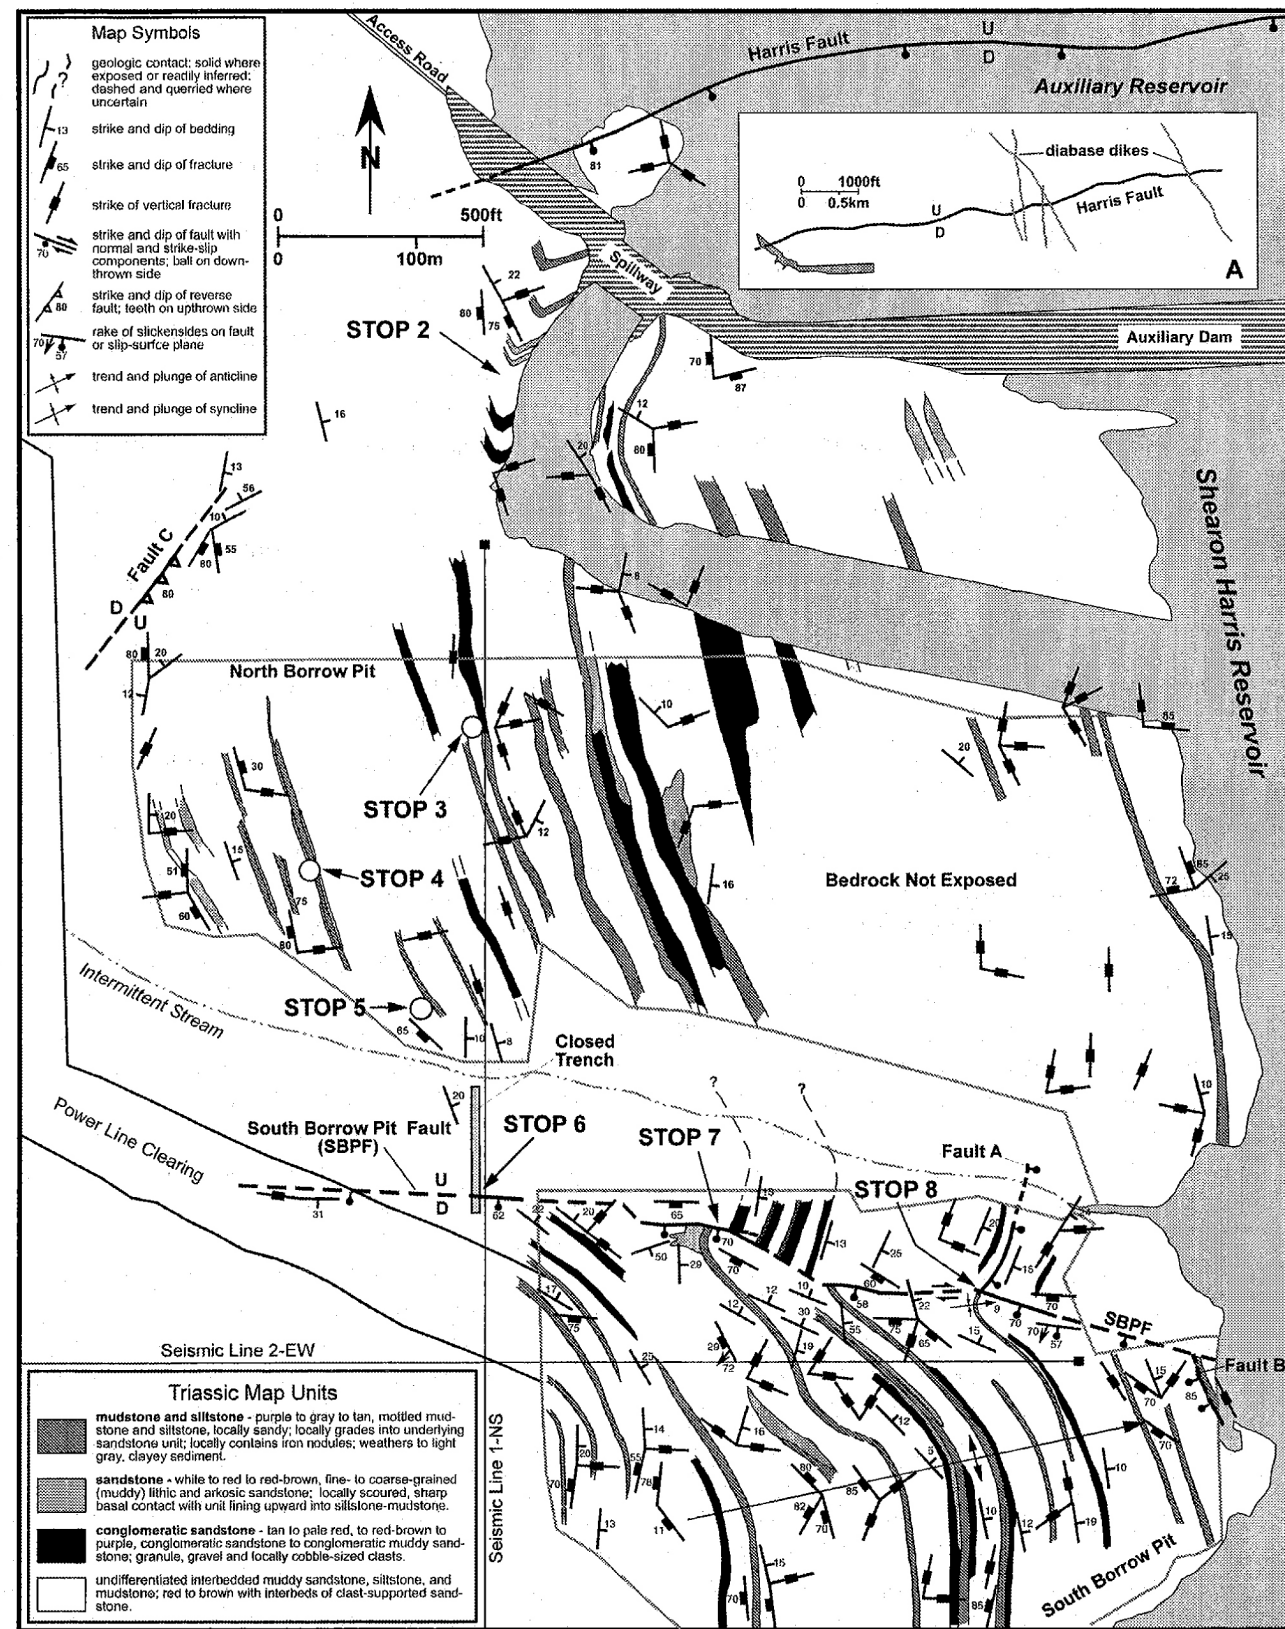
Generalized bedrock geologic map of the north and south borrow pits. Inset A shows the trace of the Harris fault to the east of the map area (from Ebasco Services, Inc., 1975).
