Clinch River Nuclear Site
Early Site Permit Application
Part 3, Environmental Report

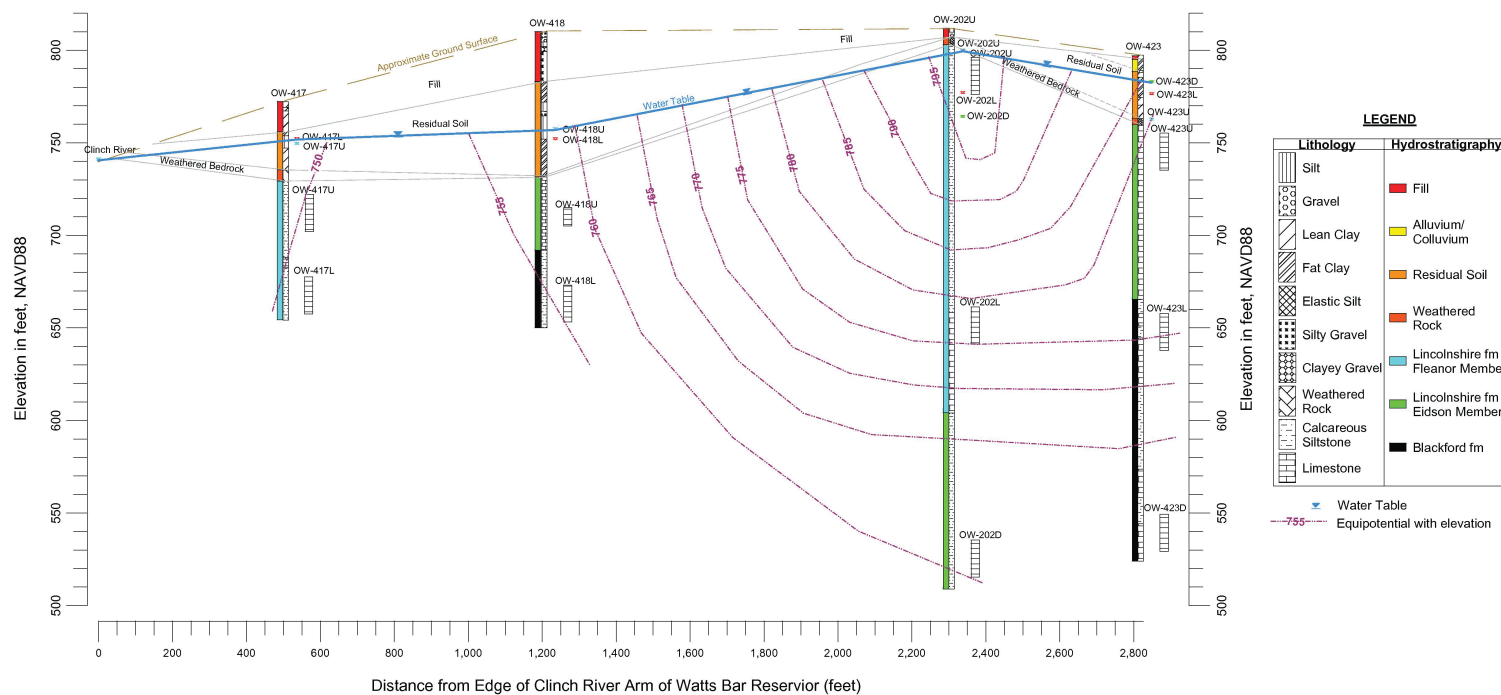
Figure 2.3.1-43. Snapshot in Time Showing Equipotential Lines in the Vertical Plane Along the Strike of the Bedding Plane on June 13, 2014

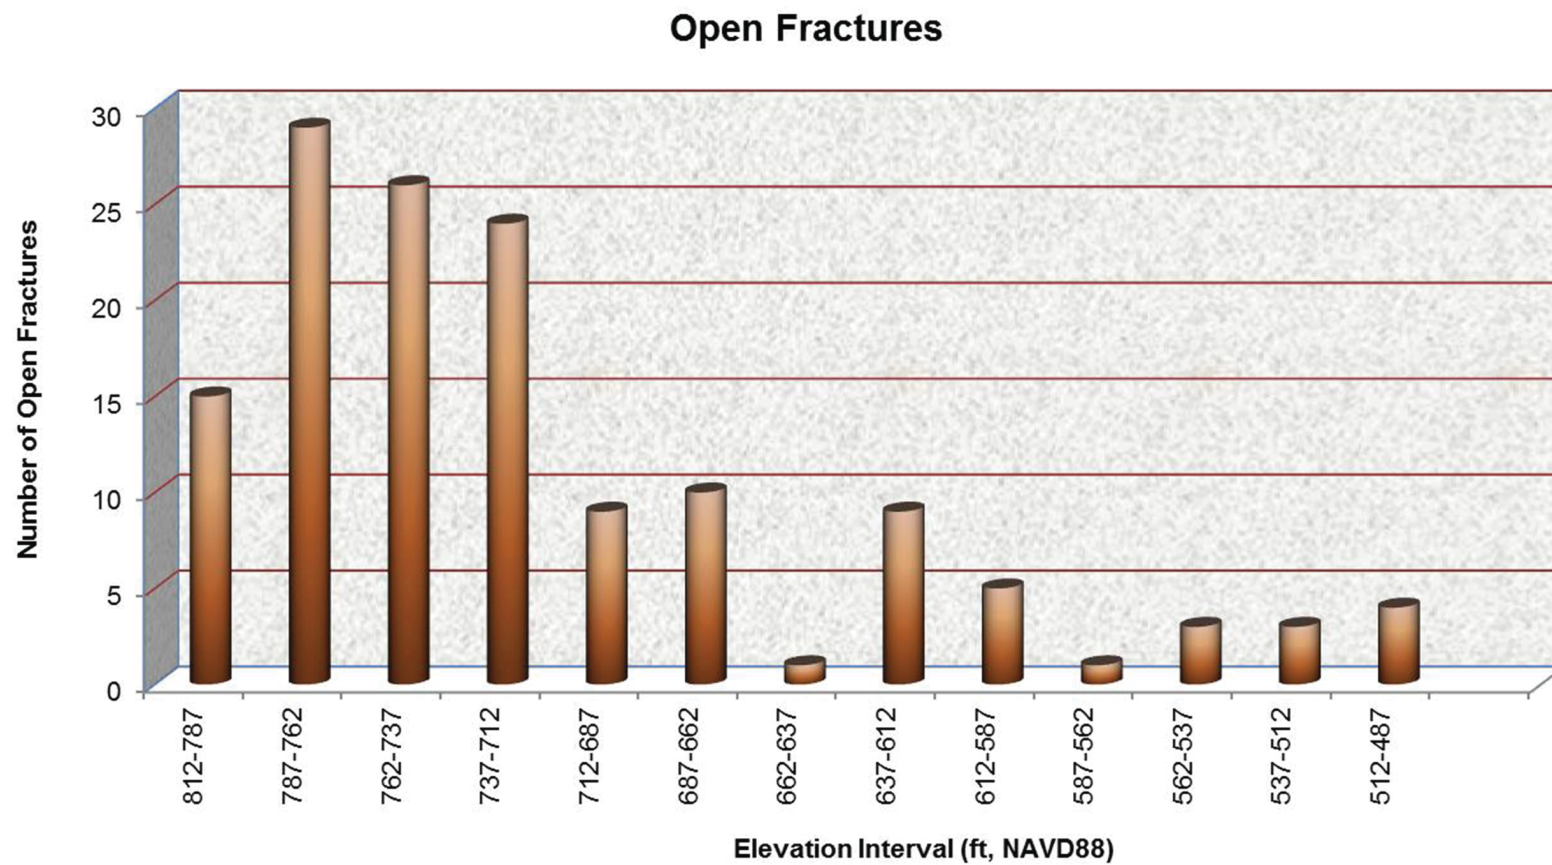
Figure 2.3.1-44. Fracture Frequency Histogram

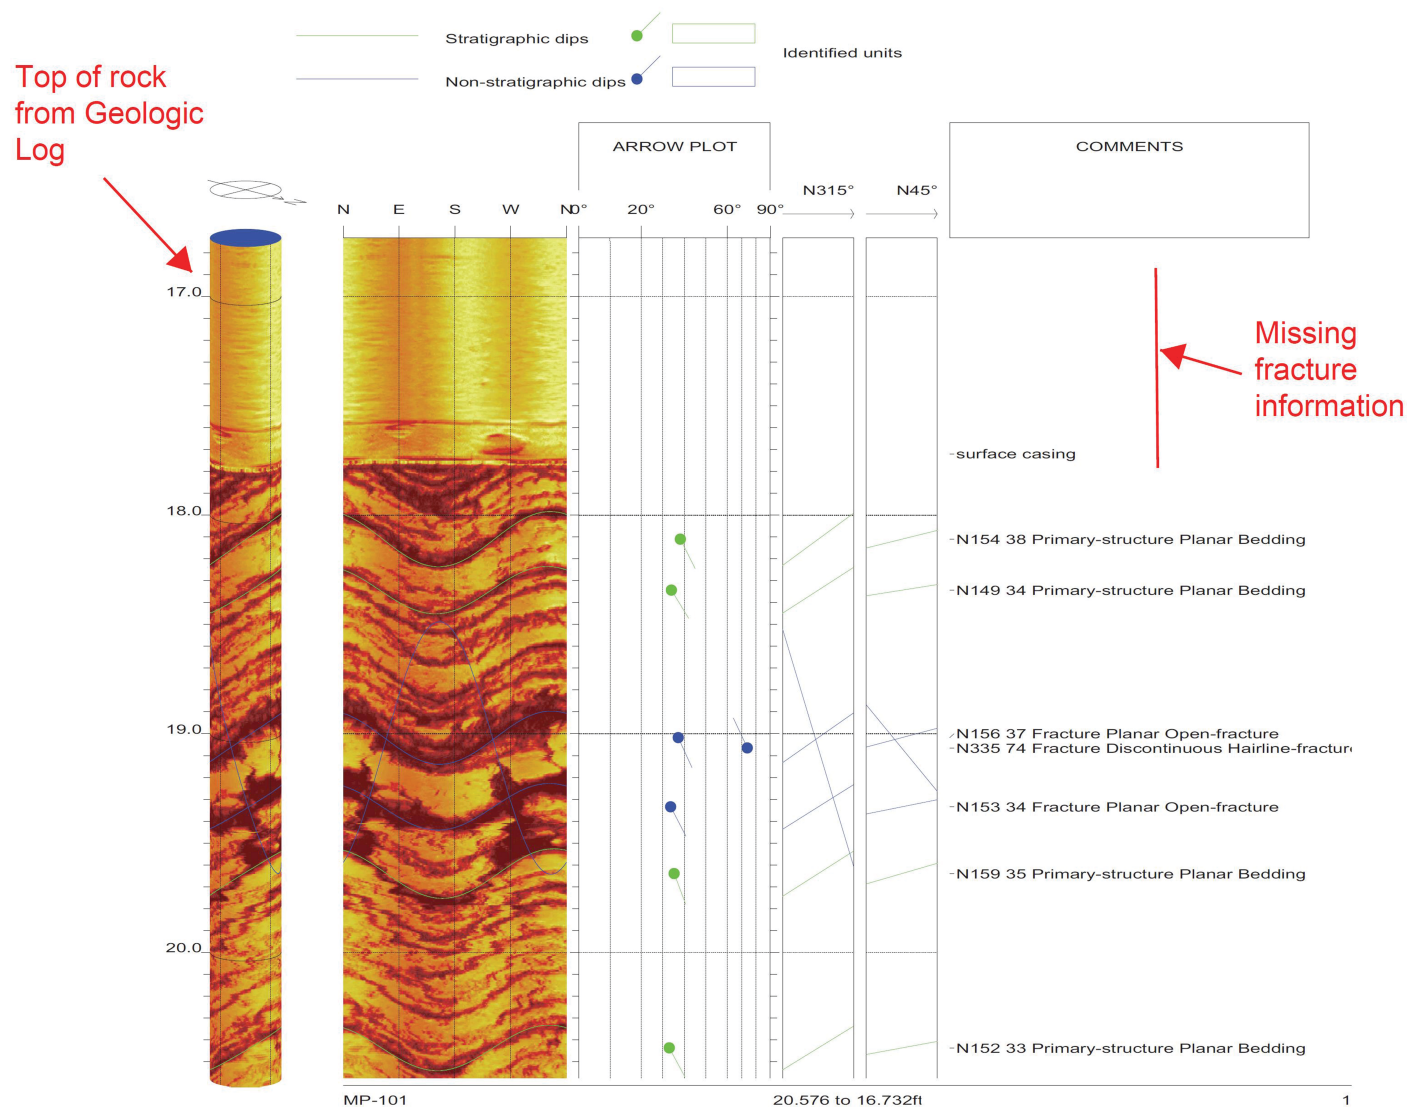
Adapted from: (Reference 2.3.1-21)

Figure 2.3.1-45. Example Acoustic Televiewer Geophysical Log

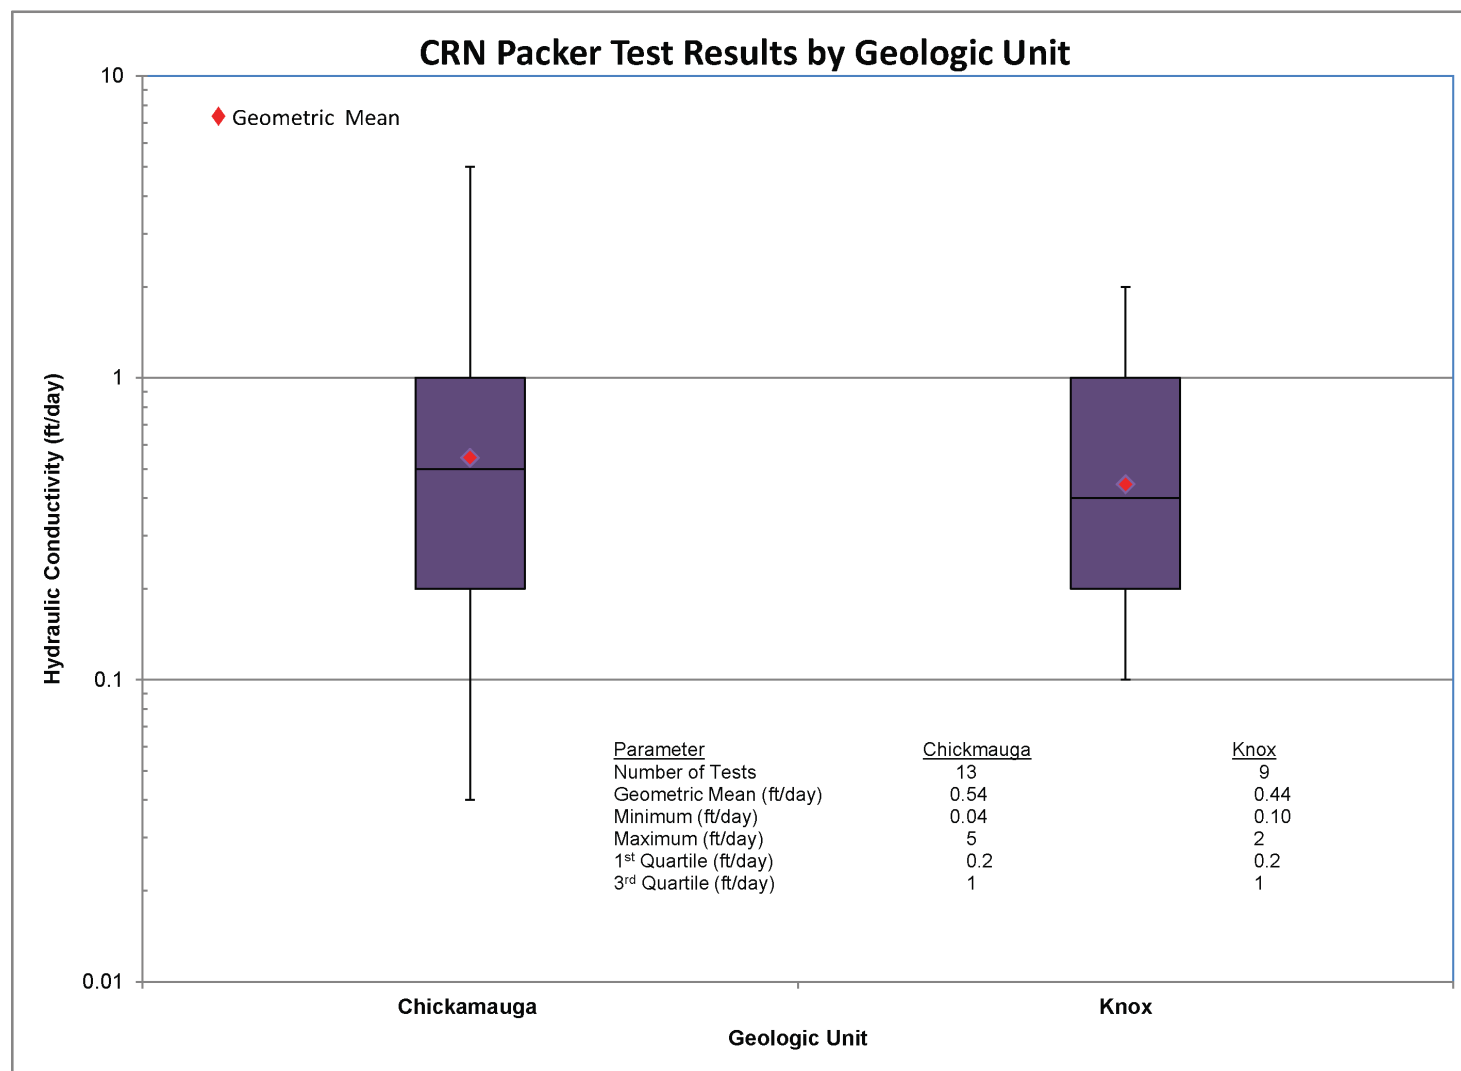
a) Box and whisker plot of CRN packer test results by geologic unit. Data from Table 2.3.1-5 and Appendix 2.3-B

Figure 2.3.1-46. Clinch River Nuclear Borehole Packer Test Results Box and Whisker Plots (Sheet 1 of 2)

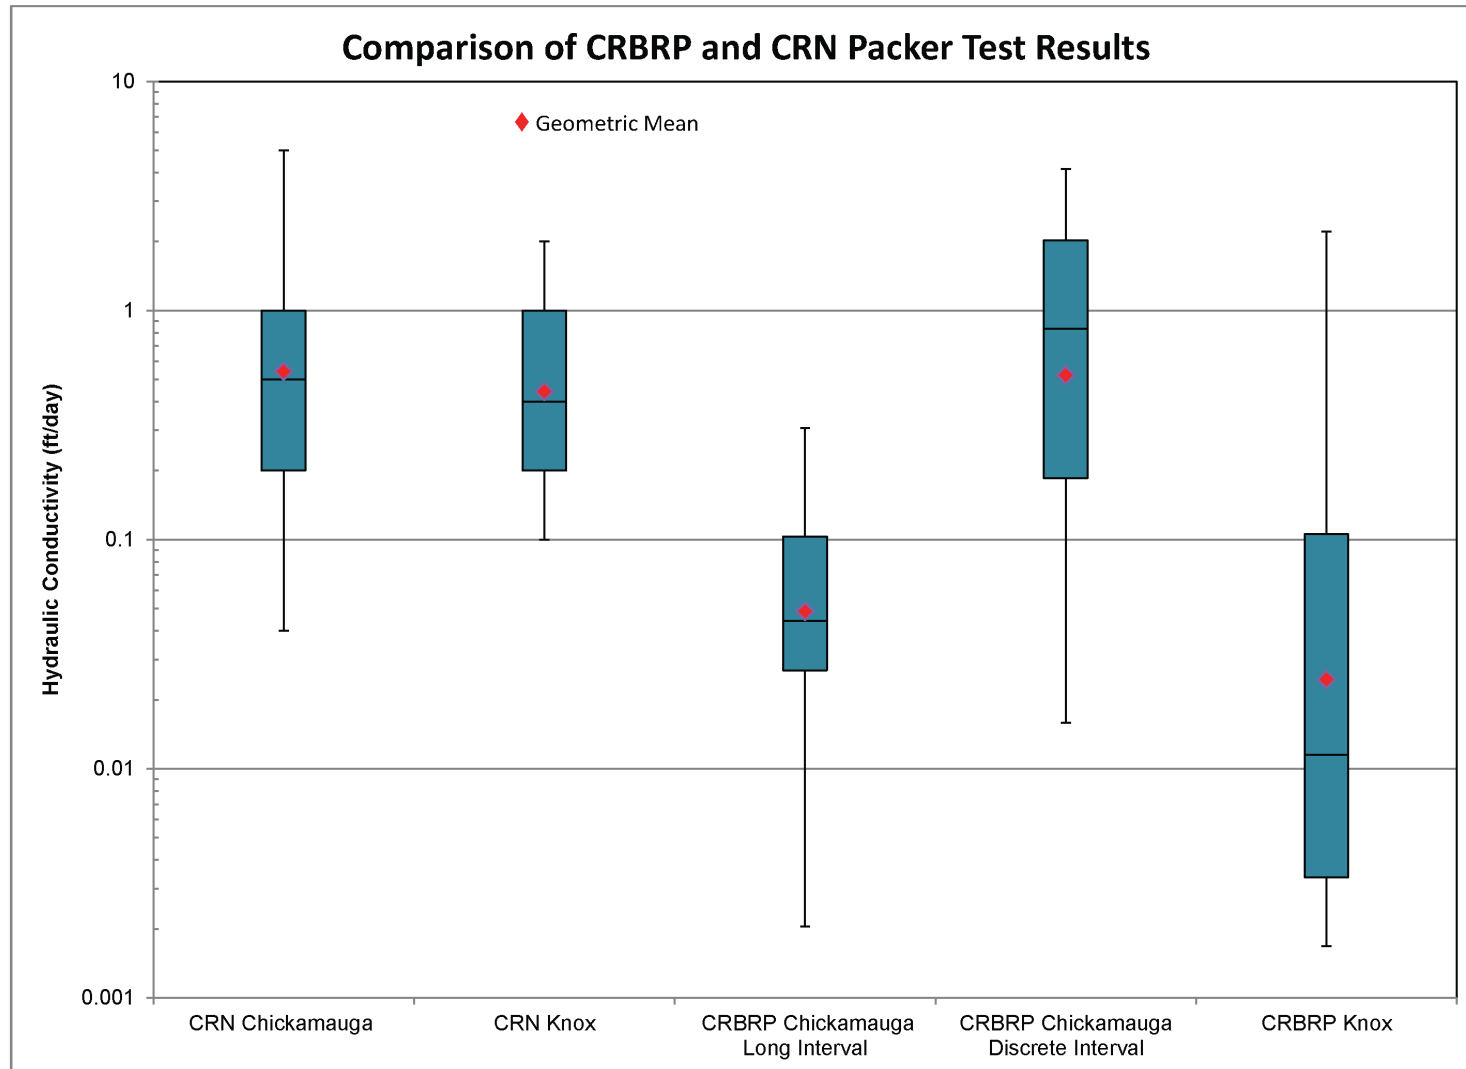
b) Box and whisker plot comparing CRN packer test results with CRBRP packer test results. Data from Table 2.3.1-5 and Appendix 2.3-B

Figure 2.3.1-46. Clinch River Nuclear Borehole Packer Test Results Box and Whisker Plots (Sheet 2 of 2)

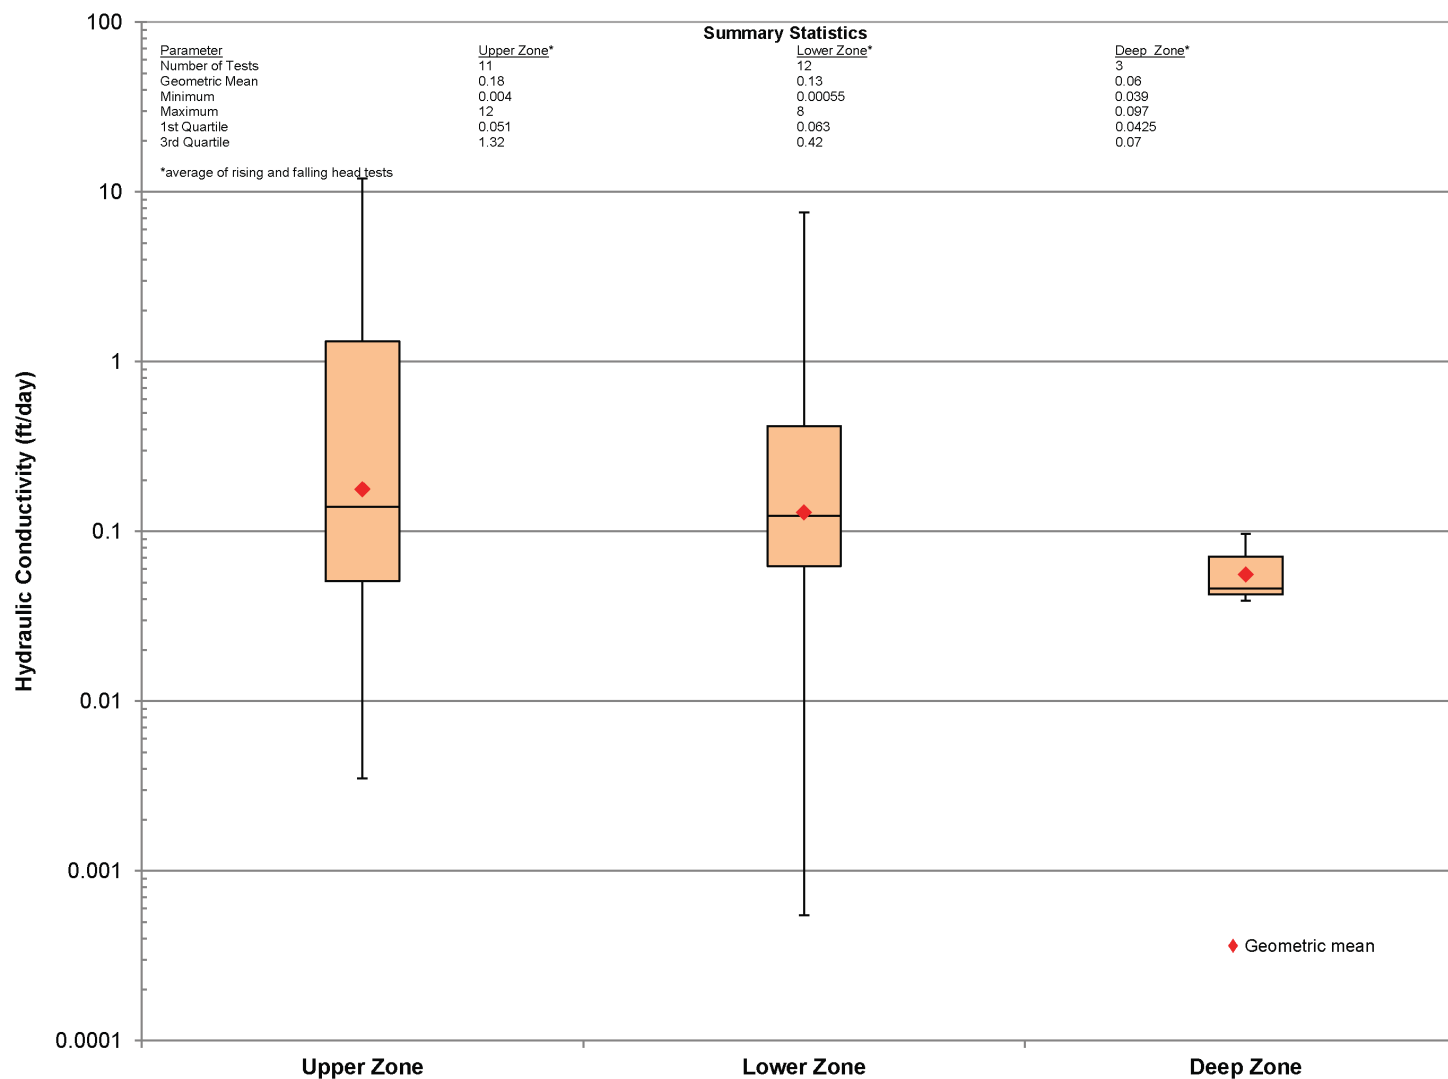
a) Box and whisker plot of slug test hydraulic conductivity by observation well monitoring zone. Data from Table 2.3.1-6

Figure 2.3.1-48. Slug Test Results for CRN Site (Sheet 1 of 2)

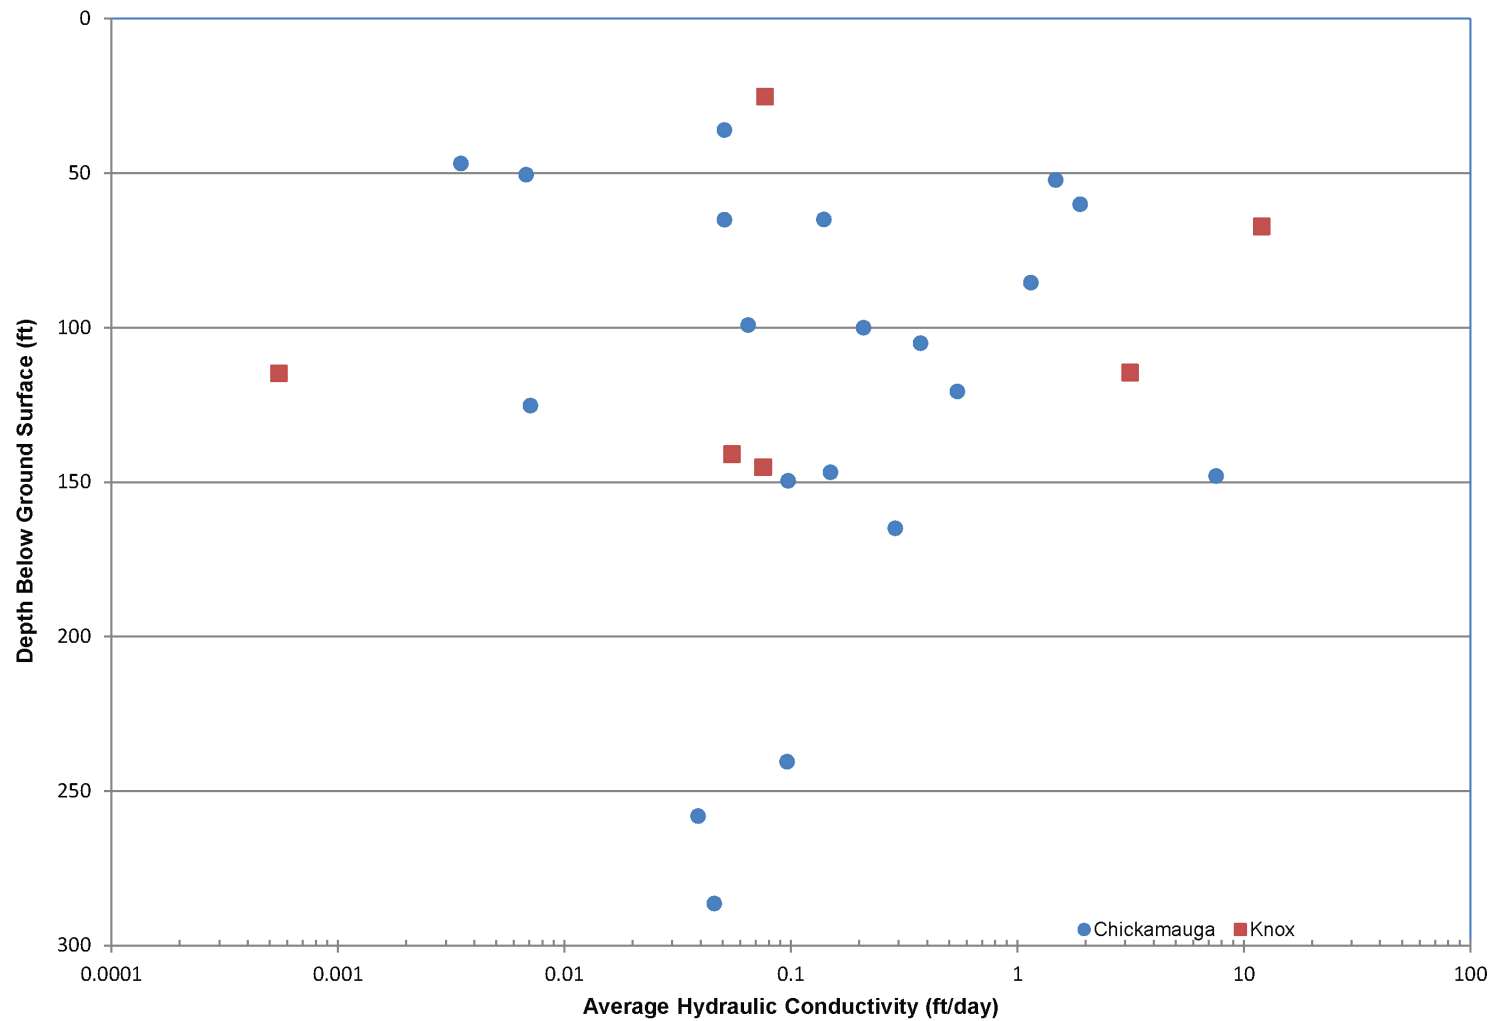
b) Scatter plot of slug test hydraulic conductivity with depth below ground surface. Data from Table 2.3.1-6

Figure 2.3.1-48. Slug Test Results for CRN Site (Sheet 2 of 2)

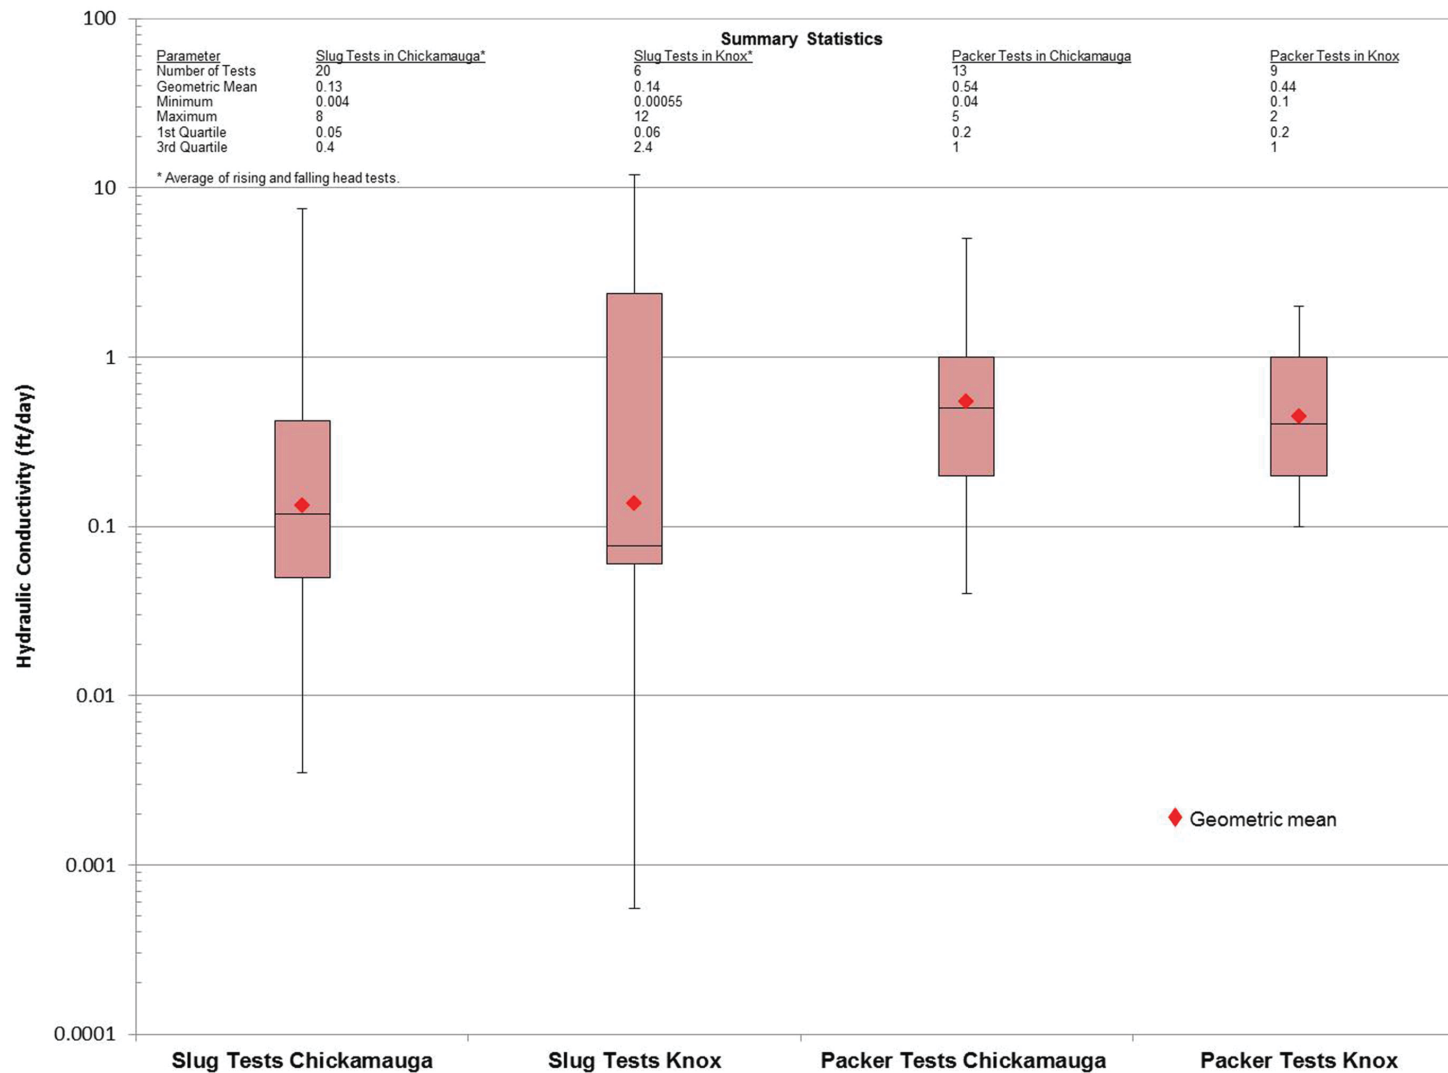
Figure 2.3.1-49. Comparison of Slug and Packer Test Results
