NRC INSPECTION MANUAL

OPERATING EXPERIENCE SMART SAMPLE (OpESS) 2018/01

EVALUATION OF LICENSEE ACTIONS TAKEN IN RESPONSE TO 10 CFR PART 21 NOTIFICATION OF THE POTENTIAL EXISTENCE OF DEFECTS RELATED TO CONTROL ROD DRIVE MECHANISM (CRDM) THERMAL SLEEVES

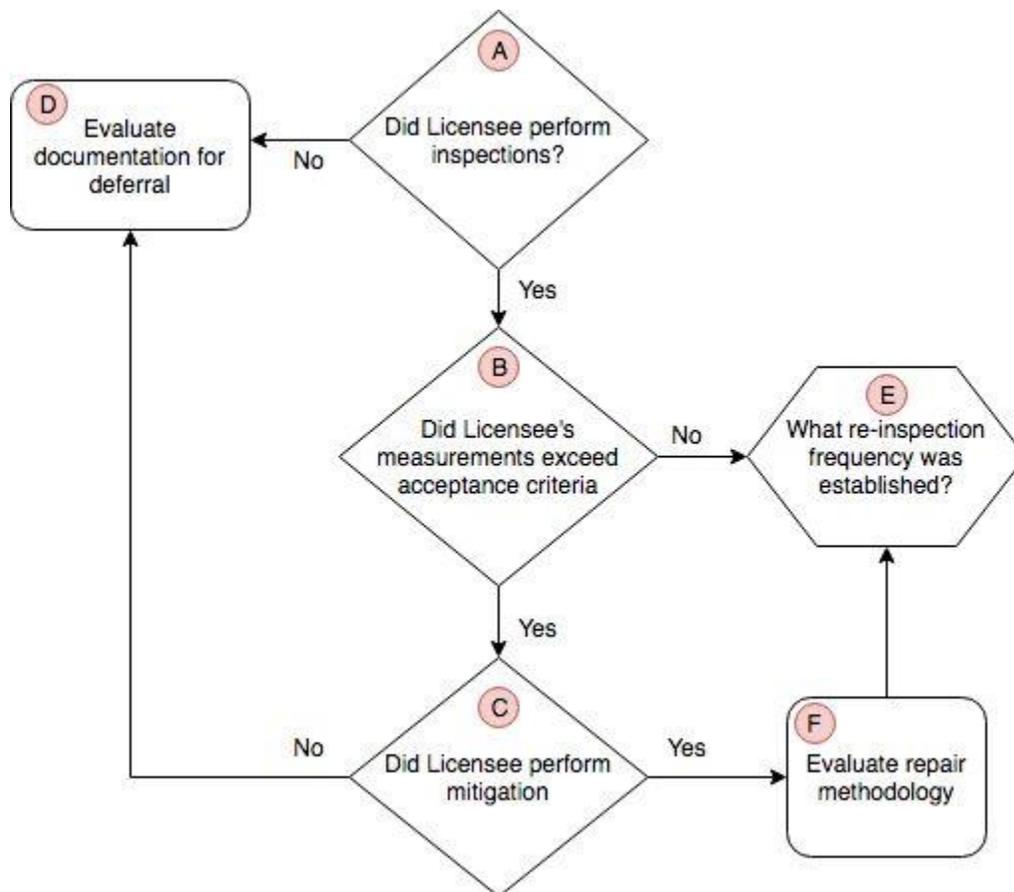
The guidance for this inspection follows the flowchart shown in Figure 1. This guidance is provided to help inspectors evaluate the effectiveness of licensee collective actions in response to NSAL-18-1. A description of the inspection and reporting expectations are as follows:

- a. Determine if the licensee performed initial inspections for CRDM thermal sleeve wear
 1. Did the licensee perform measurements of the lowering of all thermal sleeves using a method that is capable of determining the relative distance between a known reference point on the head and the bottom surface of the thermal sleeve guide funnel?

- f) Wear rate
- b. Determine if the licensee's measurements exceed acceptance criteria
 1. Determine if licensee used acceptance criteria in PWROG-16003-P or plant specific criteria was used.

- c. Review the licensee developed mitigation or repair plans
 1. Review mitigation or repair plans to determine if licensee considered actions to ensure the plant remains consistent with their license renewal commitments. Specifically, has the licensee initiated actions to evaluate this issue for incorporation into License Renewal Programs that are credited for management of age related degradation that affects vessel internals components?

- e. Review re-inspection frequency
 1. Did the licensee develop a re-inspection frequency based on the measurements and calculated wear rates from A. and any plant-specific data used to develop plant-specific acceptance criteria (as applicable from B.).

2. Does the re-inspection frequency ensure the plant remains consistent with its license renewal commitments?
 3. Did the licensee develop a mitigation plan?
